DESIGN AND ACCESS HERITAGE STATEMENT in support of applications for Listed Building Consent

81B ALBERT STREET, LONDON NW1 7LX

September 2013

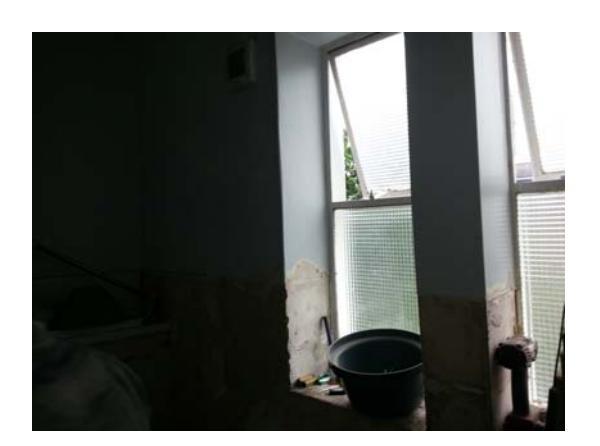
The only alteration to the building fabric occurred probably at the time of its conversion from family house into two flats, when a bathroom and kitchen were introduced to the rear rooms of the newly created top flat no. 81B, which is the subject of this application. For some reason, the construction of the bathroom prompted the removal of the original sash window. The window brick opening was reduced in height by insertion of the concrete lintel below the head arch which is still in place, the window cill was raised by two brick courses and a single brick post was inserted in the middle of the opening. Two Crittall type universal section metal frame windows with obscure Georgian wire glass were positioned on each side of the post. The introduction of the kitchen at the rear bedroom on the first floor had damaged the window architraves as they were cut short to allow insertion of the kitchen units. (Figure 1)

Figure 1 – Metal windows in 2^{nd} floor bathroom

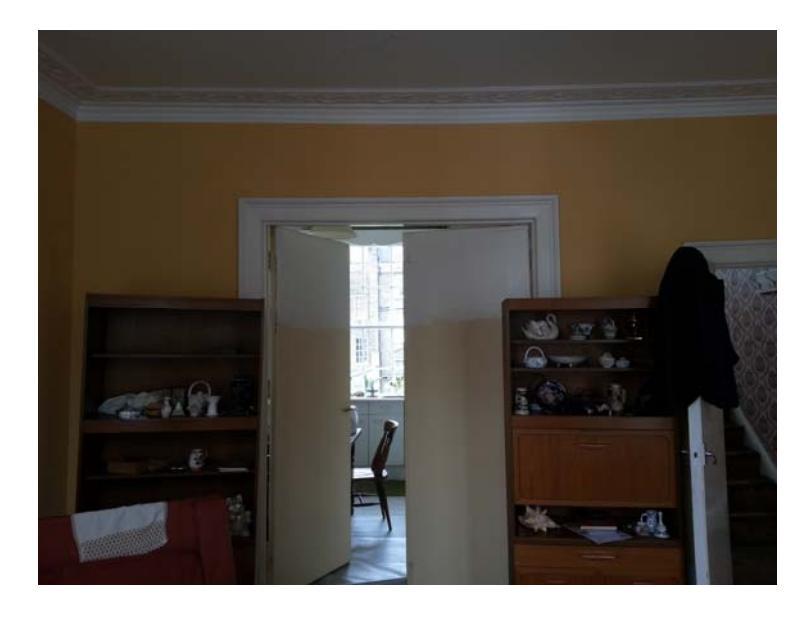
Figure 2 – 1st floor double door opening between kitchen and living room

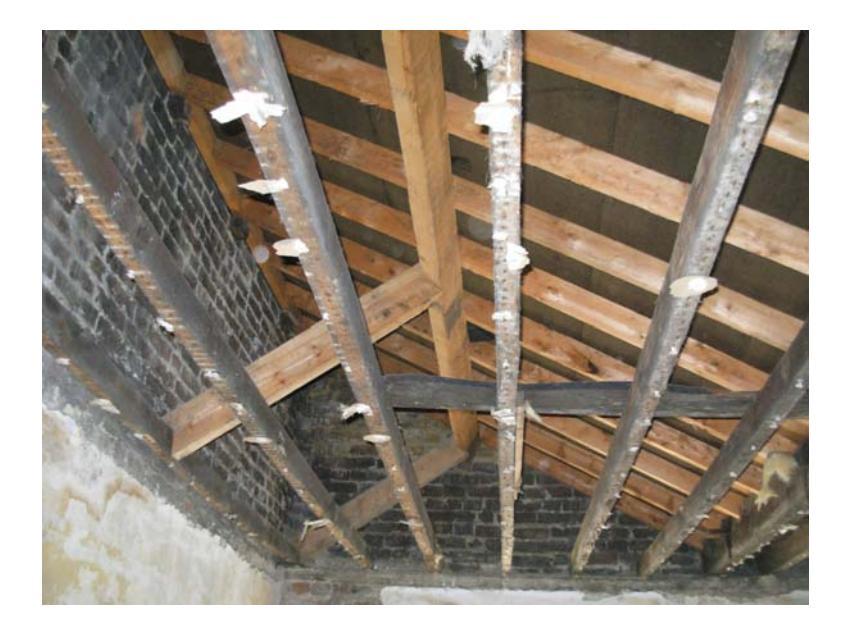
It is evident that significant work was undergone into the reparation of the butterfly roof which was probably carried out within the last 20 years. Many original timber roof elements have been changed due to dilapidation of the structure caused by prolonged water penetration. Works on the roof and water damage have probably entailed the removal of the original lime and lath plaster finishes from the top floor ceiling and stud partitions and their replacement with modern plasterboards. The original cornices have also been removed in the process. (Figure 3)

Figure 3 – Recent butterfly roof structure

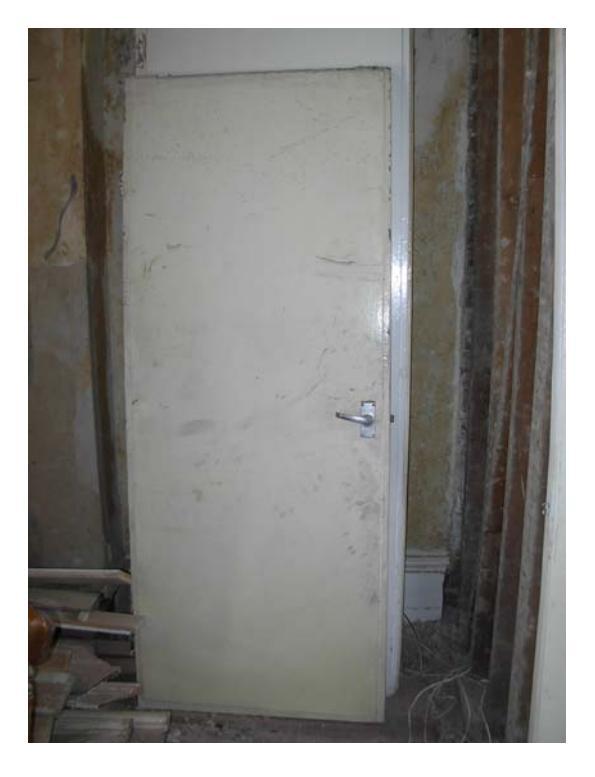
Figure 6 – Doors

All original doors to be stripped out of hard board panels from either side, repaired, decorated and reinstated in their original position.

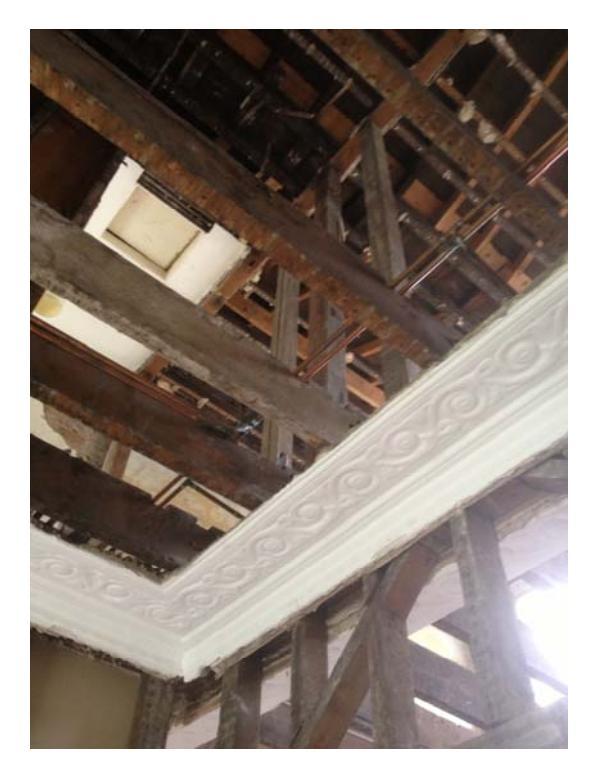
Figure 7 – 1^{st} floor cornices retained

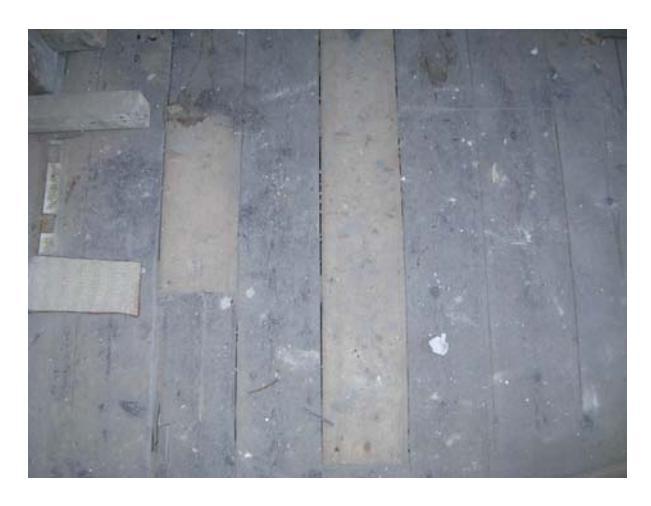
- The floor boarding is unchanged. Softwood floorboards, 175mm x 22mm locally damaged. (Figure 8)
- The chimney places are blocked at this level; the date of this alteration is not apparent but was not executed under the recent works. (Figure 9)
- Perimeter walls with original lame plaster finish in sound condition with some hair line cracks.
- Original window sashes and architraves in fair condition requiring local repairs. (F 10)
- Window architraves at the rear elevation where the kitchen use to be are cut through.

Figure 8 – 1st floor flooring

The original boards found on the first floor are largely intact and are to be retained and locally repaired where required with soft board to match existing. See drawings nos. 300/001 & 101

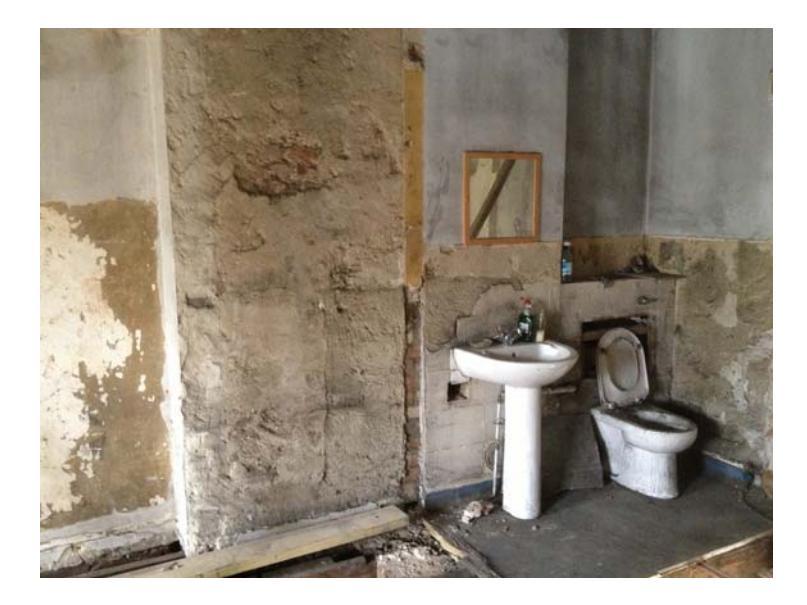
- The floor where the bathroom was is currently in plywood sheets, but most of the original floorboards have been removed, though remnant softwood floorboards, 175mm x 22mm, are found adjacent to the stairwell. (Figure 12)

Figure 12 - Remnant plywood flooring in 2nd floor bathroom

The new floor finish is proposed to be in butt jointed, salvaged floorboards, min width 175mmand 22mm thick, in either pitch pine or Scandinavian redwood fixed with cut metal nails. The material size range is taken from remnants adjacent the stairwell at second floor level. The wood is to receive a wax finish on the upper surface and to be treated on the underside to prevent cupping or warping.

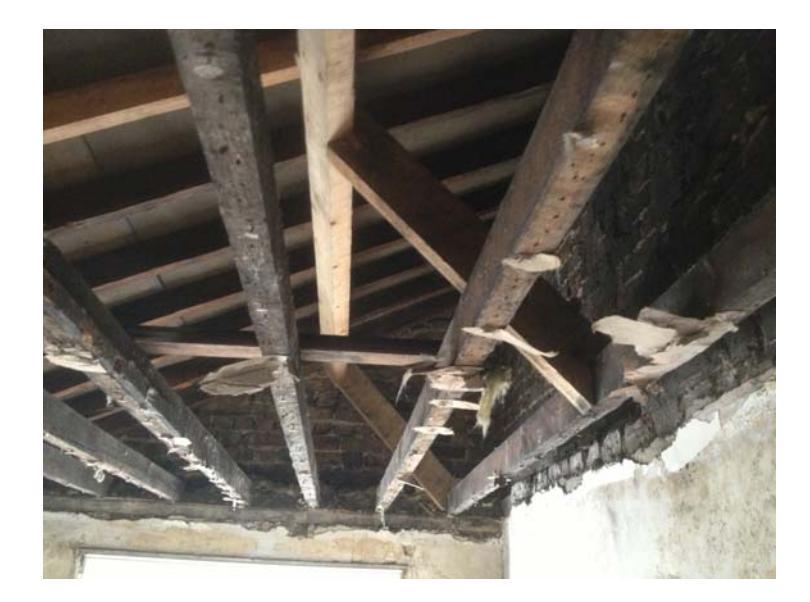
- Removal of plasterboard ceiling finishes. Evidence suggests that this ceiling was in lime and lath at the time of the roof repairs some time ago as there is no scarring from fixings other than those for timber laths. (Figure 13)

Figure 13 – 2^{nd} floor ceiling removed with plasterboard remnants and previous marks of lime and lath structure

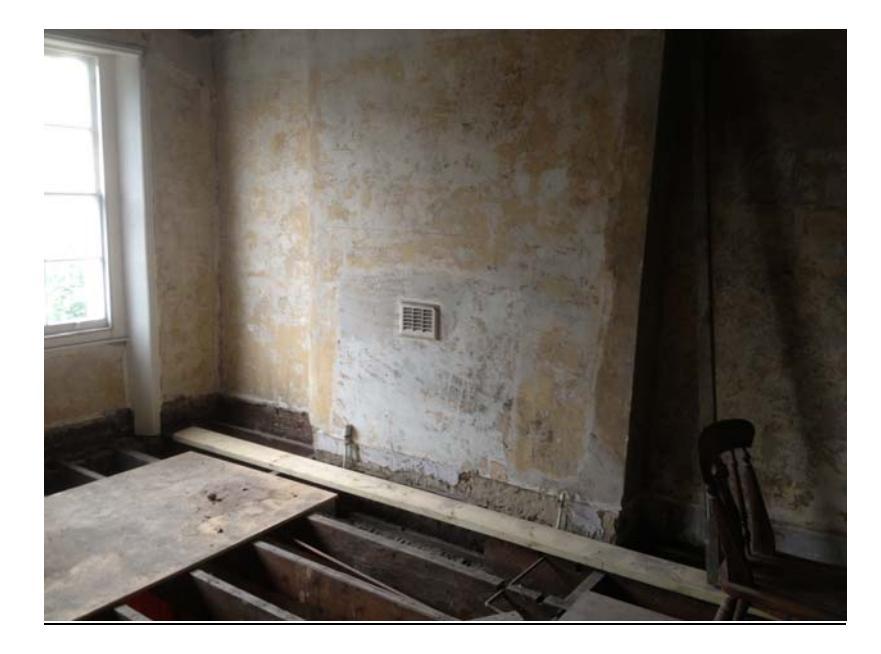
- The chimney places are blocked at this level; the date of this alteration is not apparent but was not executed under the recent works. (Figure 14)
- Perimeter walls with original lime plaster finish in sound condition with some hair line cracks. (Figure 14)
- Original window sashes and architraves in fair condition requiring local repairs. (Figure 15)

Figure 14 – Current state of rooms on 2nd floor

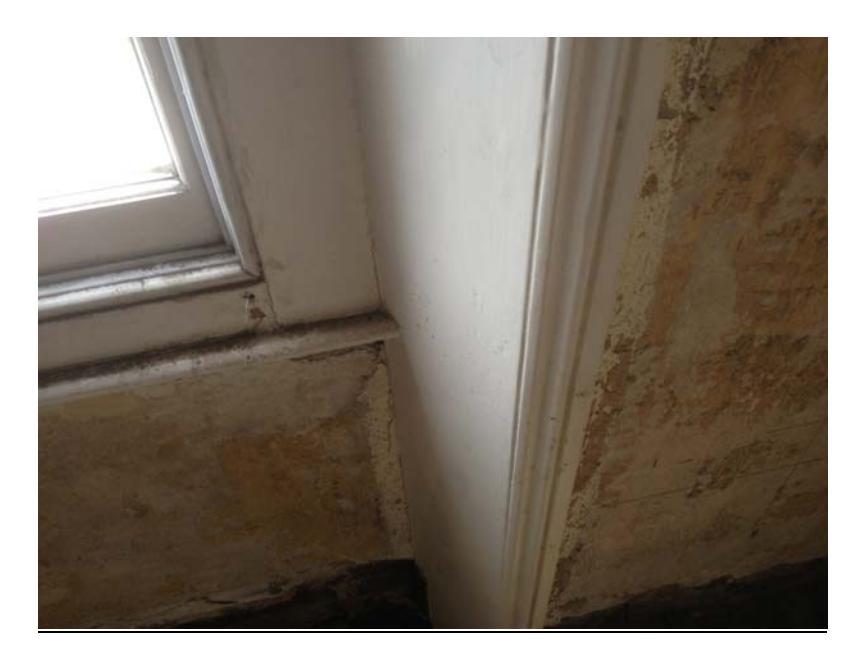
Figure 15 – window sash and architrave on 2^{nd} floor

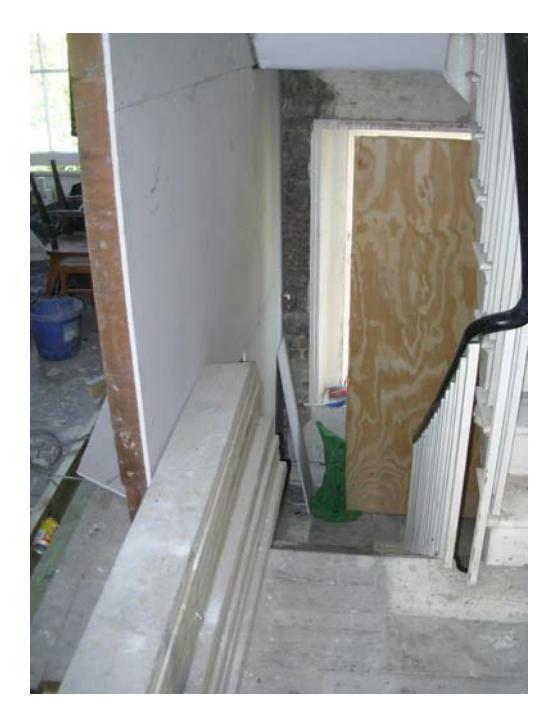
• Part replacement of lime and lath finishes to the existing stud wall dividing the stairwell from the rear room at the ground to first floor flight with modern plasterboard. (Figure 16)

Figure 16 – Lime and lath plasterworks replaced with new plasterboard

Stud wall partitioning is to be finished in traditional lime plaster on split timber lath. The proposal is made on the basis that a traditional finish was removed during the recent works.

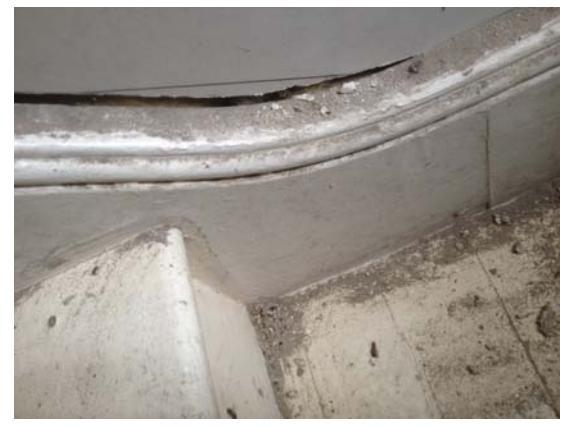
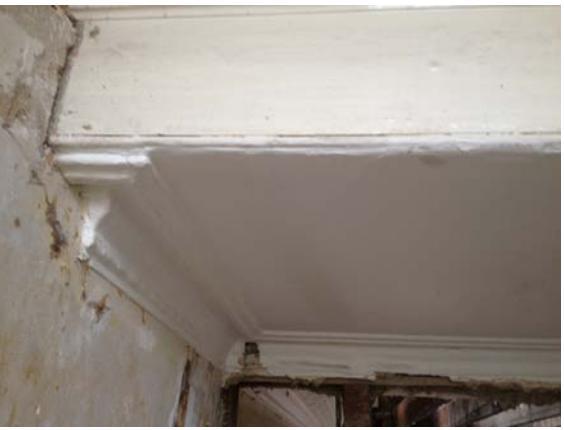
- Existing floorboarding remains at both first and second level landings. The boards would once have been continuous across the rooms at each level, but have been cut through at the dividing wall. The boards are damaged locally.
- Joists forming the first and second floor structures remain and are in fair condition.
- The staircase remains. The nosings damaged locally. (Figure 16)
- The balustrading remains. (Figure 16)
- Original window sashes and architraves in fair condition requiring local repairs
- Perimeter walls with original lame plaster finish in sound condition with some hair line cracks. (Figure 17)

Figure 17 – Original lime plaster on perimeter wall, skirting and cornice

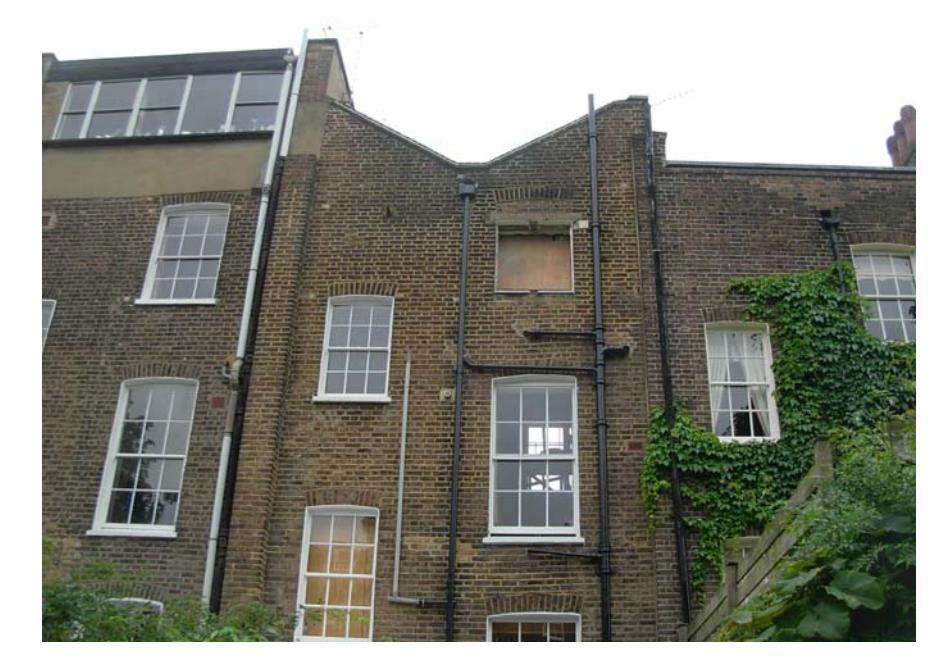
Figure 18 - Rear elevation

Drawings of the rear elevation illustrate schedules of local repairs to be executed to the brickwork facings and stone dressings. Alien elements and individual damaged bricks are to be carefully cut out and replaced using salvaged mixed stock brickwork bedded in hydraulic lime mortar. See drawing no. 300/003 & 103 and attached document "Brick samples and specification".

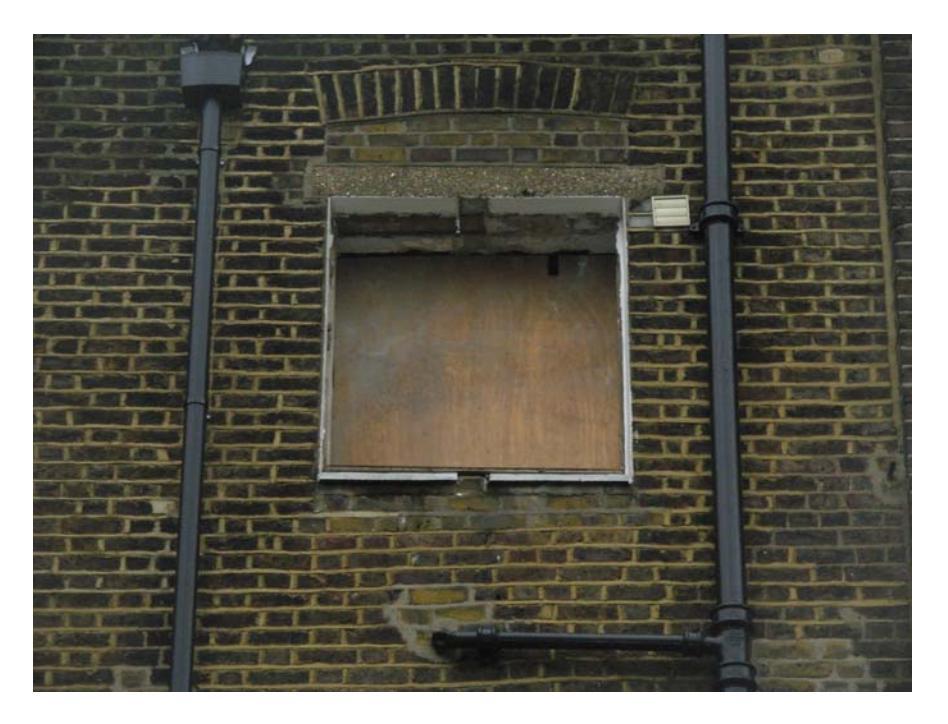
Figure 19 - Rear elevation bathroom window

After reinstating a historic window opening in brickwork as described above, it is proposed to place a new sash window with joinery detailed to match the existing on the adjacent properties in every respect. The new window will be single glazed as detailed. See drawing no 300/103

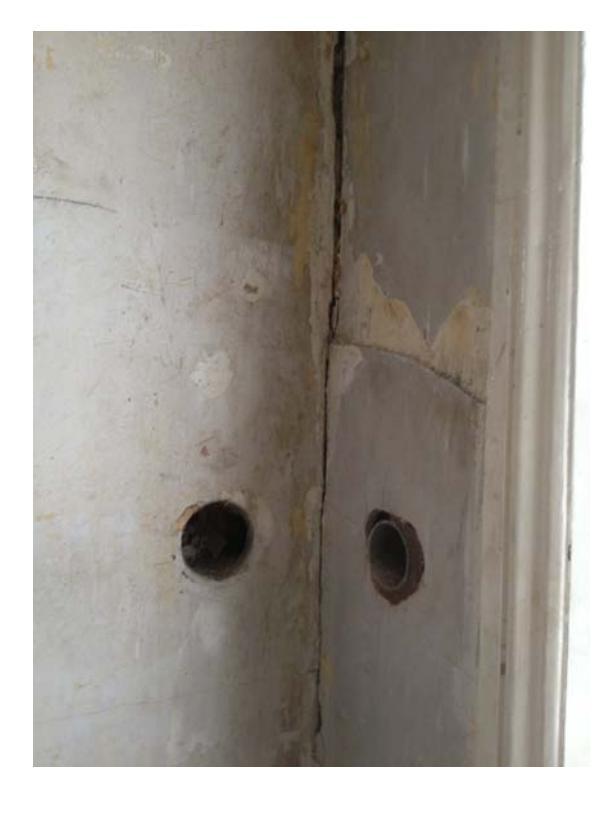
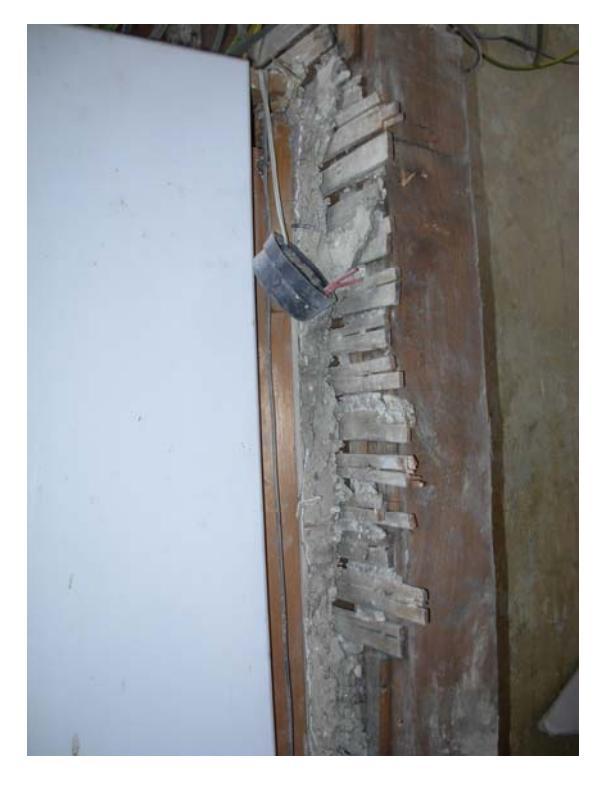
Figure 20 – Cracks and in wall plaster

Figure 21 – Remnants of lime and lath plaster

Cracks and missing small patches of perimeter wall plaster are to be replaced using Limelite renovating plaster and finished flush with surrounding finishes.

Reinstatement of lime and lath finishes to the existing stud wall will be carried out in accordance with the attached specifications and drawings submitted with this LBC application. (figure 20 & 21)

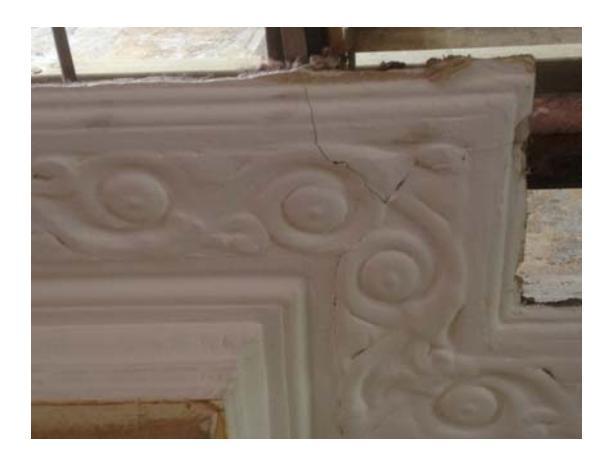
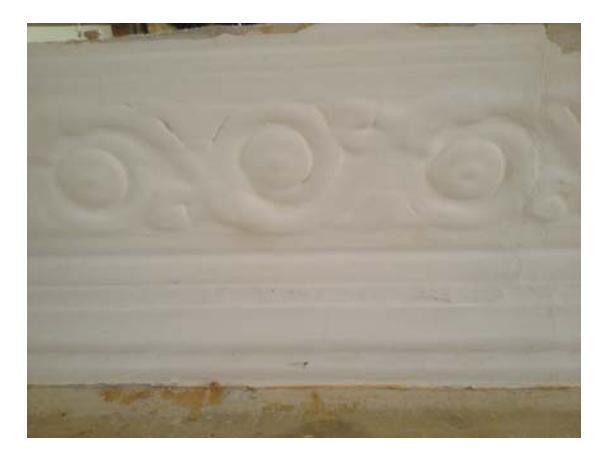
Figure 23 – Damage to original plasterwork

Cracks in the existing cornices are to be carefully raked out to remove loose or friable material and then brushed vigorously with a soft bristle brush to clear away remaining attached particles. Once clean the crack is washed out with clean water to reduce suction.

Plaster of Paris is to be used to make good the repairs. Place into the prepared crack and when workable rule off with a flat blade or appropriately shaped blade, the material should not be trowelled flat immediately after placing. (Figure 23)
