## ARBORICULTURAL IMPACT ASSESSMENT REPORT

Site Adjacent to 41 Ferncroft Avenue,  
London NW3

**Ref:** BUJ/FNC/AIA/03

**Date:** 10th May 2012

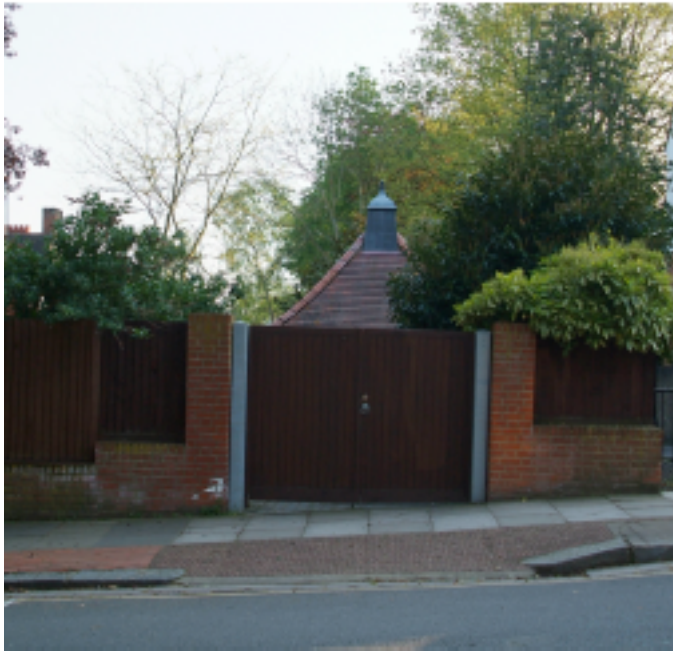
**Photograph of Existing Site Front**

- 3.1.1 The site comprises the western boundary of the garden at No. 41 Ferncroft Avenue, currently occupied by a single storey garage of 1998, brick construction with concrete base and unknown foundations.

- 3.1.2 The site is bordered by a tree-lined footpath that slopes markedly to the south. The garage base has been made-up to level ground.
- 3.1.3 In terms of the Soil Survey of England and Wales, the soil lies within the unsurveyed area of Greater London where the soils are generally, highly shrinkable clay; e.g. slowly permeable seasonally waterlogged fine loam over clay. Such soils are prone to compaction during development. Damage to soil structure can have a serious impact on tree health. Design of foundations near problematic tree species will also need to take into consideration subsidence risk. A structural engineer may be able to advise further on the local geology and its implications for development.

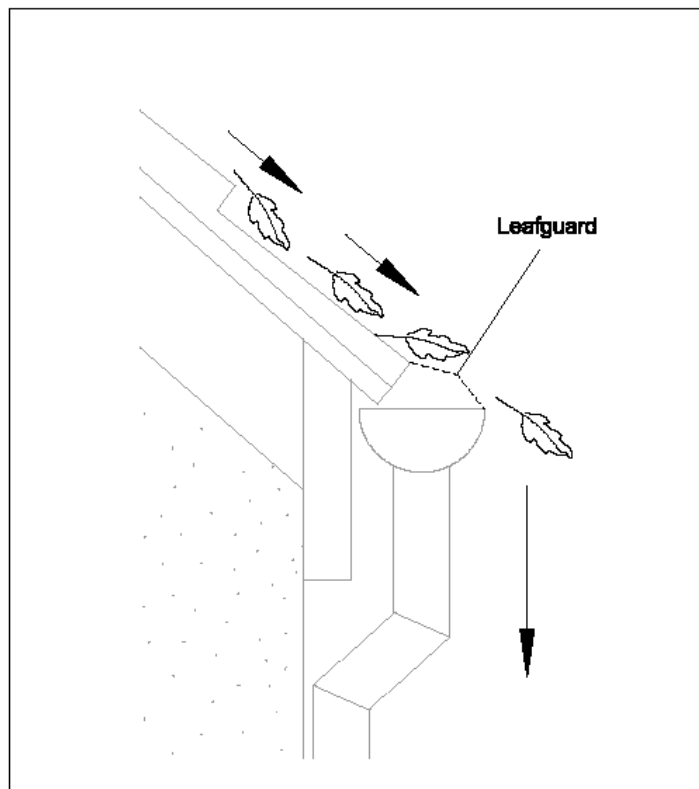
Filtration traps, as shown above, could be fitted on the gutters which can easily be maintained at 2-3m above ground.

- 6.3.5 Nuisance deposition can be mitigated with the use of a green roof and the fitting of filtration traps on the guttering.
- 6.3.6 The shading impacts has been mitigated by building design, with the provision of a substantial open aspect to north and south. Progressive crown lifting and minor crown reduction may be necessary, but not such as to impose a burden of frequent, repetitive management or to depart from the existing future burden on management in consideration of the three-storey house to the west.

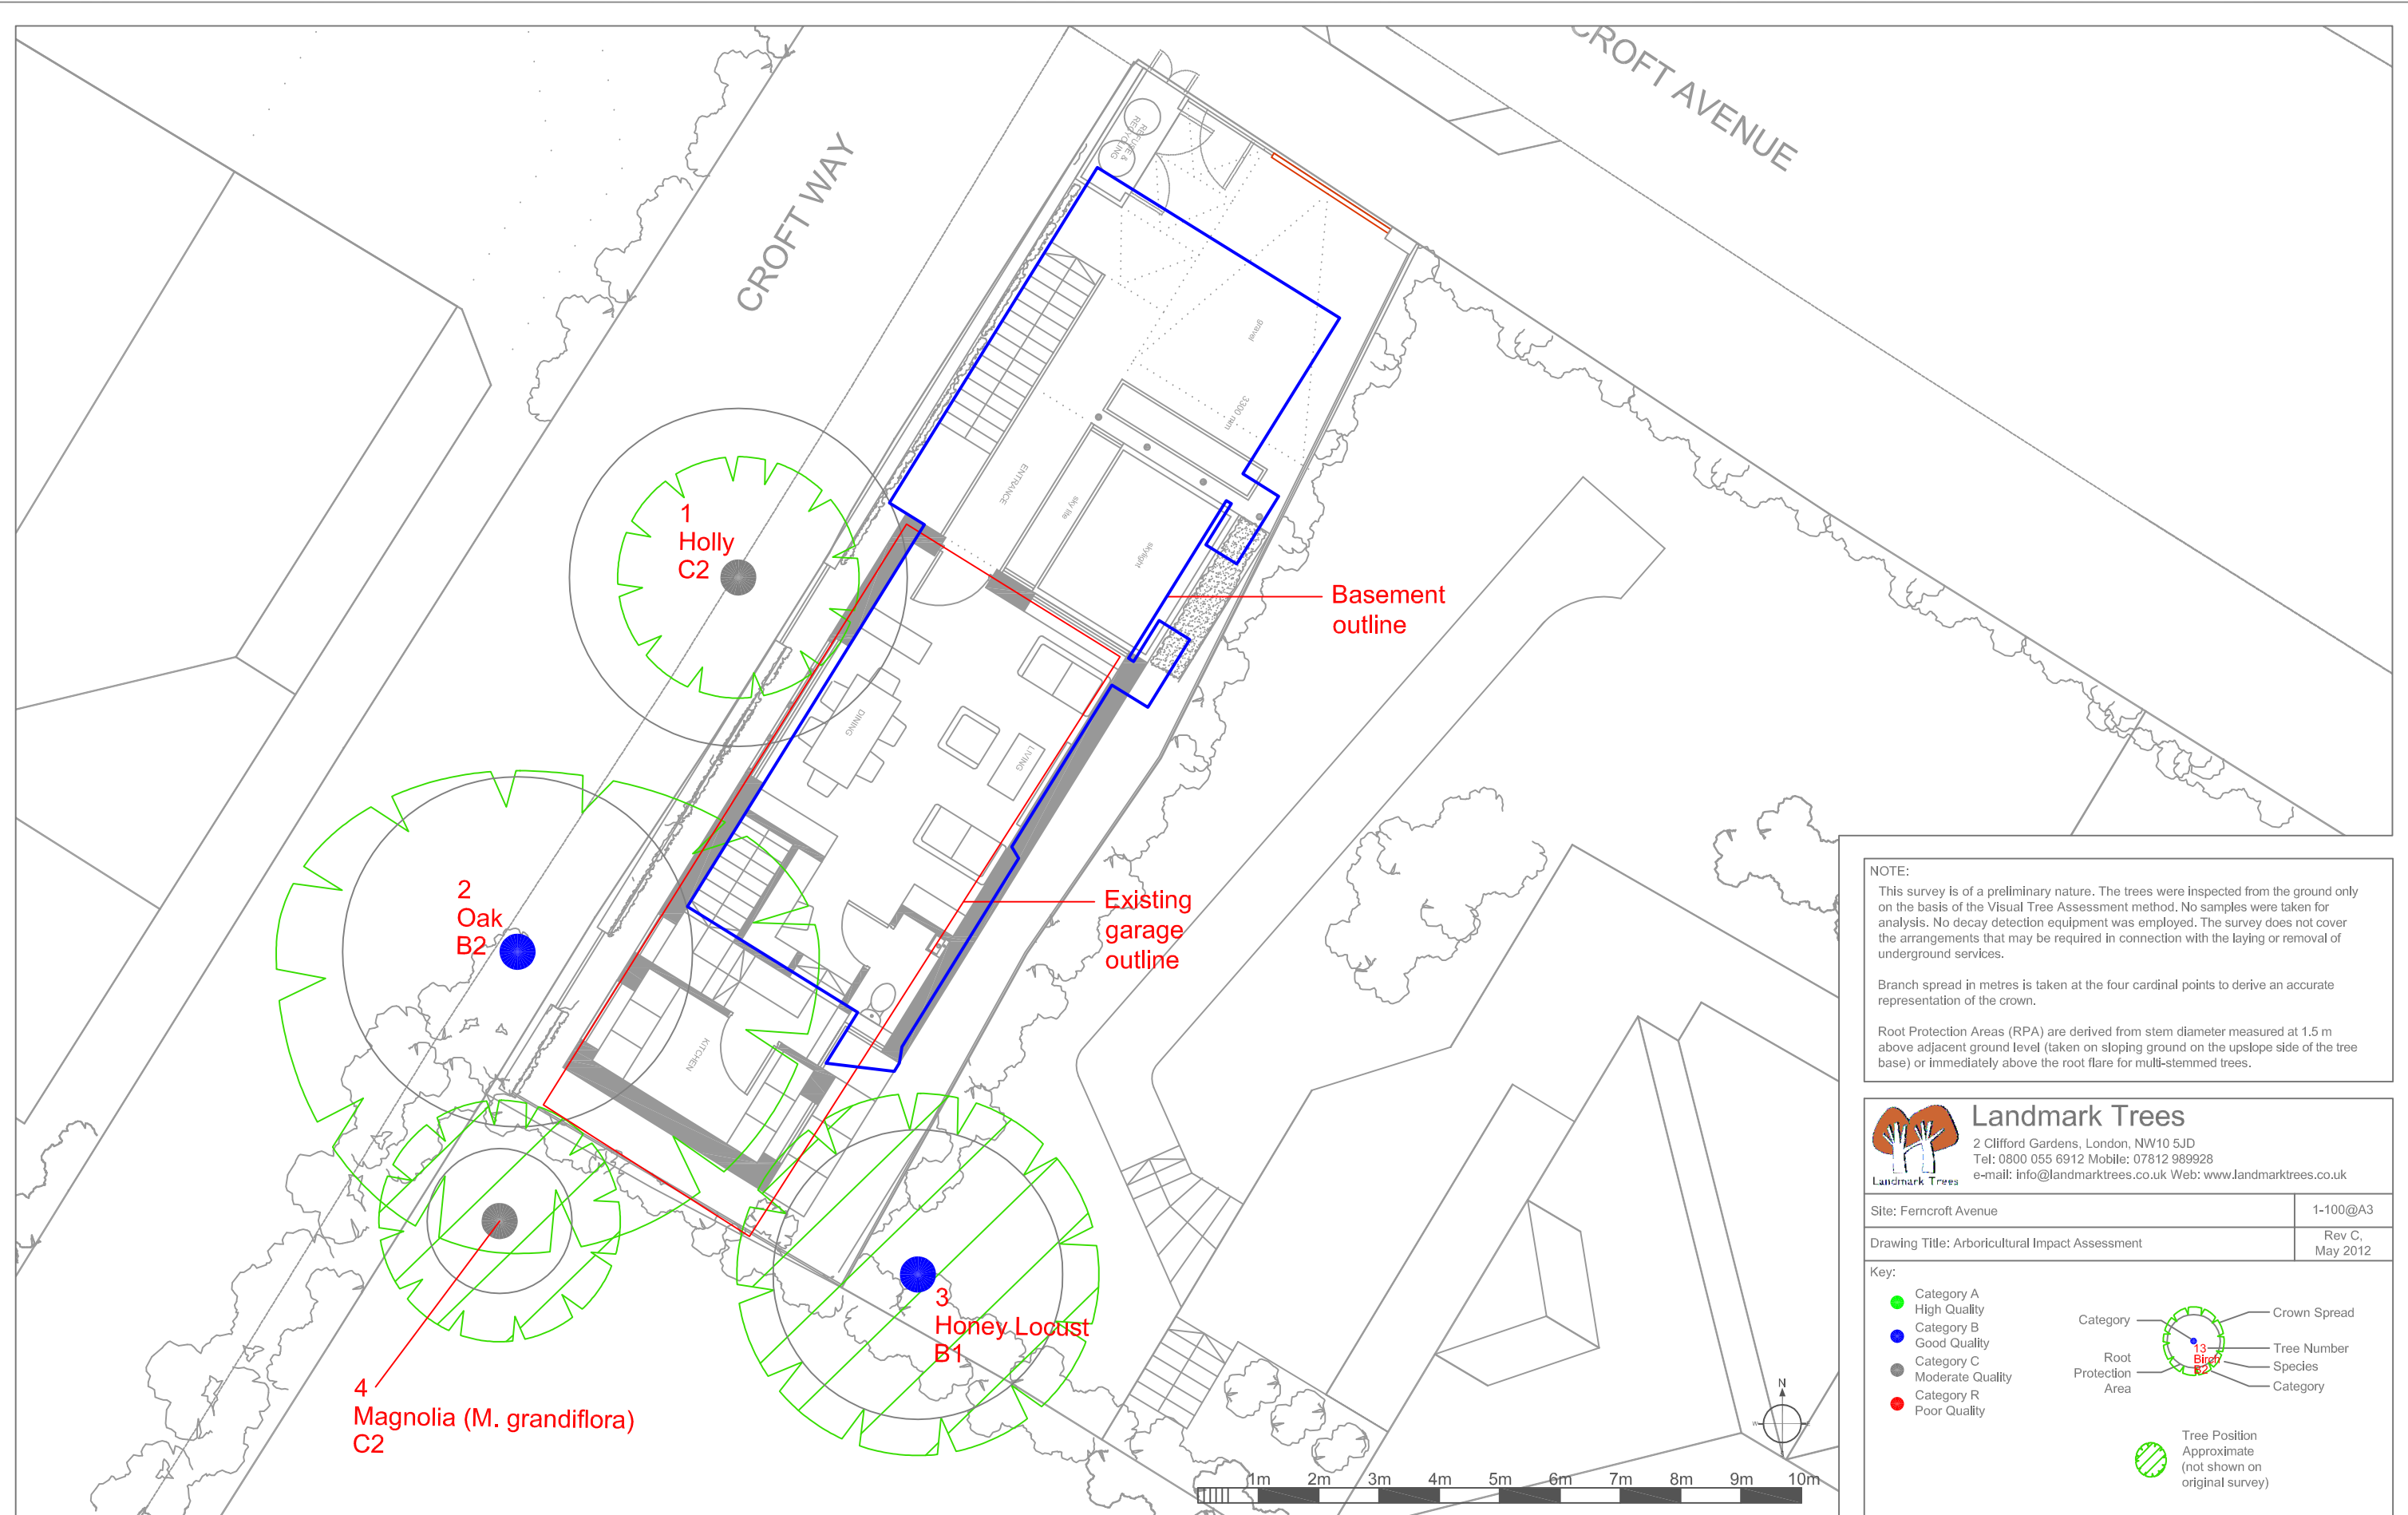
ARBORICULTURAL IMPACT ASSESSMENT PLAN

6.1.3 Excavation of a basement within the theoretical Root Protection Area (RPA) of these two trees also has the potential to cause low impacts (@10 & 13% RPA). However, the entire area of excavation is currently occupied by the recently (1998) constructed garage concrete sub-base and foundation, which are likely to have inhibited subsequent root colonisation by these young (contemporaneous) trees. The actual impact is thus, likely to be very low.

6.1.4 An RPA encroachment of <20% of RPA may be considered as low impact, given the permissive references to 20% RPA relocation and impermeable paving within BS5837 and other published references to healthy trees tolerating up to 30-50% root severance (Coder, Helliwell and Watson in CEH 2006).

- 6.3.2 The RPA encroachments should be trial excavated in the demolition of the sub-base. Roots encountered therein, can be cut cleanly under arboricultural supervision and piling allowed to proceed. A mini-piling rig will be required to avoid canopy intrusion and damage. The western wall may need to be constructed over hand without scaffolding.

- 6.3.3 The immediate T2 canopy encroachment can be avoided with a crown clean of the lower limbs of, affecting a 5-6m ground clearance as one moves away from the stem. T2 will simply be lightly trimmed back to achieve the requisite clearance
