Residential Development of 8 Fitzroy Road, Chalcot Yard, London NW1 8TX

Construction Method statement

Project Number: 273

Issue Date: 3rd May 2013

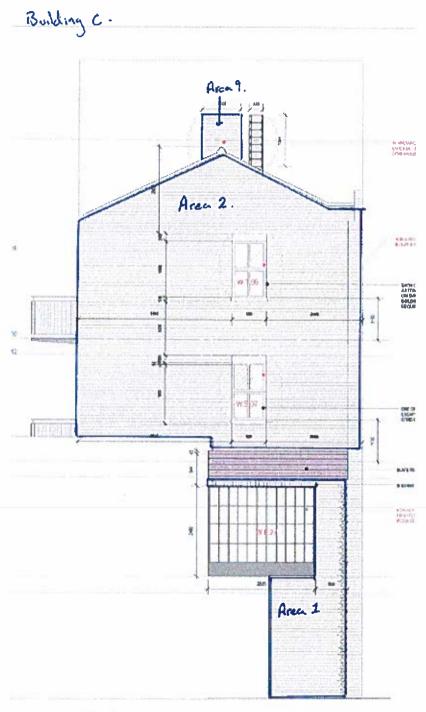
Marked Up Building C Elevation 1.

Area 1.

New brick work constructed in reclaimed Yellow stock bricks to match existing brick work of building C.

Area 2.

Existing gable end brick work retained and cleaned by specialist sub

contractor. (Part completed refer to photo)
Adjust existing window openings and install new timber windows.

Areas 3 & 4.

Existing roof level parapet brick work to remain and repainted.

Area 5 & 6

Existing brick work to be retained, carry out localised repairs and clean down brick work by specialist sub contractor.

Area 7

Existing brick panels underside of timber windows to be carefully removed, bricks that can be reused to be set aside on site for use in brick panel rebuild.

Area 8

New brick work constructed in reclaimed red Multi stock bricks to match existing brick work of building C.

Area 9

New chimney stack, brick built constructed in reclaimed Yellow stock bricks to match existing brick work of building C.

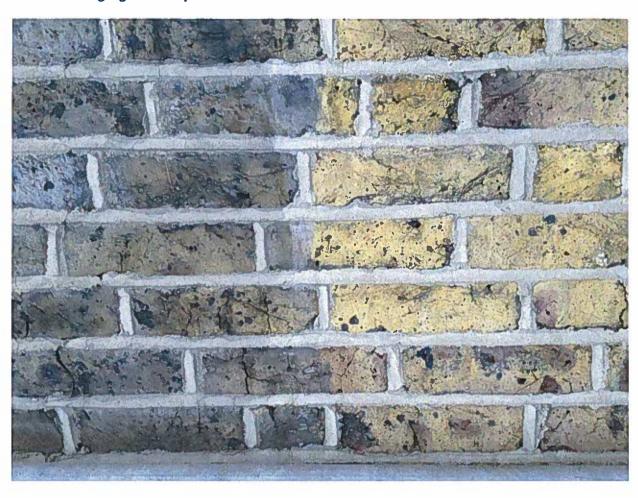
1. Building C gable wall part cleaned

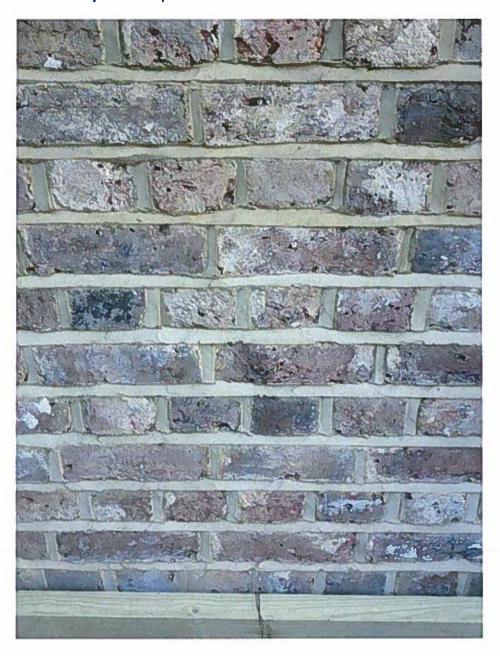
2. Example brick repair

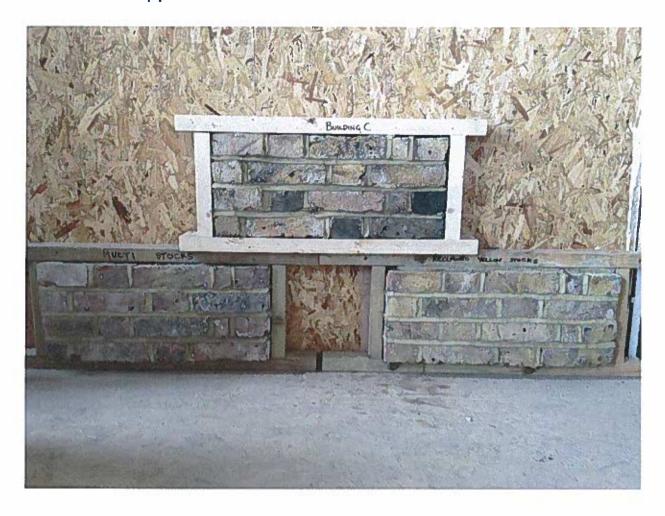
3. Brick mock up photo

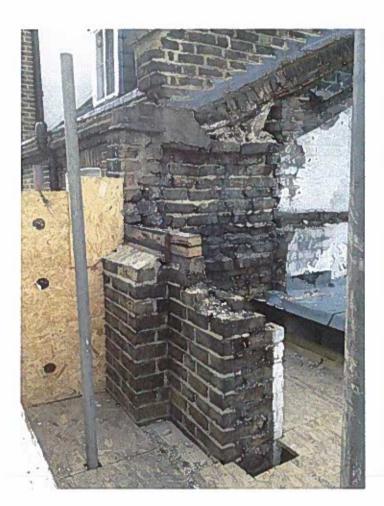
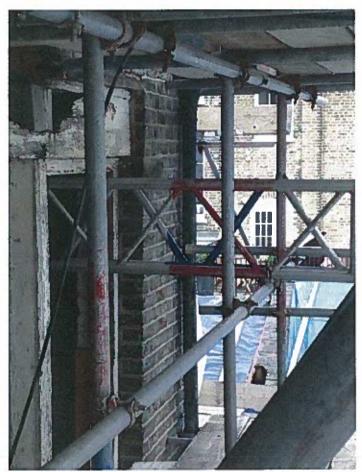
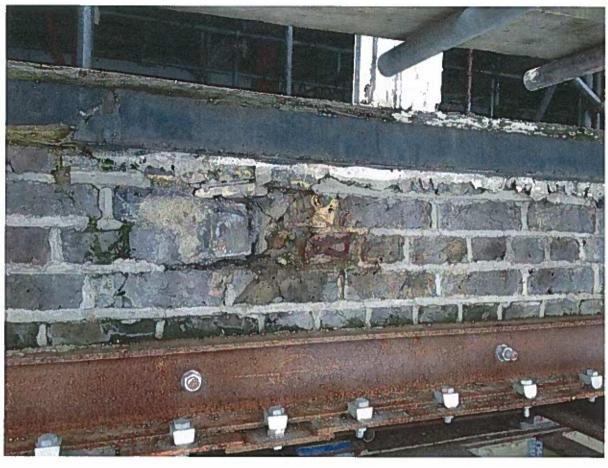
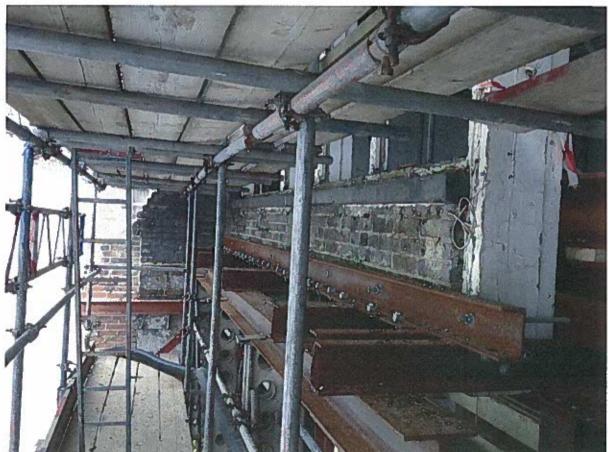
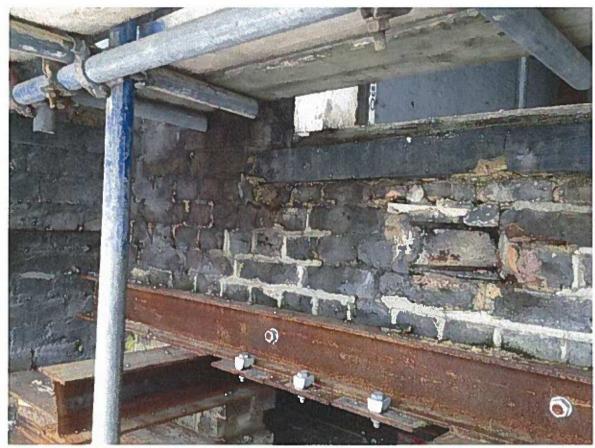
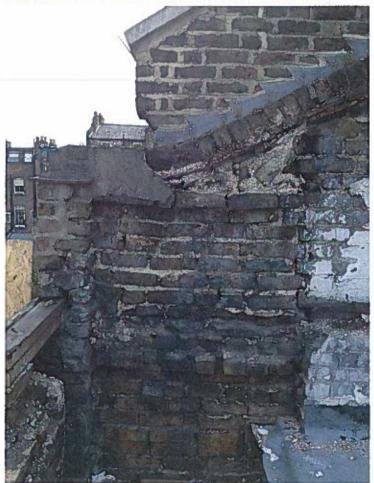
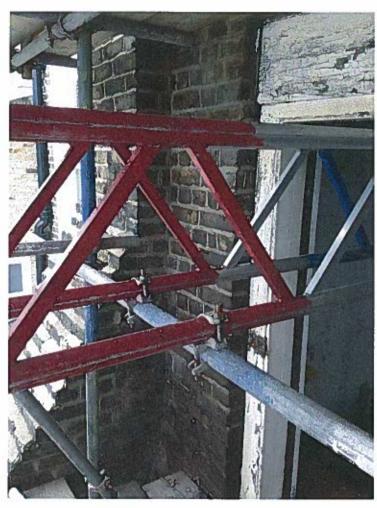
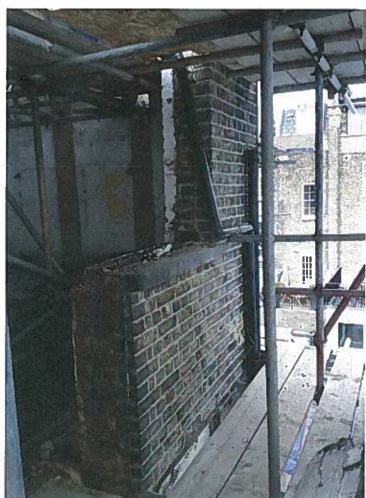
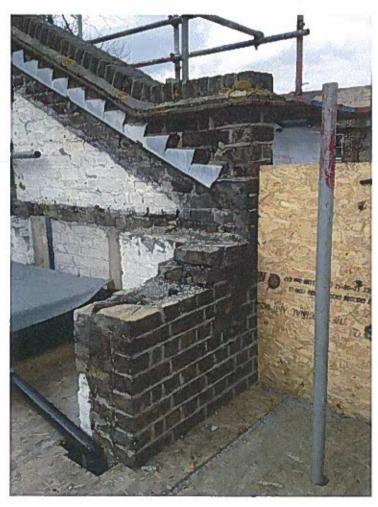
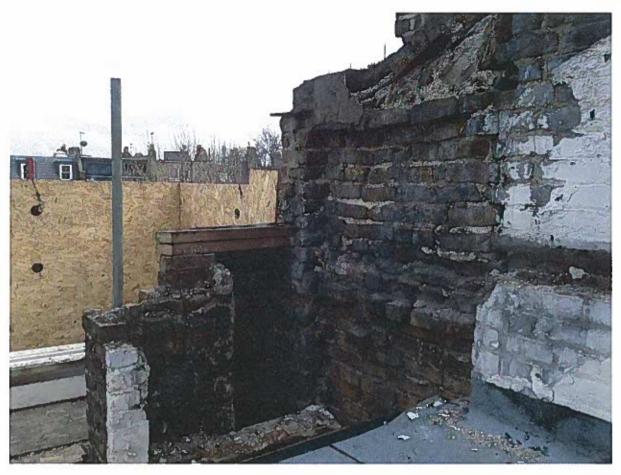
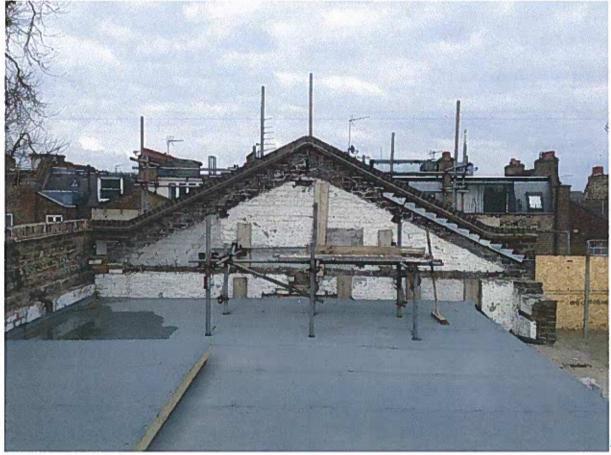
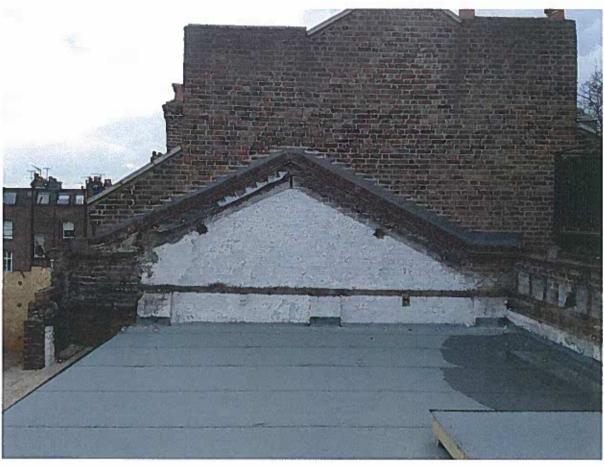
5.0 Photographs Building C Facades

5.1 The following photos demonstrate why brickwork requires repair and replacement. As it can be seen the existing building fabric, both brickwork and timber is simply not in a condition which can be left in this decayed state.
