9 Fitzjohns Avenue, London, NW3 5JY

Tree Survey. April 2013

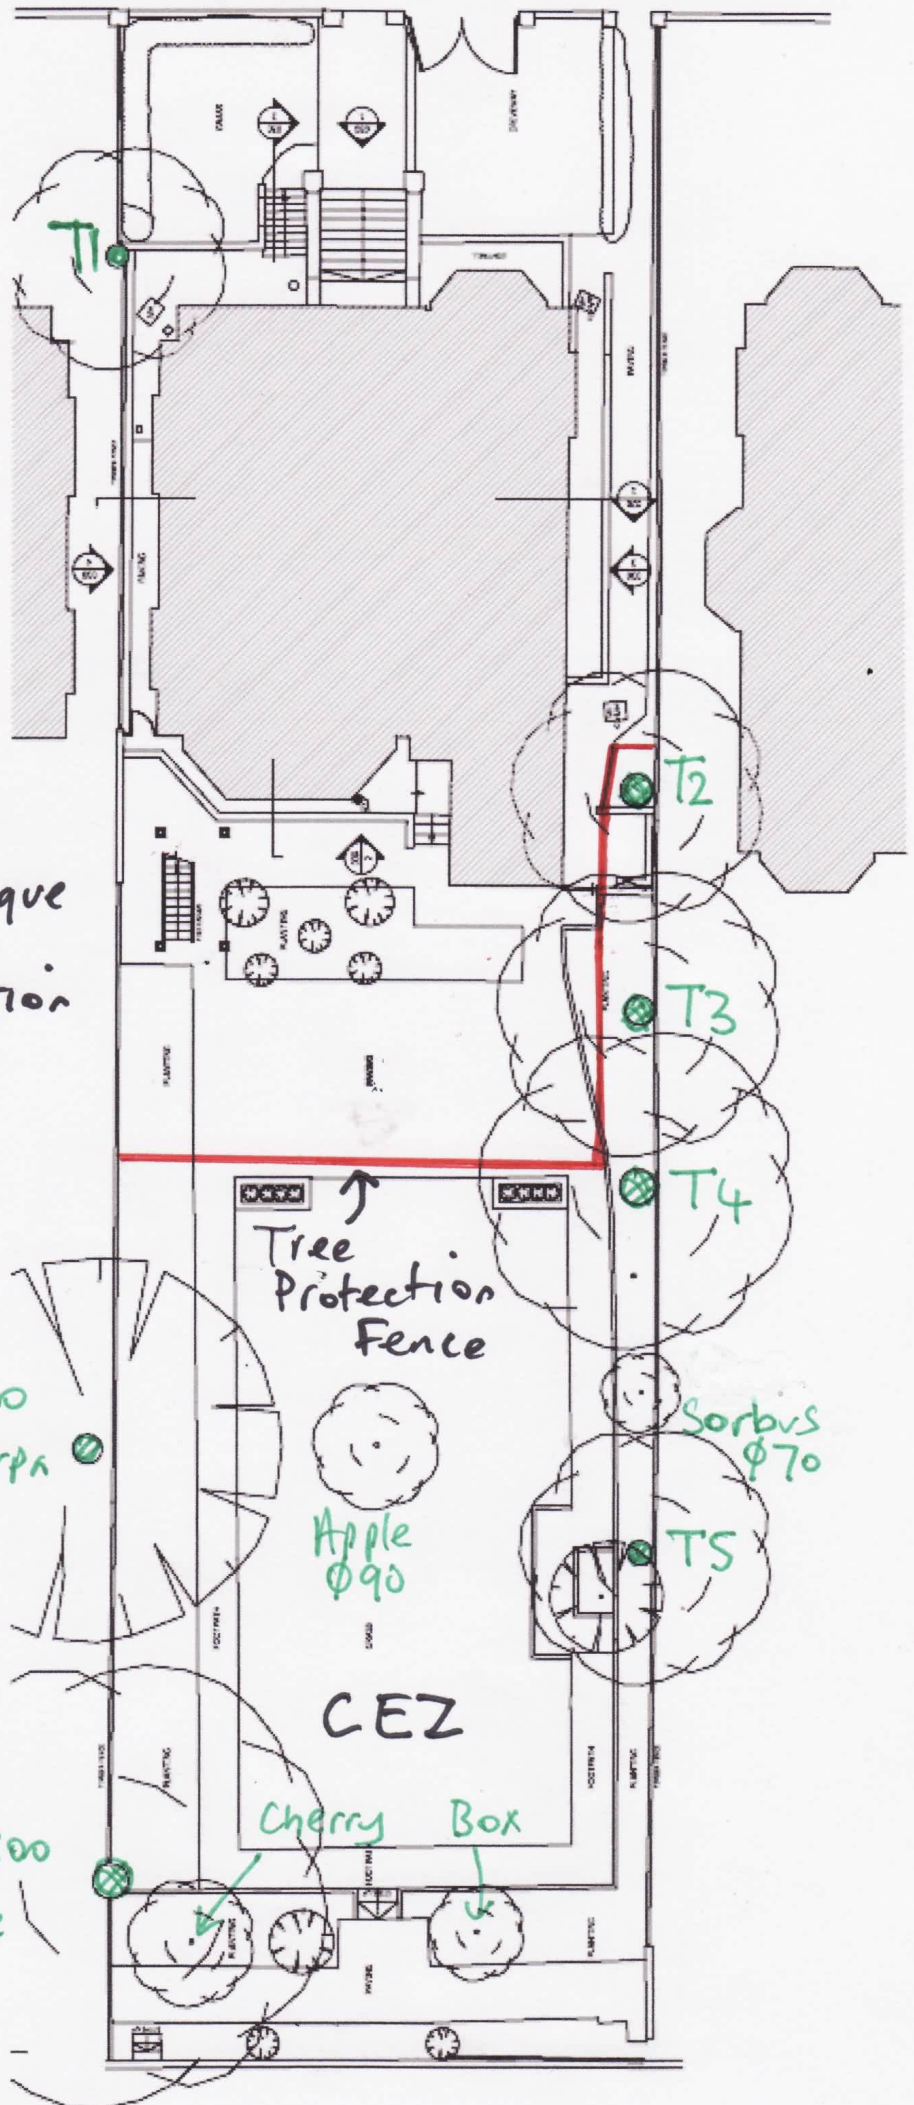
Tree Catalogue and Protection Plan

Tree numbers 1 and 2 have been pruned back from the house.

The trees are functioning normally and do not have any structural indicators which suggest that part or all of them may foreseeably fail.

All rear garden trees will be protected throughout the building process with a temporary fence as shown on figure 2 of the BS. This will be assembled prior to any works and will remain in place until all major work is completed. The position of this fence is shown on the tree catalogue and protection plan and is labelled "Tree Protection Fence".

The area enclosed is the self explanatory "CEZ", construction exclusion zone, in which there will be no activity associated with building including the storage of materials. As per advice in the BS the fence follows clearly identifiable features ie existing built structures. Any structures shown to be enclosed will remain un-demolished throughout building works as will any hard surfaces adjacent to the south elevation. These built structures ensure that the position of the fence is completely enforceable by the LPA. When all major construction works are completed and the tree protection fences have been dismantled all other demolition and building works will be carried out using hand tools only. All voids formed will be either topsoiled to their full depth or filled with washed sand in order to allow water abstracting roots to grow under new porous hard surfacing.

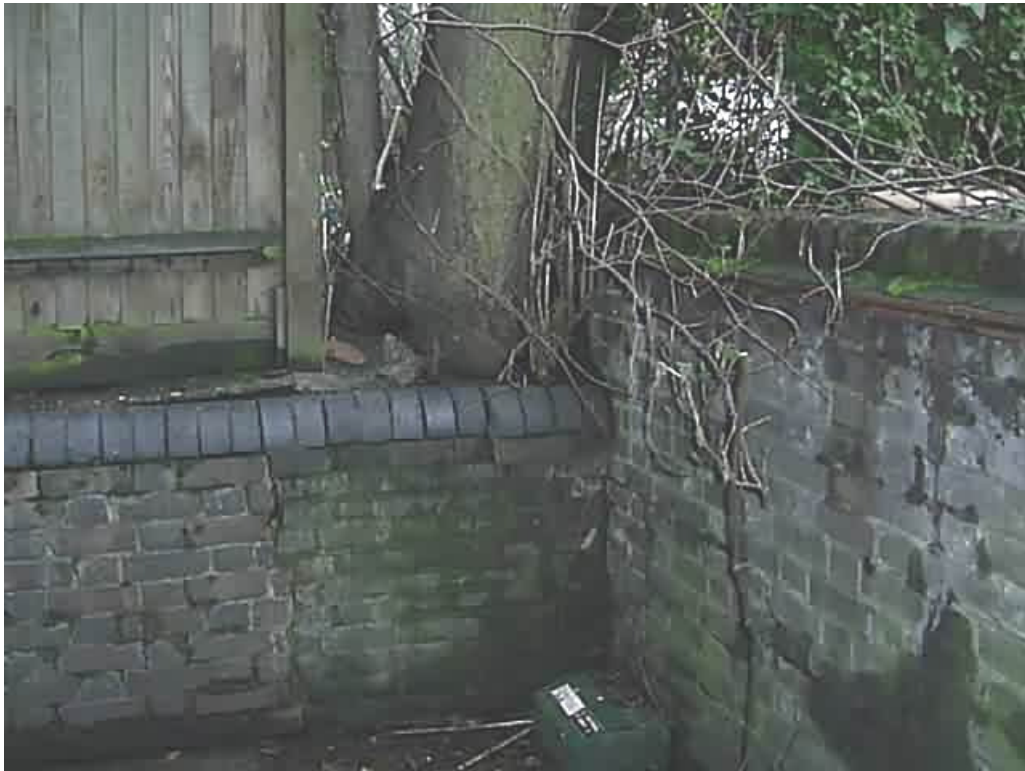
The neighbour's Lime (no. 1) is at the top of a 1m high retaining wall and has caused minor (repairable) direct damage to this wall.

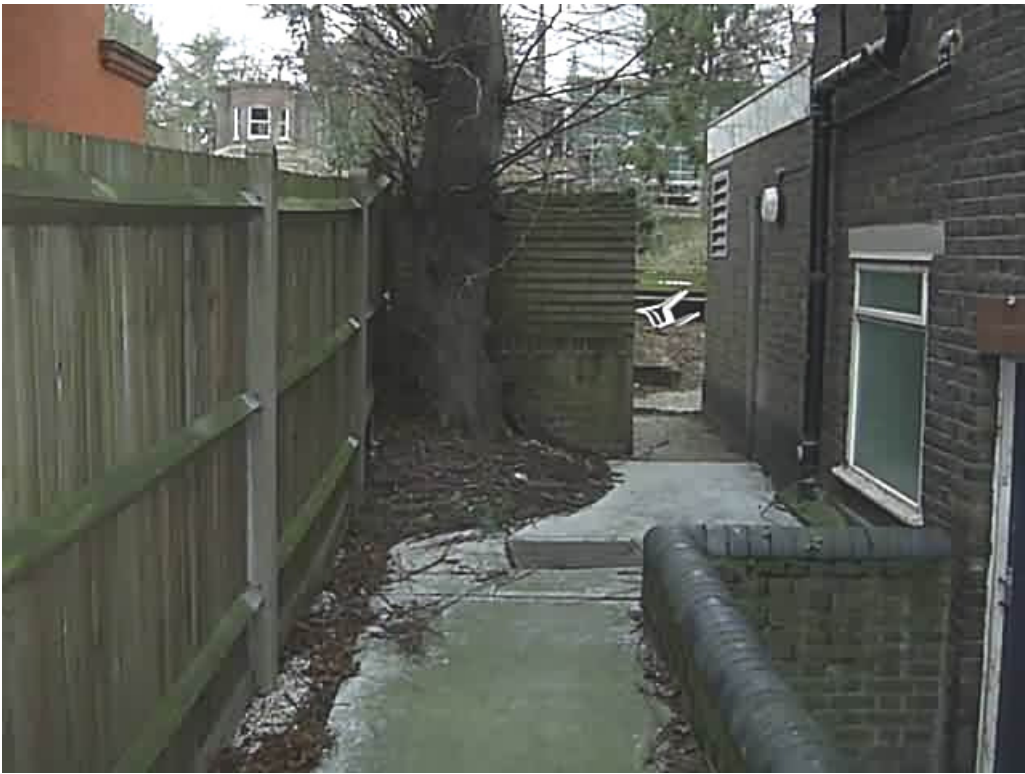
Built structures adjacent to Tree 2

In the case of Limes 2, 3 & 4 these trees are in immediate proximity to built structures which both predate and postdate the trees. Most recently rear extensions and patio building have involved excavation adjacent to the Limes.

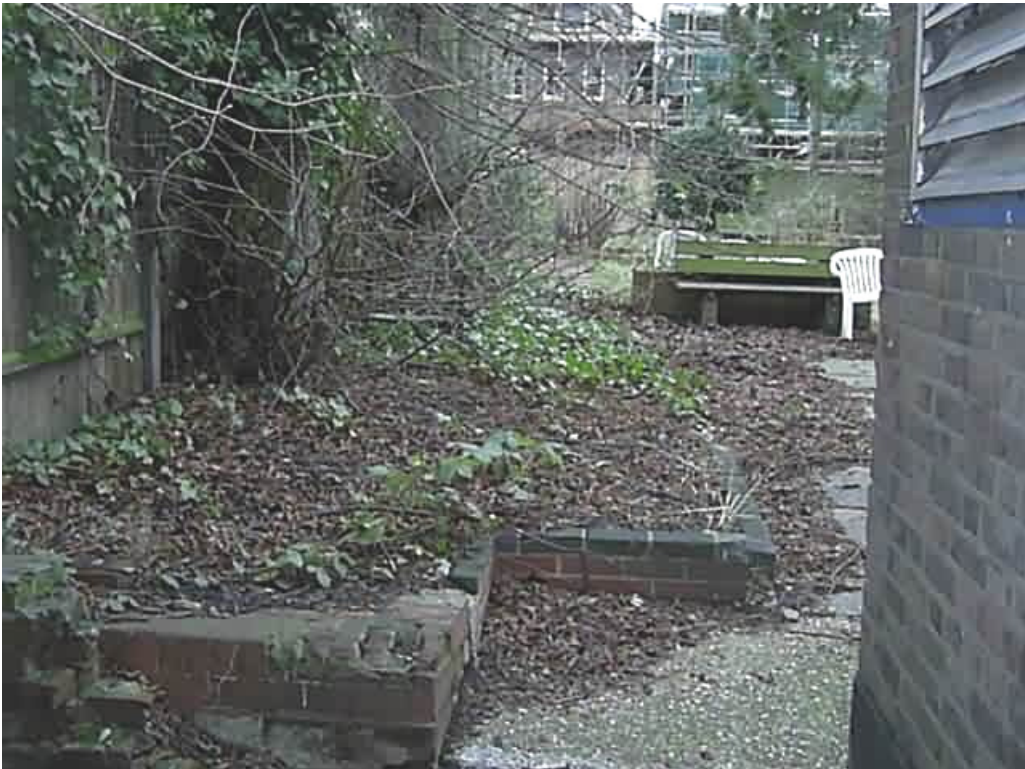
Built structures adjacent to Trees 3&4.

The largest roots are most likely running westwards and parallel with the site boundary up until the point they can subdivide rapidly underneath the lawn. It is most likely that root plates will be interlocked and grafted.
