PROPOSED ELEVATIONS

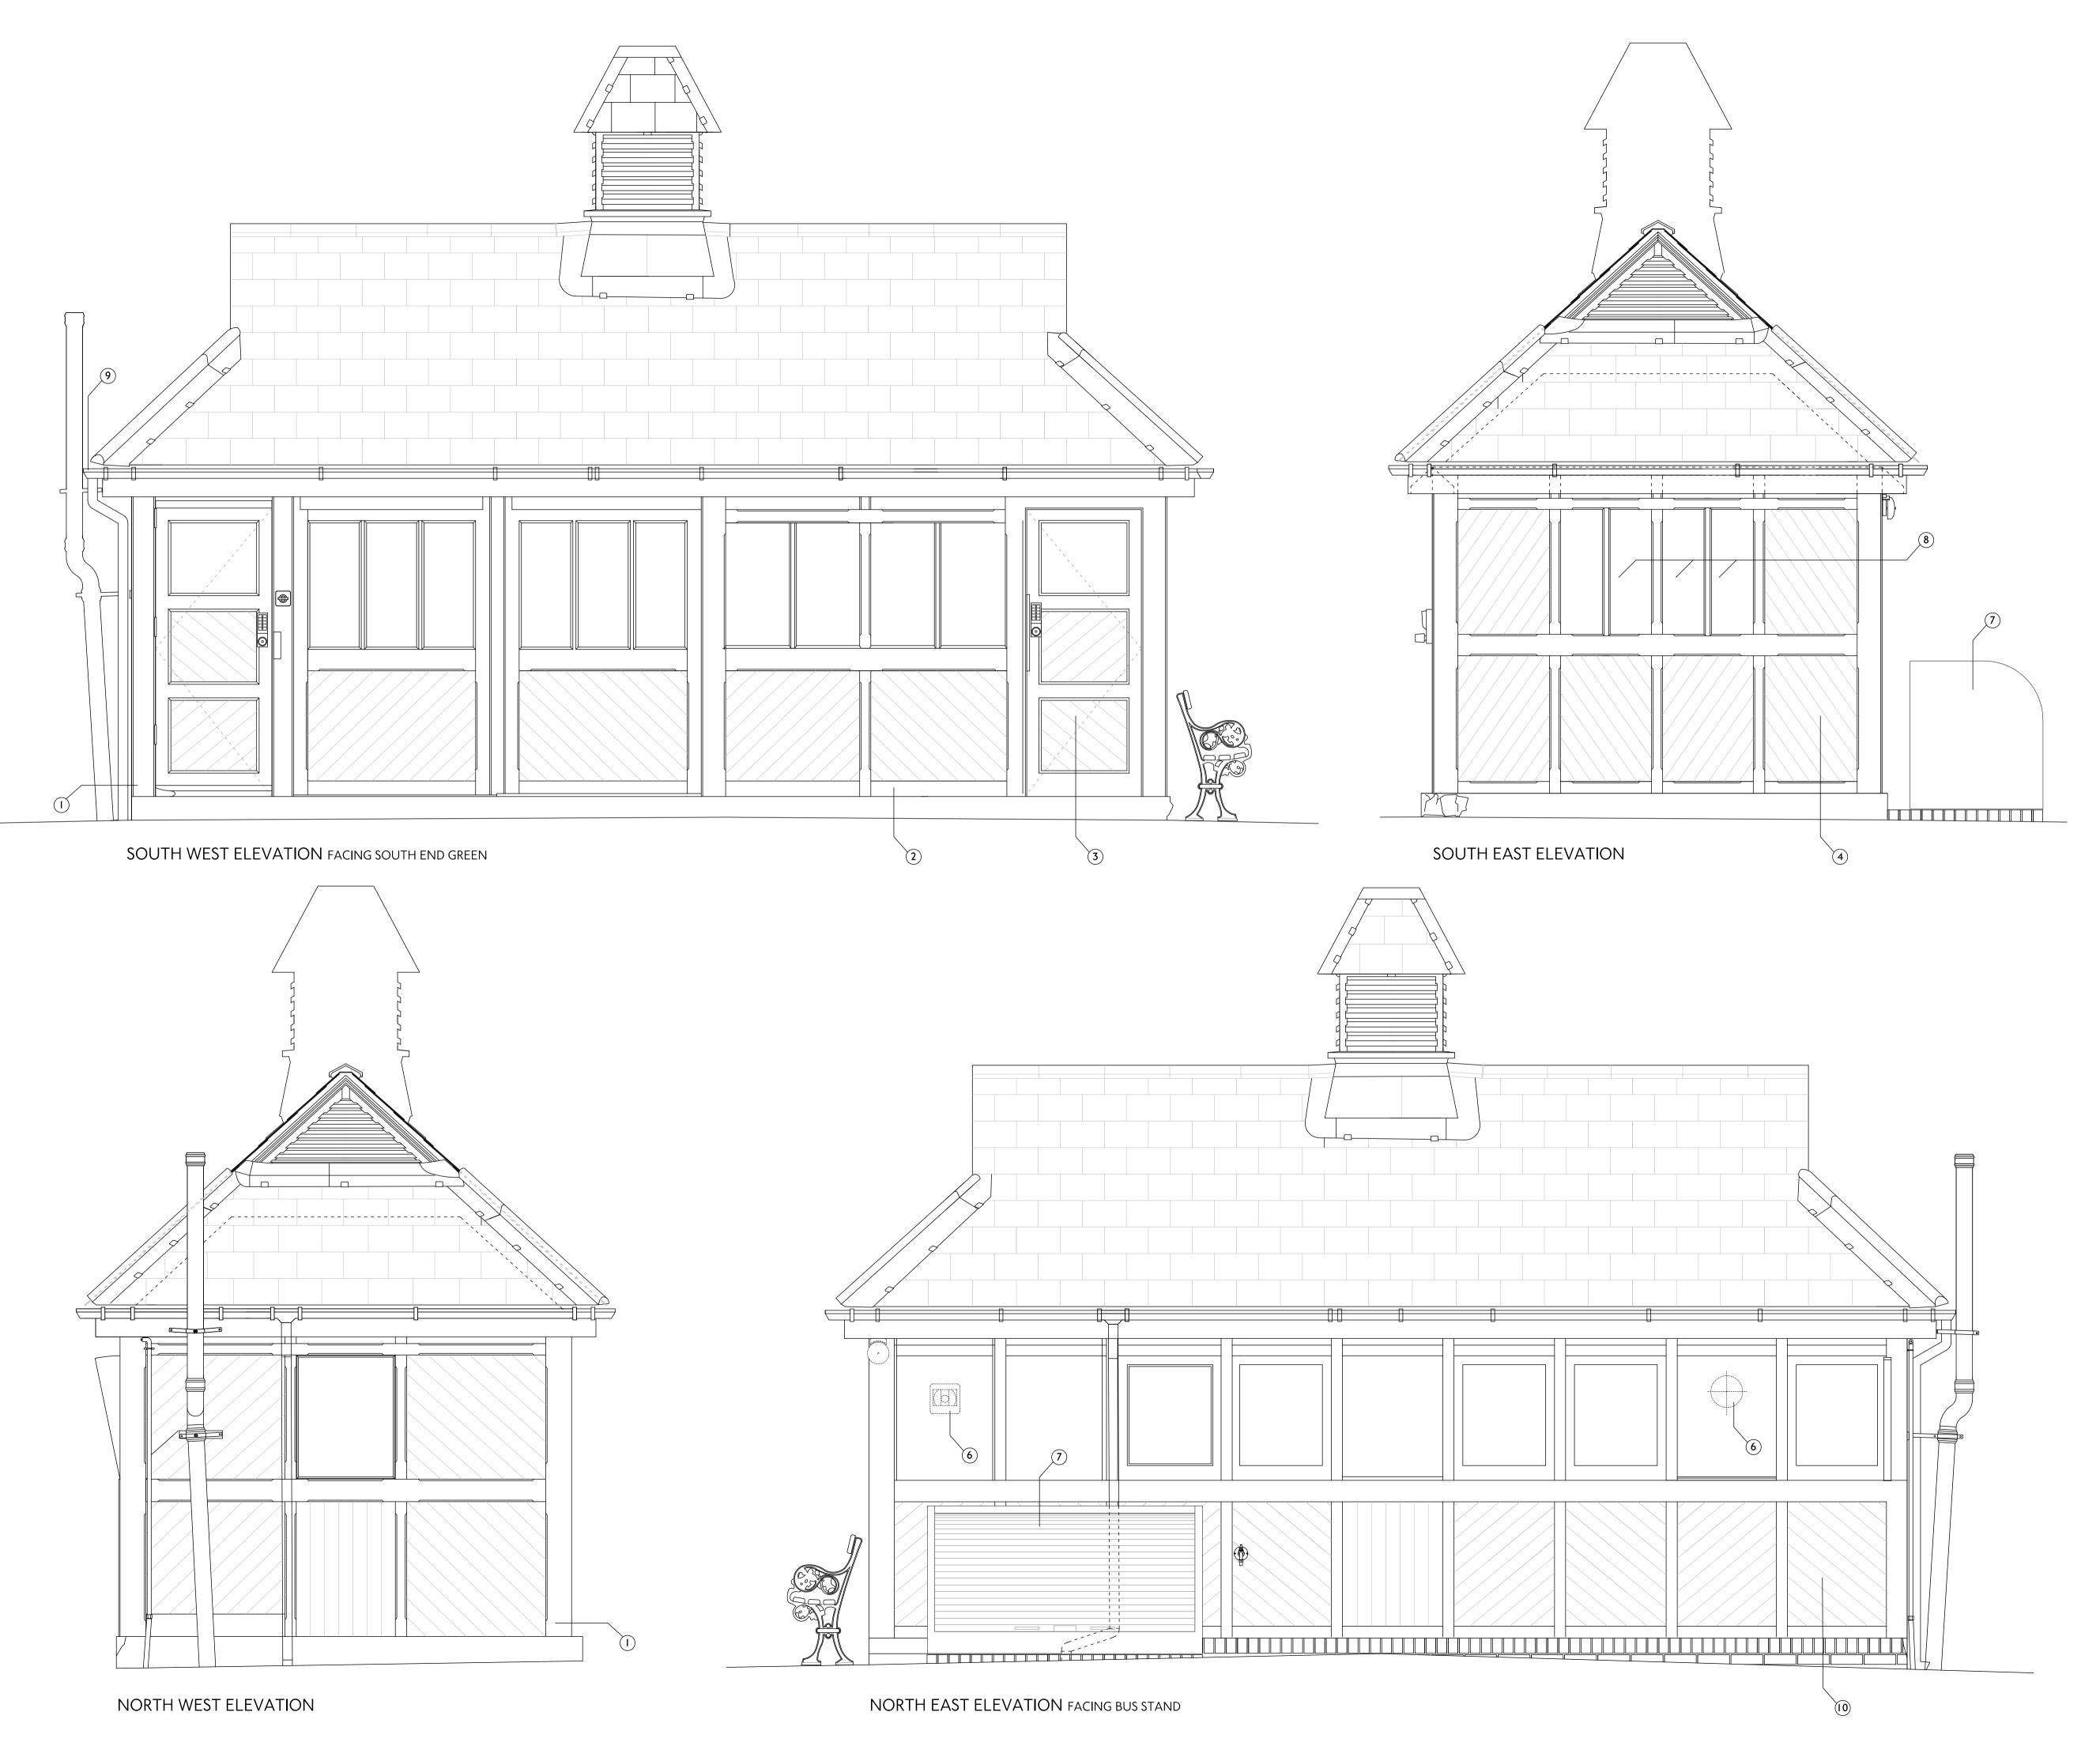
- NEW TIMBER PIECE SCARFED-IN WHERE EXISTING BASE
 OF CORNER POST HAS BECOME ROTTED DUE TO A BUILD
 UP OF URIC ACID FROM DOGS. NEW WORK DECORATED
 TO MATCH EXISTING FINISH.

- 2 EXISTING LARGE PLYWOOD SHEET AND PATCH PANELS TO BE REMOVED AND REPLACED WITH NEW INFILL TIMBER BOARDING TO MATCH EXISTING WITHIN TWO BAYS.
- 3 EXISTING DOOR PANELING CURRENTLY HAS UNSUITABLE WHITE CEMENT SHEET. THIS IS TO BE REMOVED AND REPLACED IN THE TWO LOWER PANELS WITH TIMBER DIAGONAL BOARDING TO MATCH EXISTING PATTERN AND FINISH.

- 4 FULL REPAINTING OF EXTERIOR FOLLOWING REPAIR OF AREAS OF DEGRADED TIMBERS. A SUITABLE GREY/ GREEN SHADE TO BE CHOSEN FOLLOWING FORENSIC PAINT LAYER STUDY.

- 5 VENTILATION PANELS THAT HAVE BEEN FIXED SHUT
 AND FUSED BY LAYERS OF PAINTS ARE TO BE RESTORED
 TO OPERATIONAL ORDER.
- 6 CURRENT PANEL OR WINDOW MOUNTED MECHANICAL EXTRACT FANS TO BE REPLACED BY A MORE EFFICIENT COMBINATION OF THE RESTORED NATURAL VENTS AND A DISCREET SLOT EXTRACT SYSTEM.

- 7 NEW SECURE STEEL BOX PAINTED TOP MATCH EXTERIOR WALLS AND SET ON A PLINTH OF BRICK ON EDGE DECORATED WITH TAR PAINT TO MATCH THE EXISTING PLINTH.
- 8 W.C. RELOCATED TO FORMER OFFICE SPACE.
 SECONDARY OPAQUE GLAZING LAYER ADDED
 TO PROVIDE INCREASED PRIVACY LEVEL WHIILST
 ALLOWING NATURAL LIGHT THROUGH.

- 9 EXISTING BLACK PVC GUTTER TO BE REPLACED WITH AN ALUMINIUM SYSTEM WITH A BLACK POWDER COATED FINISH
- (10) EXISTING TWO LARGE PLYWOOD SHEET PANELS
 TO BE REMOVED AND REPLACED WITH NEW INFILL
 TIMBER BOARDING TO MATCH EXISTING WITHIN
 SIX BAYS.
