**22 Church Row, London NW3 6UP**

## **Heritage Statement**

**Heritage Statement for 22 Church Row, London NW3 6UP**

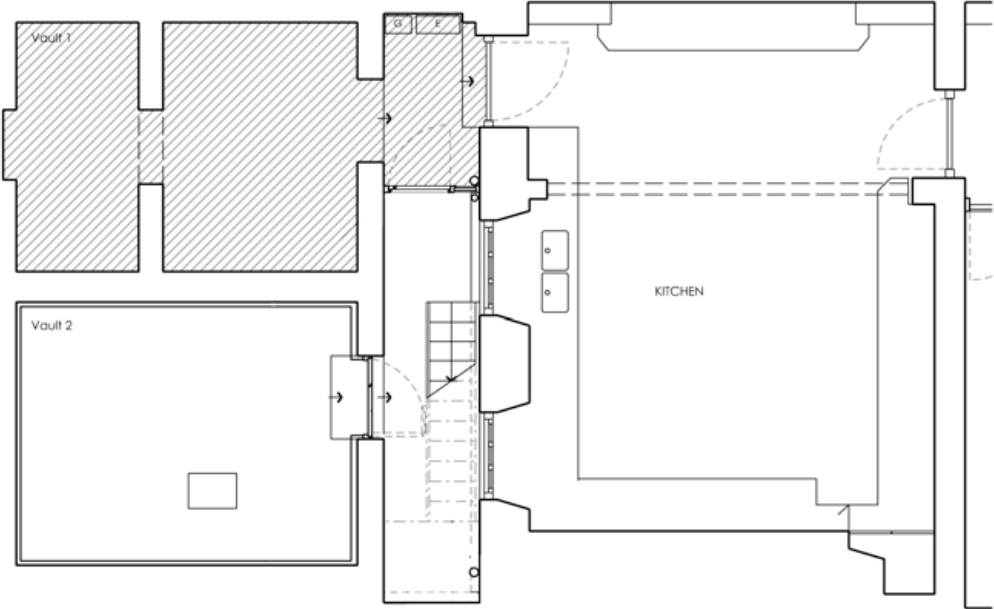
The works relate to the metal staircase and “Vault 1” of 22 Church Row. The vault is beneath the pavement and road, and is not visible from the street. The plan, shown below, marks the vault in diagonal grey.

The vault is damp due to the failure of a water membrane dating back to the nineteen seventies, As a result surface water is penetrating from the pavement and road above. The metal staircase is corroded and nearing the end of its functional life.

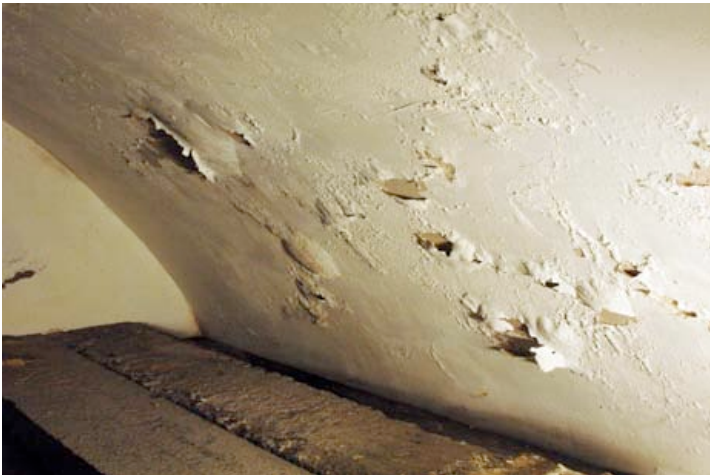
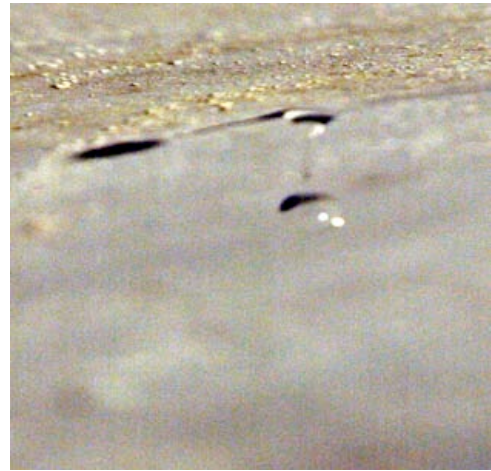
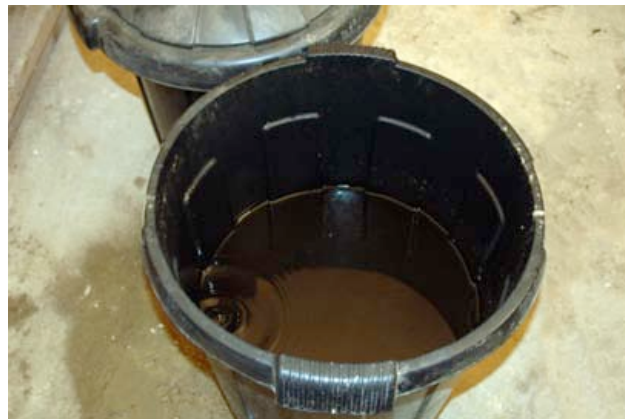
The damp proof membrane in Vault 1 is no longer functioning, making its uses extremely limited. The photographs below show water running off the ceiling, the damp blistering off the paint, and water being collected in a dustbin.

1. Carefully remove existing sand/cement render and mat reinforcement from walls and soffit in Vault 1. Break up concrete floor, remove polythene DPM and cart away. Carefully excavate a level base and provide new concrete slab. Do not excavate below the level of the existing brick spread footings. New waterproof cement to walls and soffit of Vault 1 and new plastic tanking membrane overall, drain to existing gulley. Clad with new tongue and groove boarding supported on treated softwood battens.

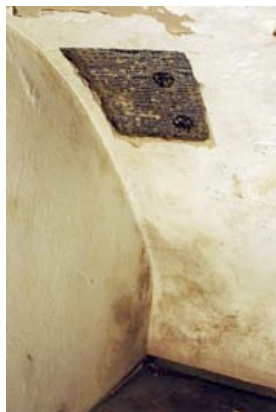
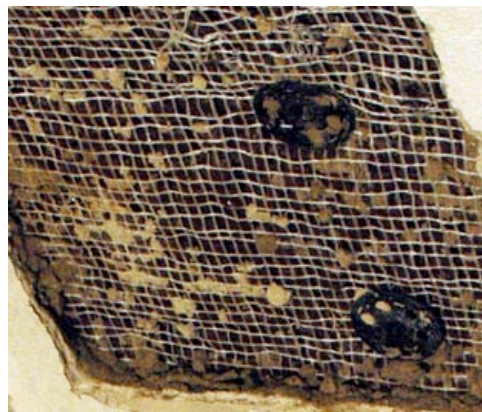
The section below shows a test patch (one foot square) of the ceiling render that has been carefully opened up to reveal that the plaster is mounted on a plastic membrane, with criss crossed ridges, secured to the arch bricks with plastic plugs.

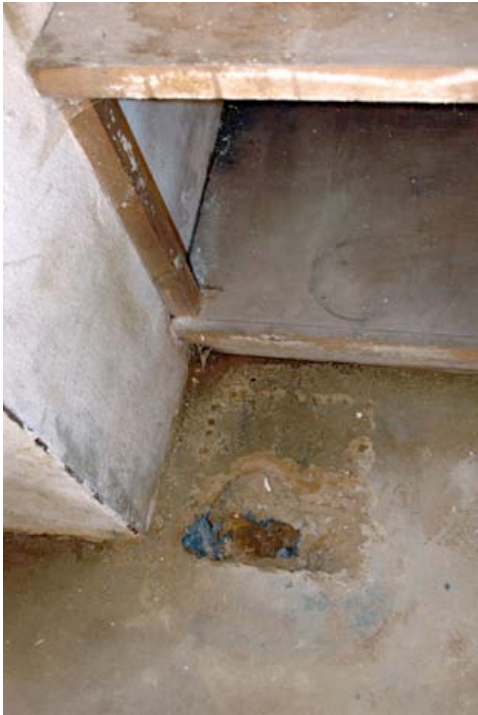
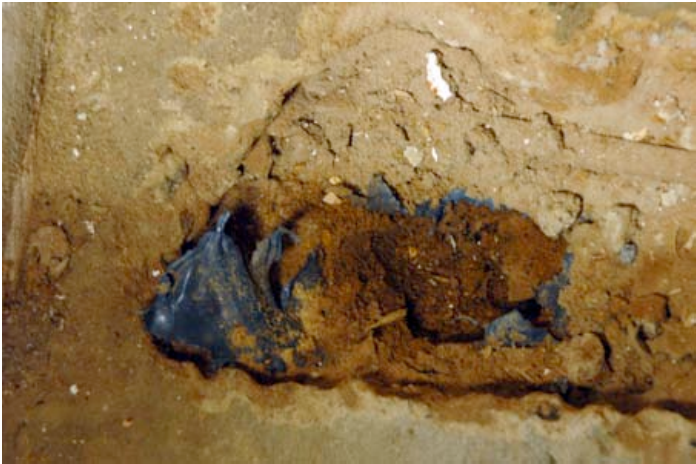
The floor is concrete. A test area has been drilled to expose a relatively thin layer of concrete mounted on plastic sheeting supported by sand.

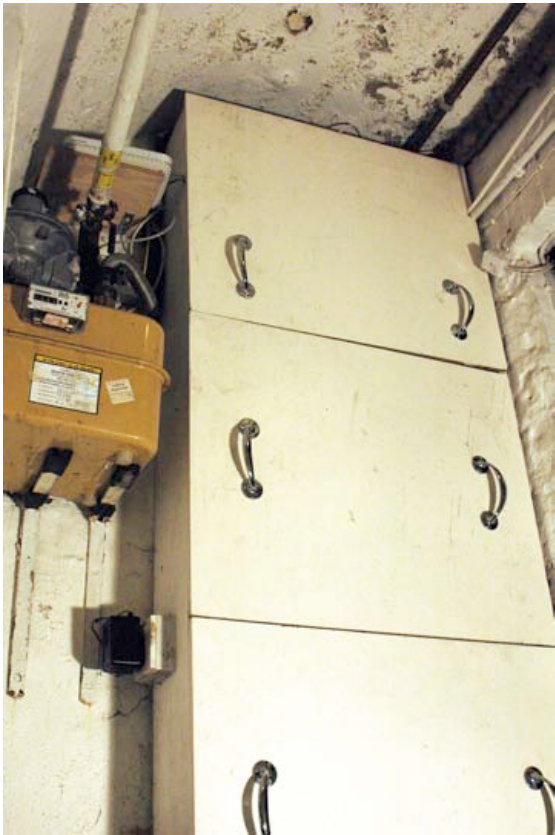
The boxing around the electricity fuse box is makeshift and was erected to prevent child access to the fuse boxes and is without architectural merit. The access panels with handles will be replaced with wooden front opening side hung doors.

2. Remove boxing around electricity fuse box and free from wall. Refit fuse box in new timber cabinet with front opening side hung doors.

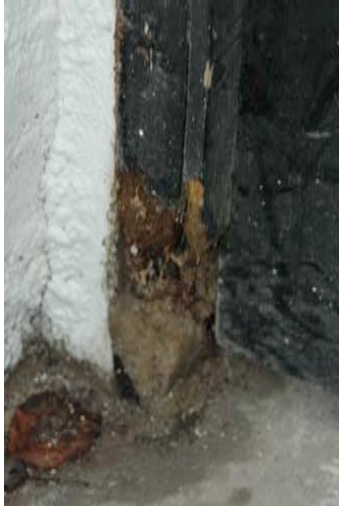
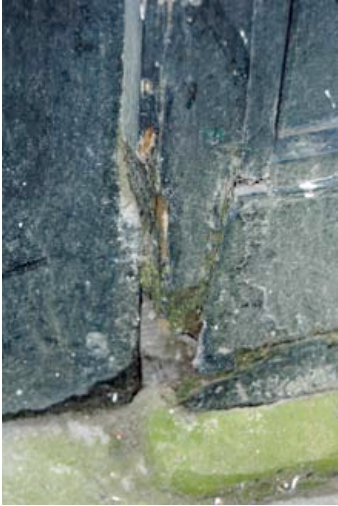
The existing basement door dates to 1996 when it was erected in an emergency following an attempted break-in, and replaced an equally undistinguished door from the seventies. The doors footings are often surrounded by pools of water and have rotted. The cause of the rot is that the York stone floor has an inappropriate slope and no threshold. This would be corrected when the York stone floor is relayed.

3. Carefully remove existing rotted door, doorframe and side panel and cart away. Remove brickwork over and remove zinc roof. New hardwood door and frame as per detailed drawing. New insulated timber framed panel above the door, and new timber roof with marine ply finish. Clad in code 5 Lead externally with new lead flashings at top and sides.

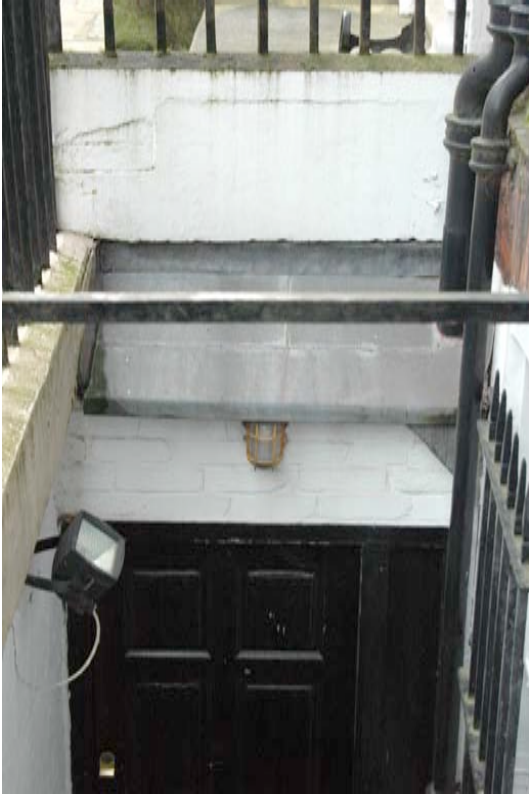
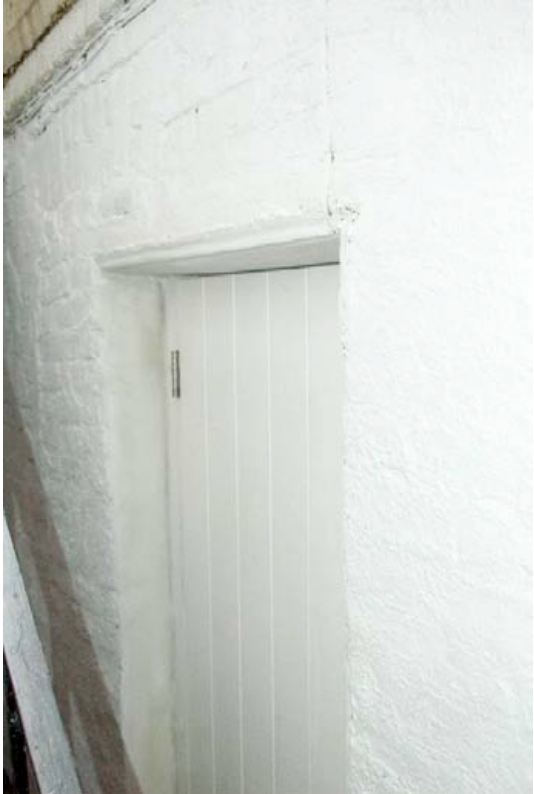
The photograph below shows the course of bricks above the door, and the short stretch of zinc roofing, to be replaced with a wooden panel and lead roof. The new door will be made out of wood and designed to match the existing door to Vault 2 (bottom right).

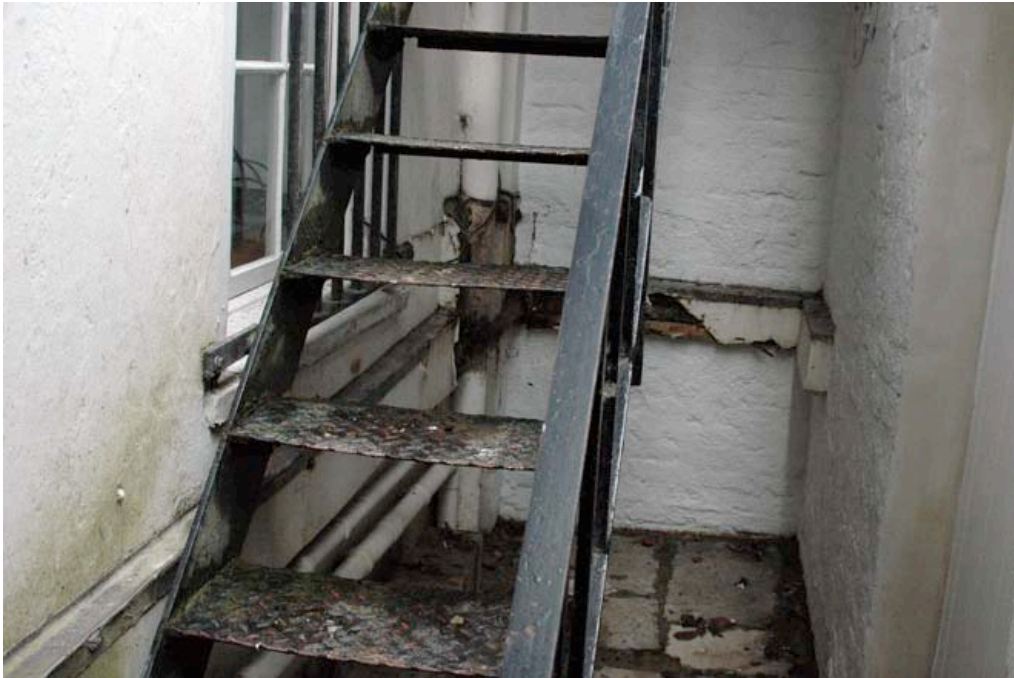
The photograph bellow shows the staircase that leads from the basement door to the street level.

4. Remove existing corroded steel staircase and cart away. New cast iron staircase as per detailed drawing.

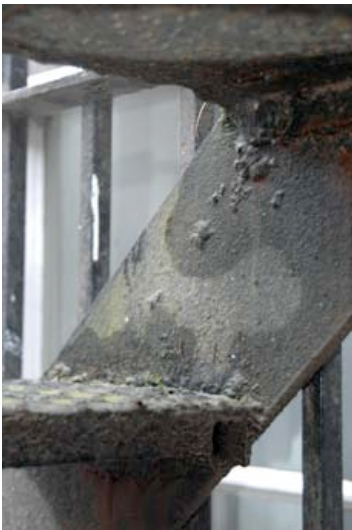
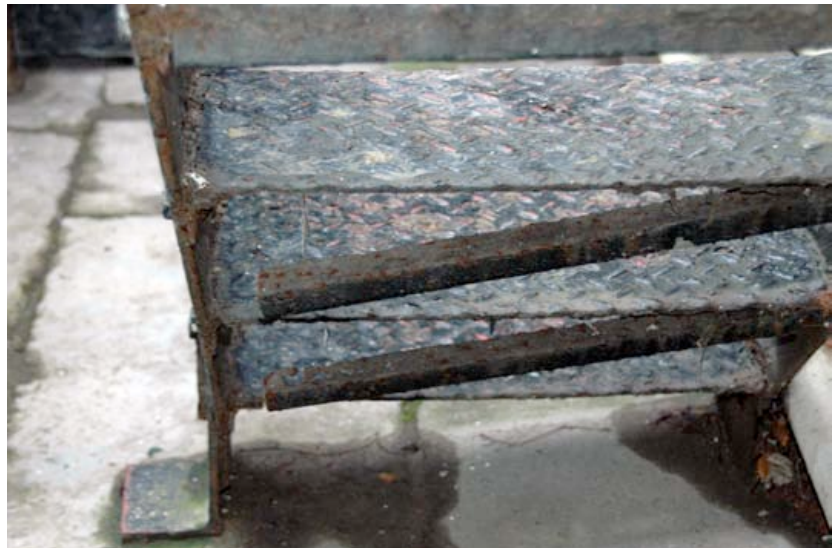
Generally the state of the metal staircase is poor. The photo below left shows the metal stringer that goes up the side of the staircase. The photo below right is taken from underneath the staircase, and shows the supports for the treads of the metal staircase have rusted through.

The new staircase will be replaced with a cast iron staircase painted in black.

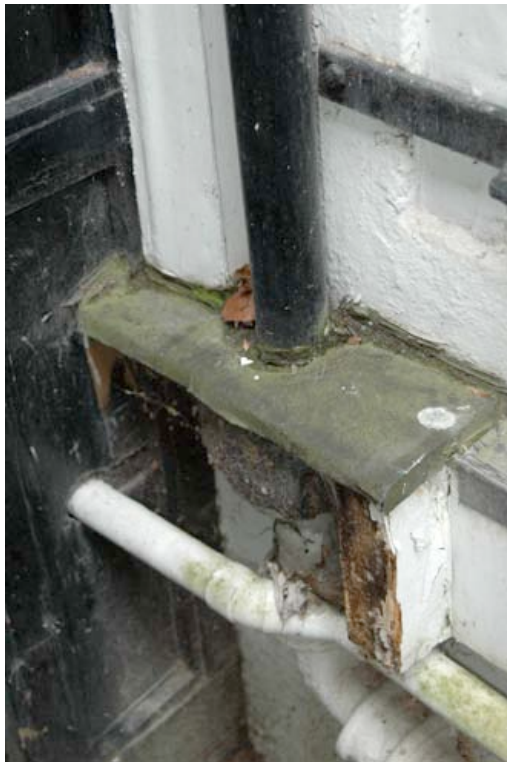
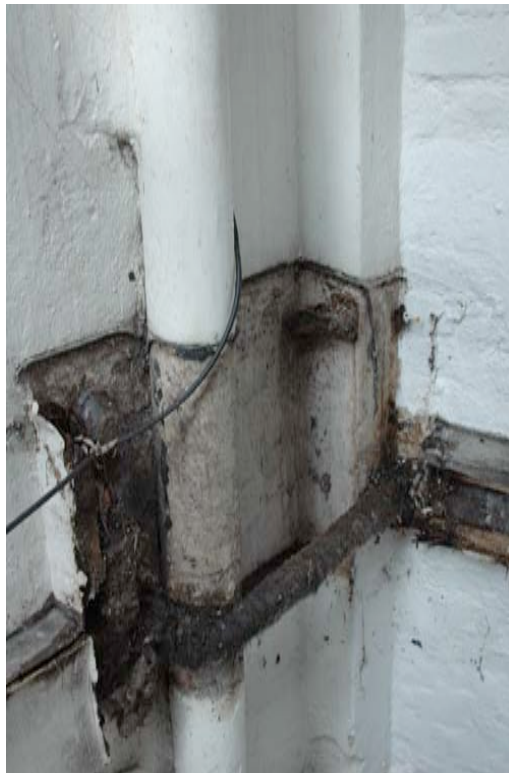
The water mains run around the small courtyard outside Vault 2, and can be seen in the above photographs behind the steel staircase.

Set out below are additional photographs showing the decay of the plywood boxing.

5. Carefully lift existing York stone paving and set aside for re-use. Remove existing external water main, Remove rotted timber boxing, re-route pipework underground and connect to existing inside the house. Relay York stone paving.

The works envisage the water mains being re-routed underneath the York stone and the boxing being done away with.

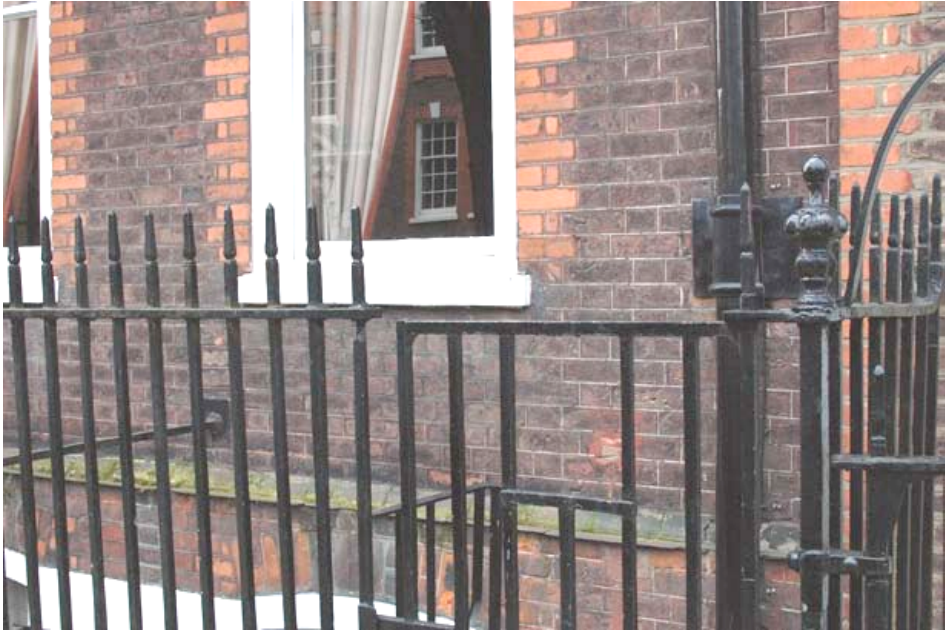
The photograph below shows the cast iron gate, without finials, and the strange “T-Bar” that creates a square space in the gate.

6. Remove horizontal "T" Bar to side gate at pavement level. Provide new full height bar and new spear headed finials to top of gate to match adjacent railings (see detailed drawing)

While the staircase is being repaired, there is the opportunity to remove the “T-Bar” and restore the continuity of the uprights and the finials, in keeping with the existing railings and the neighbour’s gate (see below) and thus with the rest of the street.
