Basement Impact Assessment

Client:	London Basement
Site:	69 Redington Road London NW3 7RP
CCS Ref:	BIA/3230
Dated:	March 2013

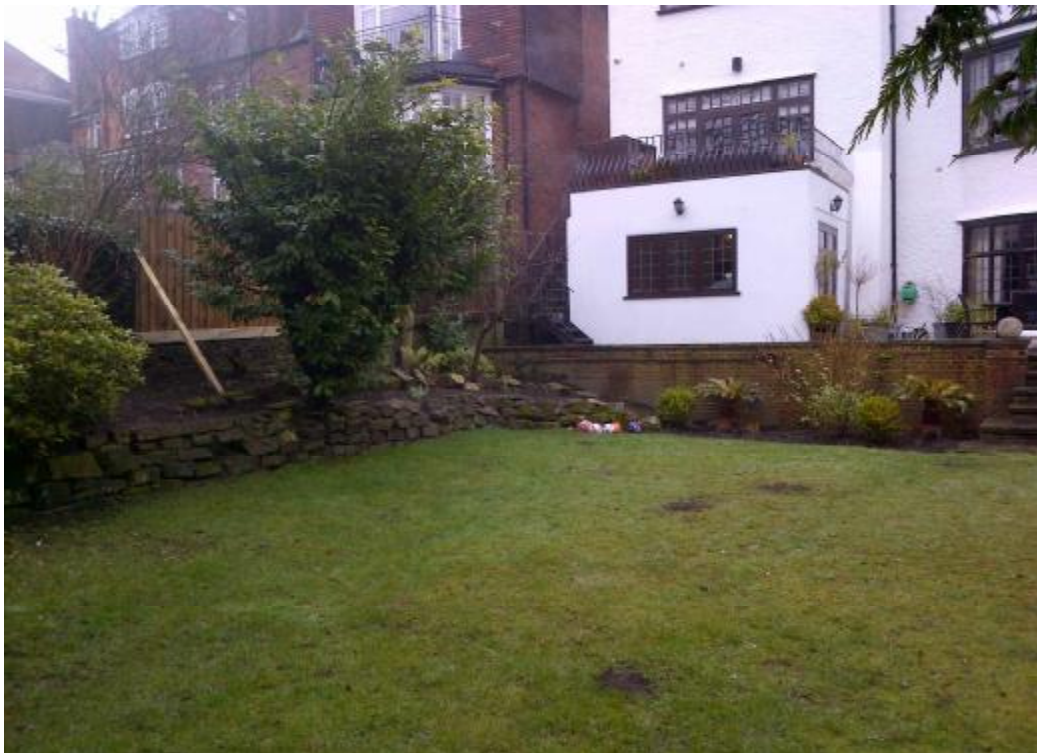
- 2.6 Along the north boundary of the rear garden there was a stonework retaining wall which supports No.71's garden, a flower bed and then a low dry stone wall bordering the lawn. The maximum retained height of the two retaining walls combined was approximately 1.5m, and this height gradually reduced westwards. The terrace at the rear of the house was separated from the lawn by flower beds and a brickwork retaining wall of approximately 1m in height. This wall showed some outward movement near its southern end (Photo 9) and is to be replaced as part of the proposed scheme. The southern boundary is marked by another retaining wall supporting No.69's garden where the ground steps down in No.67's garden.

Photo 2: Northern side of rear garden, where proposed basement will extend out beneath the lawn. Note retaining walls below boundary fence and supporting terrace, and dry stone wall to flower bed.

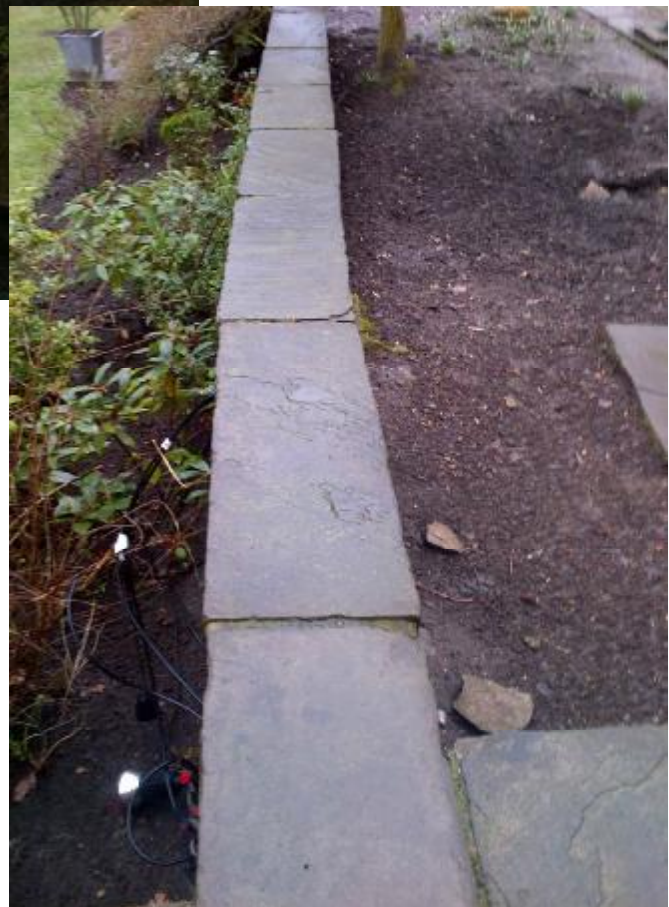
Photo 9: South end of retaining wall supporting terrace, showing outward displacement.

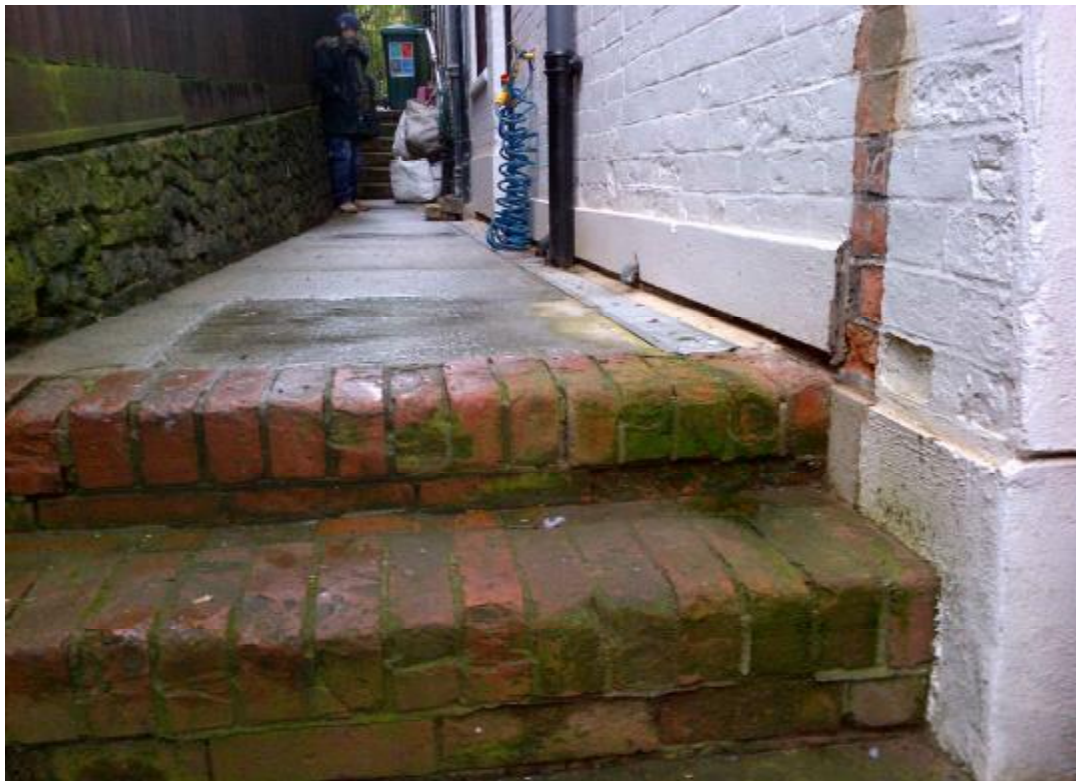
10.4.1 No evidence was seen during the site inspections of any current slope stability problems within No.69's site or in the surrounding area. The cause of the settlement of the side access path alongside No.69's north flank wall is not known, but no similar settlement appeared to have affected the adjacent path alongside No.71's south flank wall, and so the problem appeared to be a local issue, possibly associated with the drainage system. The drains alongside this wall should be water tested in order to check their integrity and a CCTV survey is recommended of the full drainage system, with any recommended repairs undertaken before or during the proposed works as appropriate.

Photo 11: Path alongside north flank wall, showing settlement relative to wall and new drain.

- 11.4 Water entries into the basement excavations are likely to be manageable by sump pumping (10.3.1).
- 11.5 No evidence was seen for current slope stability problems, although the cause of the settlement of the path along No.69's north flank wall is not known. The drains beneath that path should be water tested and a CCTV survey should be undertaken of the whole drainage system; any defects found should be repaired (10.4.1).

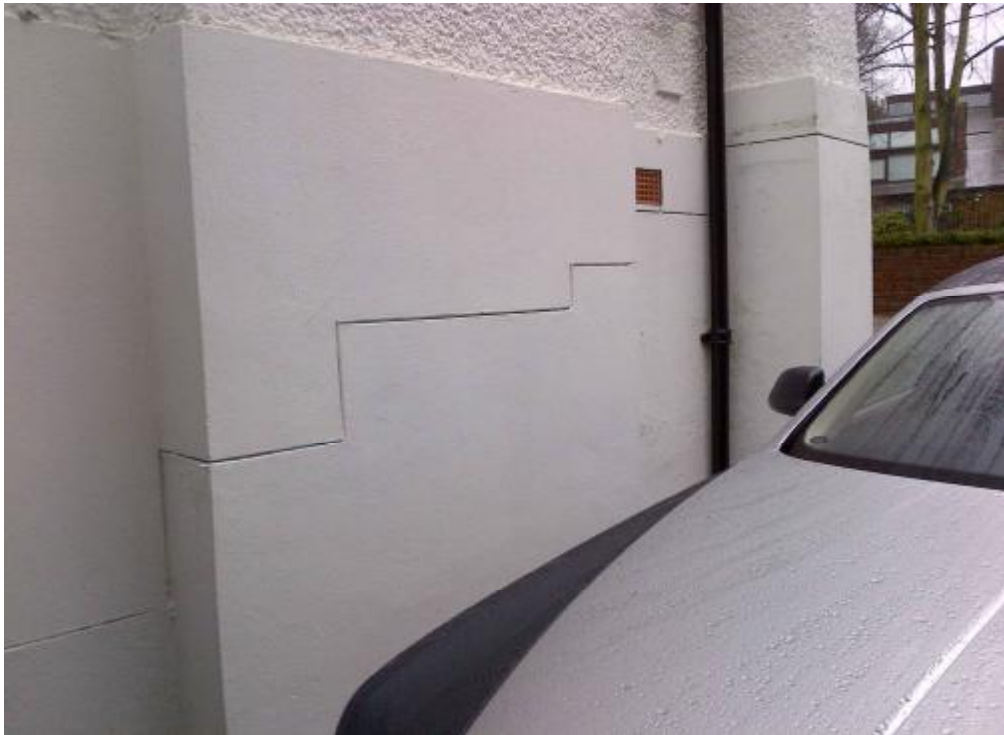
- 2.11 Most, but not all of the smooth rendered detail at the base of the external walls included a pronounced groove which was probably installed at the level of a damp proof course (dpc, possibly slate), in order to avoid the render enabling moisture to bridge the dpc. At the east end of the south flank wall this groove rises in a series of steps which appears to represent the level below which the wall acts as a retaining structure (Photo 12).

Photo 12: Stepped groove in render which probably marks position of damp proof course, with wall below that level retaining the inclined earth as seen in the crawl space beneath front part of house.
