ARBORICULTURAL IMPACT ASSESSMENT REPORT:

26a Elsworthy Road
London
NW3 3DL

Ref: ECS/ELS/AIA/01

Date: 12th February 2013

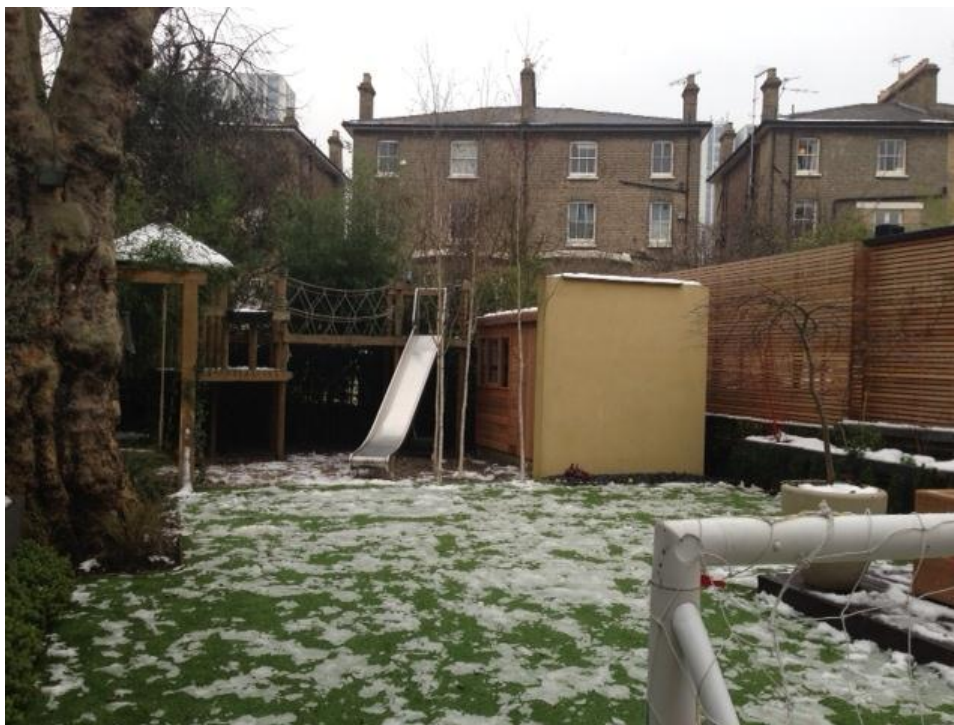
Photograph 1: Existing rear garden of 26a Elsworth Road

| 3.1.1 | The site is located within the rear garden of the residential property at 26a Elsworth Road. The area proposed for re-development lies at the northern end of the rear garden; the land is currently used as a play area with a woodchip surface, in addition to accommodating an existing shed and water feature. |
| 3.1.2 | The site is level, with various landscaped features including raised flowerbeds. The grass has been replaced with astroturf. |

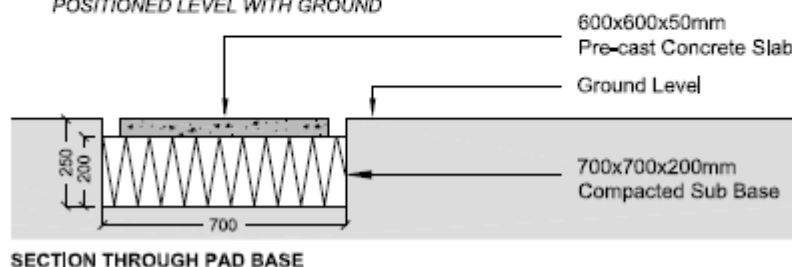
Figure 5: Proposed foundations for the Eco-building

6.3.2 The building encroachments will require the use of specialised foundation techniques, with shallow discontinuous footings hand-dug down to a depth of 250mm (see figure 5 below). This will require a further 150mm excavation below the existing level of the wood chip playground surface, with each foundation pit within the RPA pre-emptively excavated by hand under arboricultural supervision. Roots smaller than 25mm diameter may be cut cleanly with a sharp pruning saw or secateurs back to a junction. Roots larger than 25mm diameter may only be cut in consultation with an arboriculturalist.

6.3.3 The pad created will be filled with a granular sub-base, with a pre-cast concrete paving slab used to support the 'shoes' on the proposed building. In this way, the proposal will identify and protect the significant roots that may lie within the additional 150mm excavation proposed for each footing. Where significant roots are identified, the footing should be repositioned.
