Arboricultural Report

Site – Flat 1 & 2,
24 Belsize Avenue, London, NW3 4AU

Date – 19-11-2012

To be read in conjunction with –
Tree Survey Plan Drawing No. SL/BA/01

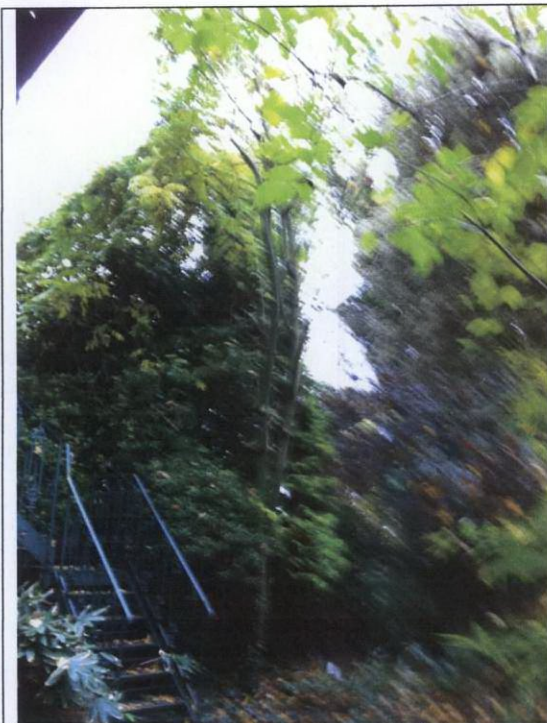
- 4.1 T1 is a young mature snake bark maple. It has been shaded by the other trees in the garden and the surrounding properties. It has very limited visual amenity from outside the garden, due to screening by other trees. The crown has been reduced in the past and the re-growth, from the old pruning points, is pole like and dense. The tree could be removed with little impact on the wider landscape, as it is screened from the adjacent gardens by T14, a Lawson cypress, and laurel shrubs.
- 4.2 Below the crowns of T1, T2 and T3 there are a number of mature shrubs, particularly pittosporum varieties. These are tall and leggy due to the dense

T1 - Snake bark maple	Fell to ground level
T2 - Cherry	Fell to ground level and poison stump
T3 - Norway maple	Fell to ground level and poison stump
T5 - Norway maple	Fell to ground level and poison stump
T11- Eucalyptus	Fell to ground level and poison stump
T12 - Goat willow	Reduce crown back to the height of the wall to form new crown.
T14 - Cherry	Prune back to the pervious pruning points

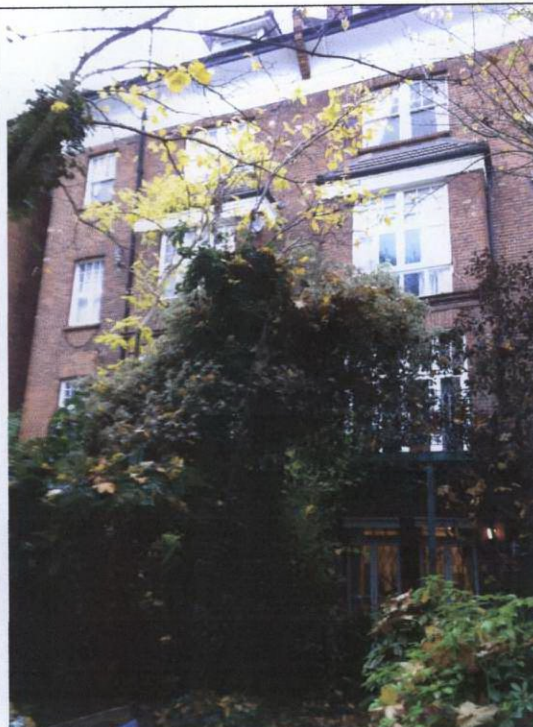
T2 - Young cherry

- shading. They are less than 100mm in stem diameter and are not protected by the Conservation area order, so can be removed without permission.
- 4.3 T2 is a young flowering cherry which is heavily covered with ivy, and has been suppressed by the trees in the neighbouring garden. As a result, it is a small tree in a poor structural condition. It also has a limited life expectancy and, due to these factors, could be removed with little impact on the wider landscape.

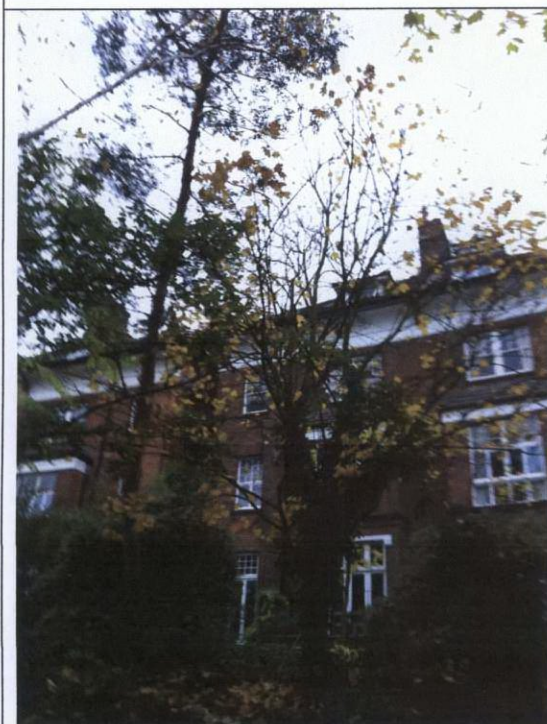
T3 - Norway maple on right with
neighbours eucalyptus on the right

- 4.4 T3 is an early mature Norway maple. It is in a fair condition, both structurally and physiologically. Within the garden it is a tree with some visual impact. However, in the wider landscape, it is not significant in comparison to the large mature trees in the neighbouring gardens. It is also screened from the east by the T13, a Lawson cypress, and from the west by the eucalyptus in the rear garden of the neighbouring property. It has large leaves and causes dense shade within the garden and to the rooms at the rear of 24 Belsize Avenue. Removal would have limited impact on the wider landscape, due to the low amenity value and large number of other trees within the garden.

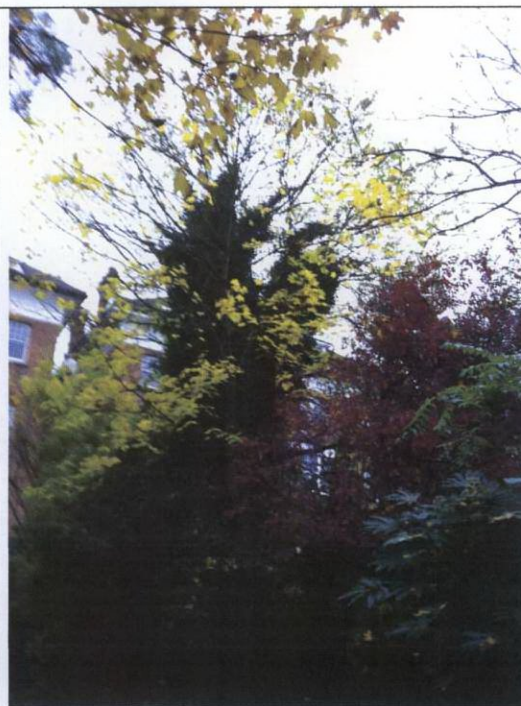
T4 - Ailanthus centre with T5 - Norway
maple in front and T9 purple leaved
plum on right

- 4.5 T4 is a mature Ailanthus or Tree of heaven. It has a dense covering of ivy, which makes a full structural assessment of the condition not possible. It is the largest and probably oldest tree in the garden. It is on the east boundary of the site and, as such, is visible from the neighbouring gardens, so is considered to have more amenity value than T1 or T3.

- 4.6 T5 is a young Norway maple growing in close proximity to T4. Due to this, the crown is unbalanced due to suppression on the north and east side. Due to the close proximity to T4, there is limited space for both trees to mature. As T4 is the larger tree, it is recommended that T5 is removed to allow T4 room to grow.

T5	<i>Norway Maple</i> <i>Acer platanoides</i>	8.5	17.5	N 1.5 S 3.5 E 1.5 W 5	3 1st main limb at 3m high on north side	EM	Fair	Fair	Remove to stop competition with T4	20-40	C

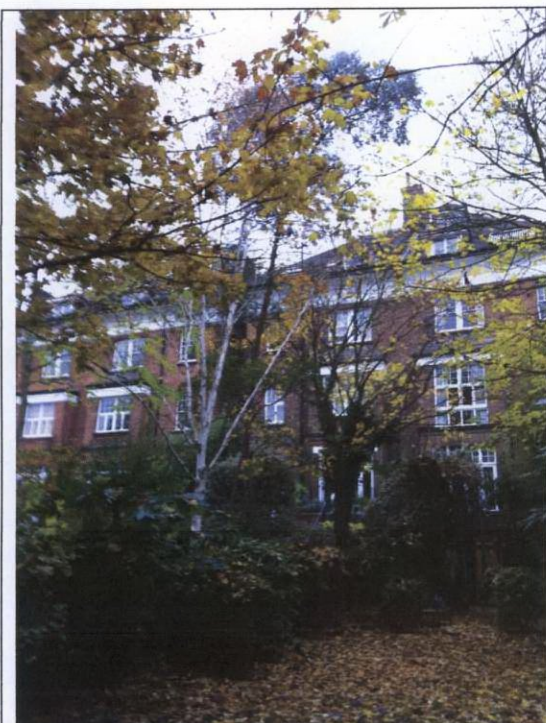
T7 - paper bark birch left, T6 - paper bark maple centre and T3 on right

- 4.7 T6 is a young paper bark maple, *Acer griseum*. It is a small tree and, though it has little impact in the wider landscape, is an attractive small specimen worthy of retention.

- 4.8 T7 is an early mature paper bark birch, *Betula jaquemanotii*. Located on the boundary, it is visible from both gardens. Again, it is an attractive small tree and, though it has little impact in the wider landscape, is worthy of retention.

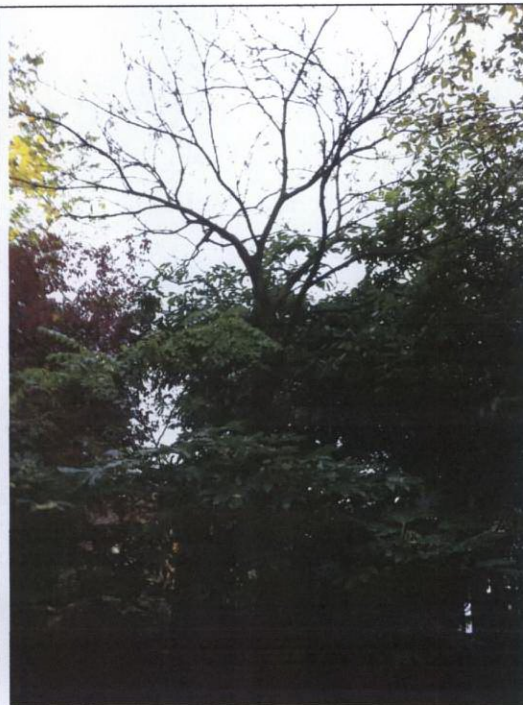
T10 - ailanthus

- 4.11 T10, an Ailanthus or Tree of heaven, is on the east boundary and provides good screening between the properties. There is burling on the trunk between 1.5m and 3m high. It appears in a fair condition and can be retained for screening value.

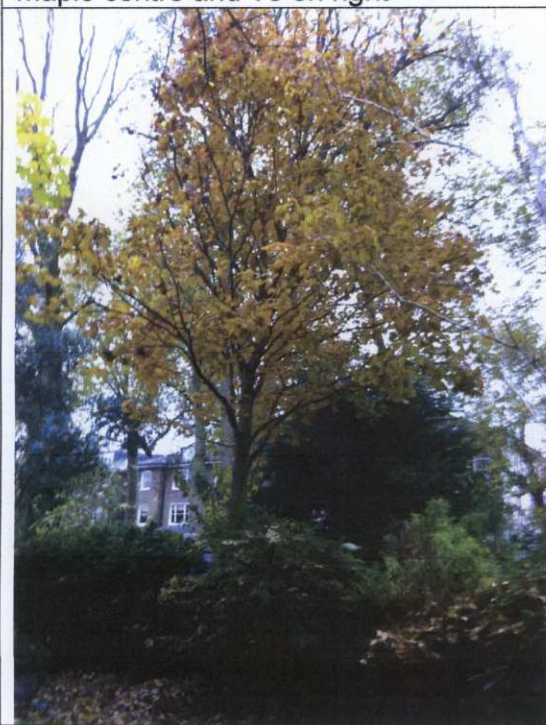
T9 - Norway maple

- 4.10 T9 an early mature Norway maple. The tree is in a good physiological condition and is considered to offer screening on the west boundary. It is worthy of retention, as the other Norway maples are either too close to the house or other better trees.

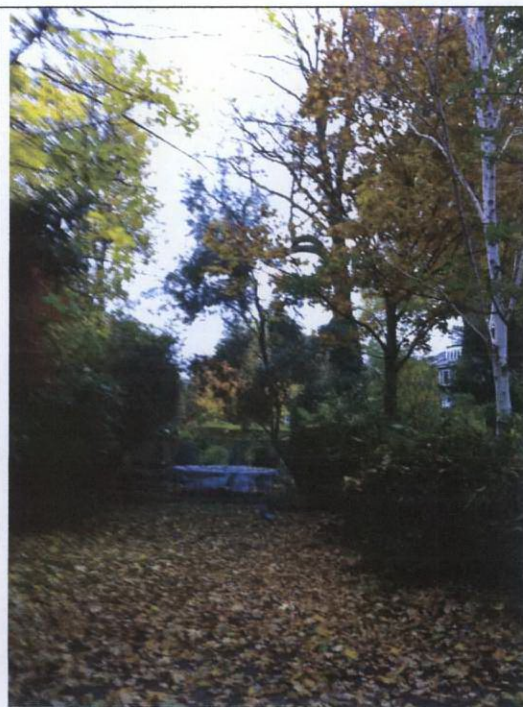
T11 - Eucalyptus in centre of picture

- 4.12 T11 is a young eucalyptus within the garden. It has limited visual amenity in the wider landscape. The tree has a main fork at 1.6m high, with two co-dominant branches above this point. There is a tight fork where they meet, with included bark, that will be a structural weakness. It is recommended that the tree is removed.

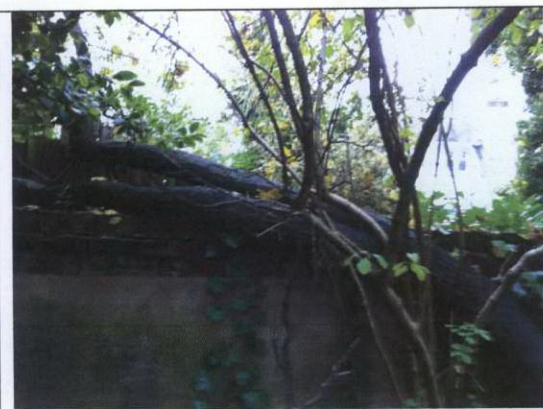
Trunk of T12 goat willow

- 4.13 T12 a mature goat willow. Physiologically, it is fair, but it is poor structurally. The crown is very unbalanced. It leans heavily to the north, with the majority of the crown over-hanging the neighbouring garden. We would recommend the tree is pollarded back to the height of the wall, to allow the crown to re-form. Willow is a species that can respond well to heavy pruning.

T12	<i>Goat willow</i> <i>Salix caprea</i>	3.5	23	N 6 S 0 E 3 W 1	2	Ma	Fair	Poor Leans heavily north, growing along the boundary and over the neighbouring garden	Reduce back the crown	10	C/U
T13	<i>Lawson Cypress</i> <i>Chaemacyparis</i> <i>lawsoniana</i>	7	12	1.2	1.2	EM	Fair	Fair		20-40	C2
T14	<i>Prunus Kanzan</i>	6	31	N 3.5 S 4 E 4 W 4	1.8	Ma	Fair	Fair 3 co-dominant stems from above the fork at 1.2m high. The crown has been reduced in the past and has responded well with re-growth from the pruning points.	Prune back to previous points	10-20	C2,3

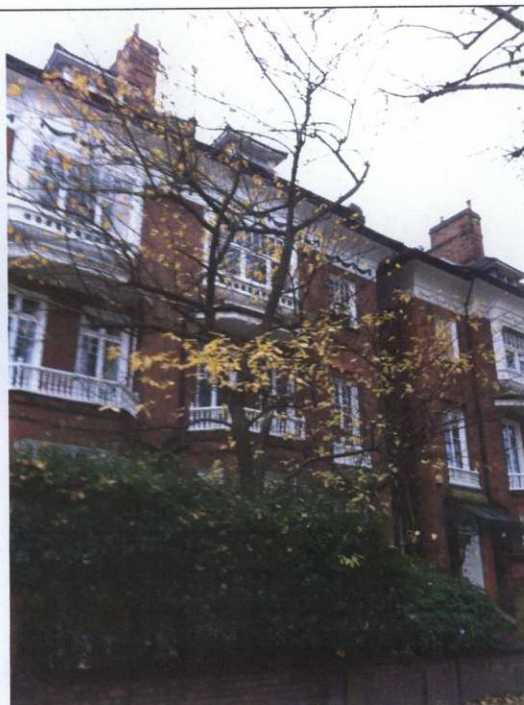
T14 - Cherry

- 4.14 T13 is a young Lawson cypress on the east boundary it is in a good structural and physiological condition. It provides good screening with the neighbouring property, and should be retained.
- 4.15 T14 is in the front garden and visible from the highway and foot path. It is slightly unbalanced due to suppression from the much larger lime tree growing in the street. It has been pruned in the past and has responded well to pruning. IT is recommended that it is pruned back to the previous pruning points to reduce shading to the ground floor and basement flats.
