REPORT

on the impact on trees
of proposals for development

9, Templewood Avenue, London, NW3 7UY

(20th December 2012)

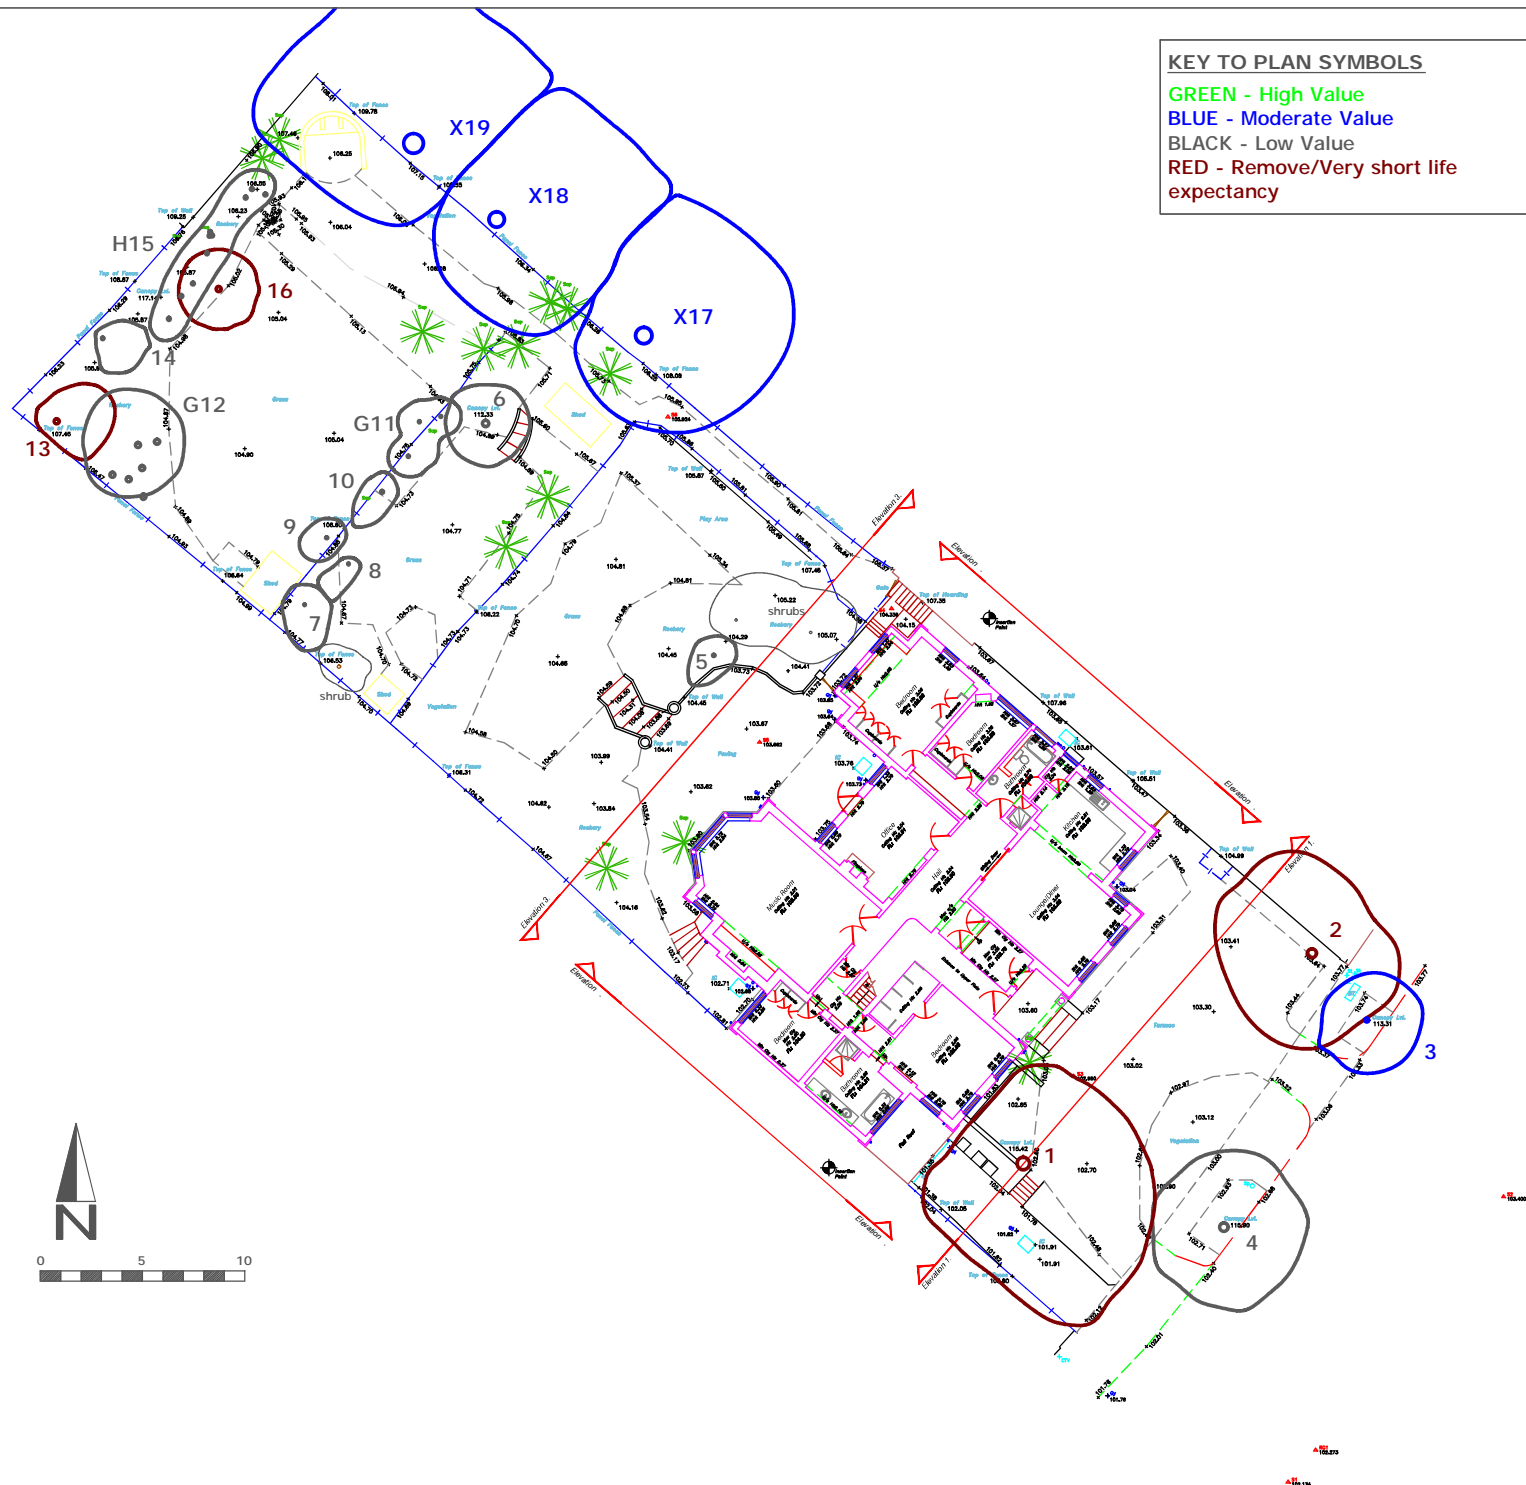
ref: 1-38-3012/P1
1:250 scale @ A3
Aug 2012

1-38-3012/P1 gives an approximate representation (in plan) of actual crown form, and is intended to indicate the relationship of neighbouring trees to each other, and should be read with the comments on crown shape and tree value in TREE DETAILS appended. The plan gives a quick reference assessment of value as per section 4, table 1, of BS 5837:2012. Assessment of value in the TREE DETAILS table appended is, in accordance with British Standard 5837:2012 'Trees in relation to design, demolition and construction - Recommendations' related mainly but not exclusively to the criterion of *visual value to the general public*. The Standard recommends a way of classifying trees when assessing their potential value in relation to proposed development. Some surveys may not include any trees of one or more categories. Table 1 suggests categories 'U', 'C', 'B' and 'A' , in ascending merit. 'U' (RED crown outline on plan) category trees are dangerous \ low value trees that could require removal for safety or arboricultural reasons. 'C' (GREY or black/uncoloured crown outline on plan) category trees are of no particular merit, but in adequate condition for retention. 'A' category trees (GREEN crown outline on plan) are trees of high vitality or good form, or of particular visual importance: 'B' (BLUE crown outline on plan) category are good trees but may be of slightly poorer form or be not sited as importantly as 'A' category trees. See TREE DETAILS appended. Category Assessment appears in column 10. This standard also provides a way of determining an area (see TREE DETAILS column 7) – the RPA – root protection area - around the trunk of the tree in which protective measures should be used in order to prevent significant damage to trees. There are various ways of achieving this. A simple way is to use exclusion fencing, but other methods have been shown by established use to be very effective.

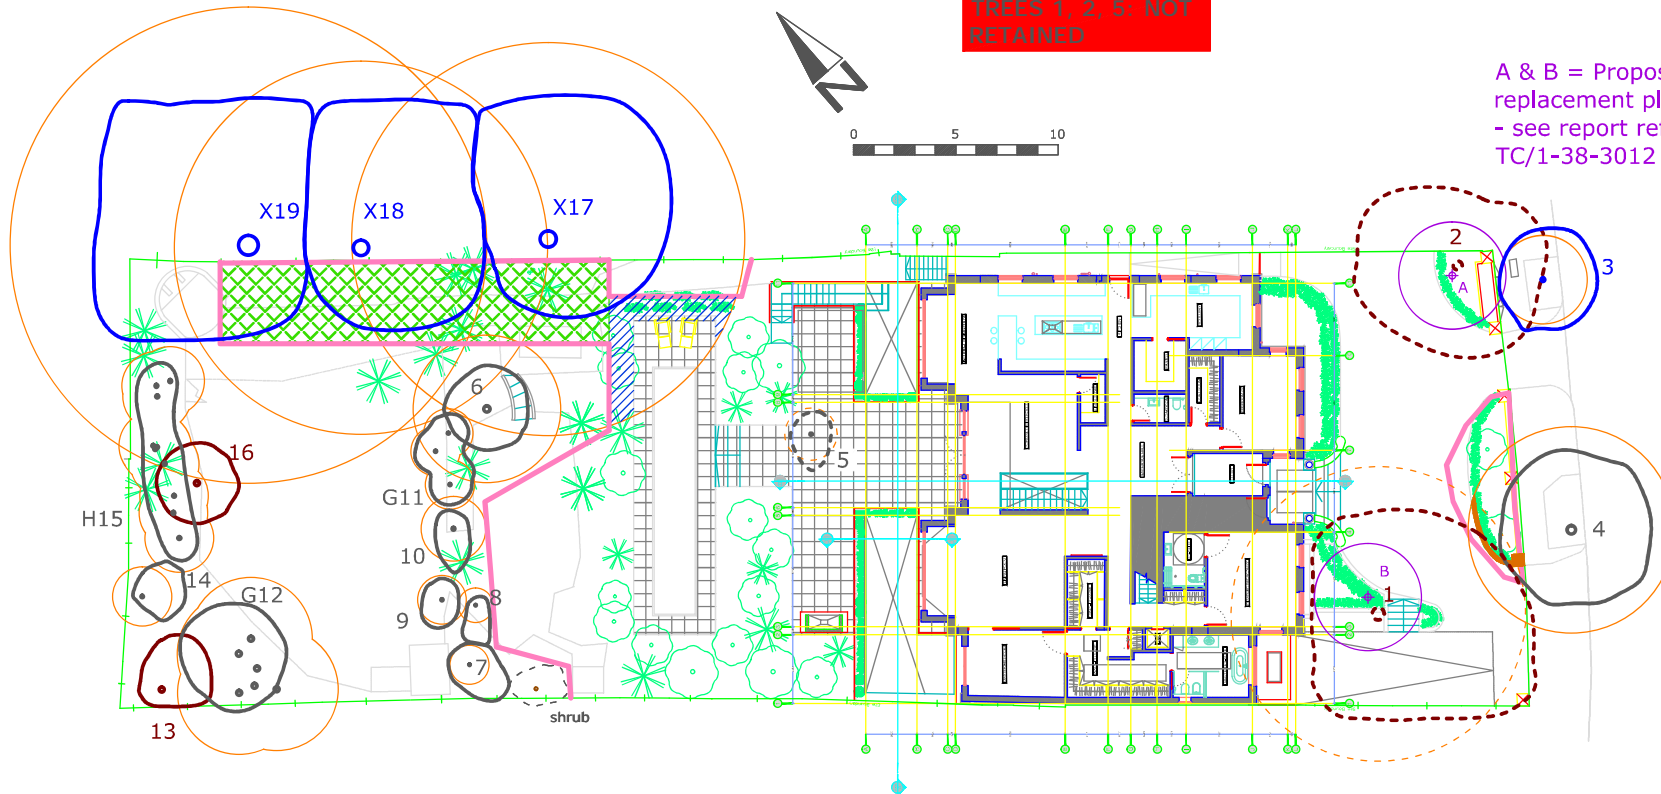
ref: 1-38-3012/P2A
 1:250 @ A3 scale
 Dec 2012

TREES 1, 2, 5: NOT
 RETAINED

1-38-3012/P2A shows proposed retained trees and is colour-coded to indicate where arboricentric methods are proposed during the construction process.

Method 4 : This method shall apply in the zone hatched **blue** on plan. No reduction in levels shall take place. Heavy - duty impermeable membrane and then continuously abutted scaffold boards or manufactured boards shall be laid so as to completely cover these zones. Any finishing paving shall be laid open jointed on lime-free sharp sand or granite chippings

Method 5 : This method shall apply in the zone hatched **green** on plan. No reduction in levels shall take place. Suspended decking shall be erected, supported by 100mm x 100mm timber pegs or timber baulks. On this formation, site huts may be erected or certain materials stored. No below-ground connections shall be made, e.g. to toilets : all such piping shall lie above ground. Rainwater collected from any such roof shall be piped back through a system of ducts that spreads the water evenly to the whole ground surface that lies below the formation. Any area not covered by site huts shall be covered by a non-slip, permeable covering. Light storage of dry, non-soluble materials only shall take place. No cement dust shall be stored in this location.
