1.0 Introduction

This document incorporates a Heritage Statement as required under Planning Policy Statement (PPS5) –Planning for the Historic Environment.

34 Great Queen Street is a five storey Georgian terraced house built in circa 1710 of similar construction to 33 & 35. The building is constructed of brown brick with red brick cornices below parapets, with a moulded brick band at 2nd floor to the rear elevation. The roof comprises of a butterfly roof, tiled with dormer windows to front and rear elevations. The adjoining premises No 33 is slated. To the front elevation there are red brick dressings and segmental arches to sash frame windows, circa C20. The shop front is circa C20. The House doorway is fitted with fanlight and panelled door.

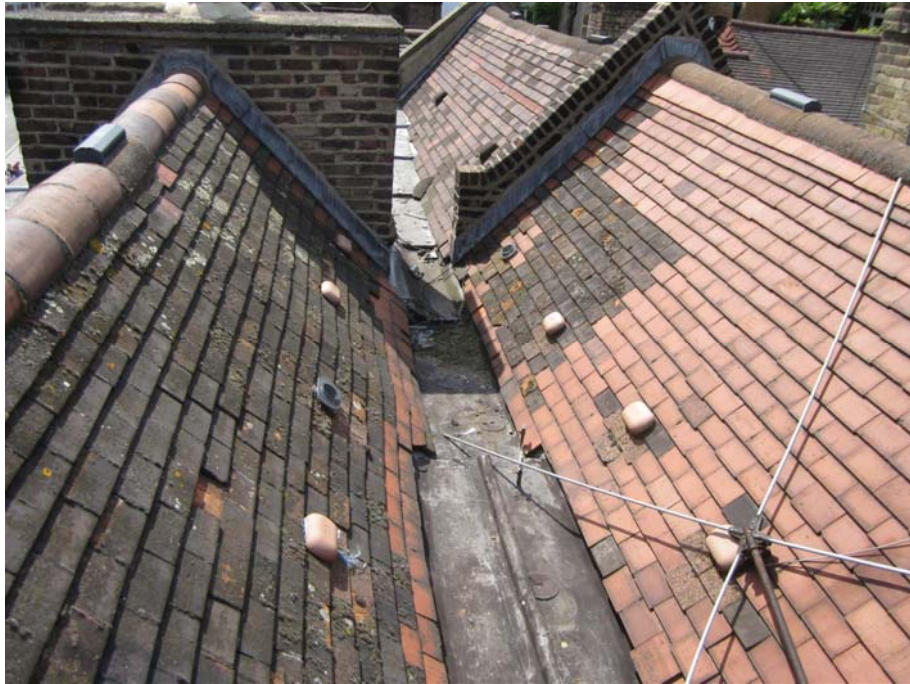
Fig 3 – Butterfly pitched roof

The existing tiled roof coverings are of poor condition and require replacement. See Fig 3. Numerous tiles are broken throughout.

The proposal is to replace the existing clay tiled roof coverings with new to match existing and period of construction. The line of the roof coverings will remain as existing, not affecting the height nor depth of the roof coverings against existing fabric. The proposal would also include the installation of a breathable roof membrane to improve ventilation without the need for ventilated tiles (as existing). Loose lay quilt insulation will be installed between the ceiling joists to improve thermal comfort.

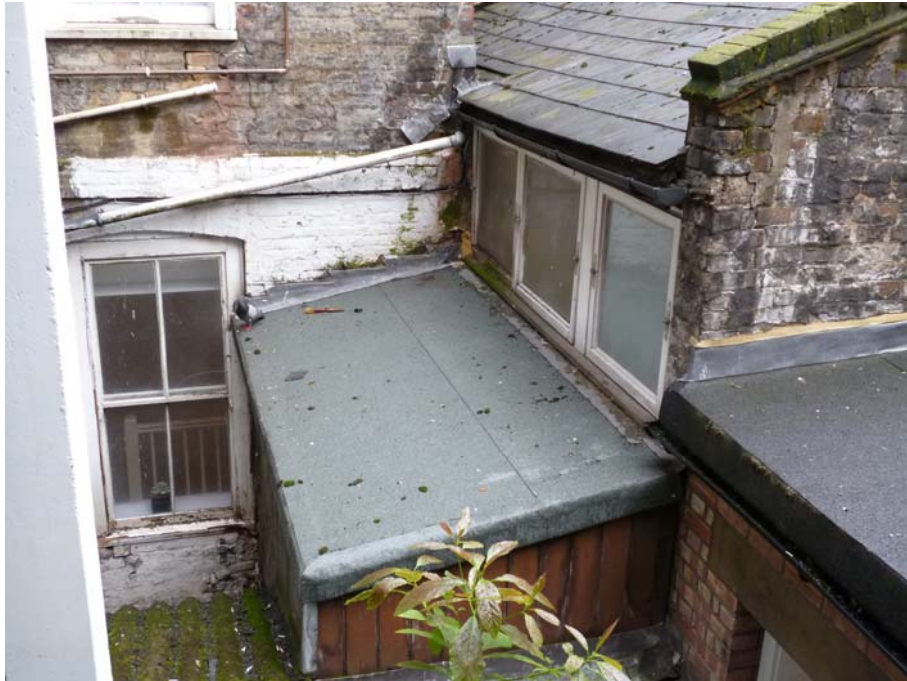
Fig 4 – Lower WC Ground floor roof

The existing felt roof coverings to the ground floor WC structure are in poor condition. See Fig 4.

The proposal is to remove the existing felt coverings, repair the sub base structure and install a new grey coloured zinc roof covering to the timber structure with standing seam abutments and flashings. We had considered the use of lead, however discounted for its weight and structural alterations to the fabric to support the material. Zinc is a light weight material and suitable for this application.

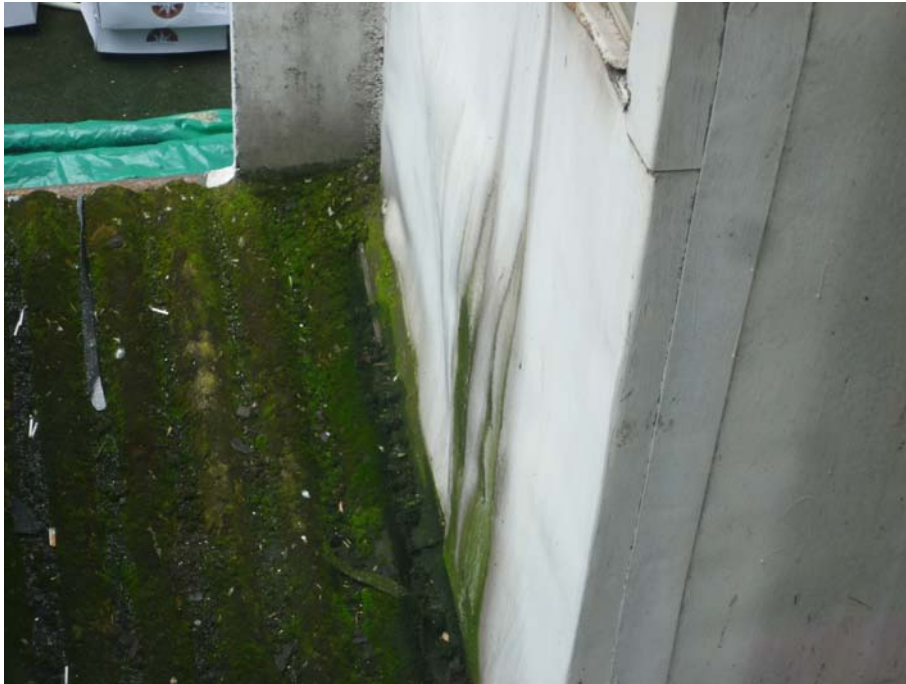
Fig 5 – Link structure roof

The existing asbestos corrugated linings to the link structure are poor with cracking to the board.

The proposal is to remove the defective coverings, repair the sub base structure and install a new timber backing board and new grey coloured zinc roof covering with standing seam abutments and flashings. We had considered the use of lead, however discounted for its weight and structural alterations to the fabric to support the material. Zinc is a light weight material and suitable for this application and will match the material used on the thunderbox toilet construction.

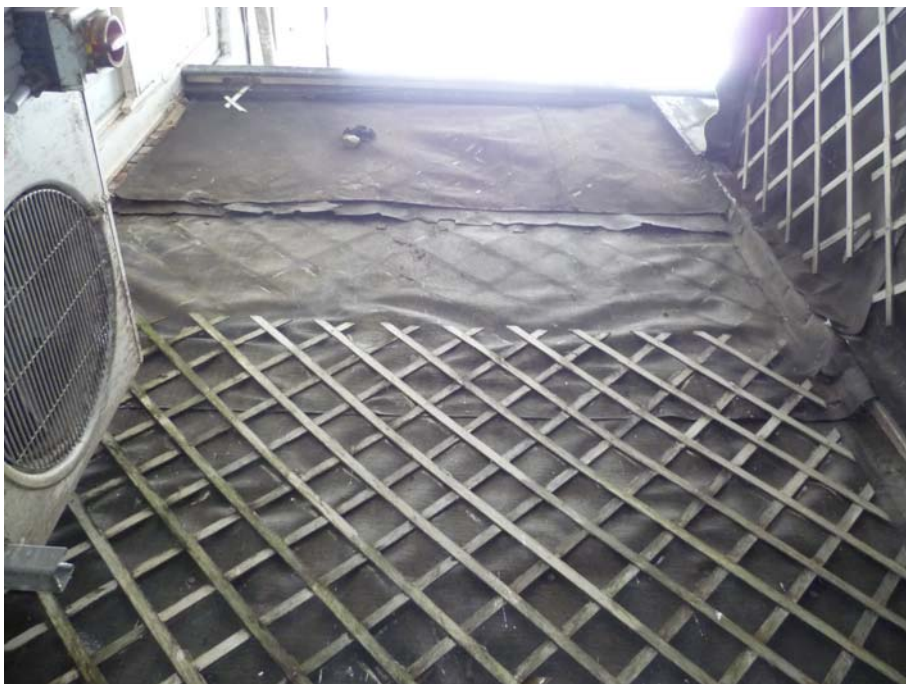
Fig 6 – Ground floor WC wall elevation

The cladding and framework to the ground floor WC and link structure is exposed allowing moisture and water to penetrate the structure, causing extensive timber decay. See figs 6, 7 & 8. The lining is perishing and is aesthetically unpleasing to the users and customers of the building.

The proposal is to remove the existing trellis and bitumen linings to expose the timber structure beneath. The timber structure will be overclad with a breather membrane, vertical battens and new Red Cedar square edge tongue and grooved boarding installed. This will aesthetically improve the appearance to the lightwell and preserve the existing structure.

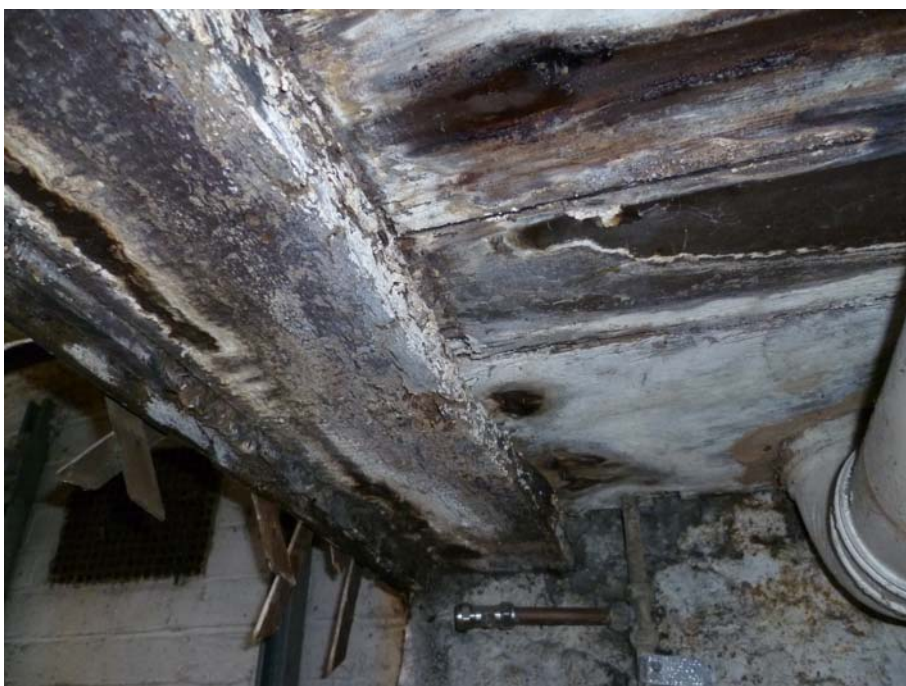
Fig 8 – Ground floor WC structure

The timber lintel and adjoining floorboards to the ground floor WC structure are exposed, resulting in extensive decay. See fig 8.

The proposal is to remove the existing timber beam and replace with new Pitch Pine timber lintel and replacement of decayed floor boards. The underside will be protected by the installation of new plywood boarding to underside and the lintel overlaid with zinc flashing.

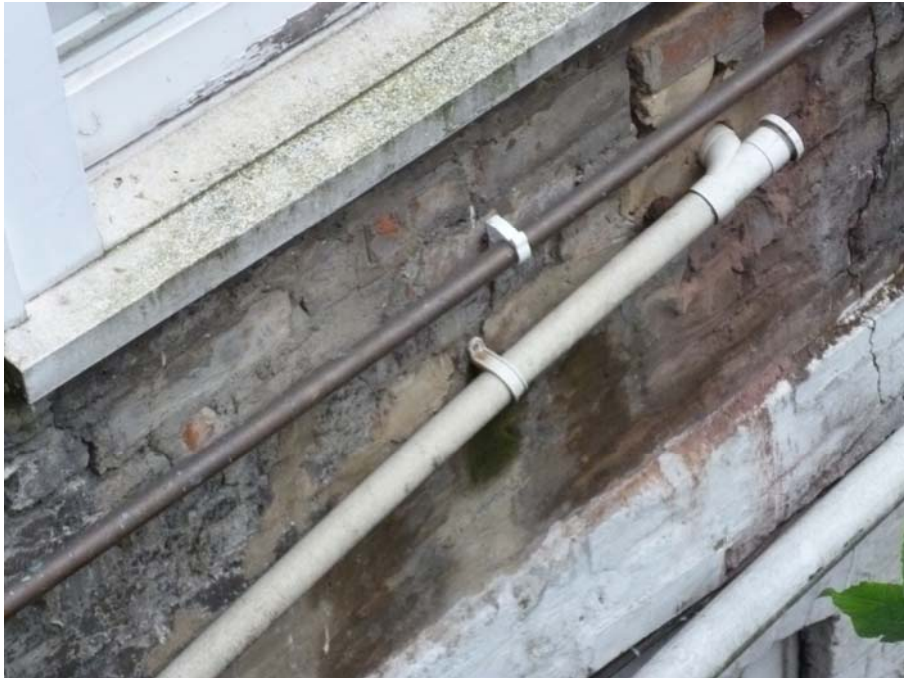
Fig 9 – Ground / First floor wall construction

The brickwork between the ground and first floor windows is defective with possible damage to the timber lintel behind the wall structure. See fig 9.

The proposals are to remove the damaged and defective masonry and timber lintel and replace with new reclaimed brickwork, pointed with lime mortar to match the original construction.

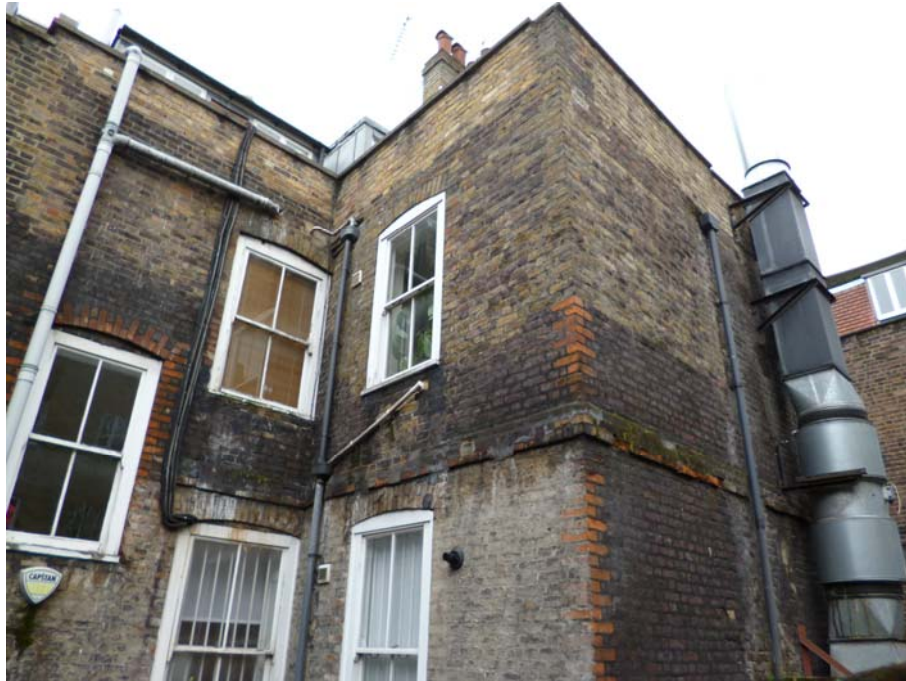
Fig 10 – Rear wall elevation

The brickwork to the second floor string course is defective with cracked and spoiled brickwork and cracked mortar pointing. See fig 10.

The existing soil and waste pipework to the rear elevation are poor and defective requiring replacement throughout. See fig 10.

The proposals are to remove the damaged and defective masonry and replace with new reclaimed brickwork, pointed with lime mortar to match the original construction.

The proposal is to remove an pipework and replace with new cast iron throughout, painted black upon completion.

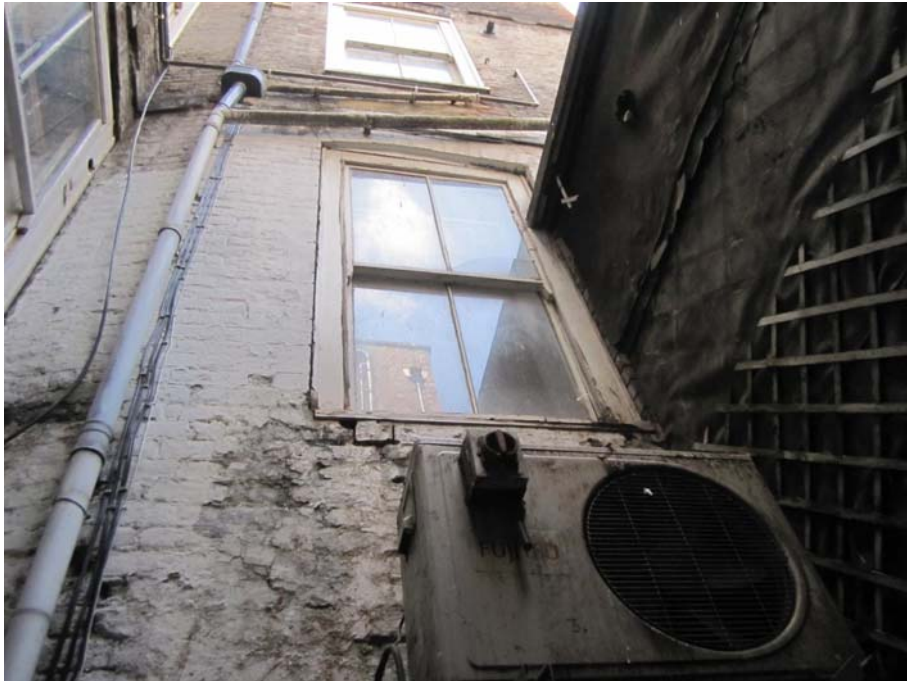
Fig 11 – Inner lightwell elevation

The existing lower ground floor and basement walls are spoiled and paint finishes are preventing the brickwork to breath. See fig 11.

The proposal is to prepare the walls and render with a lime render and lime paint finish.
