TREE SURVEY and ARBORICULTURAL METHOD STATEMENT

A report to accompany a Planning Application for
development on land at 86 Canfield Gardens, London, NW6
3EE

Report by Dr Martin Dobson

7 November 2007

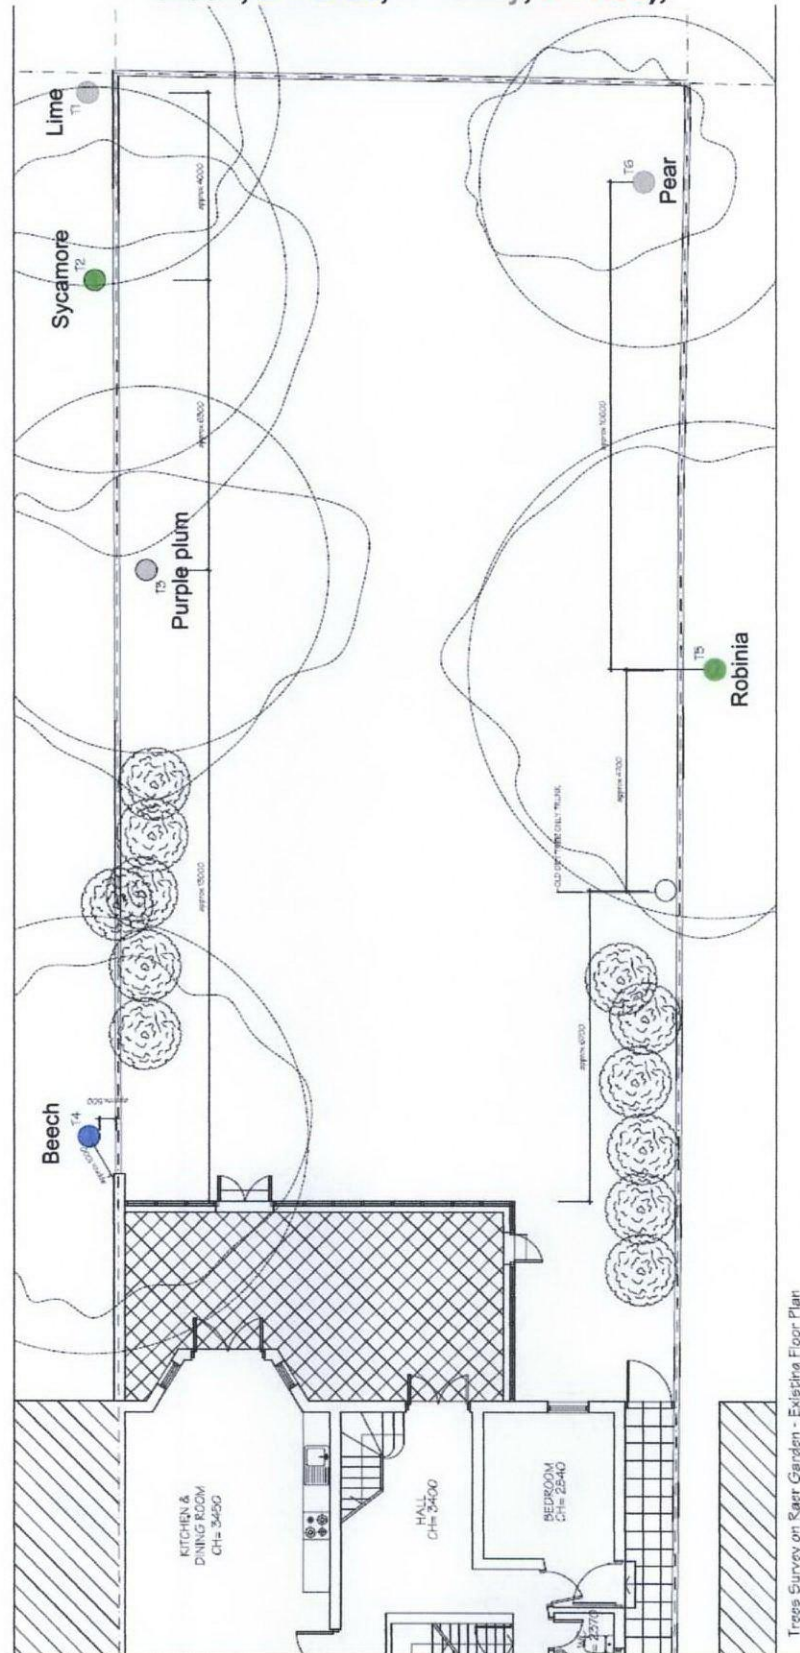
APPENDIX MD2

Site survey drawing showing tree numbers and BS5837 colour codes (A – Green, B – Blue, C – Grey, R – Red),

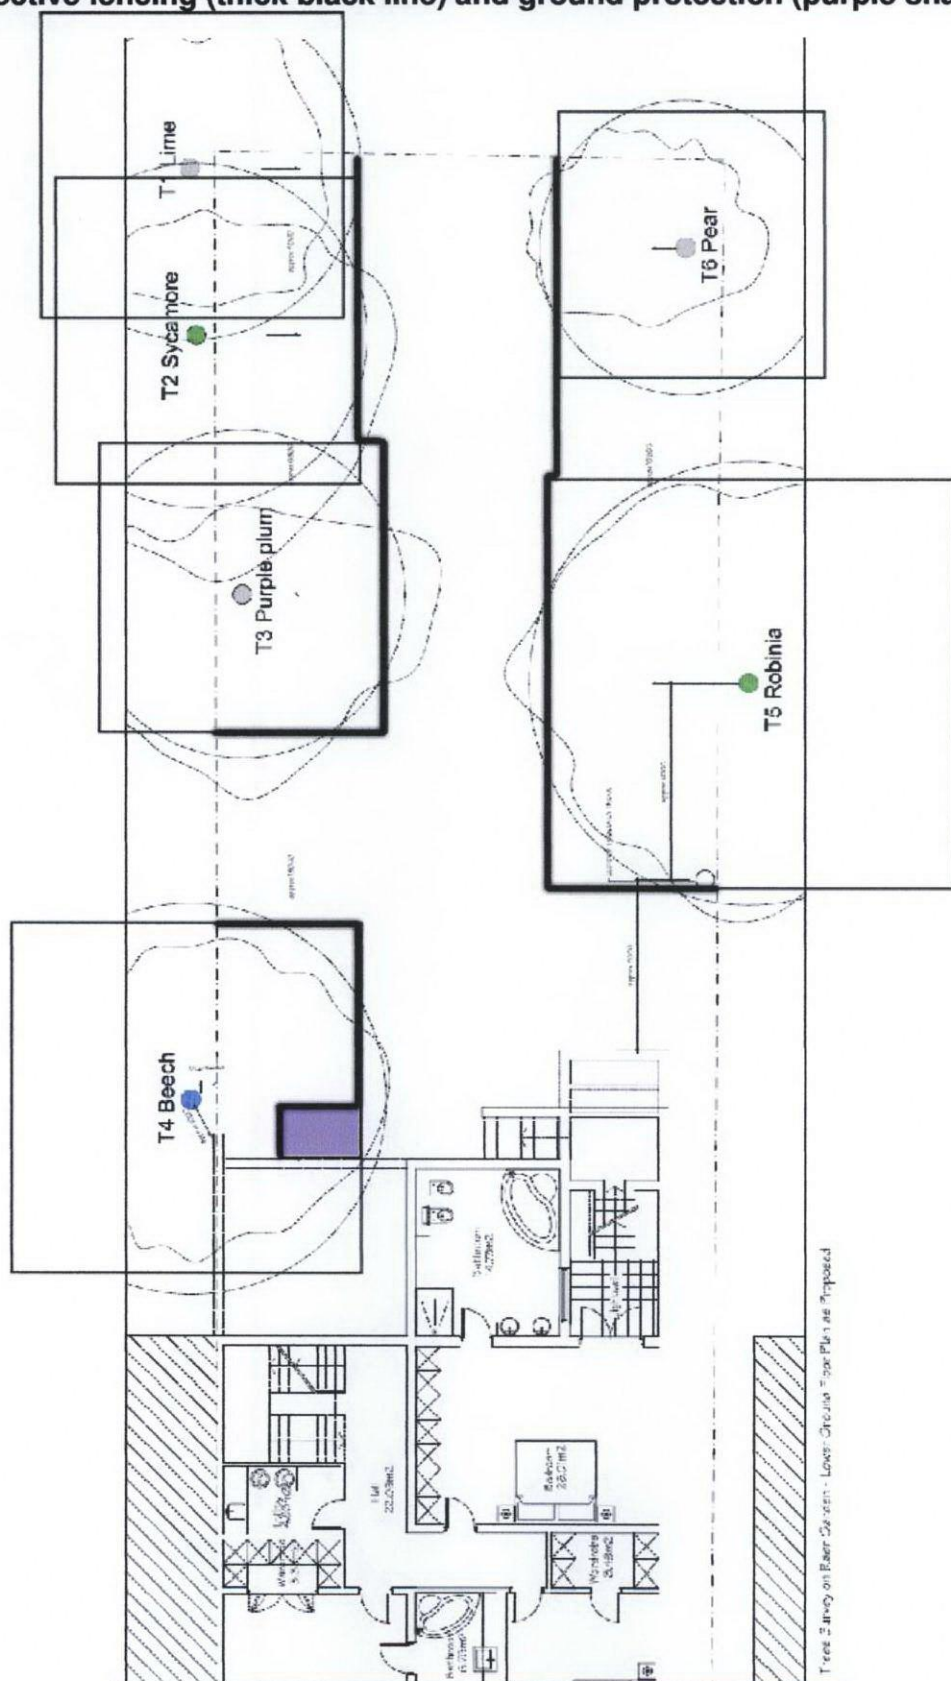
Proposed new layout and positions of root protection zones (thin black lines), protective fencing (thick black line) and ground protection (purple shading)
