Fireplace Strategy

JOB TITLE ARGENT (KING'S CROSS) LTD. STANLEY SOUTH BUILDING (KXC - E1) KING'S CROSS REDEVELOPMENT	JOB NO. 212	DRWG. TITLE EXISTING: THIRD FLOOR PLAN FIREPLACES	STATUS PLANNING	
		DRWG. NO. 212 / PD / 123 (A3 ORIGINAL FORMAT)	REV:	SCALE: 1:100
Studiowornie ARCHITECTS LLP	TEL: +44 (0) 20 7269 7745 studiodownie@studiodownie.com	All dimensions to be checked on site by the Contractor and confirmed with the Architect prior to construction. Do not scale off this drawing.		Drawn by: EDC DATE: 05/04/12

Existing Ceilings

Existing Wall Linings

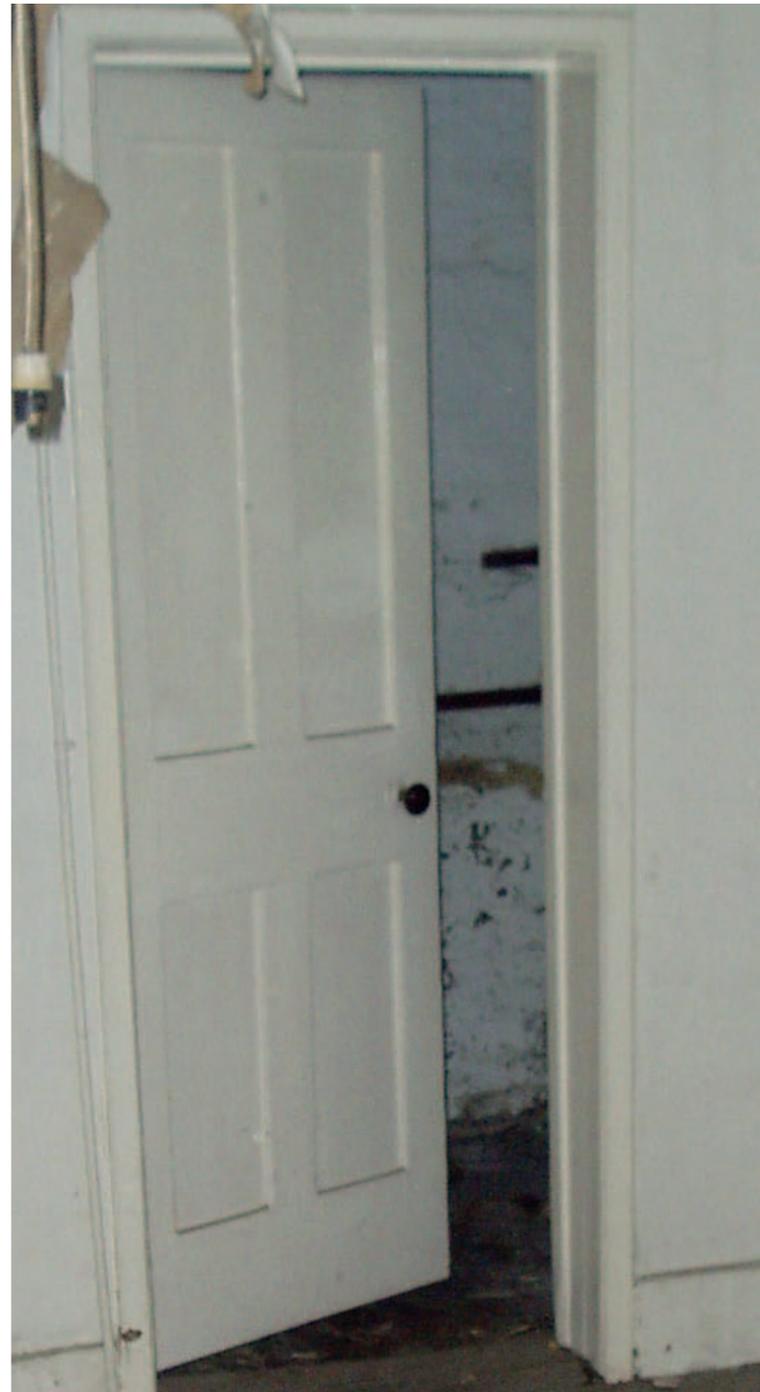
Existing Doors

The existing exterior and interior doors within the Southern Stanley Building do not meet the modern fire, acoustic and accessibility requirements and therefore are unable to be re-used as part of the building's refurbishment.

New solid wood reproduction doors will match the existing quarter panel design, with internal doors having laminated glass in the top two panels.

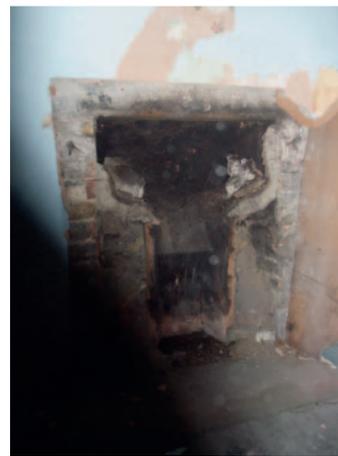
exposed brickwork where fireplace taken away

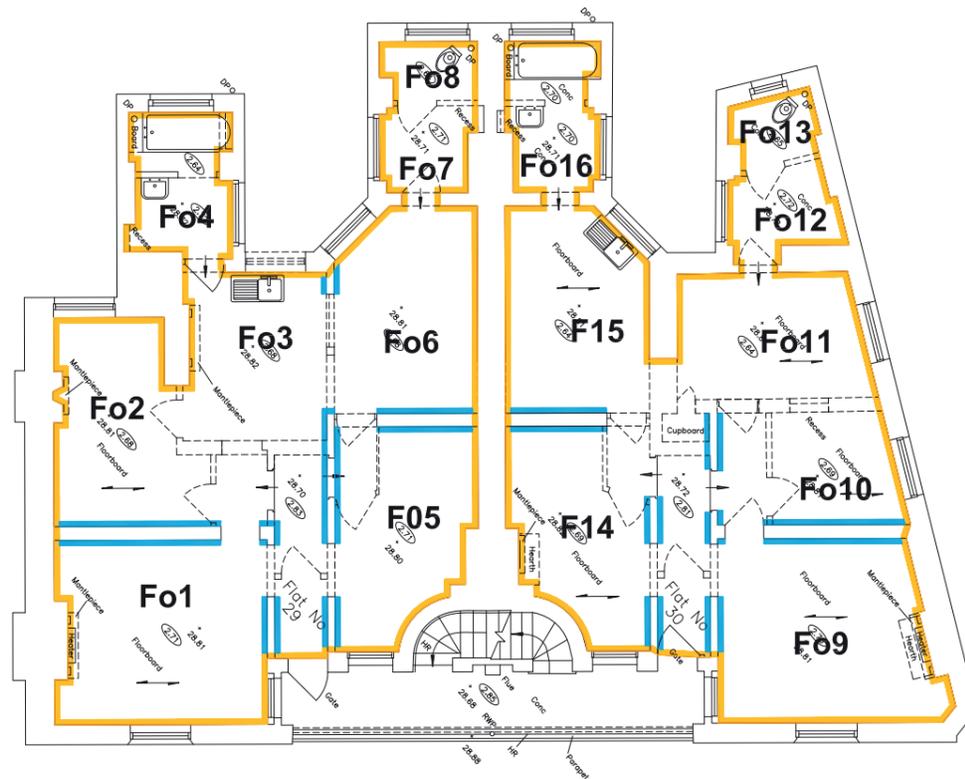
Plaster Walls

- Existing wall covers include wall paper, vinyl wall paper, painted
- Areas of cracking, areas of blown plaster, areas of damp (especially in corners)
- Internal dividing walls especially, numerous holes for shelving units since removed, and also shelving units to be removed during soft strips will leave further holes, some large random holes (unexplained)

- LIME BASED PLASTER (perimeter)
Remove papers, recent finishes
- ACOUSTIC PLASTERBOARD (Internal walls)
Remove papers, recent finishes and existing plaster

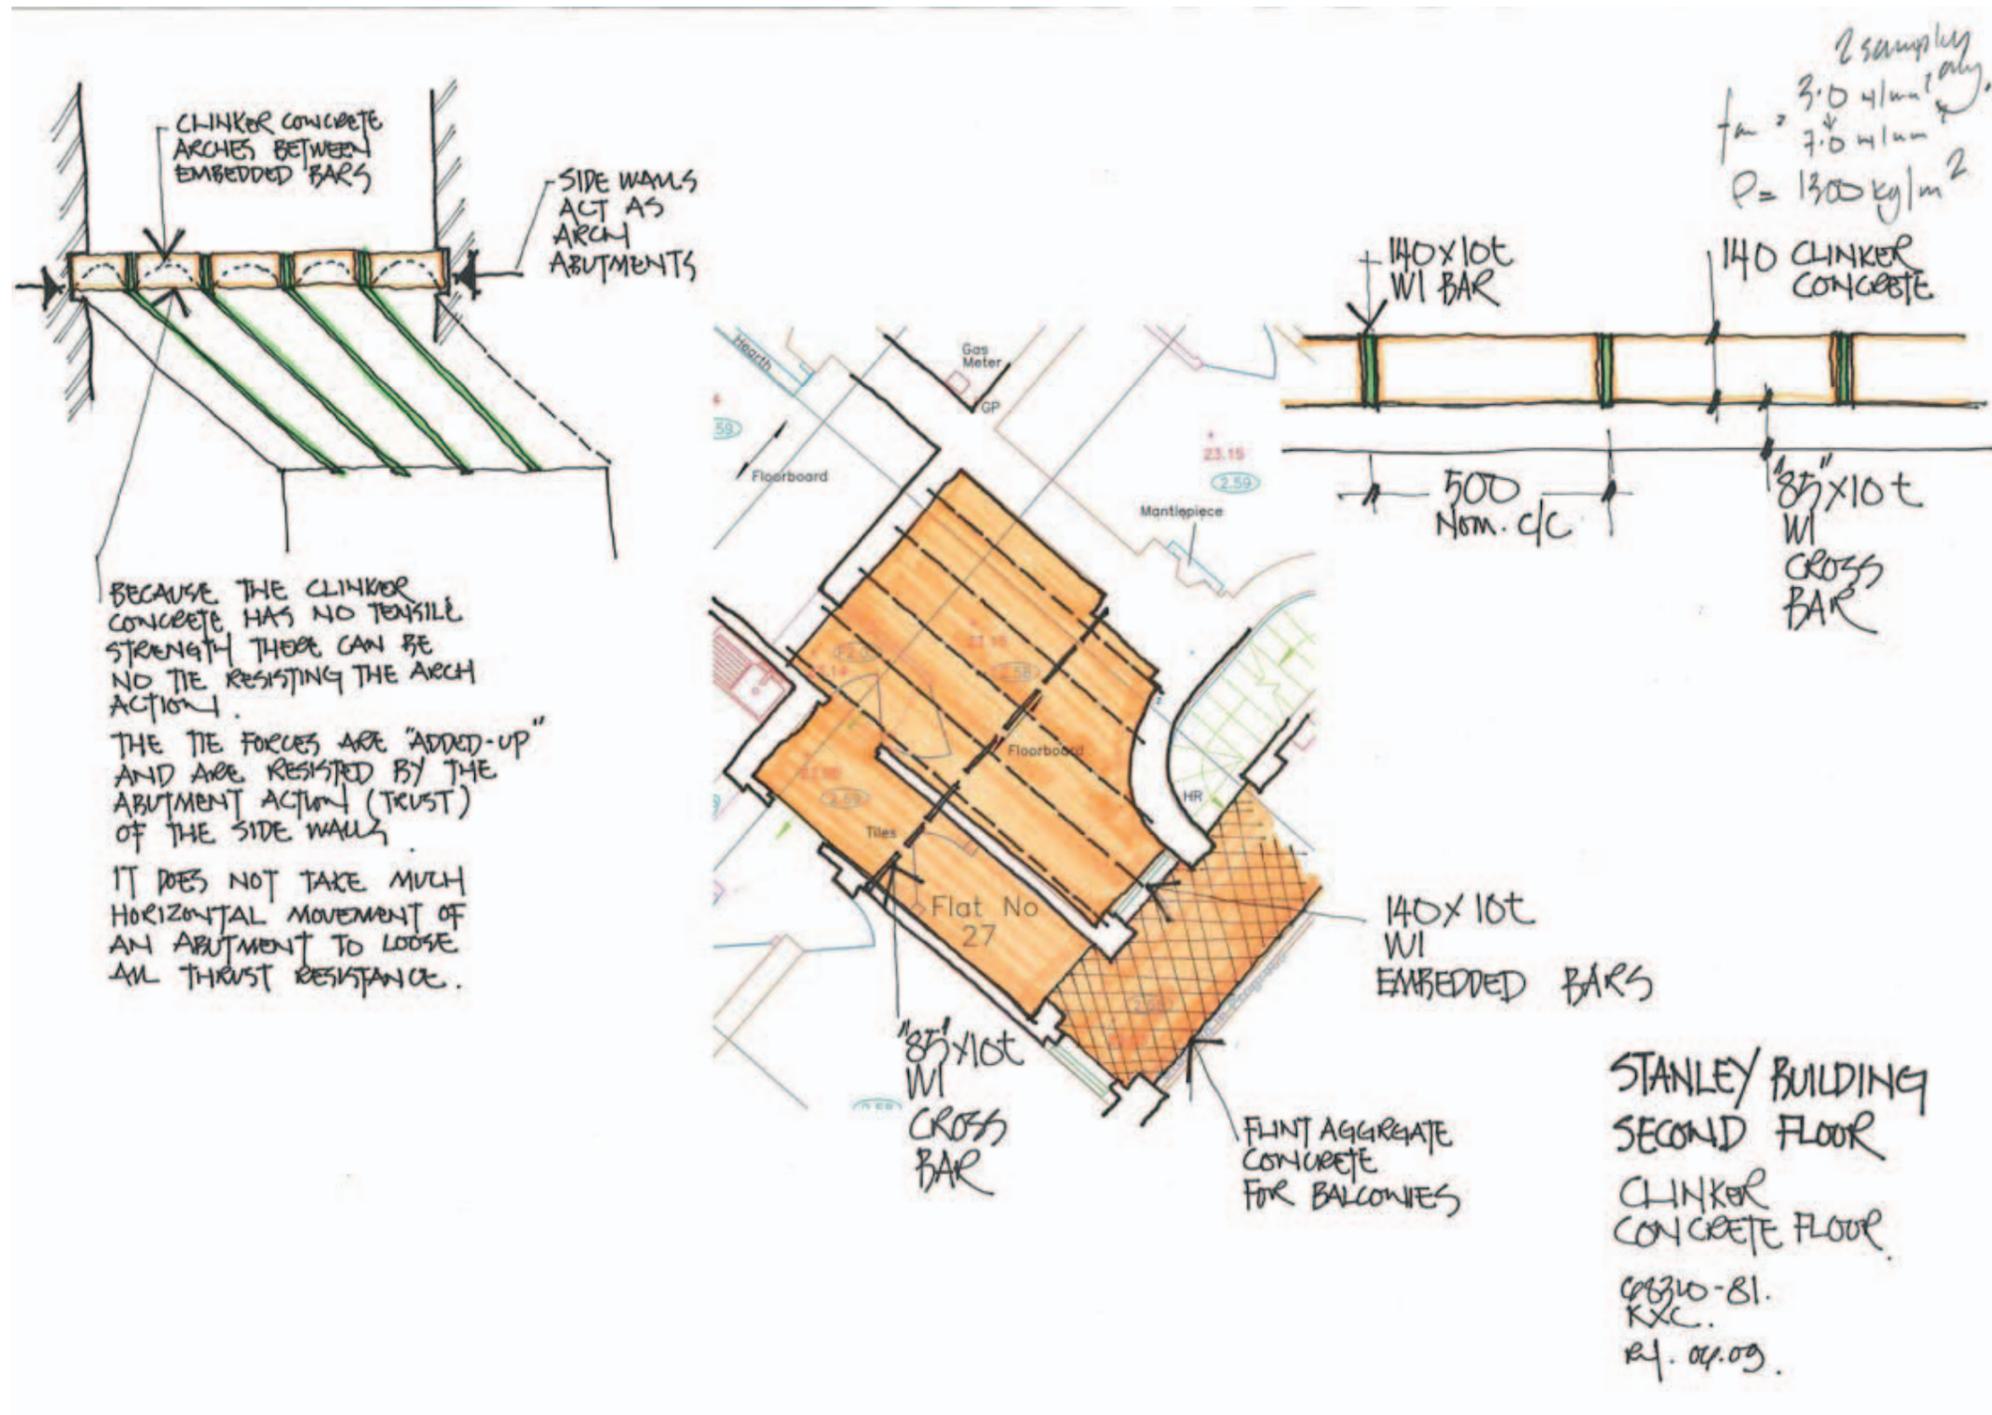
5 Sketch

- The clinker concrete is friable and fragile; 8 out of 10 samples failed the compression testing;
- Edge support conditions will be altered through the course of construction works which is a probable outcome even if the floors were somehow to be kept in situ;
- Alternative methods of support are not possible due to the headroom constraints of the existing building;
- Inability to warrant the construction leading to consequential marketing, value and insurance problems;
- To verify loading criteria, load tests would always be needed at the completion of the refurbishment works, leading to an unacceptable level of project uncertainty.

It is proposed to replace the clinker floors and roof due to the inability to justify the structural performance and hence the satisfactory retention of these elements.
