Application for tree works: works to trees subject to a tree preservation order (TPO)
and/or notification of proposed works to trees in a conservation area.

Arboricultural Consultancy for Great Lakes Reinsurance (UK) Plc

Dreamgate Properties Limited – 18 Bramshill Gardens, London NW5 1JH Subsidence Insurance Claim

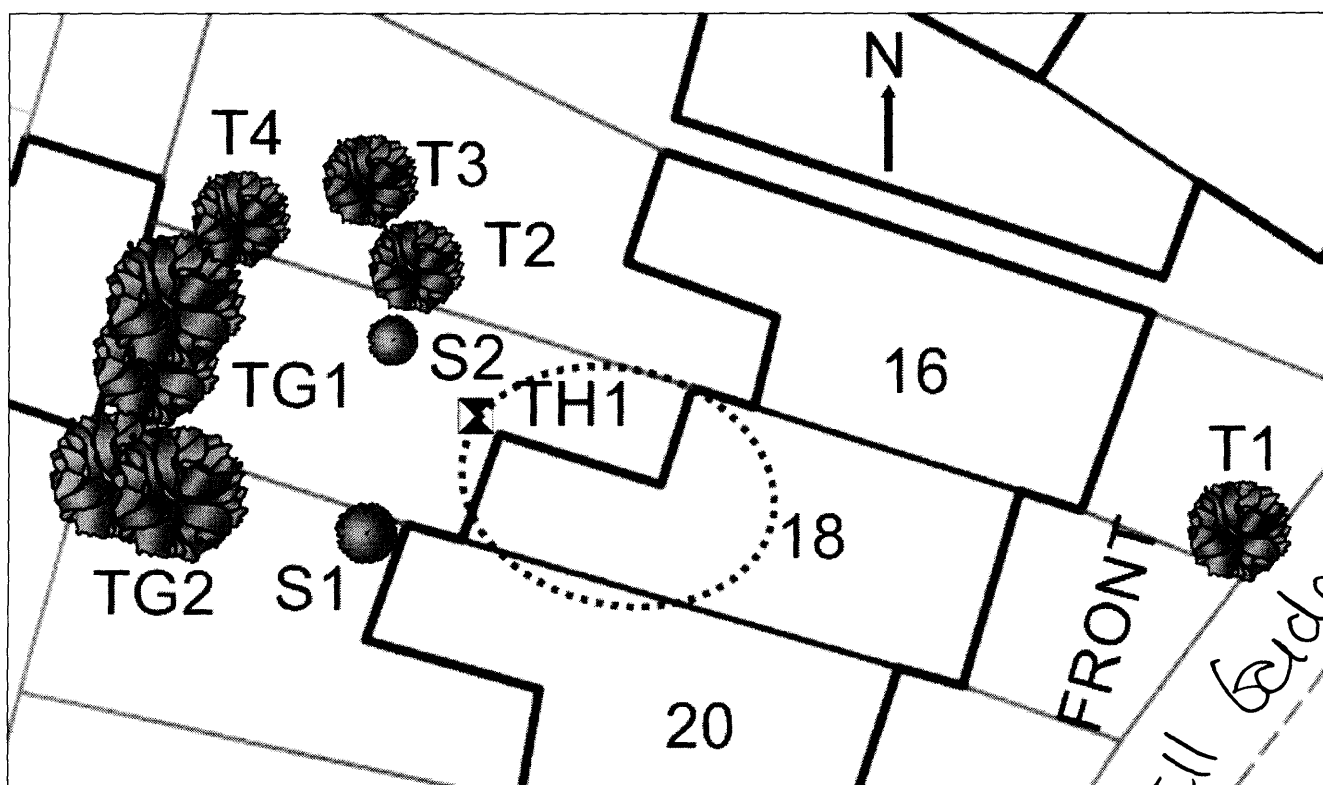
7. Site Plan

Roots recovered from TH1 have been formally identified as *Acer* and *Tilia* spp. The most likely origin of the roots is TG1 (Mixed Species Group) and TG2 (Acer). Pomoideae gp roots were also found in TH1, these roots could originate from either T2 (Apple) or T3 (Pear). Such circumstances confirm the potential for TG1 (Mixed Species Group), TG2 (Acer), T2 (Apple) and T3 (Pear) to influence soil volumes and to contribute to the damage observed.

Given the above information, results of site investigations, and when considered on balance of probability, it is our opinion that TG1 (Mixed Species Group), TG2 (Acer) and T2 (Apple) will be exerting the principal vegetative influence in respect of the current damage. T3 (Pear) and S1 (Forsythia) are also likely to be influencing soil volumes in proximity to the insured property, albeit in a secondary capacity when compared to TG1 (Mixed Species Group), TG2 (Acer) and T2 (Apple).

Tree No.	Species	Age Cat	Approx. Height (m)	Distance to Building (m)	Ownership	Action	Requirement
S1	Forsythia	1	3	2.1	A - Third Party 20 Bramshill Gardens. London. NW5 1JH.	Remove	Remove and treat stump to inhibit regrowth.
S2	Shrub/s - Escallonia	1	1.8	4	C - Insured	No Action	No Works
T1	Lime	1	5.5	7.3	A - Third Party 16 Bramshill Gardens. London. NW5 1JH.	Action to avoid future risk	Do not allow to exceed 6m height.
T2	Apple	1	5.5	3.7	A - Third Party 16 Bramshill Gardens. London. NW5 1JH.	Remove	Remove and treat stump to inhibit regrowth.
T3	Pear	1	7	5.5*	A - Third Party 16 Bramshill Gardens. London. NW5 1JH.	Remove	Remove and treat stump to inhibit regrowth.
T4	Lilac	1	5	7	A - Third Party 16 Bramshill Gardens. London. NW5 1JH.	No Action	No Works
TG1	Mixed Species Group (H) Acer x 1. Lime x 1.	1	13	8.2	C - Insured	Remove	Remove and treat stumps** to inhibit regrowth.

TG2	Acer	1	15	7	A - Third Party 20 Bramshill Gardens. London. NW5 1JH.	Remove	Remove and treat stumps** to inhibit regrowth. x2 Acer trees.
Age Cat: 1 = Younger than property; 2 = Similar age to the property; 3 = Significantly older than property
