DESIGN AND ACCESS STATEMENT:
10 NEW SQUARE, LINCOLN'S INN, LONDON WC2A

Repairs to sub-pavement vaults under Serle Street

**10 NEW SQUARE: SUB-PAVEMENT VAULT UNDER SERLE STREET.
Photographs to accompany application for Listed Building Consent for repairs.**

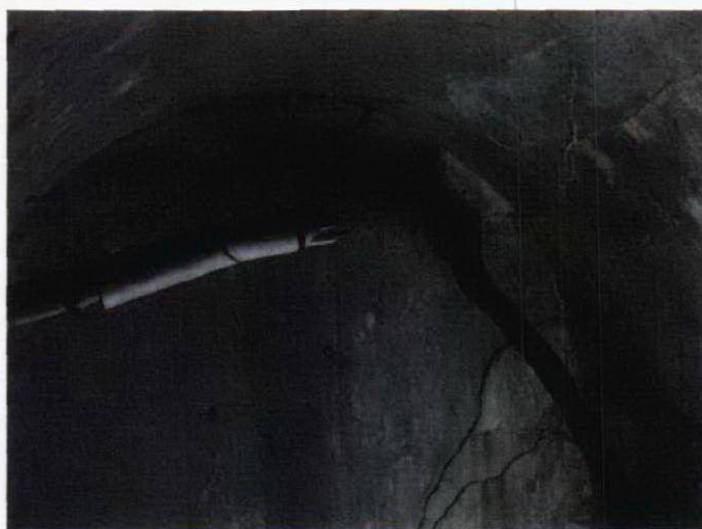
2: South vault (Vault 3), with old water-proof render finish.

- 3.1 The external appearance of the vaults will remain unchanged as a consequence of the works. The finishes of the vaults internally will also be the same, except the rear walls of the central and south vaults (numbered 2 and 3 on drawing 10142D/01) where additional retaining structure will be inserted. This can be finished to retain the present rendered finish which was previously applied to vault 3 [photo 2].

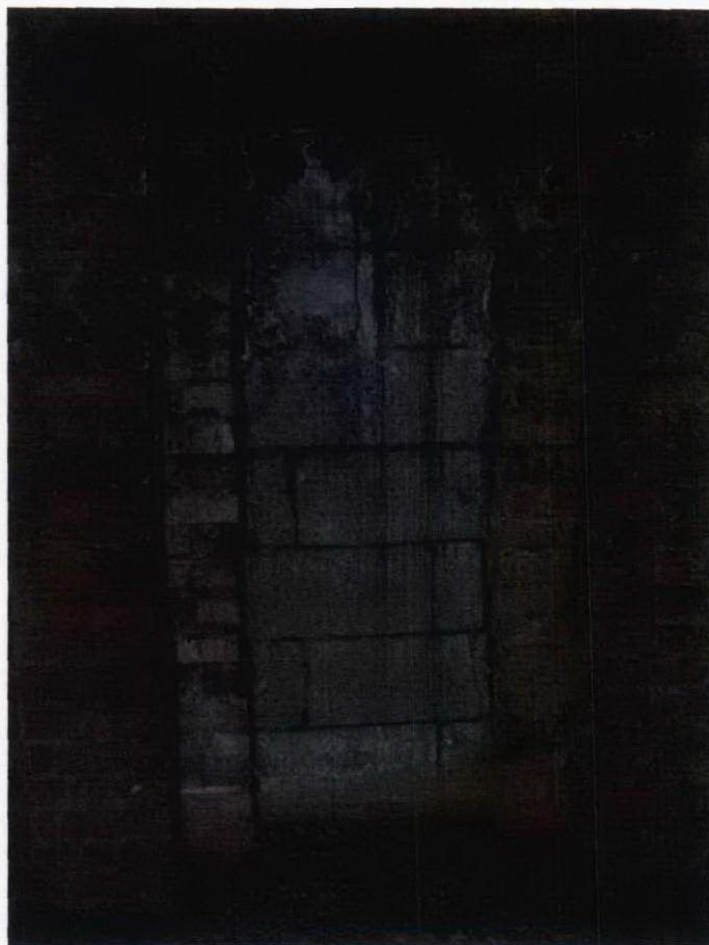
- 1.3 The present arrangement of the area adjoining the vaults is a consequence of the most recent modernisation of the area; the modern ladies cloakroom fills what should be a lightwell, and direct access to two of the vaults is, consequently, blocked [photo 3]. A hatch from the cloakroom leads to the tenanted remains of the lightwell, from which the northern of the three vaults may be reached. The three vaults are linked together by C20th holes formed through the cross walls between the vaults. There are further vaults south of those affected by the proposed works.

3: Middle vault (Vault 2), infill to historic opening to the original area, which will be temporarily removed in order to undertake the repairs.

- 4.1 These are indicated on drawing 10142D/01, and include the careful removal and reinstatement of the existing area railings along Serle Street, which will be put back into the rebuilt rendered plinth wall. The grating over the remaining basement area will likewise be removed and reinstated. The existing vent cap over the cloakroom will be temporarily removed. The existing blockwork infill to the openings to vaults 2 and 3 [photo 3] will be removed altogether to allow access to these vaults and rebuilt on completion.
