Planning Statement

3 Arlington Road, Camden, NW1 7ER

Discharge of Condition 3 and 4 of Listed Building Consent 2010/1589/L

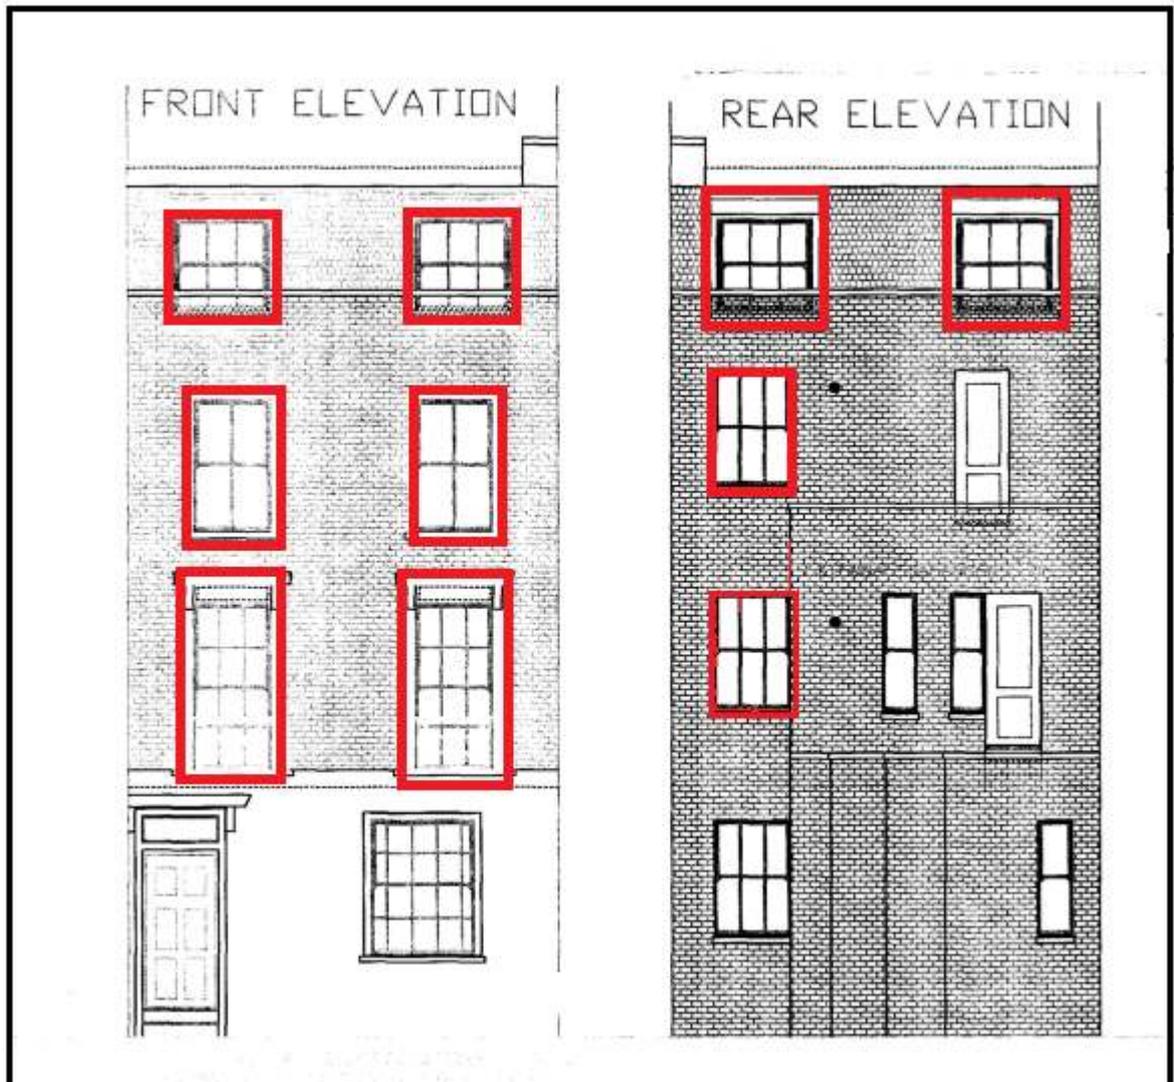
2.1 This application seeks to replace those windows highlighted in red on the elevations below;

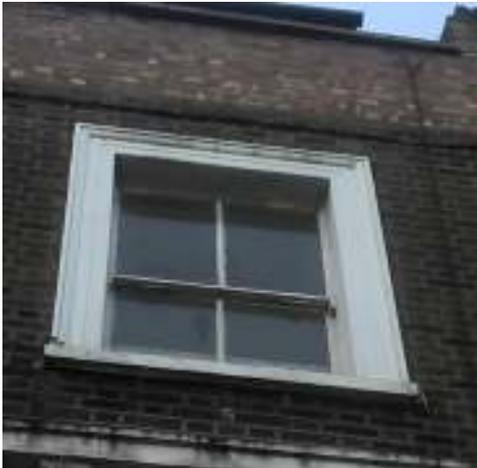
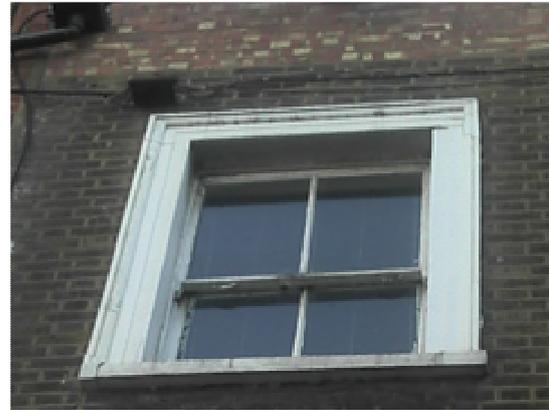
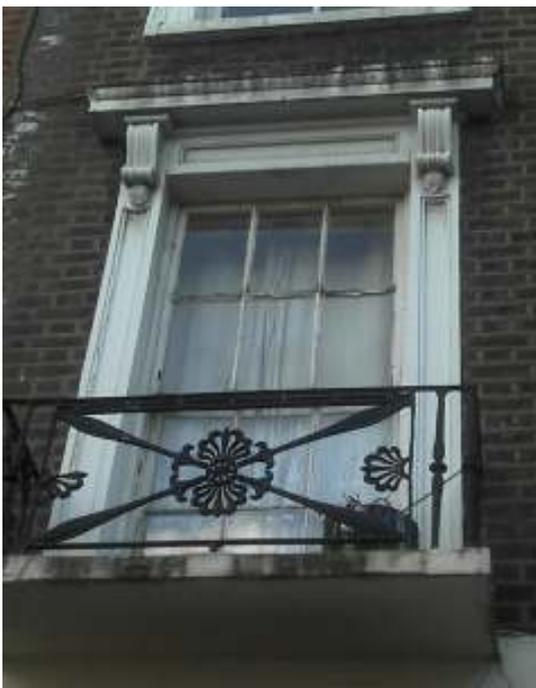
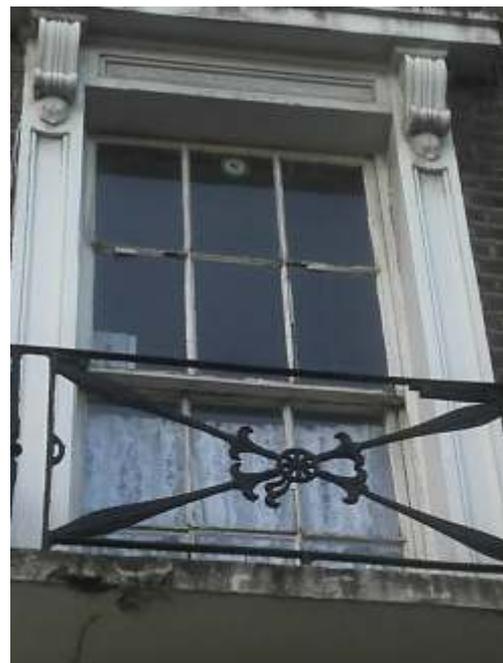
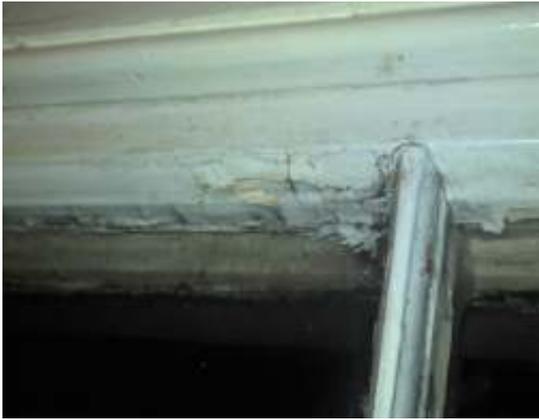
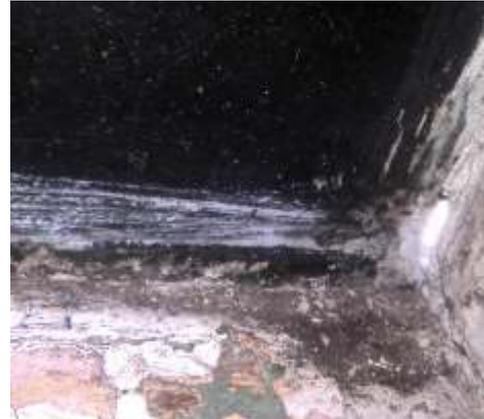
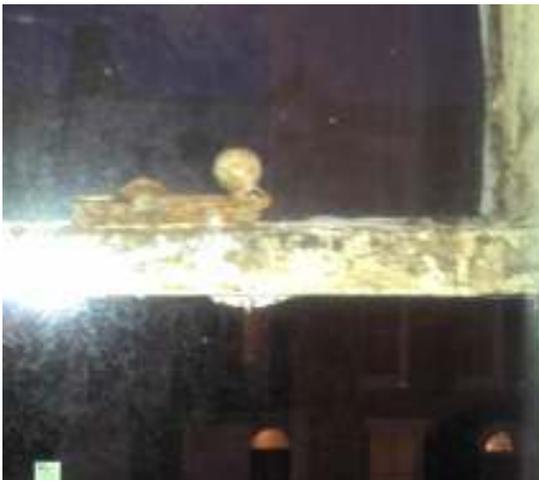
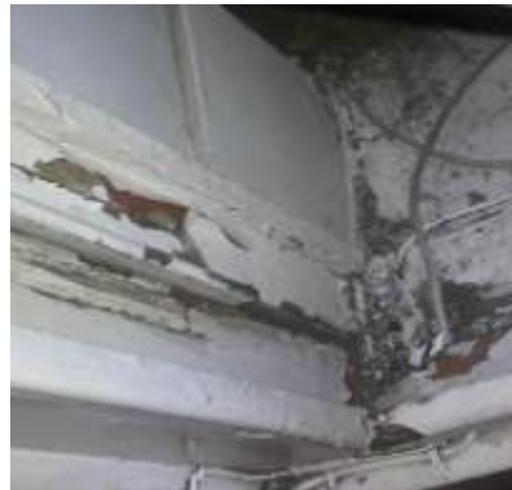
2.2 I understand that these windows are to be replaced because of their poor condition, which is resulting in heat loss and inadequate sound insulation. These consequences are detrimental to the sustainability of the building and the amenity of the occupants. Photos are provided below of the poor condition of some of the windows. The condition of these windows is reflective of many others;

- 2.4 The surveyor describes the condition of the current windows as a “mixture of old and poor quality replacements that have been badly installed and maintained...wet rot and timber fibre degeneration are plainly evident...black mould and internal wet rot are clearly visible on all of the windows.”

- 2.5 Importantly he notes that “previous attempts at renovation are now pulling away from the repaired areas creating gaps for further water ingress. Painting over the weaknesses has only exacerbated the deterioration of the timber as excess moisture has been trapped with the paint cover.”

- 2.7 The replacement of the windows will enable the building to be significantly more heat efficient, sound insulated, and the presence of harmful mould and rot can be adequately eliminated on a long term basis.
- 2.8 I understand that the Council have already seen the poor condition of the windows at the recent appeal hearing which involved a site visit.
