St Pancras London

Replacement External Window Units To Fire Damaged Stonework Ground Level Left Hand Window

PAYE_SP_05

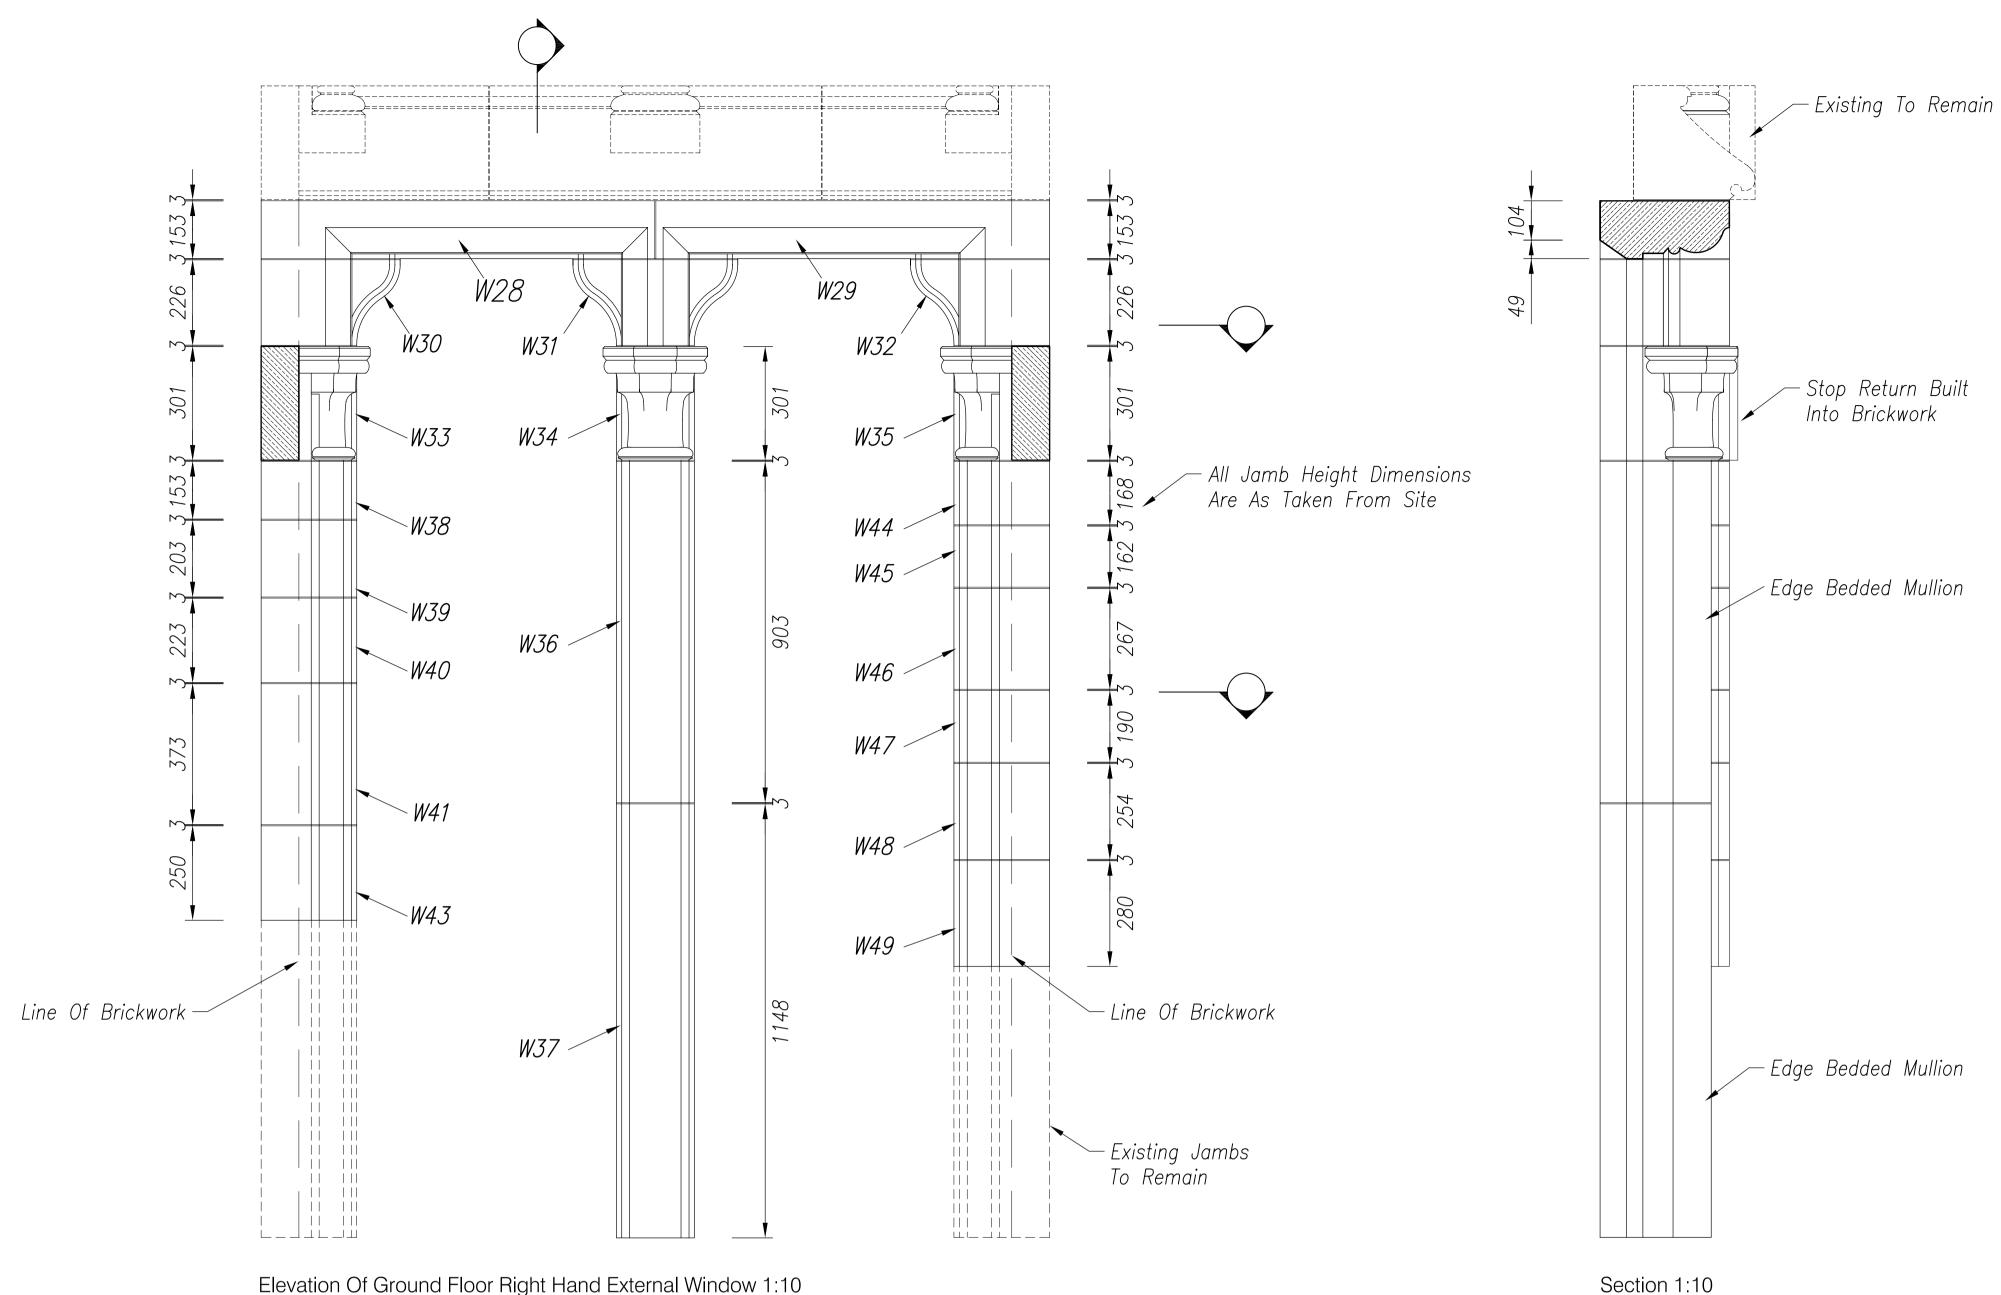
Elevation Of Ground Floor Right Hand External Window 1:10

Stone Sections, Profiles, Moulds And Jointing Patterns Have Been Taken From The Existing Remnants On Site. The Detailing Shown Is As Faithful A Reproduction As Is Possible To Achieve Given The Extensive Level Of Fire Damage To The Existing Masonry.

Mullions Ref: W36 & W37 Are To Be Edge Bedded As The Originals On Site To Achieve The Required Height Dimensions.

All Stone Is To Ancaster Hard White As Approved Sample.
