Landmark Trees

ARBORICULTURAL IMPACT ASSESSMENT REPORT:

44 Canfield Gardens,
London NW6 3EB

Ref: TRN/CNF/AIA/01

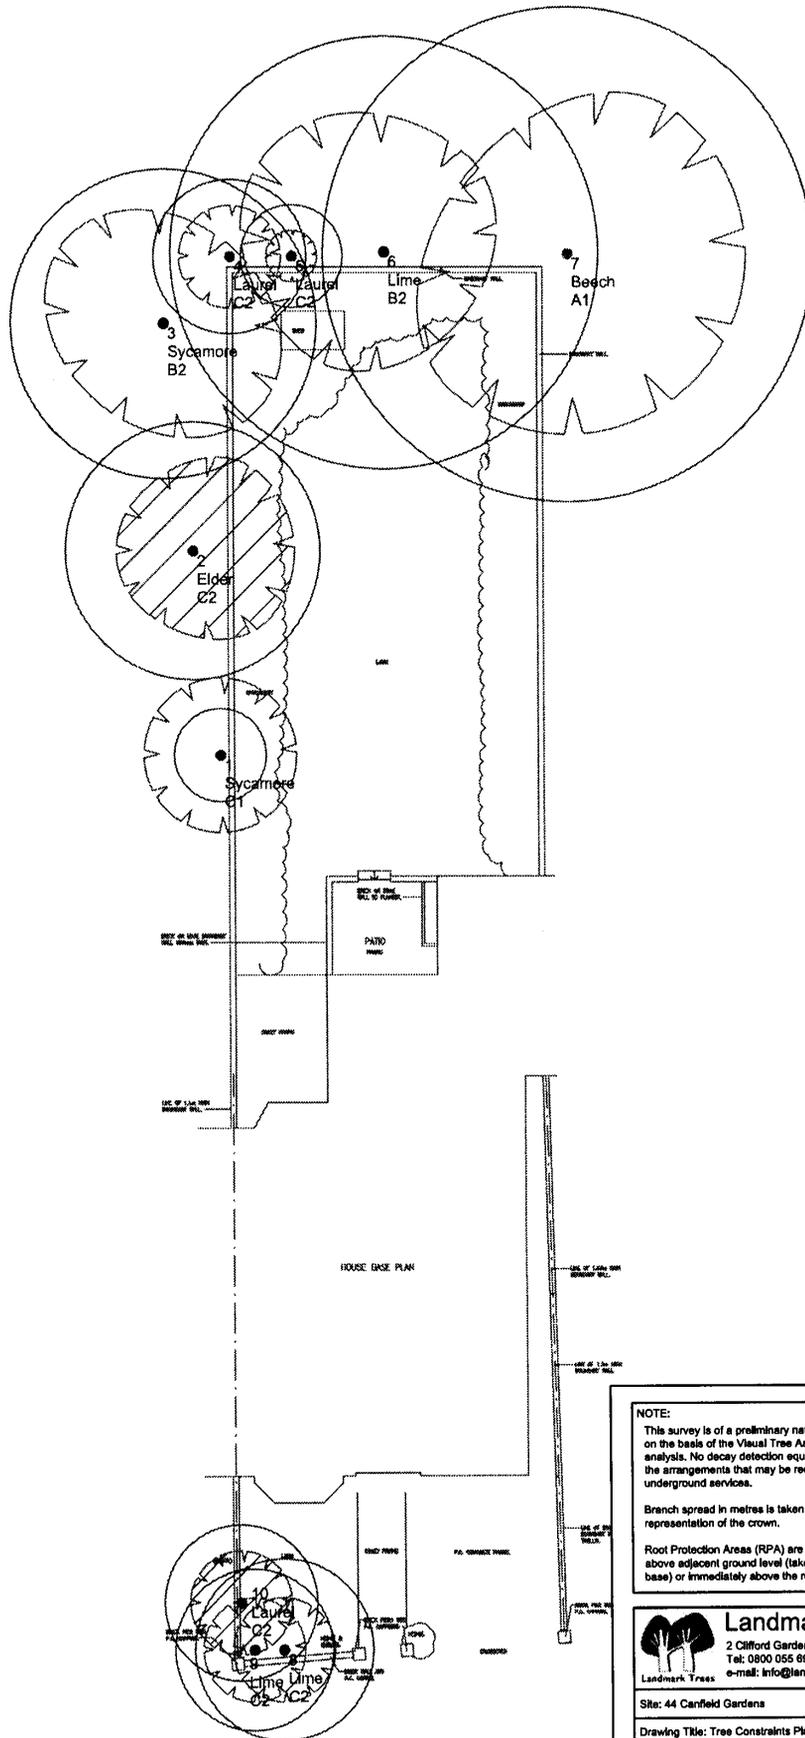
TREE CONSTRAINTS PLAN

- 3.2.3 The lime tree pollards at the front of the site (T8 & 9) are of indifferent quality: they have been unprofessionally topped (crown and canopy removed arbitrarily at 2-3m above ground) and have decay in the pruning heads. They are semi-mature.

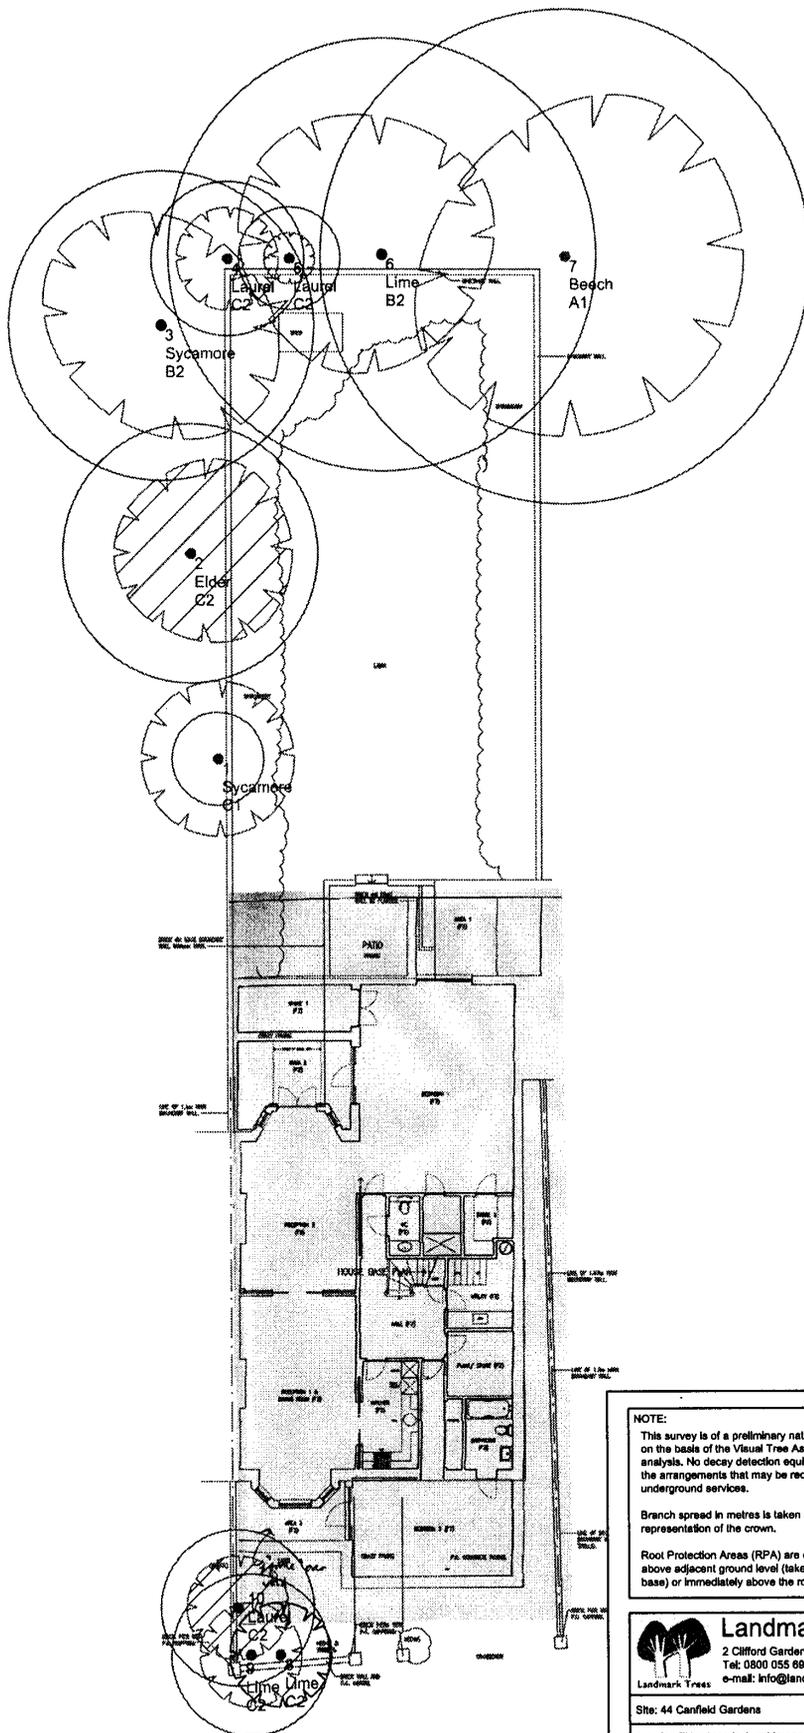
ARBORICULTURAL IMPACT ASSESSMENT PLAN

6.1.1 The principal primary impacts in the current proposals are the removal of two semi-mature, lime pollards (T8 & 9) of indifferent quality with decay in the pollard heads. The unprofessionally topped trees obscure a perfectly serviceable tall laurel hedge (T10), providing adequate visual amenity for this small courtyard garden.

6.1.2 There is a further small encroachment of T10 laurel's theoretical RPA by 5% / 1.5m² for the light well. The impact occurs within existing hard standing, where root activity is likely to have been limited and can be hand pruned.

6.3.1 New more appropriate and healthy, native fruit tree(s) could be replanted in the place of limes T8 & 9, a little inset from the proposed sliding gates, which necessitate their removal, but given the presence of street trees nearby, it is not clear that the onus on the confined site would be necessary. The question can be resolved under condition.

6.3.2 The lightwell encroachment of the laurel (T10) will be preemptively excavated by hand or with an Airspade under site supervision. Roots smaller than 25mm diameter may be cut cleanly with a sharp pruning saw or secateurs back to a junction. Roots larger than 25mm diameter may only be cut in consultation with an arboriculturalist. If the latter is not present (though supervision is recommended) larger roots should be temporarily wrapped in dry, clean hessian sacking to prevent desiccation and exposure to extreme temperature fluctuations.
