11 NETHERHALL GARDENS NW3

TECHNICAL REPORTS SUPPORTING PLANNING APPLICATION OF AUGUST 2009

ARBORICULTURAL CONSTRAINTS REPORT:

11 Netherhall Gardens Hampstead London NW3

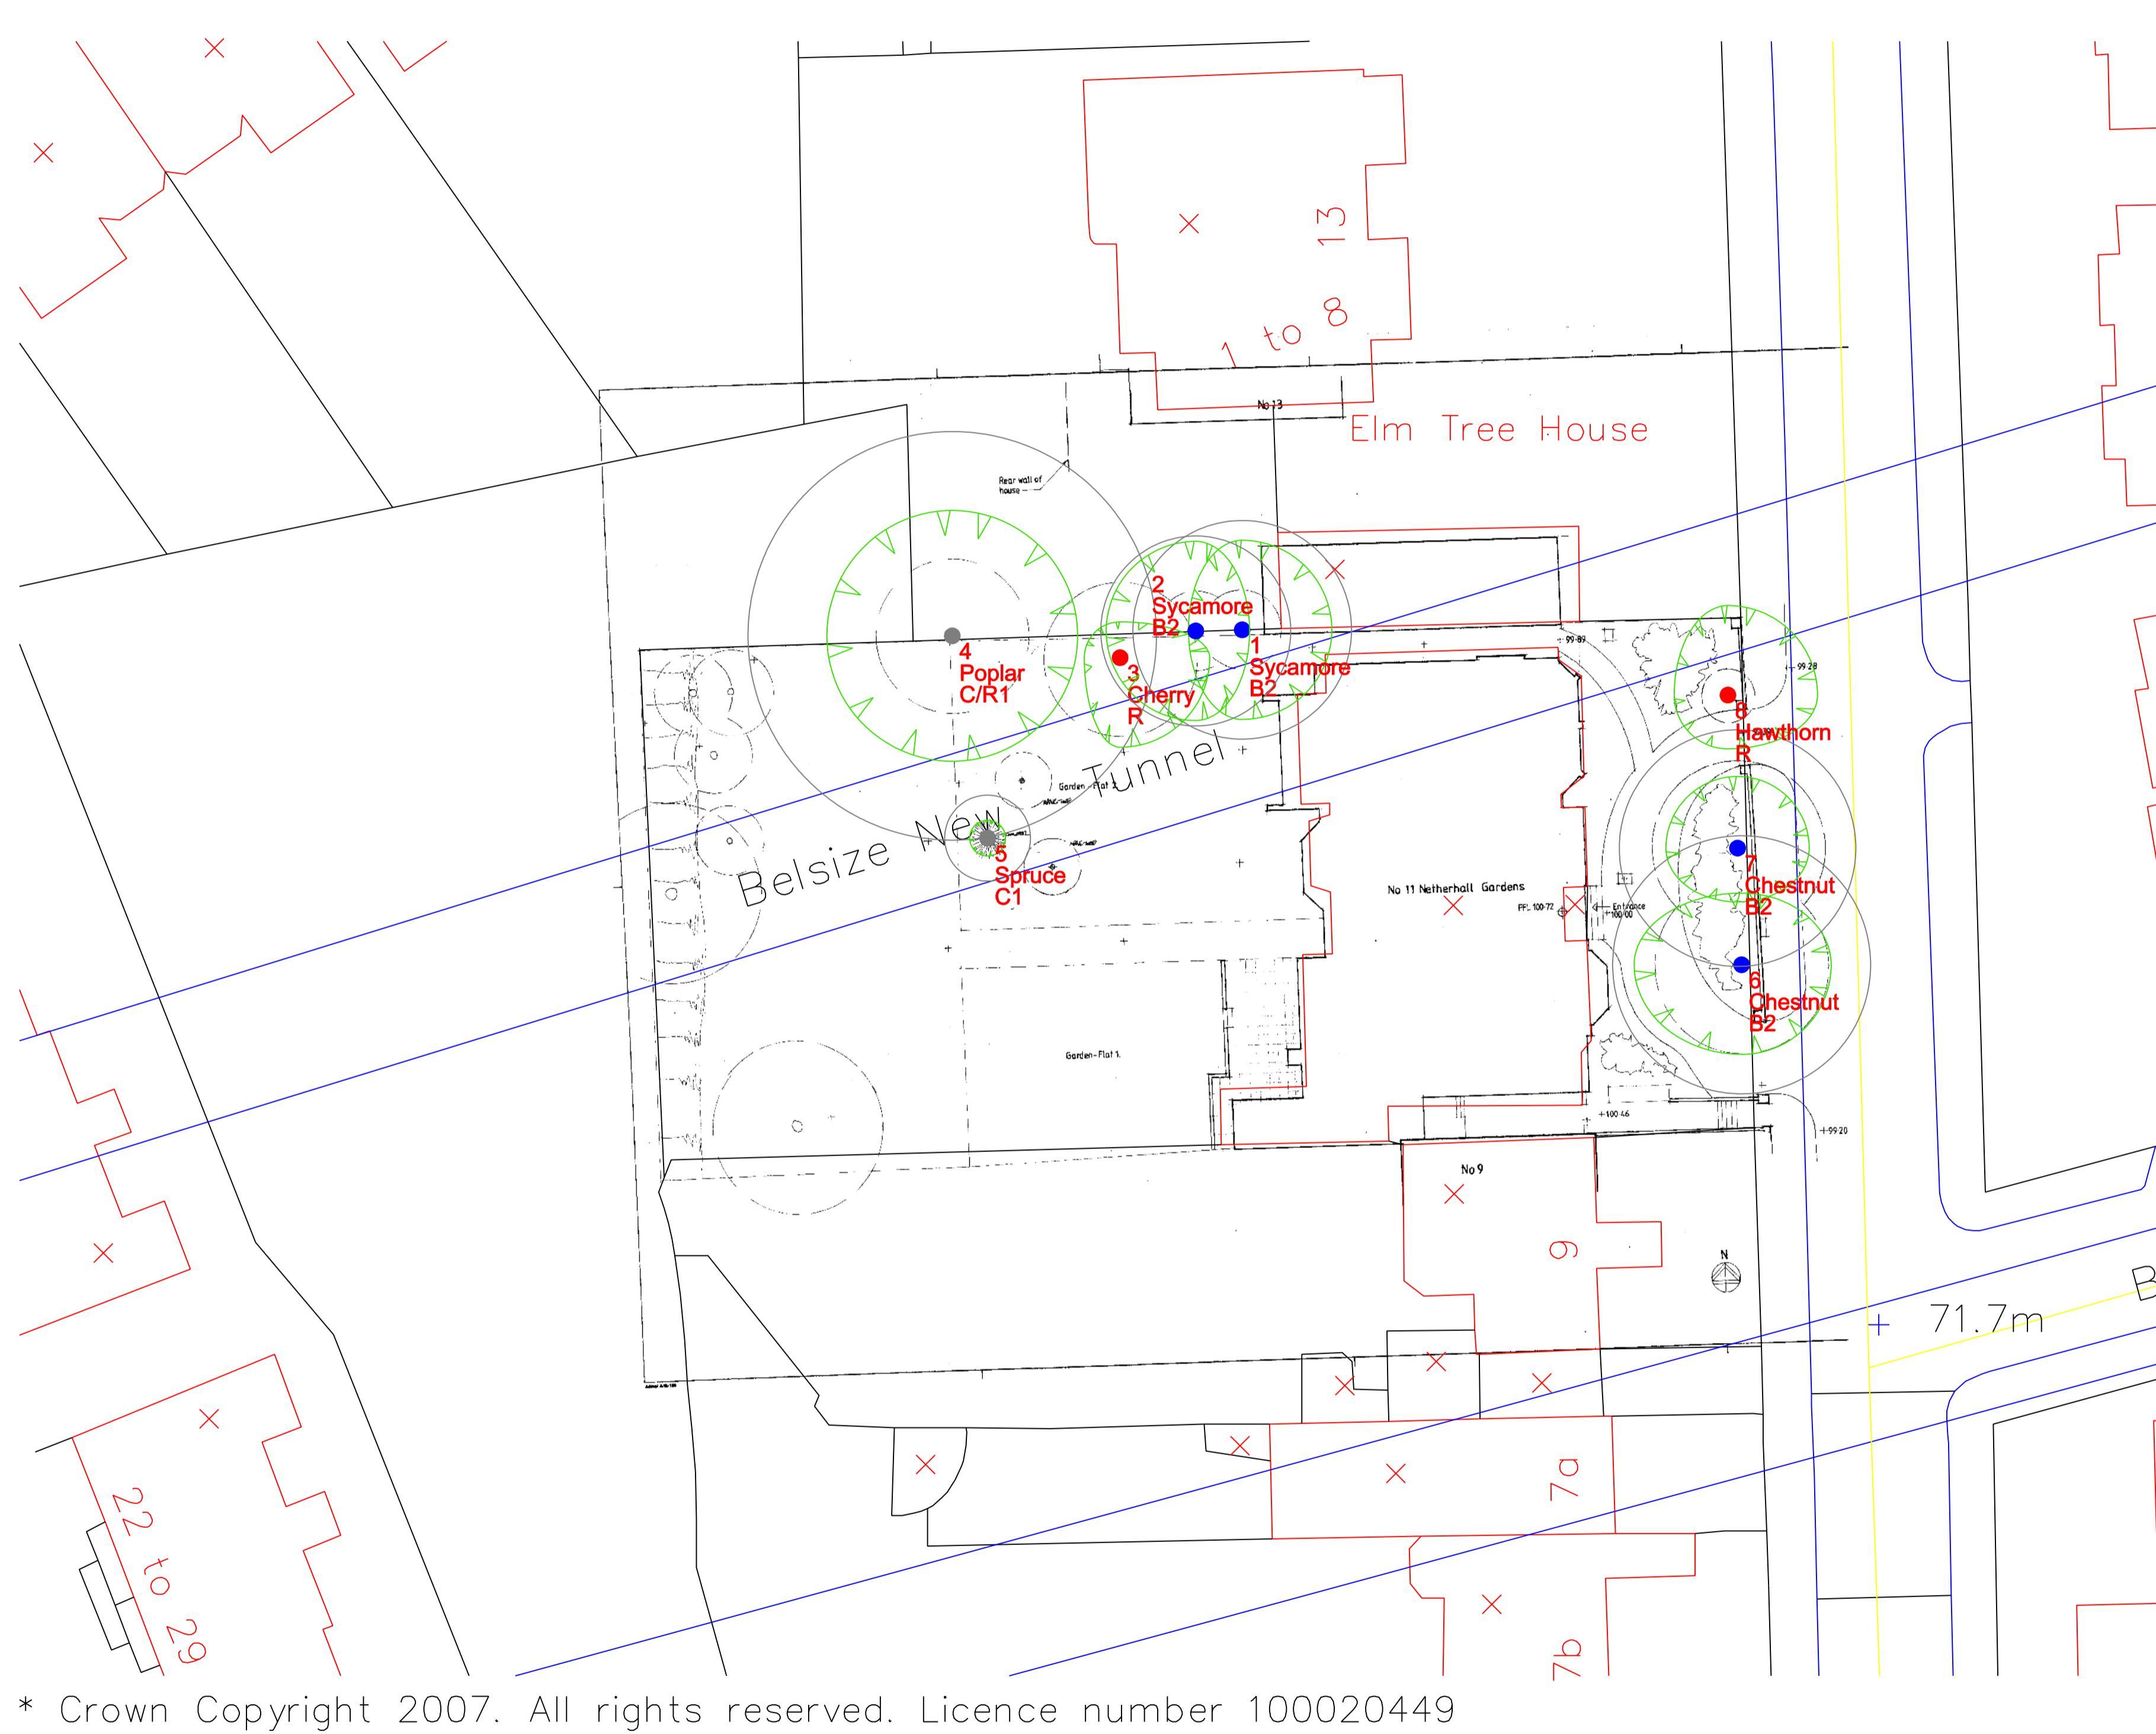
TREE CONSTRAINTS PLAN

- 3.3.3 The B category trees are 2 horse chestnuts (T6 & 7) at the front of the property and the 2 sycamores (T1 7 2) to the rear. The chestnuts appear in robust health, but a full visual inspection of the stem was not possible, because of the density of surrounding vegetation. It is recommended that this shrub cover be cut back to facilitate closer inspection. Similarly, the sycamore stems were covered in dense ivy, but these trees are third party trees, so severance mat not be possible.

- 3.3.5 The R category trees are a dying, ivy smothered cherry to the rear and a hawthorn of poor form (topped at 3m) with a pronounced lean across the front drive undermined by a weak rootstock and basal wound. Both trees should be felled and replaced with new trees to balance the age demographic.

- 3.3.6 The C/R category tree is an over mature poplar, the nearest of many in the neighbouring derelict woodland. It is a lapsed pollard, bifurcated at 5m with 1 of the 2 forks decayed into a

residual stub of 250mm and the 1 surviving stem growing to 10m. Thereafter, the top has been pollarded with 6m+ regrowth, interspersed with 2m failed stubs in variable states of decay. Large sections of the 6m regrowth are broken but hanging in the canopy.

- 3.3.7 A poplar of this size (c. 1000mm diameter) with such top rot, is likely to have related heart rot in the main stem and decayed roots. Such a level of assessment on a development survey of a neighbour's tree was not possible. Clearly the tree is hazardous. The question arises as to whether repollarding will suffice to make it "safe."

- 8.1.1 Tree surgery recommendations are found in Appendix 2 to this report.
- 8.1.2 Cooperation with third-parties in a wider woodland management plan would be beneficial in the long term.

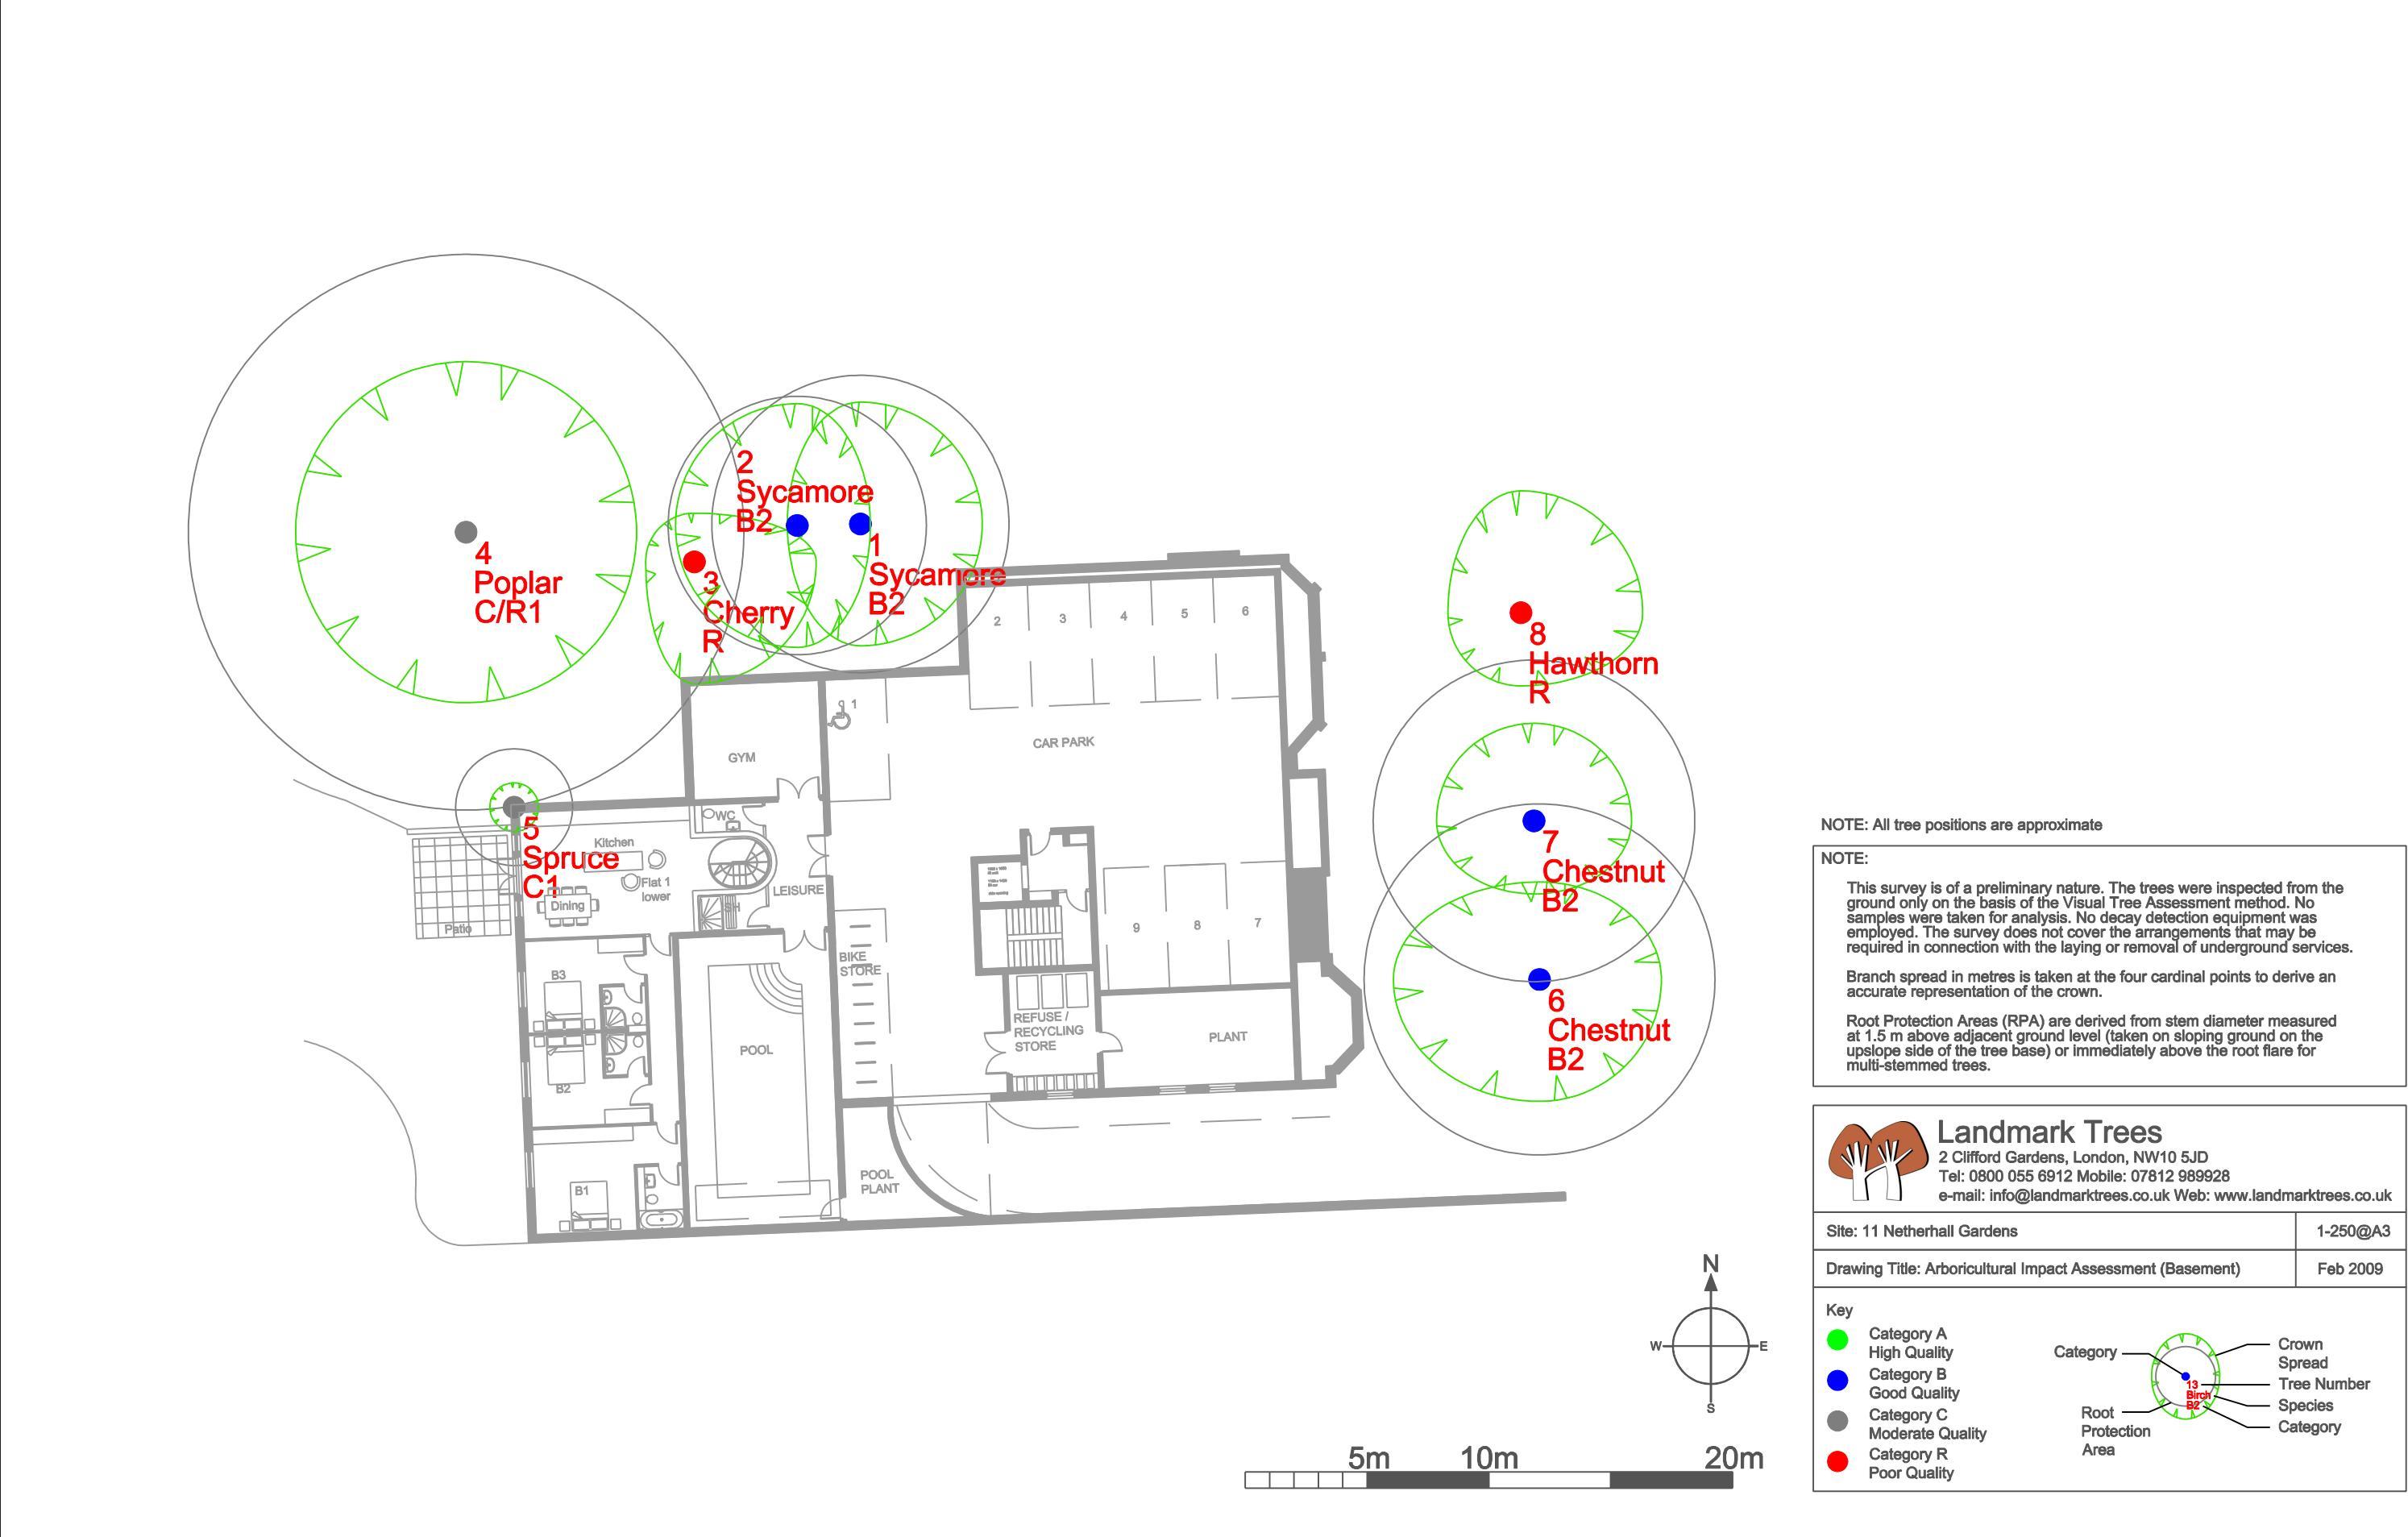
IMPACT ASSESSMENT PLAN

- 7.1 There are no significant primary or secondary impacts of development.
- 7.2 The threat of structural failure from the poplar remains real and shading from the western woodland could affect potential land use, if it were not managed in any way. However, these issues relate to third-party ownership, outside the scope of this report.
- 7.3 Therefore, the site has the potential for redevelopment without having any significant impact on either the retained trees or wider landscape.
