ARBORICULTURAL IMPACT ASSESSMENT REPORT:

56 Belsize Avenue,
London NW3 4AA

Ref: STR/BLZ/AIA/01

Date: 7th July 2010

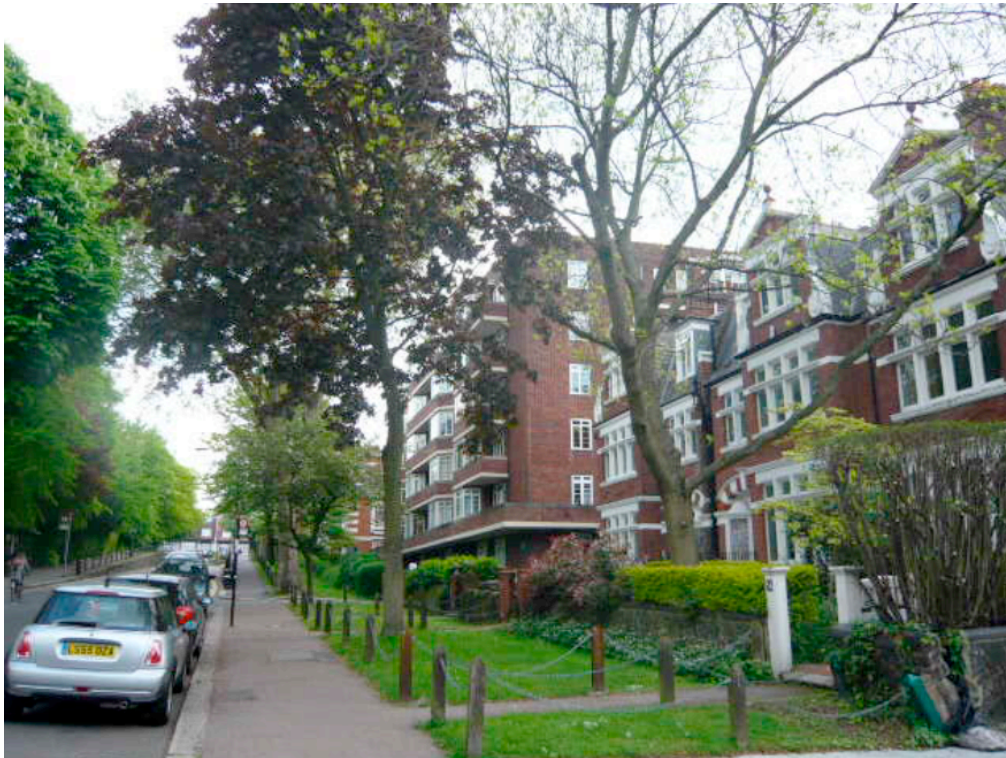
Fig. 1 Looking NE along the avenue with T4 (right) & T5 (left) in foreground

| Tree No. | English Name | Height | Crown Spread | Ground Clearance | Age Class | Stem Diameter | Protection Multiplier | Protection Radius | Growth Vitality | Structural Condition | Landscape Contribution | B.S. Cat | Sub Cat | Useful Life | Observations |
|---|---|---|---|---|---|---|---|---|---|---|---|---|---|---|---|
| 4 | Ash, Common | 15 | 6,10,8,5 | 3 | Mature | 510 | 12 | 6.1 | Normal | Fair | Medium | C | 2 | 20-40 | Co-dominant limbs Entry wounds on trunk Sprawling habit 5m to build |

- 8.1.1 Tree works recommendations are found in Appendix 2 to this report. Any tree removals recommended within this report should only be carried out with local authority consent.
- 8.1.3 Replace felled tree T4 with 1 x native lime (*Tilia cordata*) pit-planted as 14-16 cm girth nursery stock under current best practice; i.e. conforming to and planted in accordance with the following:

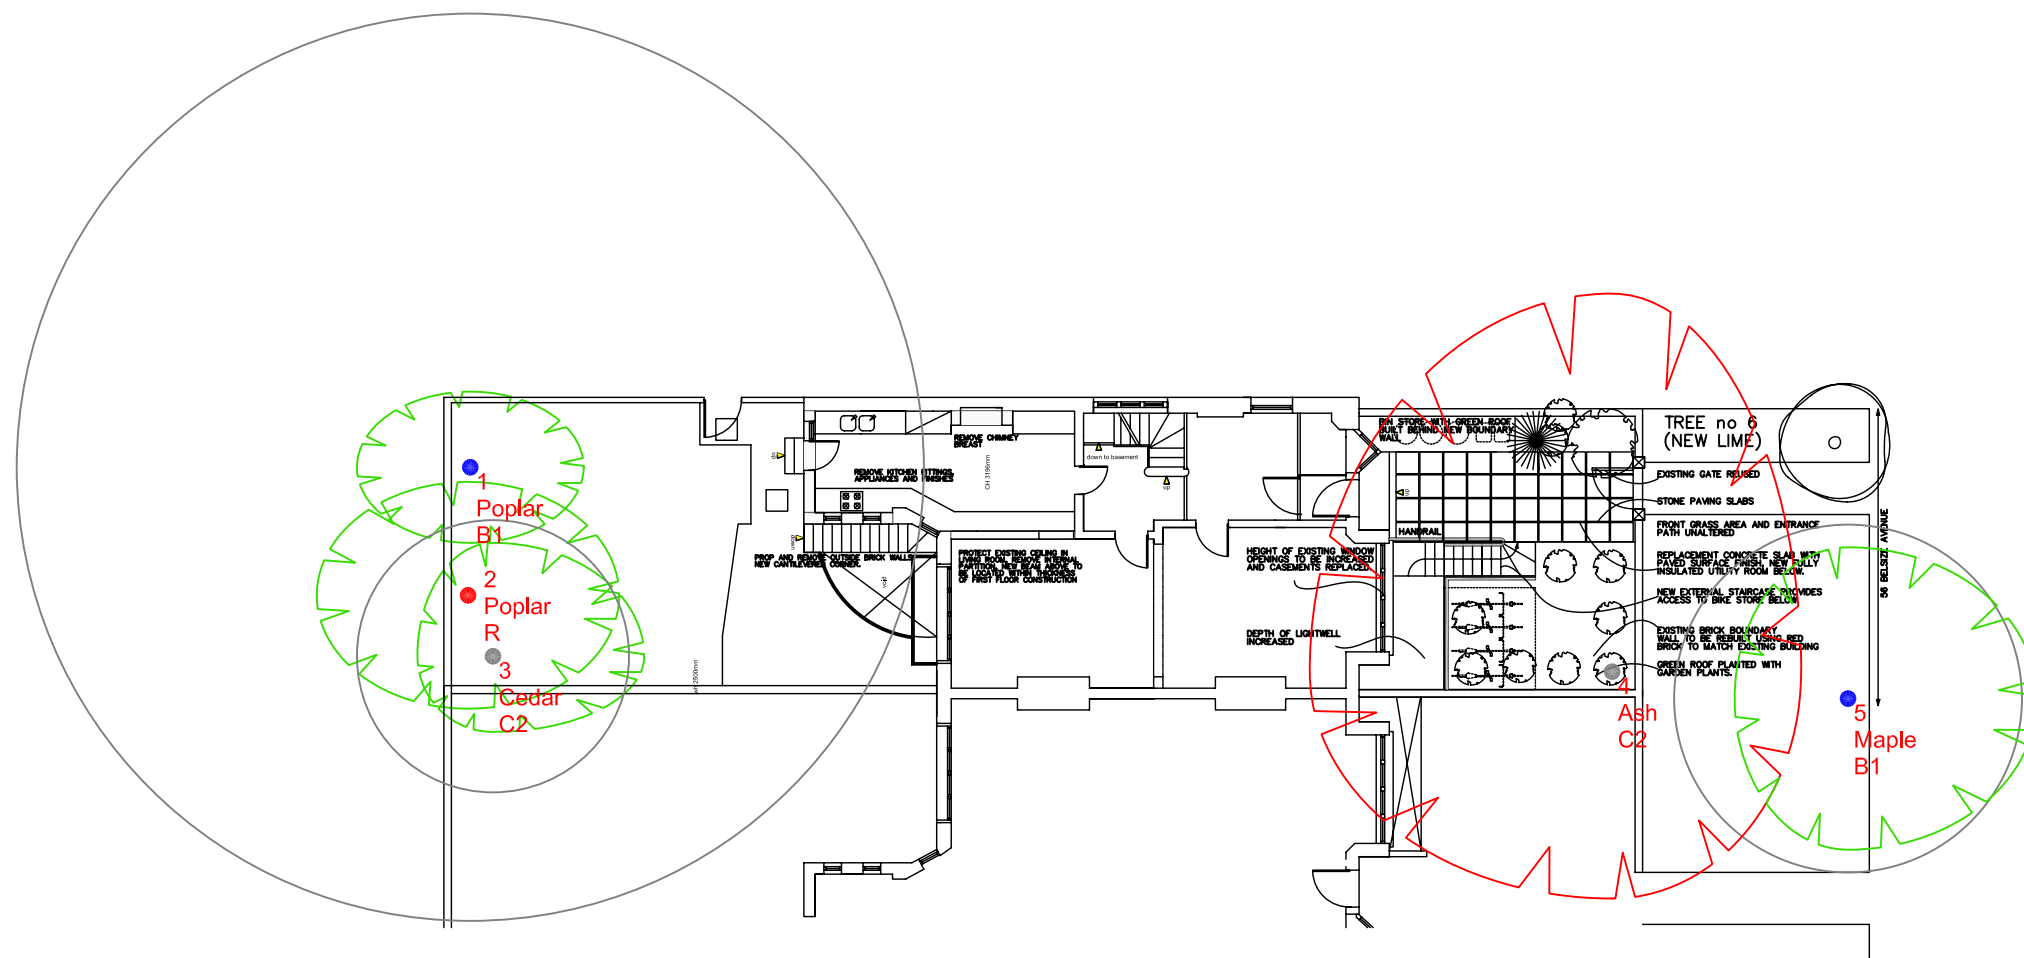
APPENDIX 5ARBORICULTURAL IMPACT ASSESSMENT PLAN

- 6.1.1 The sole impact in the current proposals is the removal of T4. Although the tree is mature and stands within the conservation area it has been rated low quality: its sprawling habit and dominance of the front garden space detracts from the rhythm and line of the open avenue of tall lime trees with their regular and erect habits. Removal of the tree may actually improve the visual character of the area from an aesthetic point of view.
- 6.1.2 Removal of T4 is rated low impact.

- 6.3.1 In this instance, a new lime tree is proposed for the roadside verge to complement the existing lime avenue and replace another verge tree that was recently lost to the area.
