Arboricultural Report

Site – 1 Millfield Place, London, N6 6JP

Planning application number – 2010/2046

Date of survey – 17/05/10

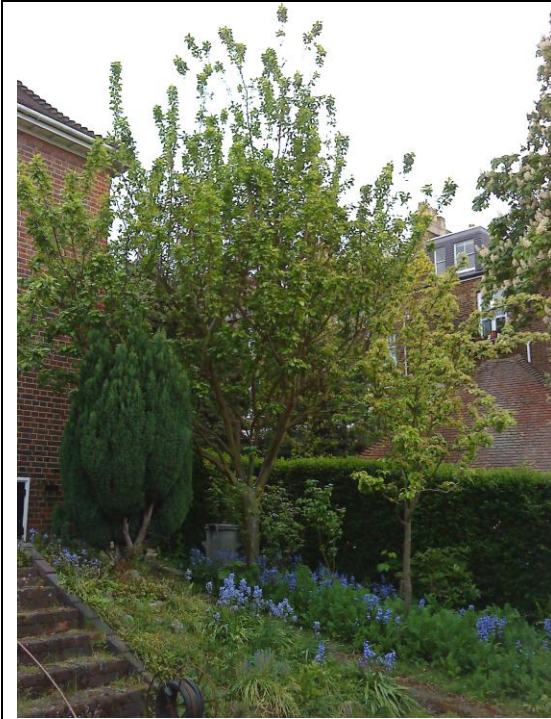
- 4.1 The T1 is a plum tree, located close to the east boundary of the property. It is a semi mature tree in a good to fair physiological and structural condition. The crown has relatively dense secondary growth, typical of plum species. The tree is visible from the road and has been reduced

back from the road in the past. The tree has been given a C rating, as it is visible from the private road. It is however a small tree and could be removed and replaced with an appropriate tree when the construction has been completed.

- 4.2 T2 is a small young tree apple that could easily be transplanted.
- 4.3 T3 is a mature Apple tree that is in a fair structural and physiological condition. It has been pruned heavily back to the two main limbs. The crown is formed from the re-growth from this pruning. There is minor dead wood through out the crown. The tree affords screening of the proposals from the adjacent property. It has been given a C2 rating in line with BS5837:2005.

T1 – plum on left and T2 pear on the right

Tree no. & class.		RPA m/sq	Radi of RPA (M)	Tree implications assessment	Mitigation to consider
T1	<i>Cherry Plum Prunus domestica var</i>	18	2.4	The proposed building work is outside the Root Protection Area (RPA) and crown spread. However an area to the west of the RPA maybe encroached into to facilitate the development	Additional ground protection inline with BS5837:2005 will be required over approximately 3.6 m/sq of the RPA to facilitate access during the build
T2	<i>Pear Pyrus comunis var</i>		0.72	They proposals are well outside the root protection area and crown spread of the tree. If the tree is protected it should suffer no long term detrimental affects from the construction.	Protect the tree in line with BS5837:2005 section 9.
T3	<i>Apple Malus domestica var</i>		3.2	They proposals are well outside the root protection area and crown spread of	Protect the tree in line with BS5837:2005 section 9.

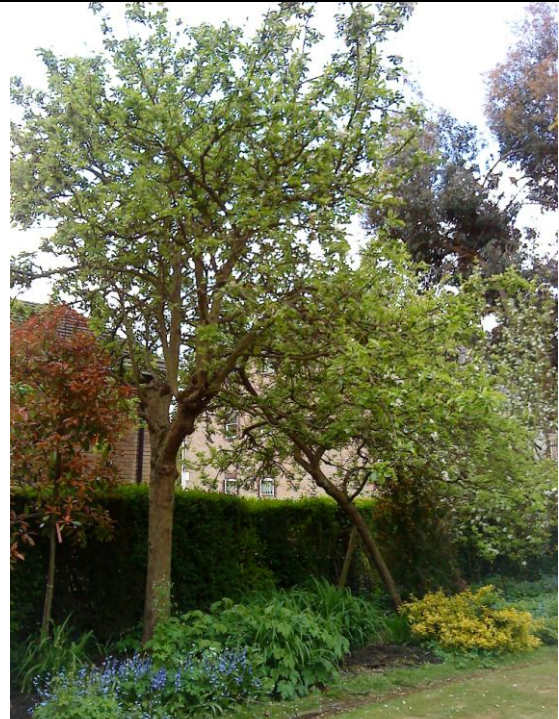
- 4.4 T4 is a smaller fruiting apple tree than T3, which leans to the east, so has been considered to have a fair structural condition. The physiological condition is good. It again affords screening of the proposals from the adjacent property. It has been given a C2 rating in line with BS5837:2005.

T3 on left and T4 on right apple trees with T10 in the back ground right

the tree. If the tree is protected it should suffer no long term detrimental affects from the construction.	
T4	<i>Apple Malus domestica var</i>		1.7	They proposals are well outside the root protection area and crown spread of the tree. If the tree is protected it should suffer no long term detrimental affects from the construction.	Protect the tree in line with BS5837:2005 section 9.
T5	<i>Apple Malus domestica var</i>		1.5	They proposals are well outside the root protection area and crown spread of the tree. If the tree is protected it should suffer no long term detrimental affects from the construction.	Protect the tree in line with BS5837:2005 section 9.
T6	<i>Eucalyptus spp</i>		4.4	They proposals are well outside the root protection area and crown spread of the tree. If the tree is protected it should suffer no long term detrimental affects from the construction.	Protect the tree in line with BS5837:2005 section 9.

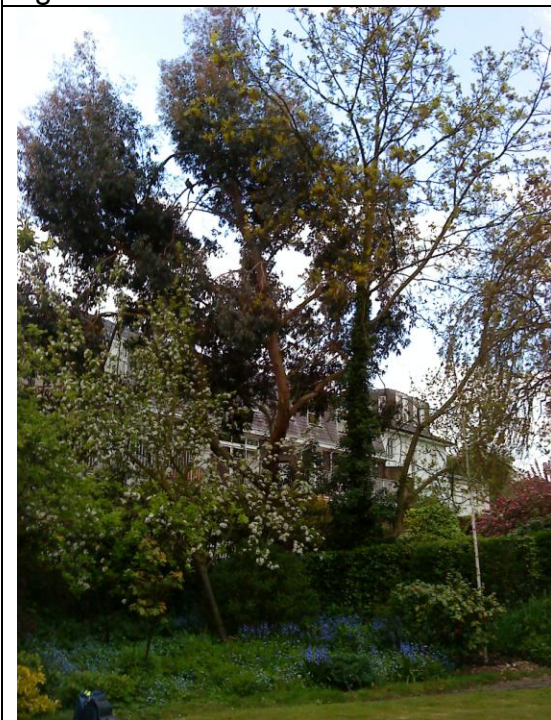
- 4.5 T5 is the third fruiting apple along the south boundary. It is in a good to fair physiological condition. Structurally the tree leans significantly to the south. It has a main fork at 1.4m high from which there are 2 main limbs. It too has been given a C rating, as it also screens the proposals from the properties to the south.

- 4.6 T6 is a large mature eucalyptus, which is located in the garden of the neighbouring property. The ground level in the garden, where the tree is growing, is around 3m lower than the ground level in 1 Millfield place. Access to the base of the tree was not possible, so the diameter of the trunk has been estimated. It has been rated as in a good to fair condition, both structurally and physiologically. However, there are 2 lines in the bark running around the girth of the tree, at about 6m above ground level. These could be the result of wires or ropes running around the tree in the past, which have now been included into the trunk of the tree. If this is the case, then it is a potential structural defect within the trunk. The tree has been given a B2 rating, due to its size in the landscape of the area. It affords screening between the proposals and the adjacent properties.

- 4.7 T7 is a young mature ash tree on the boundary of the property. It appears to be in a fair physiological condition. Structurally it leans to the east, due to suppression from T6. The dense covering of ivy on the trunk makes full structural assessment of the trunk and main scaffold not possible. The tree, along with T6, is important in the wider landscape of the area and, as such, has been give a B2 rating in line with BS5837.

T6	<i>Eucalyptus spp</i>	14	Esti 40	N 3 S 3 E 3 W 4	5	Ma	Fair	Fair The trunk is located in the next garden and the ground/ base level is around 3m lower than the level of the garden at 1 Millfield. At 6m up on the east side there are a pair of rings in the bark suggesting the tree may have been girthed by wire – rope that has now been included into the stem.	Na	40+	B2
T7	<i>Ash Fraxinus excelsior</i>	10	29	N 6 S 3 E 3 W 2	2	Ma	Fair	Fair Leans to the east due to suppression from T6. The dense covering of ivy on the trunk makes full structural assessment of the trunk and main scaffold not possible.	Na	40+	B2
T8	<i>Pear Pyrus comunis spp</i>	8	19.5	N 2 S 3 E 3 W 2	2	Ma	Good - fair	Good – fair Leans to the south	Na	20-40	C2
T9	<i>Magnolia Magnolia soulangeana</i>	6	m/s 19	N 2 S 3 E 2.5 W 2.5	1.5	Mi	Good – fair	Good – fair Multi stem specimen with 2 main stems and 1 smaller limb. The small limb crosses and rubs at 1m on the south side	Remove crossing branch	20-40	C2

T5 apple on the left, T6 eucalyptus in the centre and T7 ash on the right.

T7	<i>Ash Fraxinus excelsior</i>		3.8	They proposals are well outside the root protection area and crown spread of the tree. If the tree is protected it should suffer no long term detrimental affects from the construction.	Protect the tree in line with BS5837:2005 section 9.
T8	<i>Pear Pyrus comunis spp</i>		2.3	They proposals are well outside the root protection area and crown spread of the tree. If the tree is protected it should suffer no long term detrimental affects from the construction.	Protect the tree in line with BS5837:2005 section 9.
T9	<i>Magnolia Magnolia soulangeana</i>		1.9	They proposals are well outside the root protection area and crown spread of the tree. If the tree is protected it should suffer no long term detrimental affects from the construction.	Protect the tree in line with BS5837:2005 section 9.
T10	<i>Eucalyptus spp</i>		4.8	They proposals are well outside the root protection area and crown spread of the tree. If the tree is protected it should suffer no long term detrimental affects from the	Protect the tree in line with BS5837:2005 section 9.

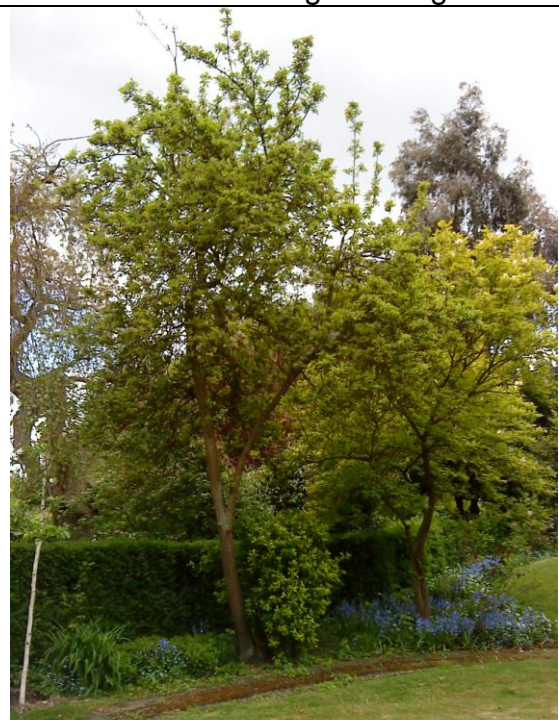
- 4.8 T8 is a mature fruiting pear in a good to fair condition. It also adds to the screening of the proposals from the adjacent properties. It has been given a C2&3 rating.

- 4.9 T9 is a young mature magnolia. It is an attractive tree within the garden but has limited visual amenity from outside the site. It is in a good condition and has been rated as a C2 category rating.

T8 pear on left and T9 magnolia on right with T10 in the back ground right

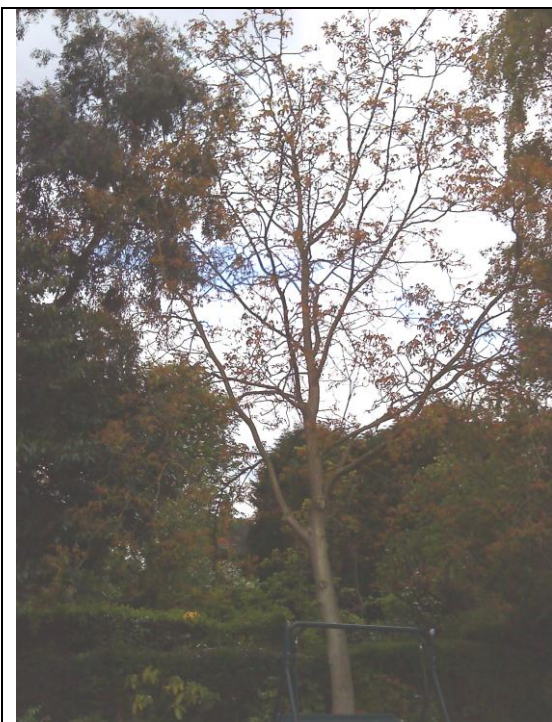
- 4.10 T10 is a large mature eucalyptus which is located in the garden of the neighbouring property. It is in a fair physiological and structural condition. There are a series of cavities running up the trunk on the east side, which appear to have some localised decay associated with them. It is visual in the wider landscape and, with T11 & T12, forms a good screen of the proposed development from the properties to the west. As such, it has been given a B2 rating.

- and physiological condition, though they are shaded by T10. Both have been given a C rating due to their screening value.
- 4.12 T13 is a young mature walnut tree, in both a good structural and physiological condition. It has limited value in the wider landscape, due to the presence of T10, T11 and T12 to the west. It is, however, a good specimen. Taking this into consideration, it has been given a B-C rating in line with BS5837, as it would be expected to have a safe useful life expectancy of more than 40 years.

T10	<i>Eucalyptus spp</i>	12	Esti 40	N 3 S 3 E 3 W 4	5	Ma	Fair	Fair There are a series of cavities running up the trunk on the east side that appear to have some localised decay associated with them	Na	40+	B2
T11	<i>Portuguese laurel</i> <i>Prunus lausitanica</i>	6	Esti 20	N 3 S 5 E 3 W 2	3	Ma	Good – fair	Good – fair	Na	10 – 20	C2
T12	<i>Portuguese laurel</i> <i>Prunus lausitanica</i>	6	Esti 20	N 3 S 5 E 3 W 2	3	Ma	Good – fair	Good – fair	Na	10 – 20	C2
T13	<i>Walnut</i> <i>Juglans nigra</i>	10	24	N 3 S 3.5 E 5 W 4	1.8	Mi	Good	Good	Na	40+	B2
T14	<i>Silver birch</i> <i>Betula pendula</i>	14	59	N 4 S 4 E 3.5 W 4	3	Ma	Good	Good – fair The dense covering of ivy on the trunk makes full structural assessment of the trunk and main scaffold not possible.	Na	20-40	B2
T15	<i>Cornelian cherry</i> <i>Cornus mas</i>	10	M/s 50	N 4 S 3 E 3 W 4	3	Ma	Good – fair	Good – fair Multi stem specimen The dense covering of ivy on the trunk makes full structural assessment of the trunk and main scaffold not possible.	Na	20 – 40	C2

T13 walnut with T10 Eucalyptus behind

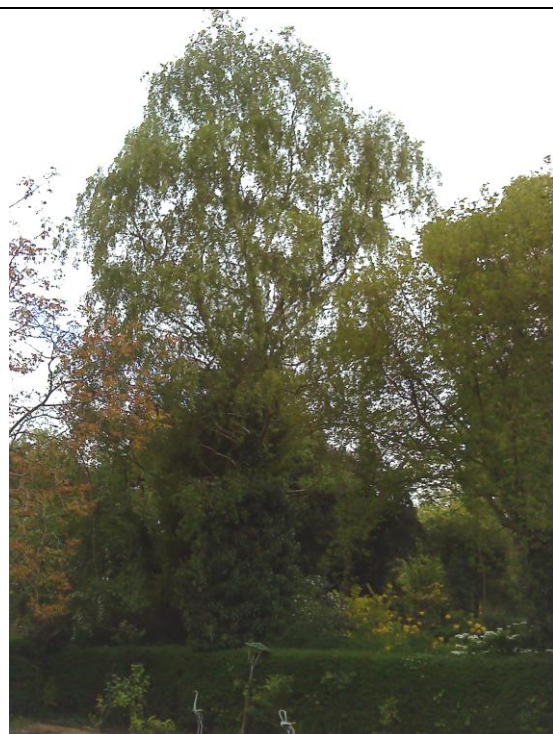
- 4.13 T14 is a large mature silver birch tree, located in the neighbouring garden. It is in a good physiological condition. The dense covering of ivy on the trunk makes full structural assessment of the trunk and main scaffold not possible. T14 is important in the wider landscape of the area and, as such, has been given a B2 rating in line with BS5837.

T14 – silver birch

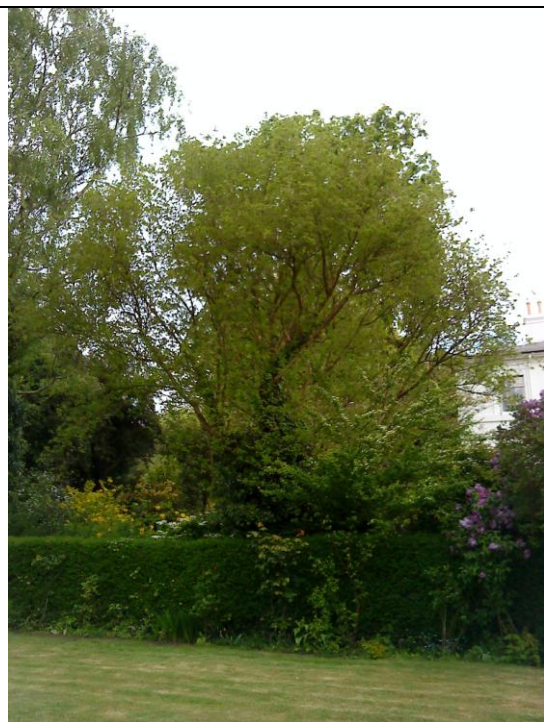
- 4.14 T15 is a large example of a Cornelian cherry tree. It is a multi stem specimen. As with T14, the dense covering of ivy on the trunk makes full structural assessment of the trunk and main scaffold not possible. It appears to be in a good physiological condition. It has been given a C rating as, though it is a nice small tree or large shrub, the views of it from the wider landscape are limited.

T15 – Cornelian cherry

T15	<i>Cornelian cherry</i> <i>Cornus mas</i>		5.0	The proposed building work is outside the Root Protection Area (RPA) and crown spread. However an area to the east of the RPA maybe encroached into to facilitate the development	Additional ground protection inline with BS5837:2005 will be required over approximately 3.8 m/sq of the RPA to facilitate access and scaffold during the build
