Landmark Trees

ARBORICULTURAL CONSTRAINTS REPORT:

Garden Flat

185 Goldhurst Terrace

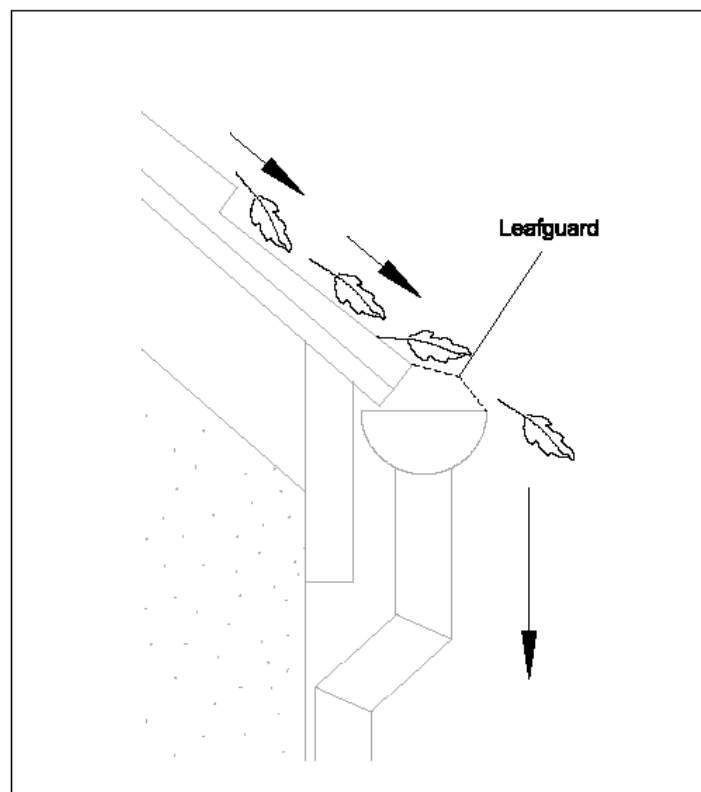
Filtration traps, as shown above, could be fitted on the gutters which can easily be maintained at 2-3m above ground.

6.3.4 Nuisance deposition can be mitigated with regular crown cleaning and filtration traps on the guttering, as necessary. Alternatively, a green roof construction might be considered.

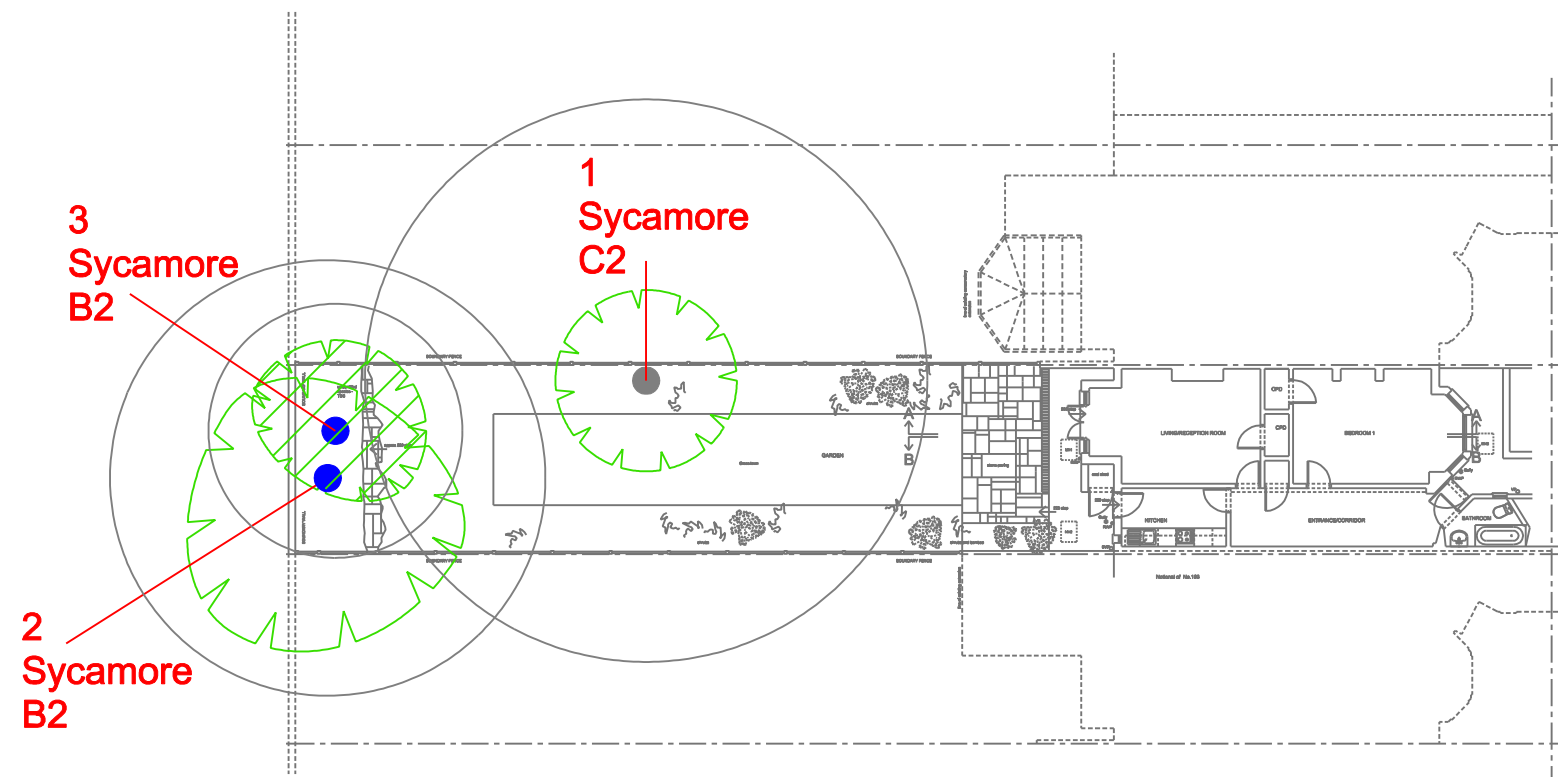
TREE CONSTRAINTS PLAN

- 1.2 There are 3 surveyed trees on site, all mature sycamores. T2 & 3 are 'B' category *(Moderate Quality) trees and therefore, a material constraints.

3.2.4 T1 is apart from this screen and with its crown removed (topped) has little contribution to make. When a tree has to be topped, it generally means that it is unsuitable for its location. Given its structural defects (that may have precipitated the hard pruning), and the dearth of small ornamental trees, it would be best replaced. However, this decision should be made after the planning application, lest it compromise the application and lead to a refusal.

3.2.5 T2 & T3 are in fair condition, but T3 in particular is smothered in ivy, potentially exacerbating a pre-existing condition of low vigour. The creeper's presence may also conceal structural defects that should be addressed prior to any development next to the trees. Therefore, the ivy should be severed and a further inspection of the crown architecture made.

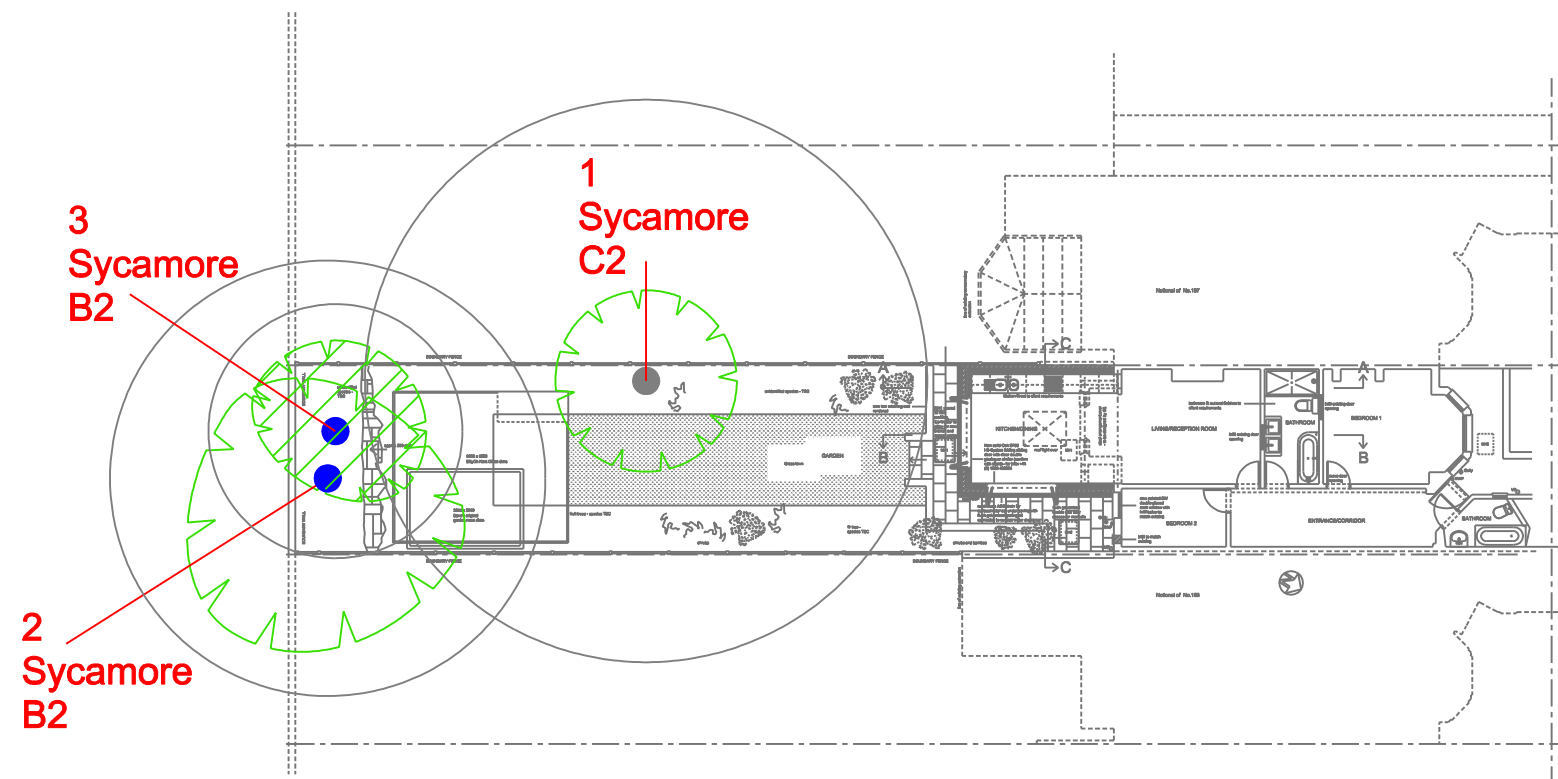
ARBORICULTURAL IMPACT ASSESSMENT PLAN

- 1.3 The only primary impact in the extension proposal is the tangential patio construction, minutely encroaching the Root Protection Area (RPA) of T1. The impact is 0.18% of total RPA, which is virtually non-existent. There are no secondary impacts (post-development pressures) to this pollard tree, which has already had its canopy removed. Therefore, the rear extension is arboriculturally viable.

- 1.5 The primary impacts of the (optional) garden room proposal would be the marginal encroachment of all 3 RPA's by the larger design footprint. The impacts are of the order of 10-15% of total RPA, which is considered a low impact: one that a moderately healthy specimen of the affected species should tolerate adequately, provided the recommendations of this report are followed: both direct impacts and restrictions on future growth can be mitigated by employing low-invasive foundation techniques.

6.3.2 The garden room encroachments will require the use of specialised foundation techniques, such as mini-piling or pad and raised beam. The foundation pits within the RPA should be trial-excavated by hand using a double-headed spade (“shove-holer”) or similar to minimise breadth of hole required for inspection. Alternatively, the room could comprise a wooden structure supported above ground on discrete footings.
