**Design and Access Statement**  
**Scope of Works and Justification**

**Proposed Refurbishment and Link Works to**  
**8 Southampton Place, London WC1A 2EA**

Holborn Links Limited  
September 2009

Document Reference: 058/A/7001

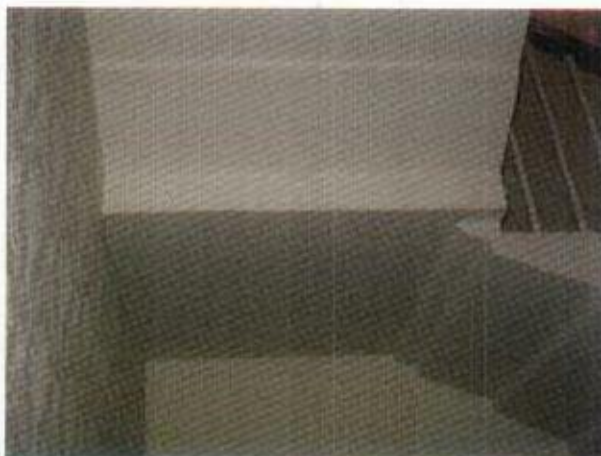
We were asked to have a look at the cantilever staircase where a crack was obvious in the location of the quarter landing between first and second floor level. From the underside there is a crack in the quarter landing stone which was considered to be very straight and perpendicular with the party wall of the property. The crack continues through the first step above where it then runs in a diagonal direction. The carpet covering to the top surface was lifted locally and it was clear that there is a straight joint in the quarter landing in this location. The diagonal crack to the next step above is likely to be caused by movement in the quarter landing in the location of the straight joint which in turn has allowed minor movement in this step.

**Photograph 1:** Cracking to underside of quarter landing

We would recommend that the crack in the first step should be repaired using a stainless steel clamp. This can be done from above where a staple shaped clamp can be resin fixed across the crack and made good after. We would also recommend that any joint between the landing and first step is pointed to limit any further future movement.

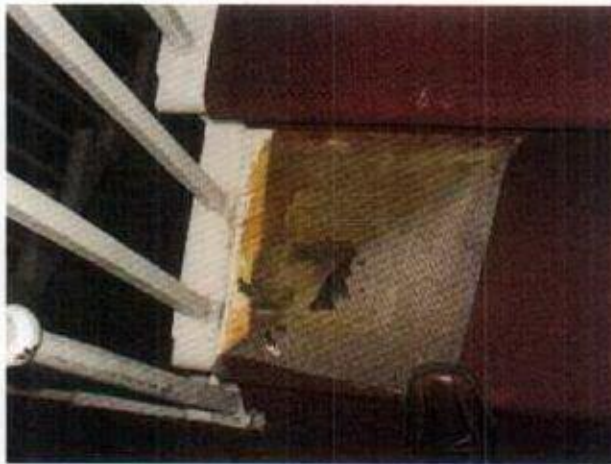
**Photograph 2:** Diagonal cracking to top of cantilever stone step.
