HEYNE TILLET STEEL
STRUCTURAL ENGINEERS

Job: VALE OF HEALTH, HAMPSTEAD Date: APR '09
Title: COURTYARD INFILL SCHEME Eng: M.T
Job No: 0337 Sheet: SK01 Rev:

0337 Woodbines, Vale of Health
Site Visit, 09-05-07

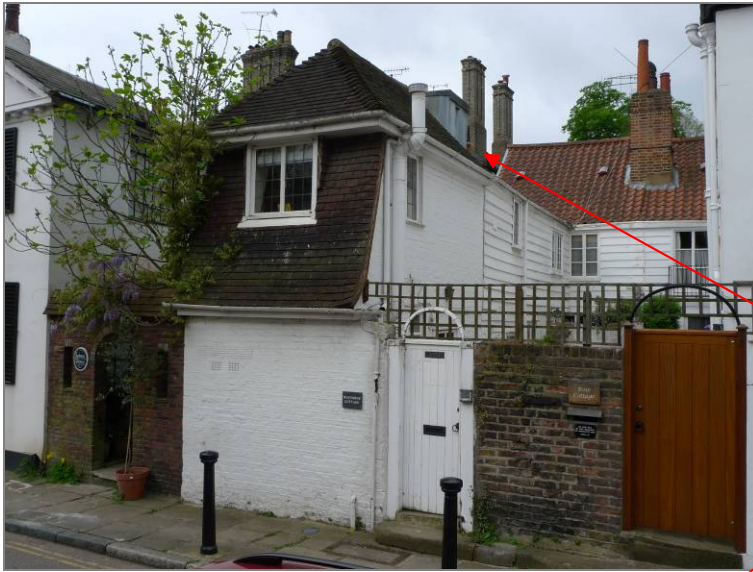
Existing roof pitch varies, pan tiles to front slate to rear. Roof spans across the building onto external walls

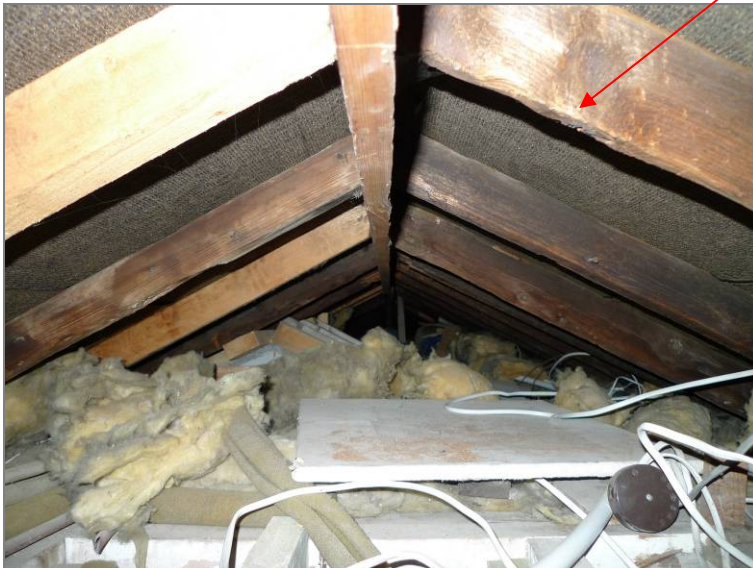
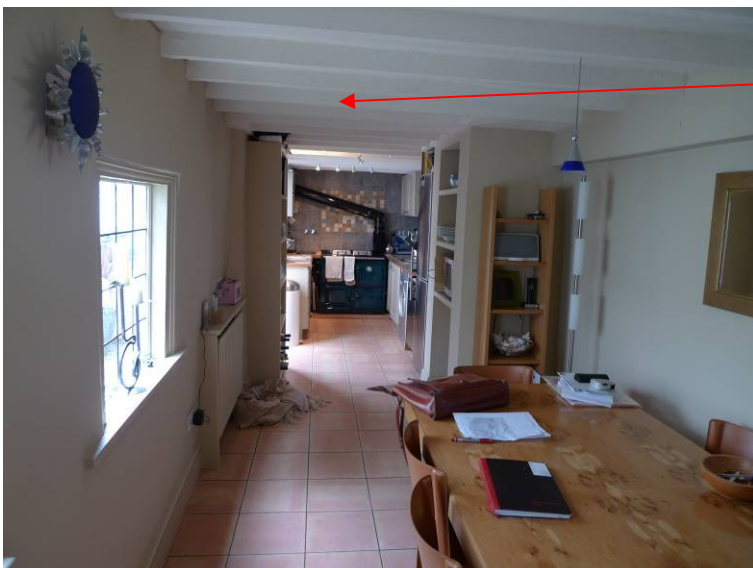
First floor timber joist structure spanning across property and loading onto external walls. Ground bearing concrete floor slab throughout ground floor.

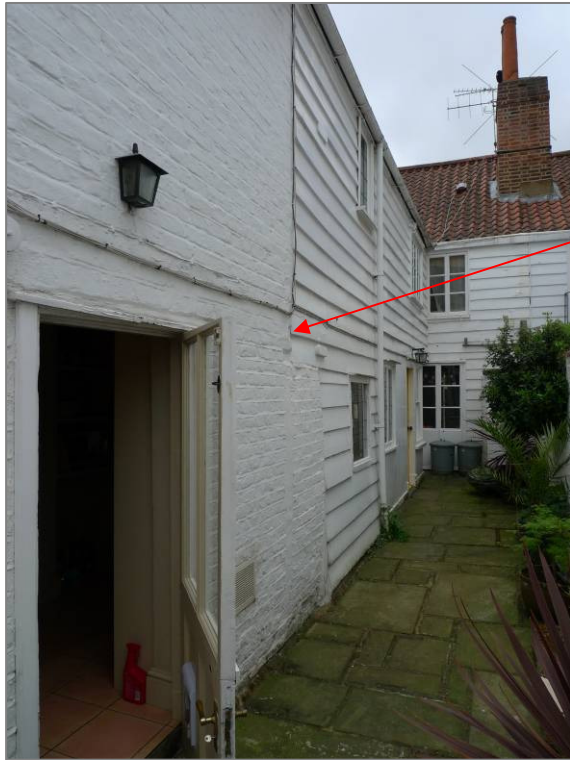
Wall construction changes from solid 9" masonry to timber framed weather board construction at this location over both storeys.

Investigation works will need to remove weather board locally at two locations along the length at first floor level to establish joist / stud / wall plate relationship to inform ease and robustness of glazing support angle fixing.

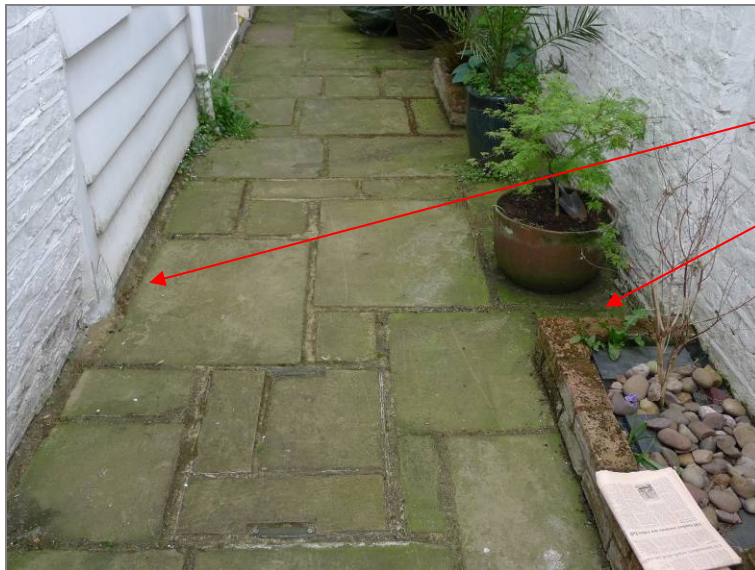
Probable locations for trial pits in yard.

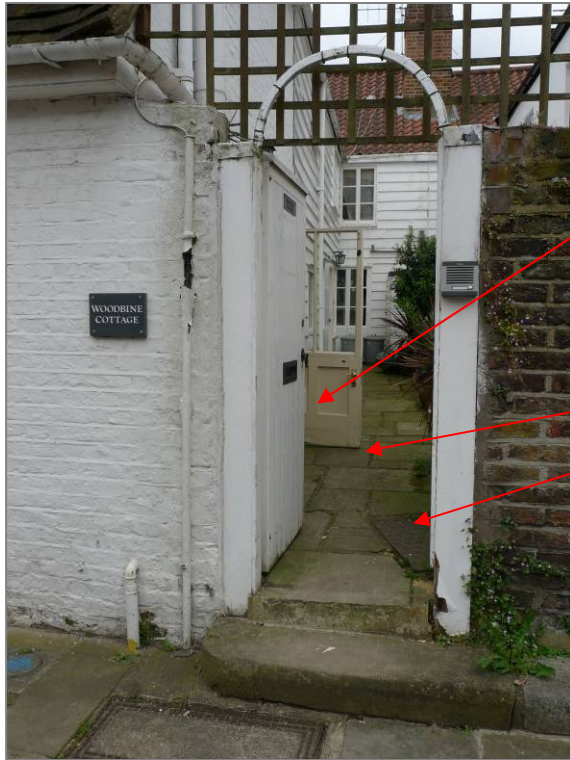
Level change from pavement to yard of approx 270mm, then from yard to ground floor slab of a further 180mm. Indicating load bearing ground maybe deeper than assumed, resulting in deeper proposed footings.

Two manholes noted, appears to be a combined system draining the house through the yard into main sewer in street. CCTV drains survey to be undertaken in next phase of works. All of this run will need to be re-laid and cast into new foundation slab with recessed covers double-sealed covers.

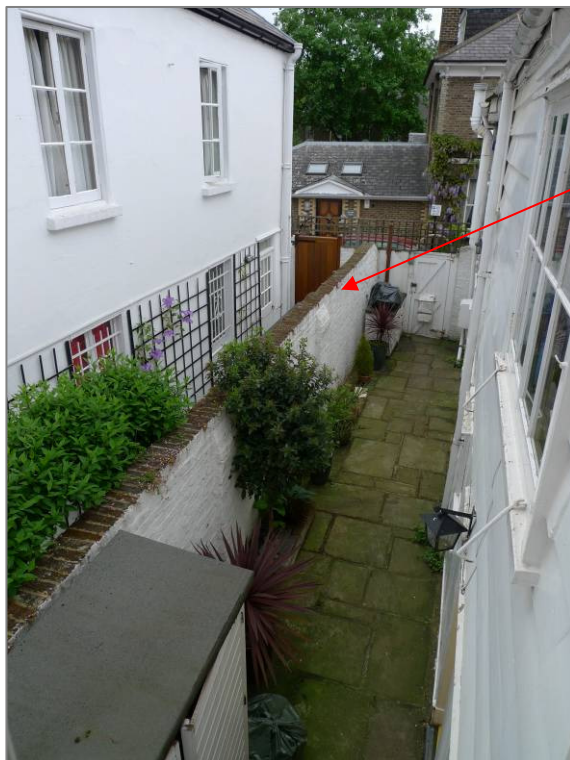
9" party fence wall. Ground level appears similar on both sides of wall - important for construction sequence and any retaining action to be undertaken in temporary condition
