BS5837:2005 Tree Survey Report, incorporating Arboricultural Implications Assessment and Method Statement

In support of an application for a docking station on the footway at:

Longford Street Camden

Status: FINAL Date: 29 April 2009

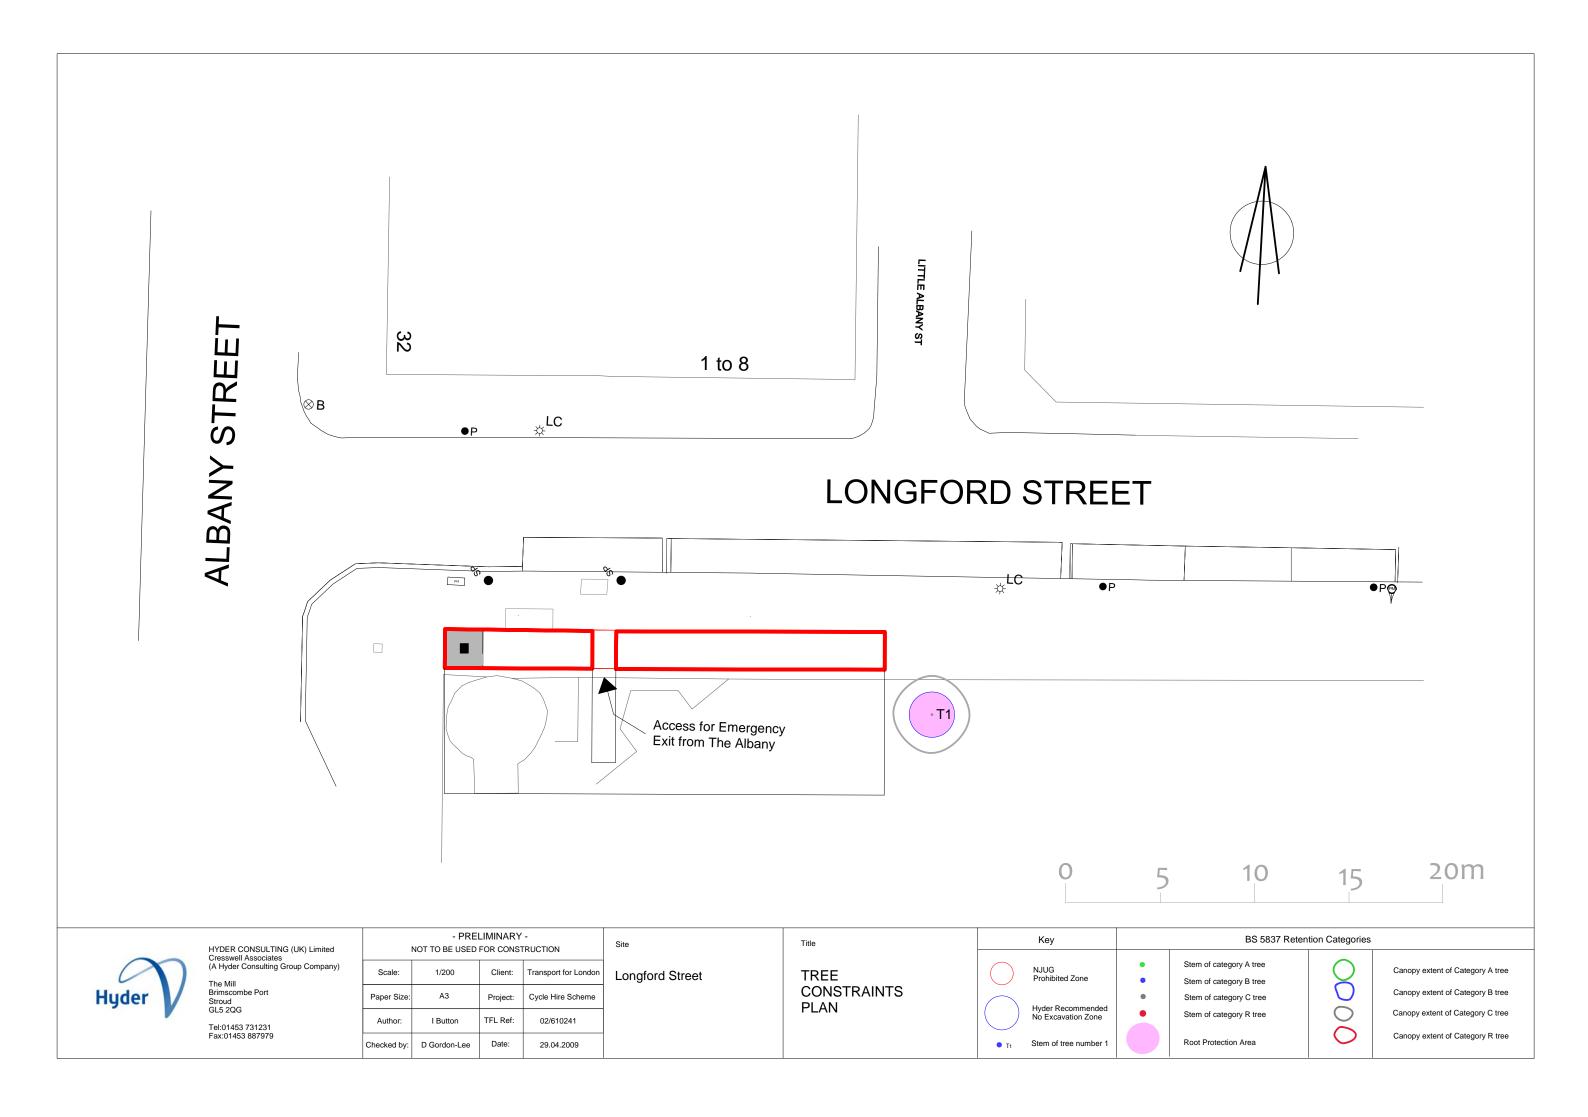
APPENDIX 4: TREE CONSTRAINTS PLAN

The Tree Constraints Plan (Appendix 4) shows the location of T1 in relation to the proposed development. The plan indicates that the proposed docking station is located just beyond the RPA of T1. As such, any excavation within the site is only likely to encounter minor roots and shall not have a significant detrimental impact on T1.

T1 is a semi mature tree located approximately 2.5m from the Site. This tree is a small garden variety which will got grow to sizeable proportions and will not impact on the site.
