A096 3a Hampstead Lane

Design report 04 18 March 2009 Design and Access Statement

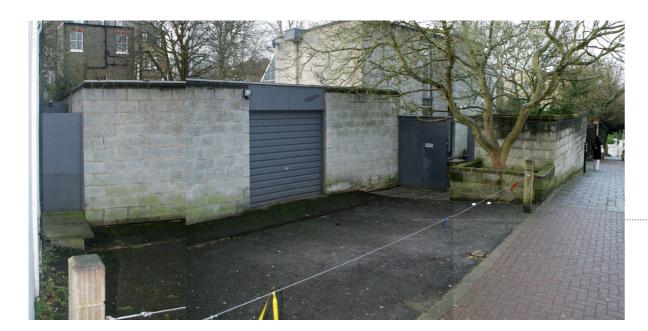
Hard standing in front of the building

- 1. Improve the street scene. By employing an extensive and specialist cleaning, tinting and re-pointing method to the concrete blocks, we hope to return them to a condition similar to when the building was newly constructed. We will also introduce a gate across the property boundary with the street, reducing litter and misuse of the hard standing in front of the building.

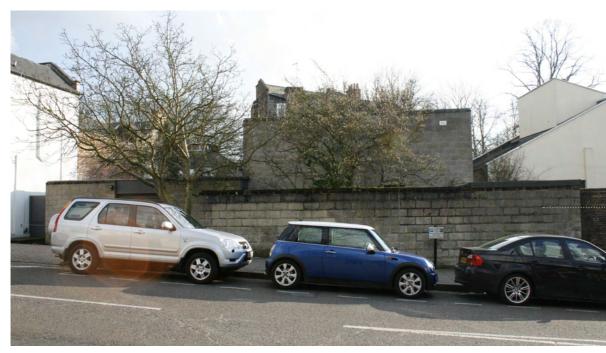
Concrete blocks adversely effected by weathering and badly stained

hard standing infront of garage door, view from Hampstead Lane

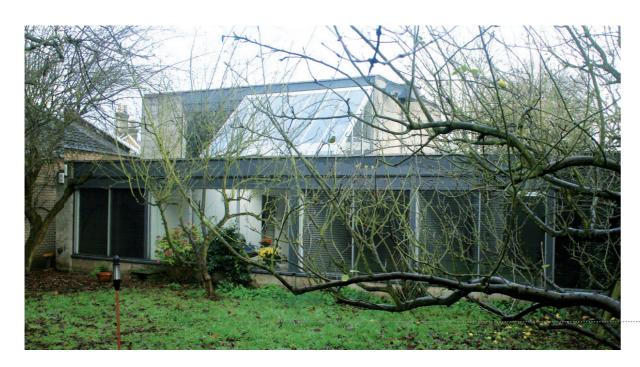
Rear garden

- 2. Enhance the ecology of the surrounding area and add amenity to the street by replacing the roof with a planted 'green roof' and by re-landscaping the garden, replacing dead/diseased trees and introducing new plants.

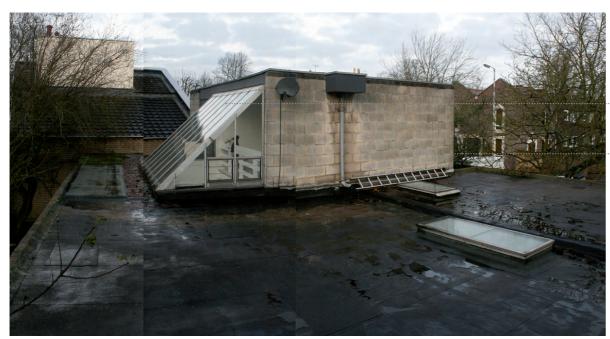
Aluminimum framed, single glazing to rear

First floor, concrete blocks adversely effected by weathering and badly stained

Rear elevation showing extent of full height glazing, Roof and head of prism shaped glazing at first floor level and east facing wall

The east facing blockwork wall of the first floor extension is also in poor condition and is damp in places. The freeze-thaw action of this dampness has caused the mortar to fall out in places and this wall will need substantial re-pointing.

- 3. Reduce the energy consumption of the building. By replacing the single glazing with a high performance system and introducing insulation to the roof, floor and the cavity wall. We also propose to introduce a renewable energy source to work in conjunction with the underfloor heating to reduce the buildings carbon footprint.
