## **APPENDIX II PHOTOGRAPHS**

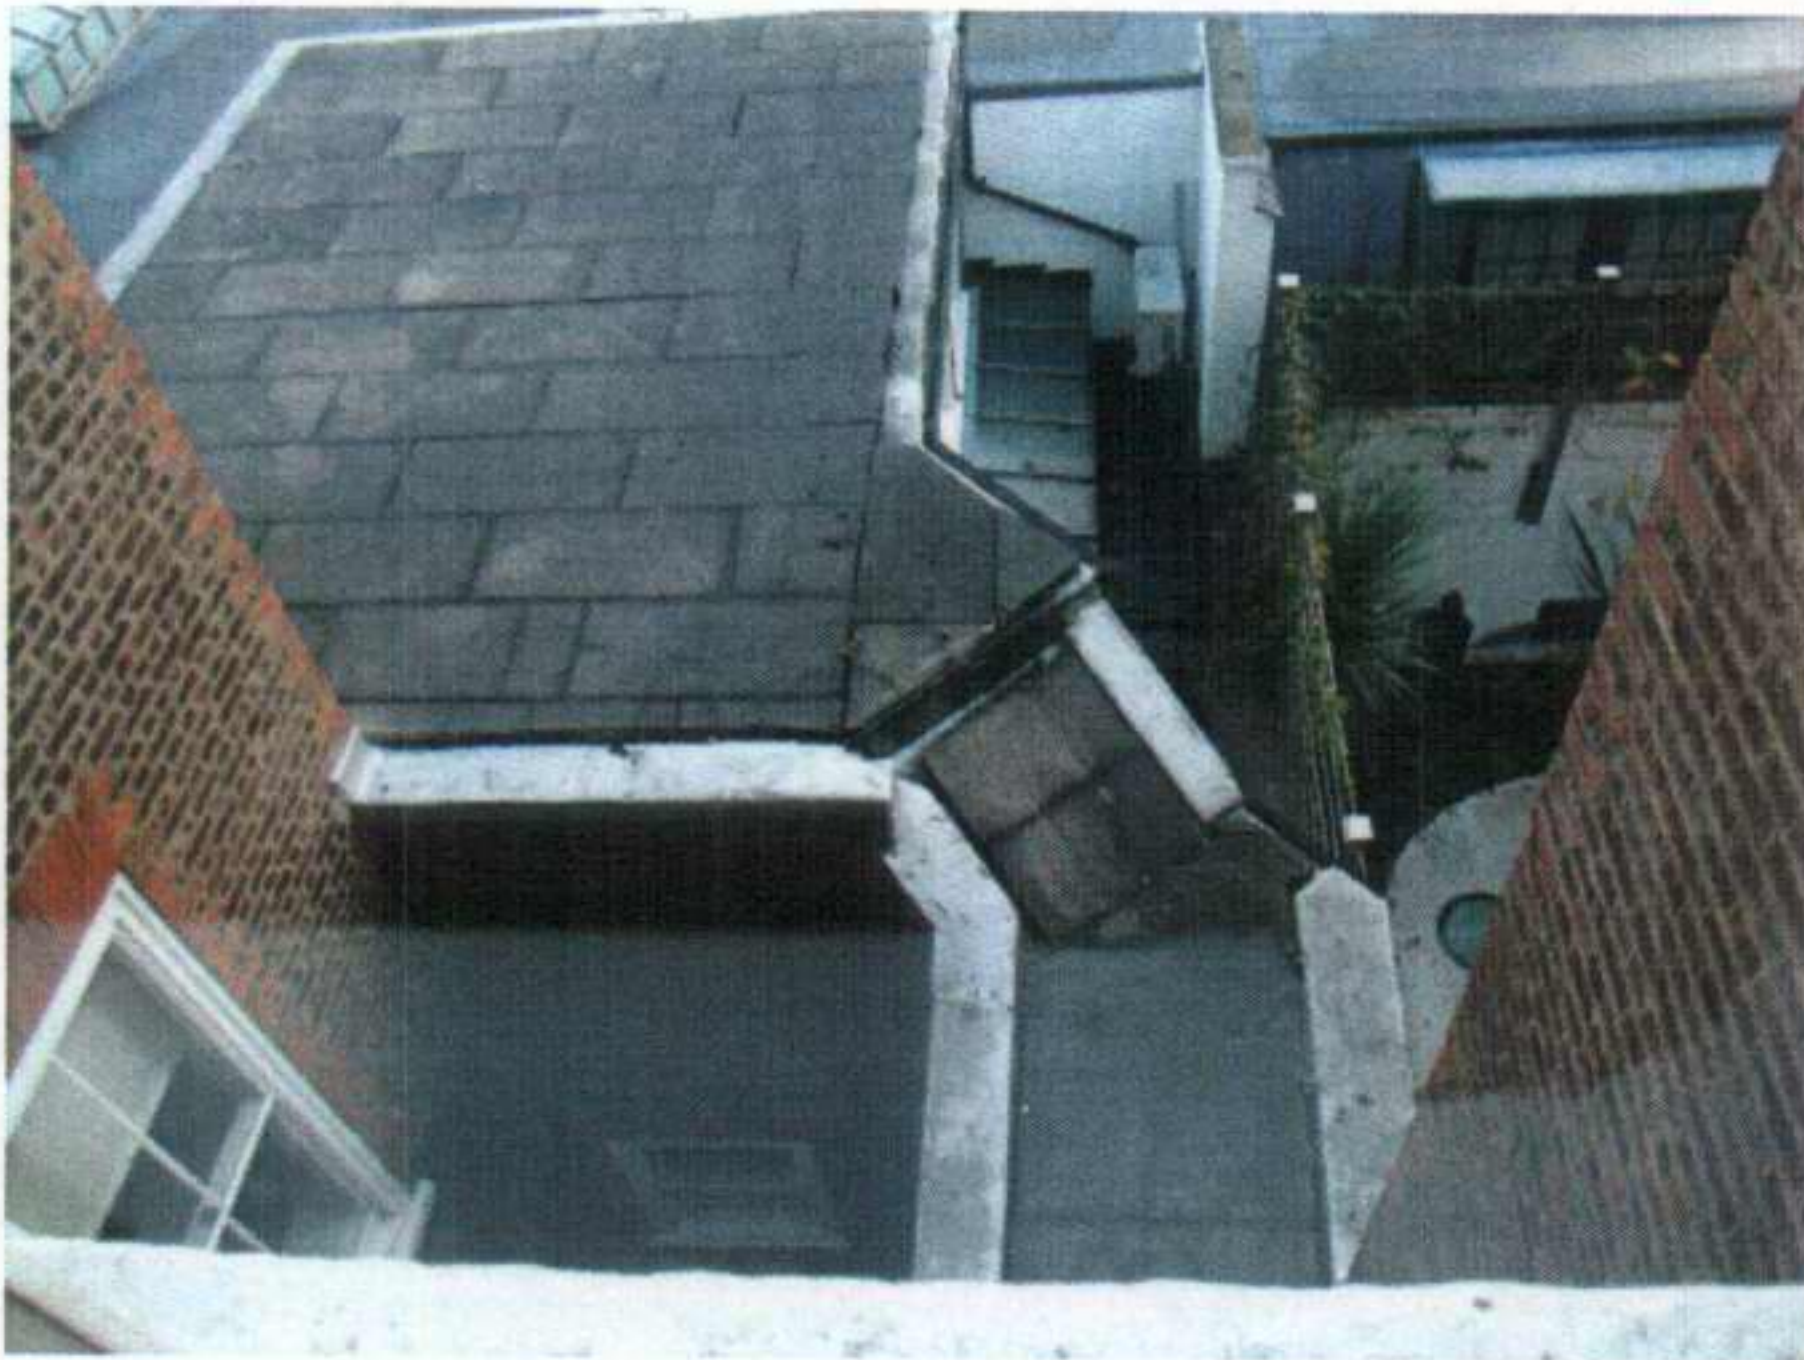
Figure 1  
External view of modern 2 storey extension to the rear of no. 11

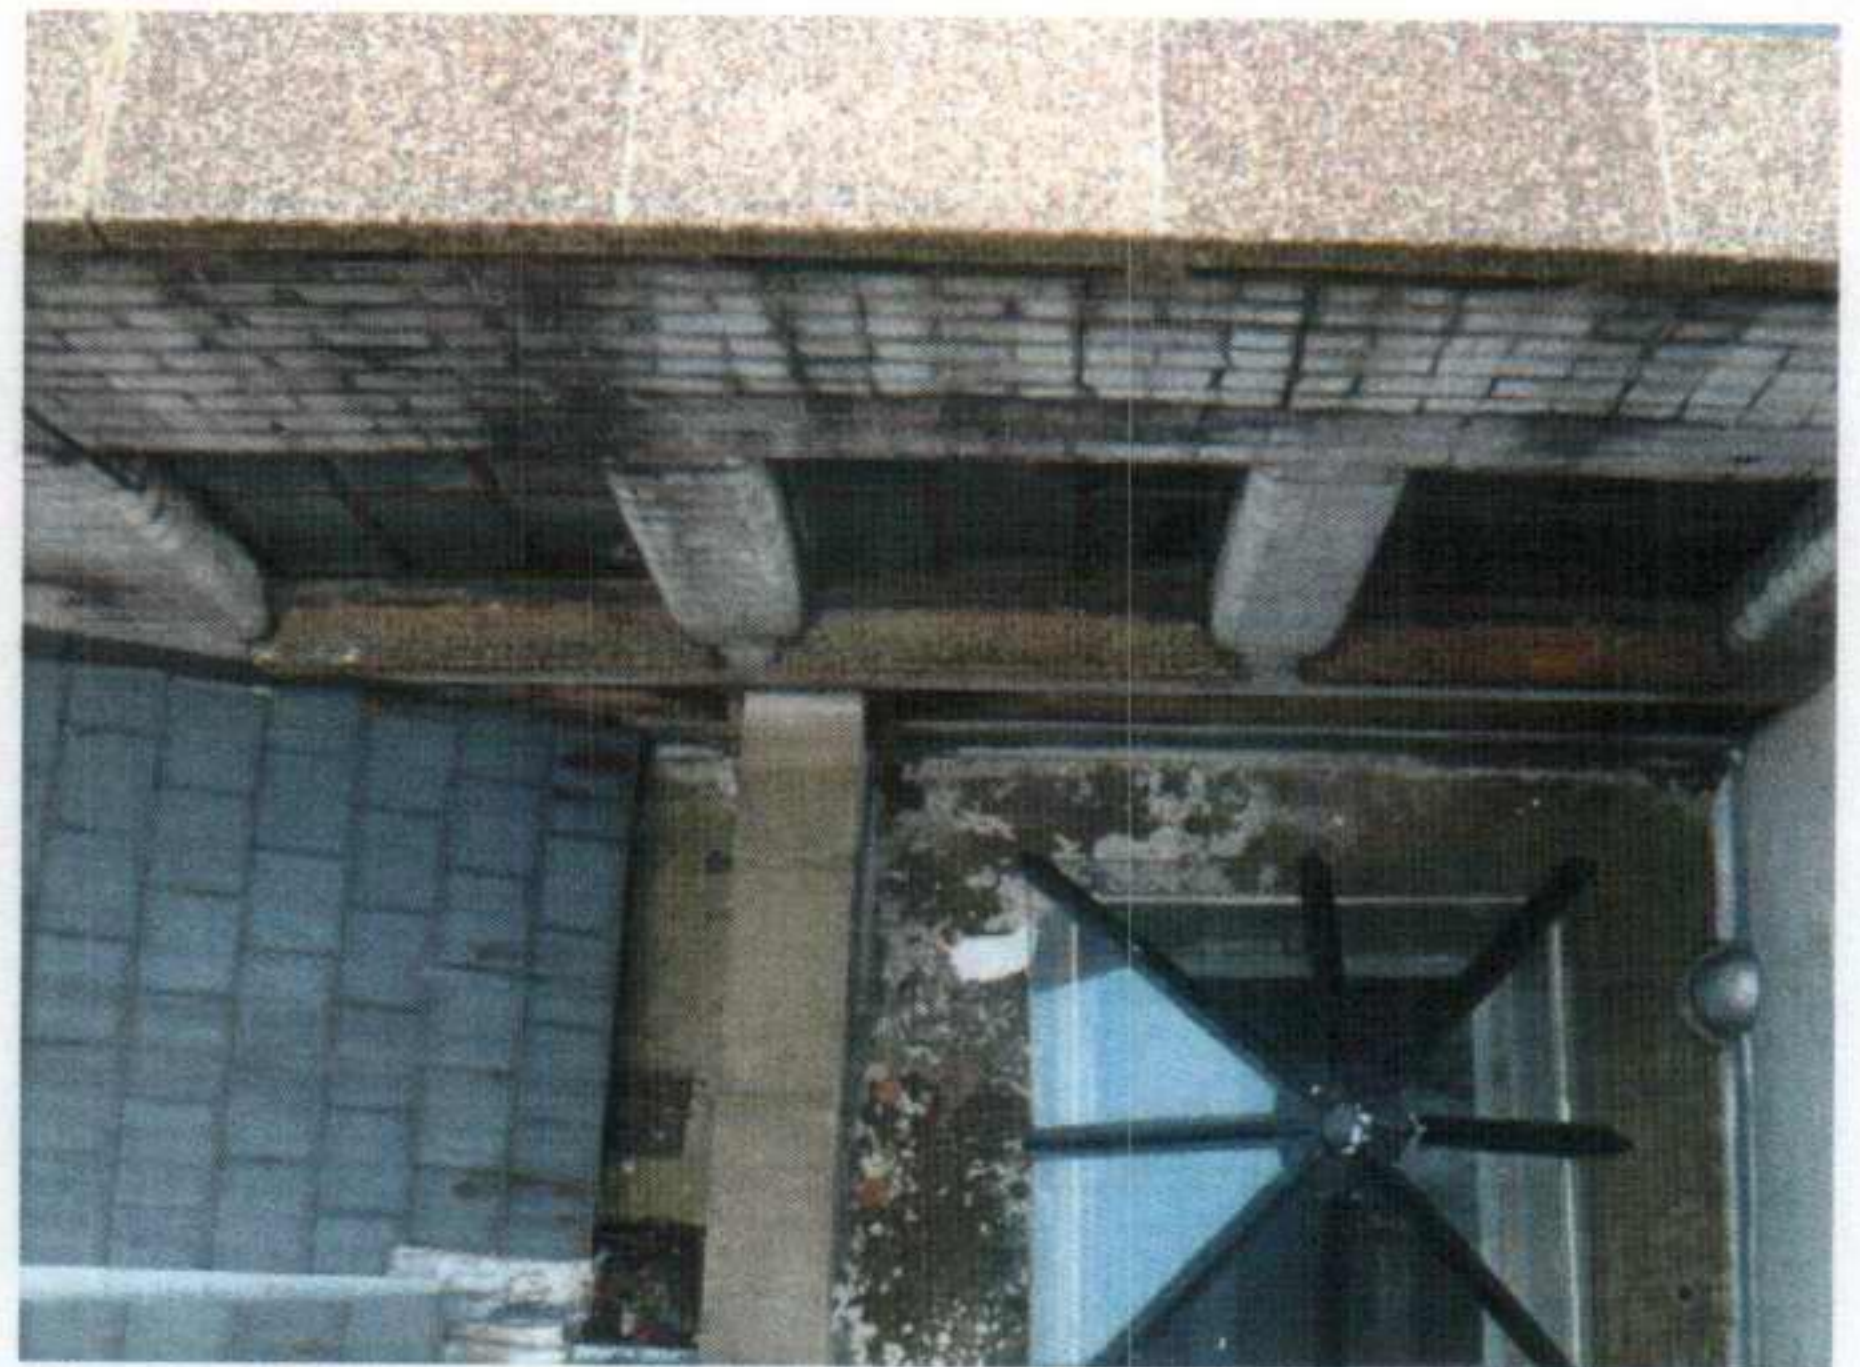
Figure 2  
Existing modern extension to rear of no.12

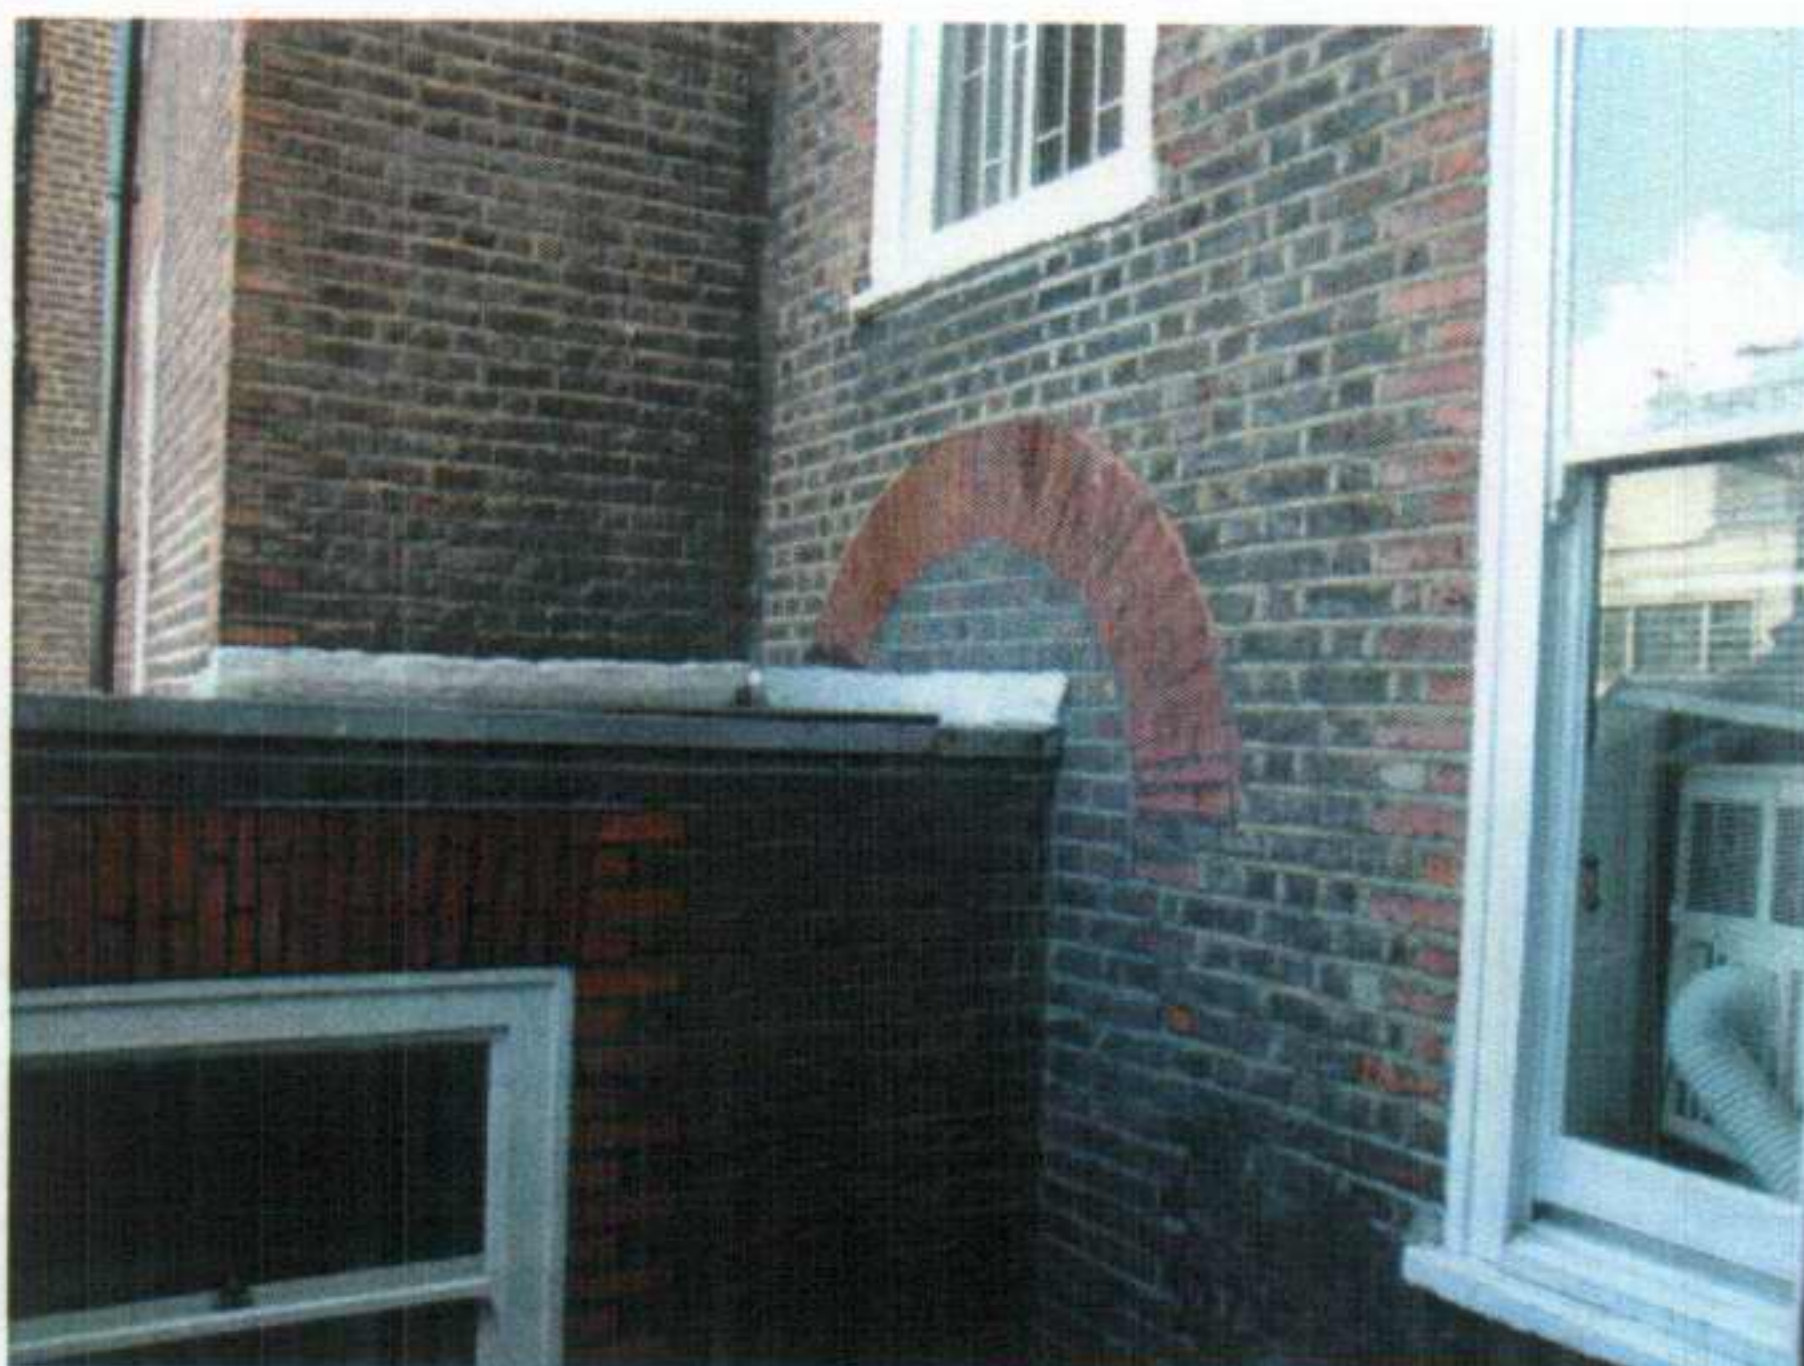
Figure 3  
No 11, modern two storey extension, external junction with historic house. Original arched window to stair to be reinstated

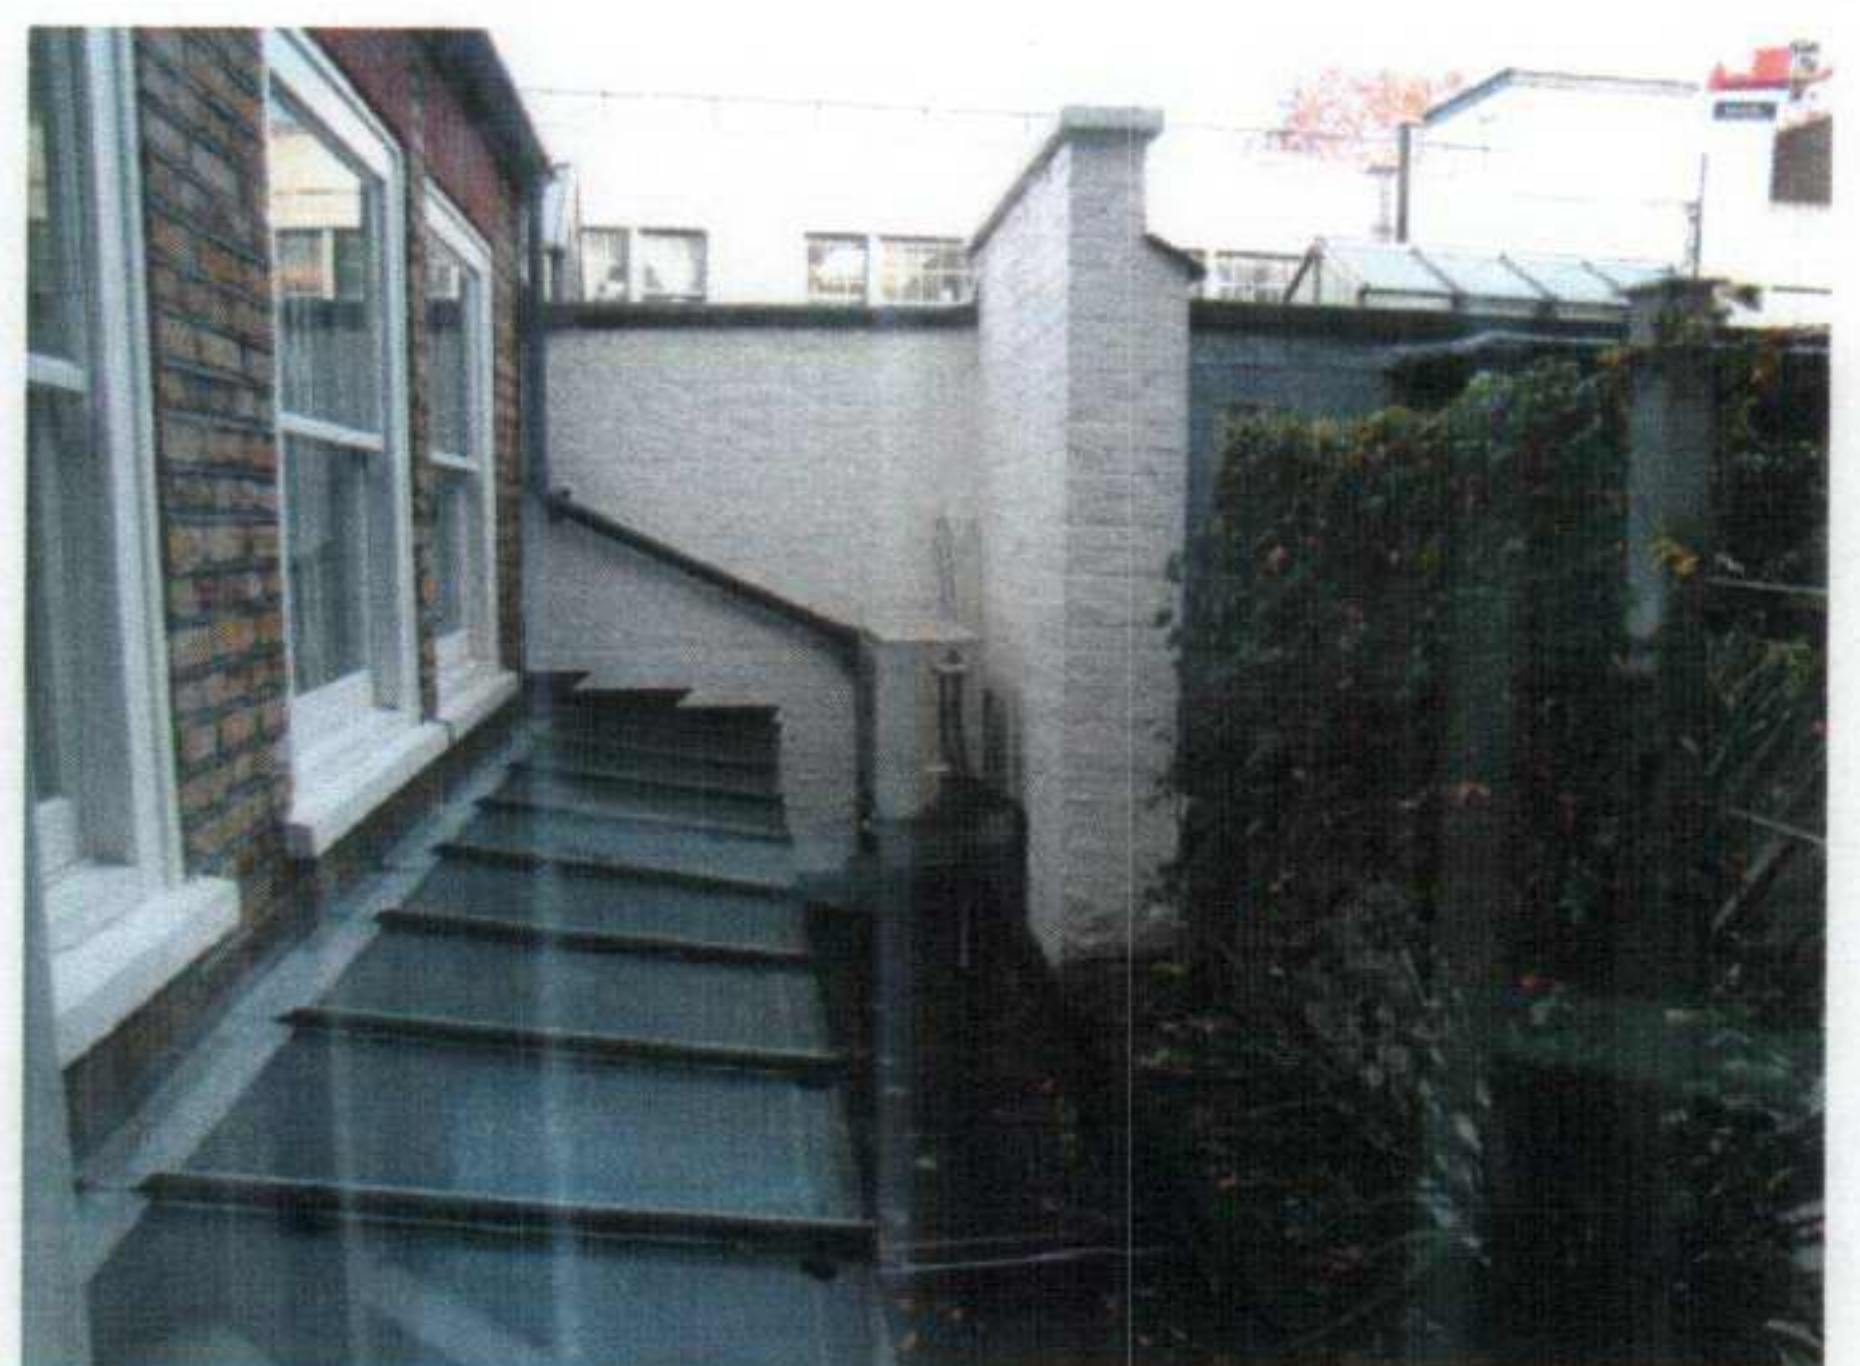
Figure 4  
Rear party wall to No.11. Height to remain as existing.

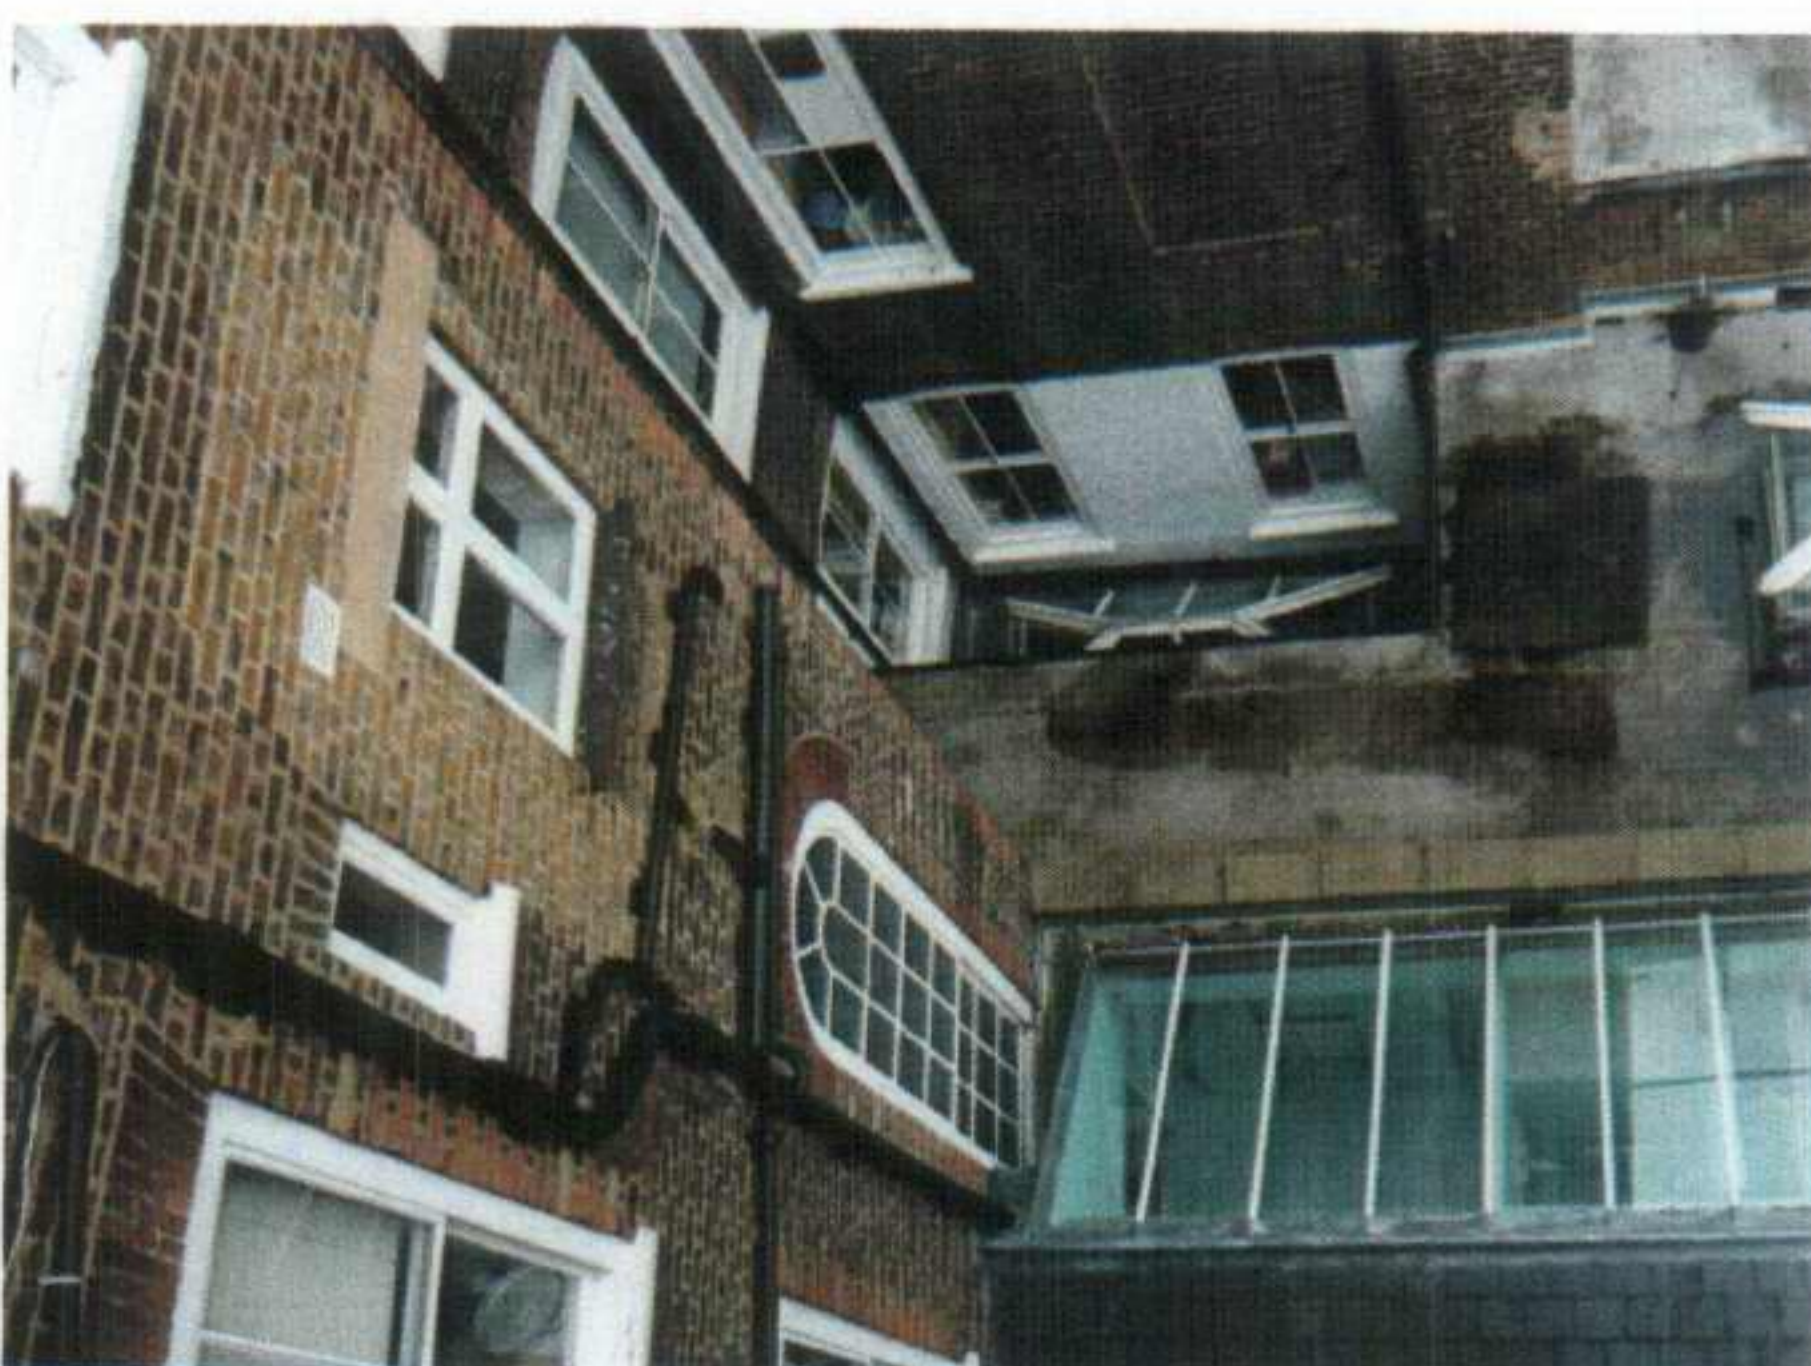
Figure 5  
Rear Elevation to no.12. showing alterations to windows. Original window configuration to be reinstated.

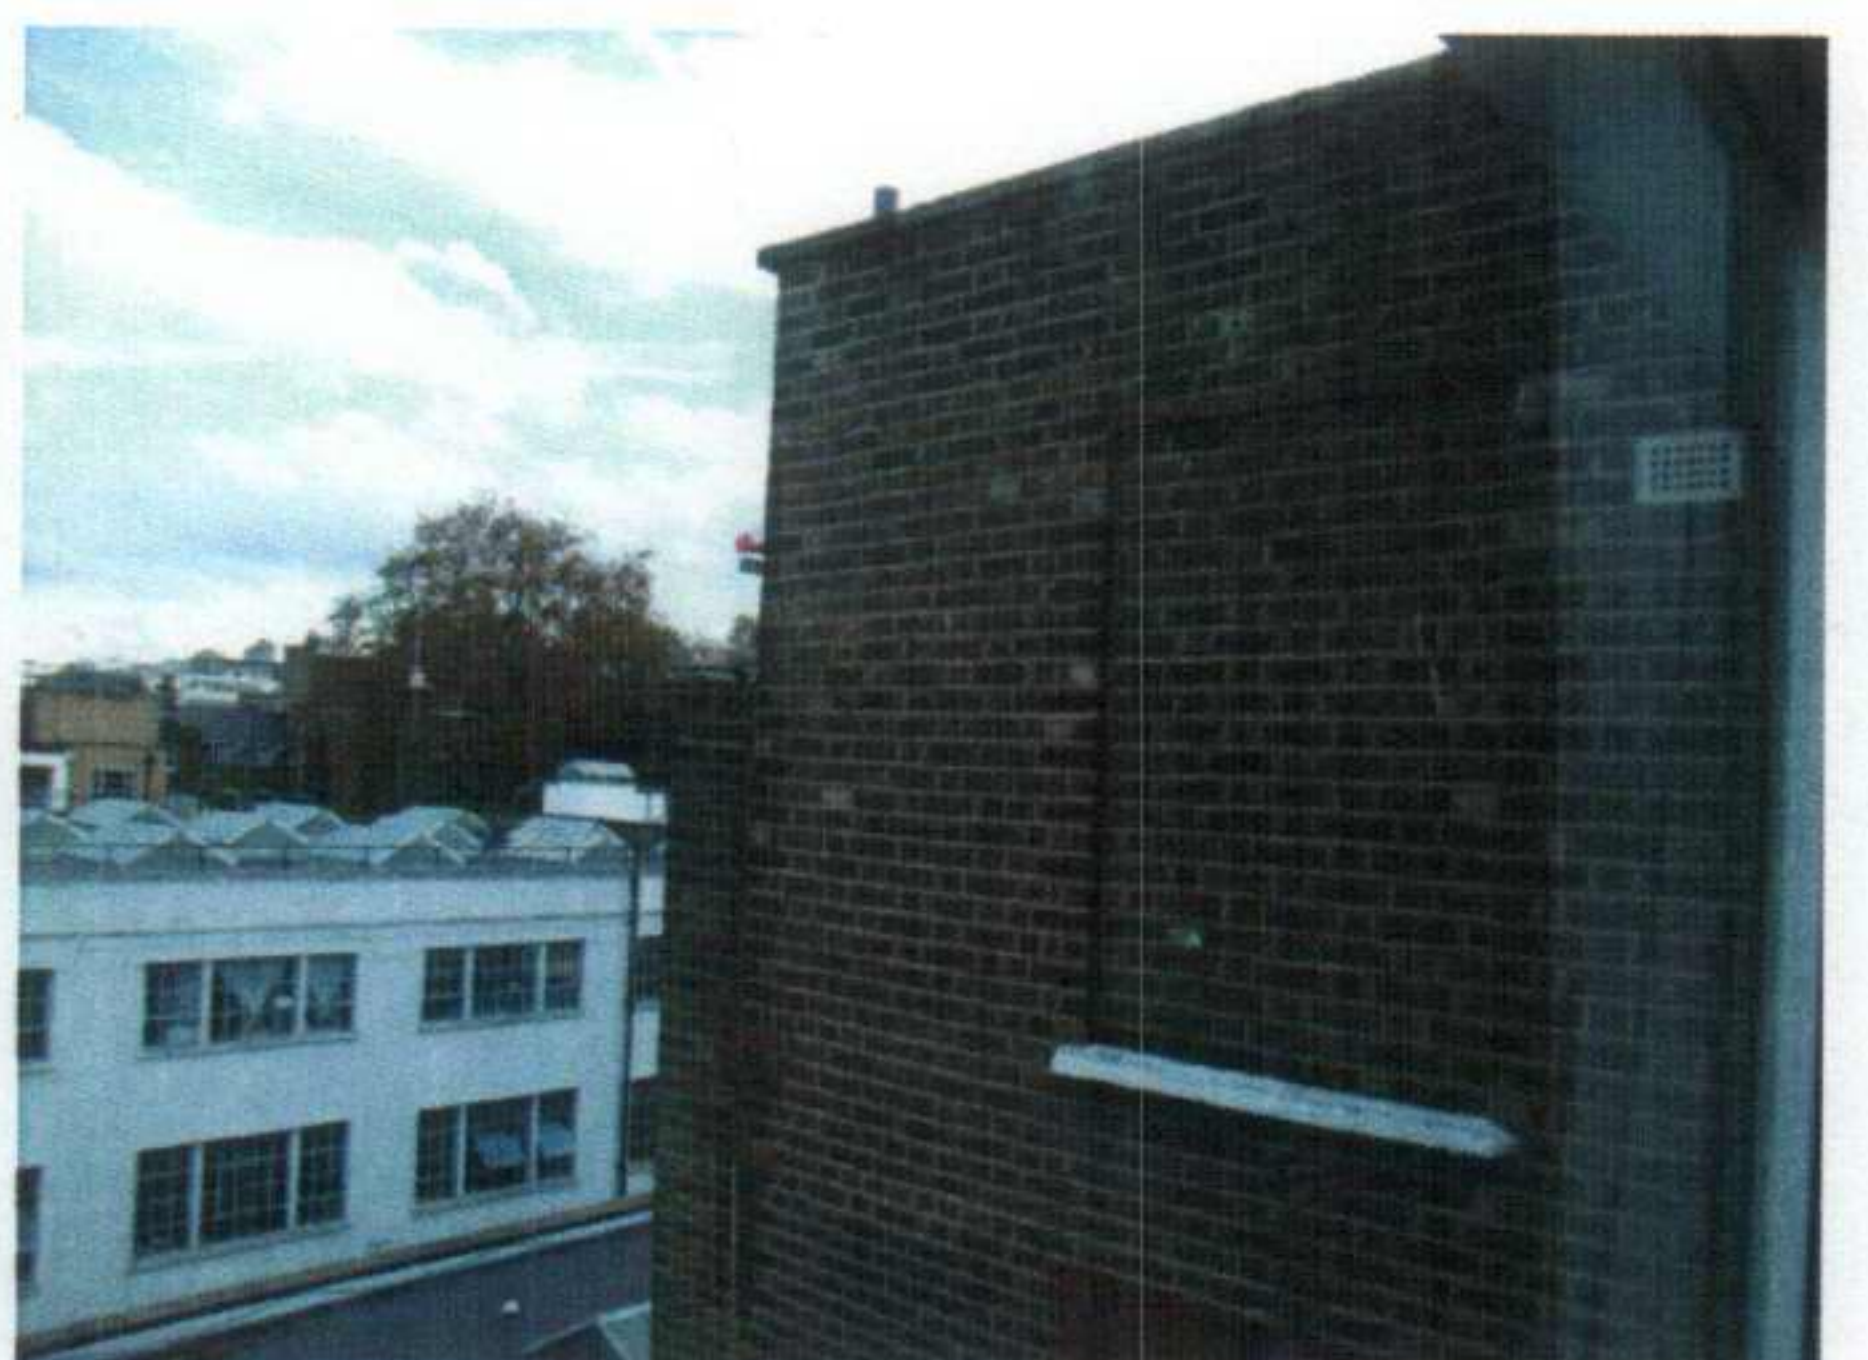
Figure 6  
Third floor annexe probably re-built post war with added buttress.

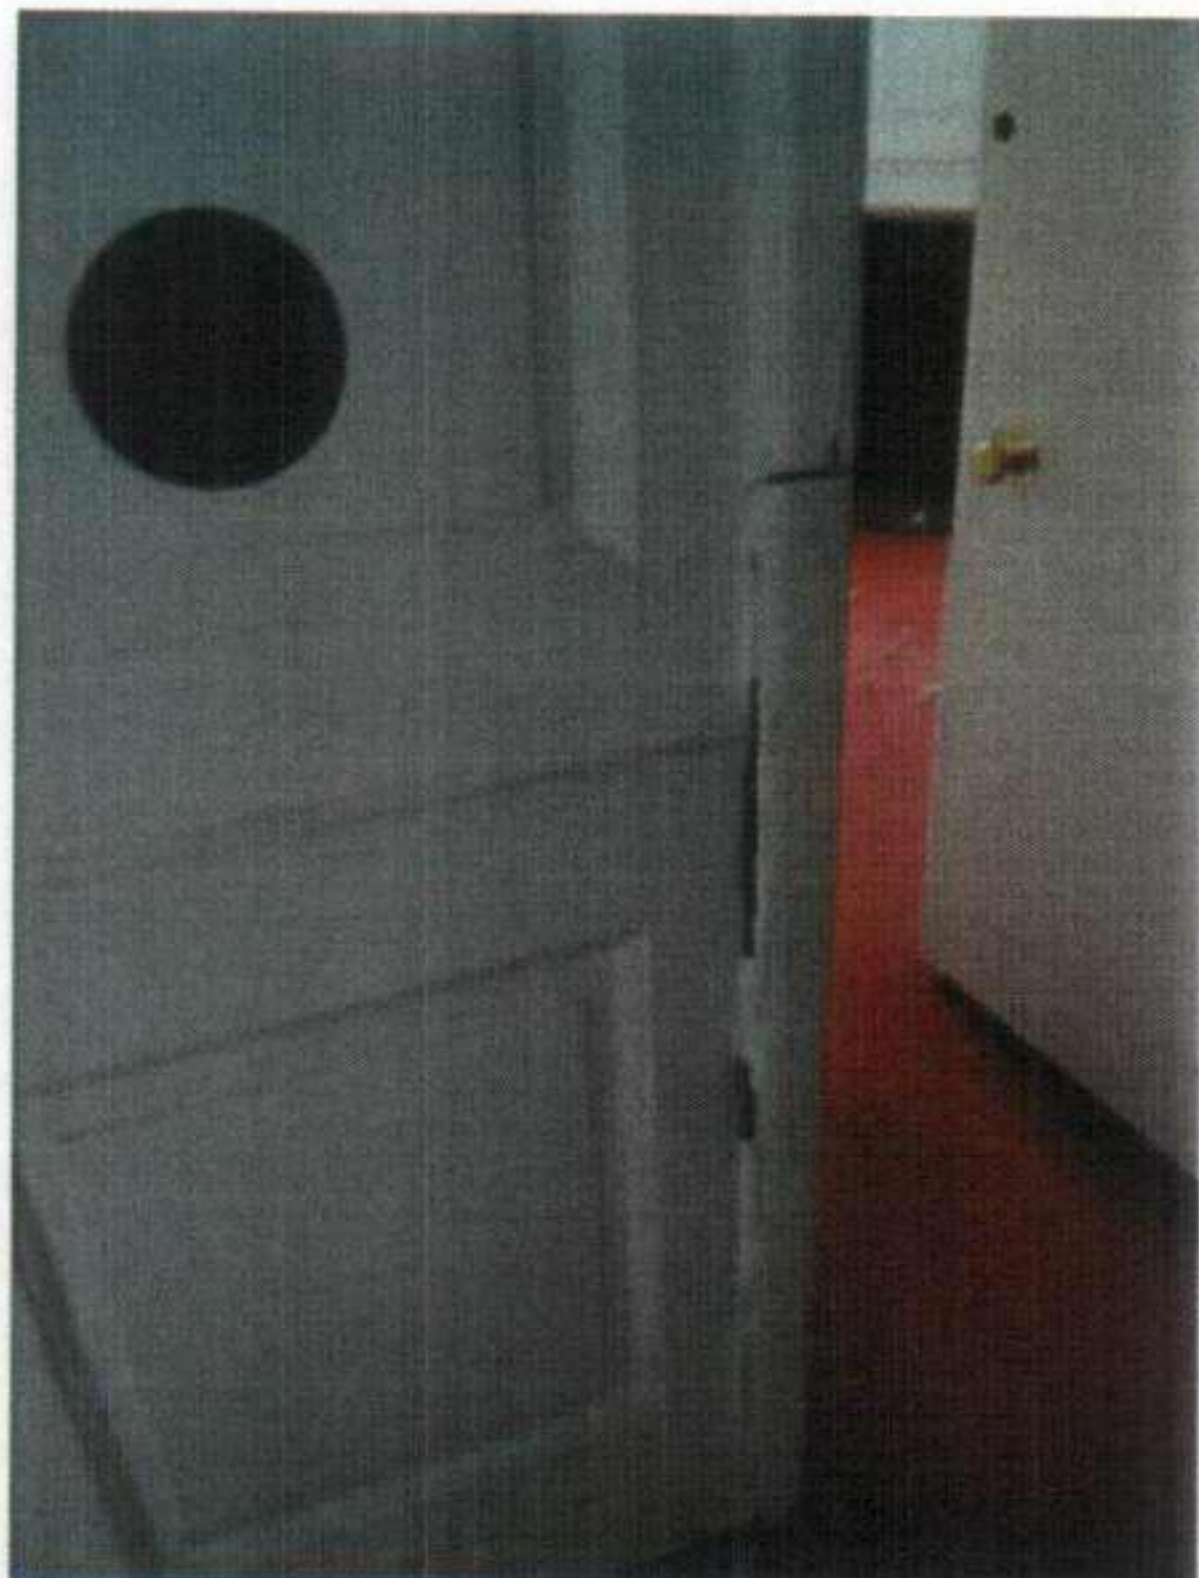
Figure 7  
Panelling repairs to be carried out.

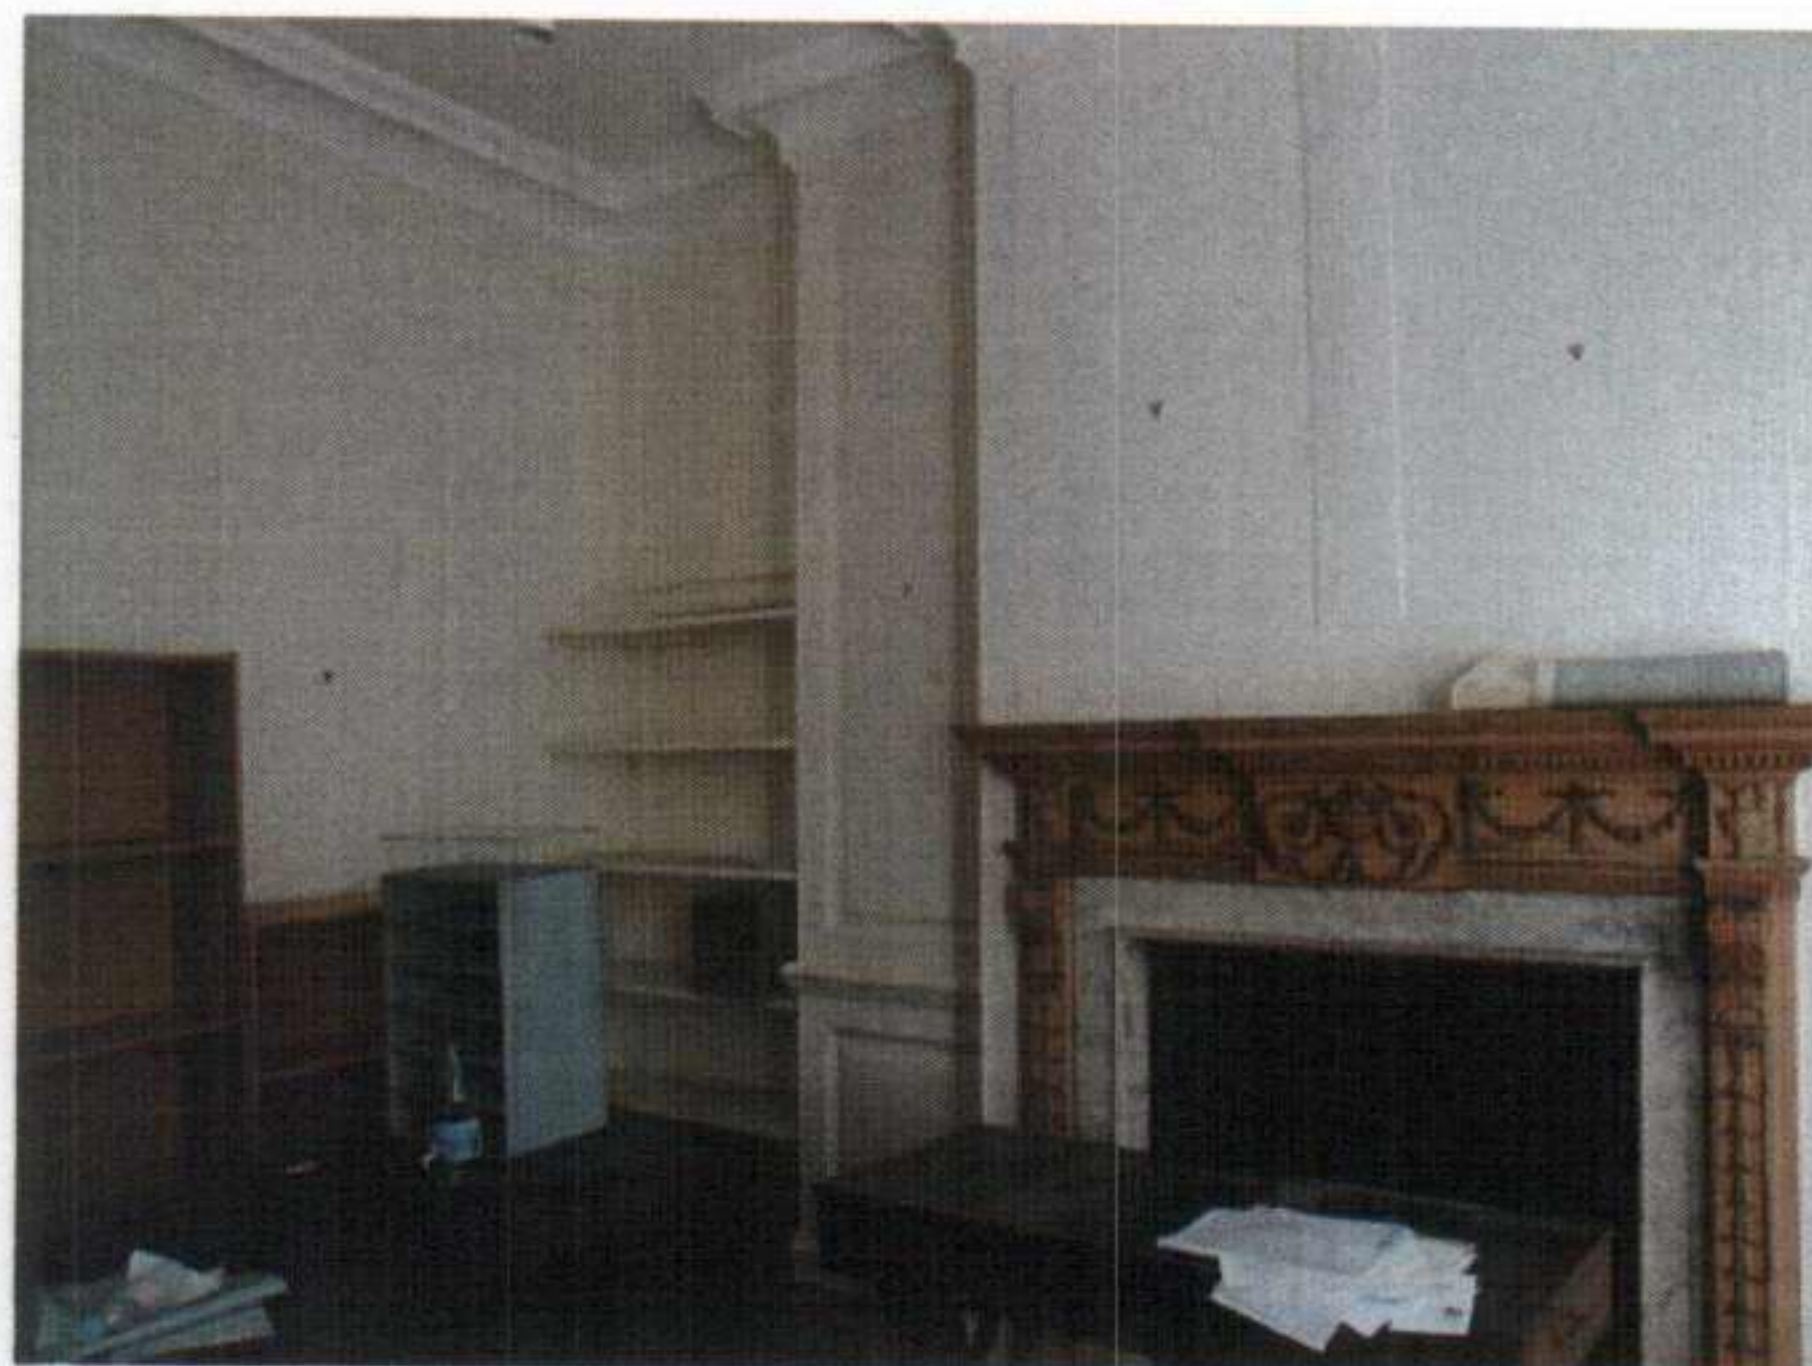
Figure 8  
Fireplace to F4. Party wall and panelling to be reinstated.

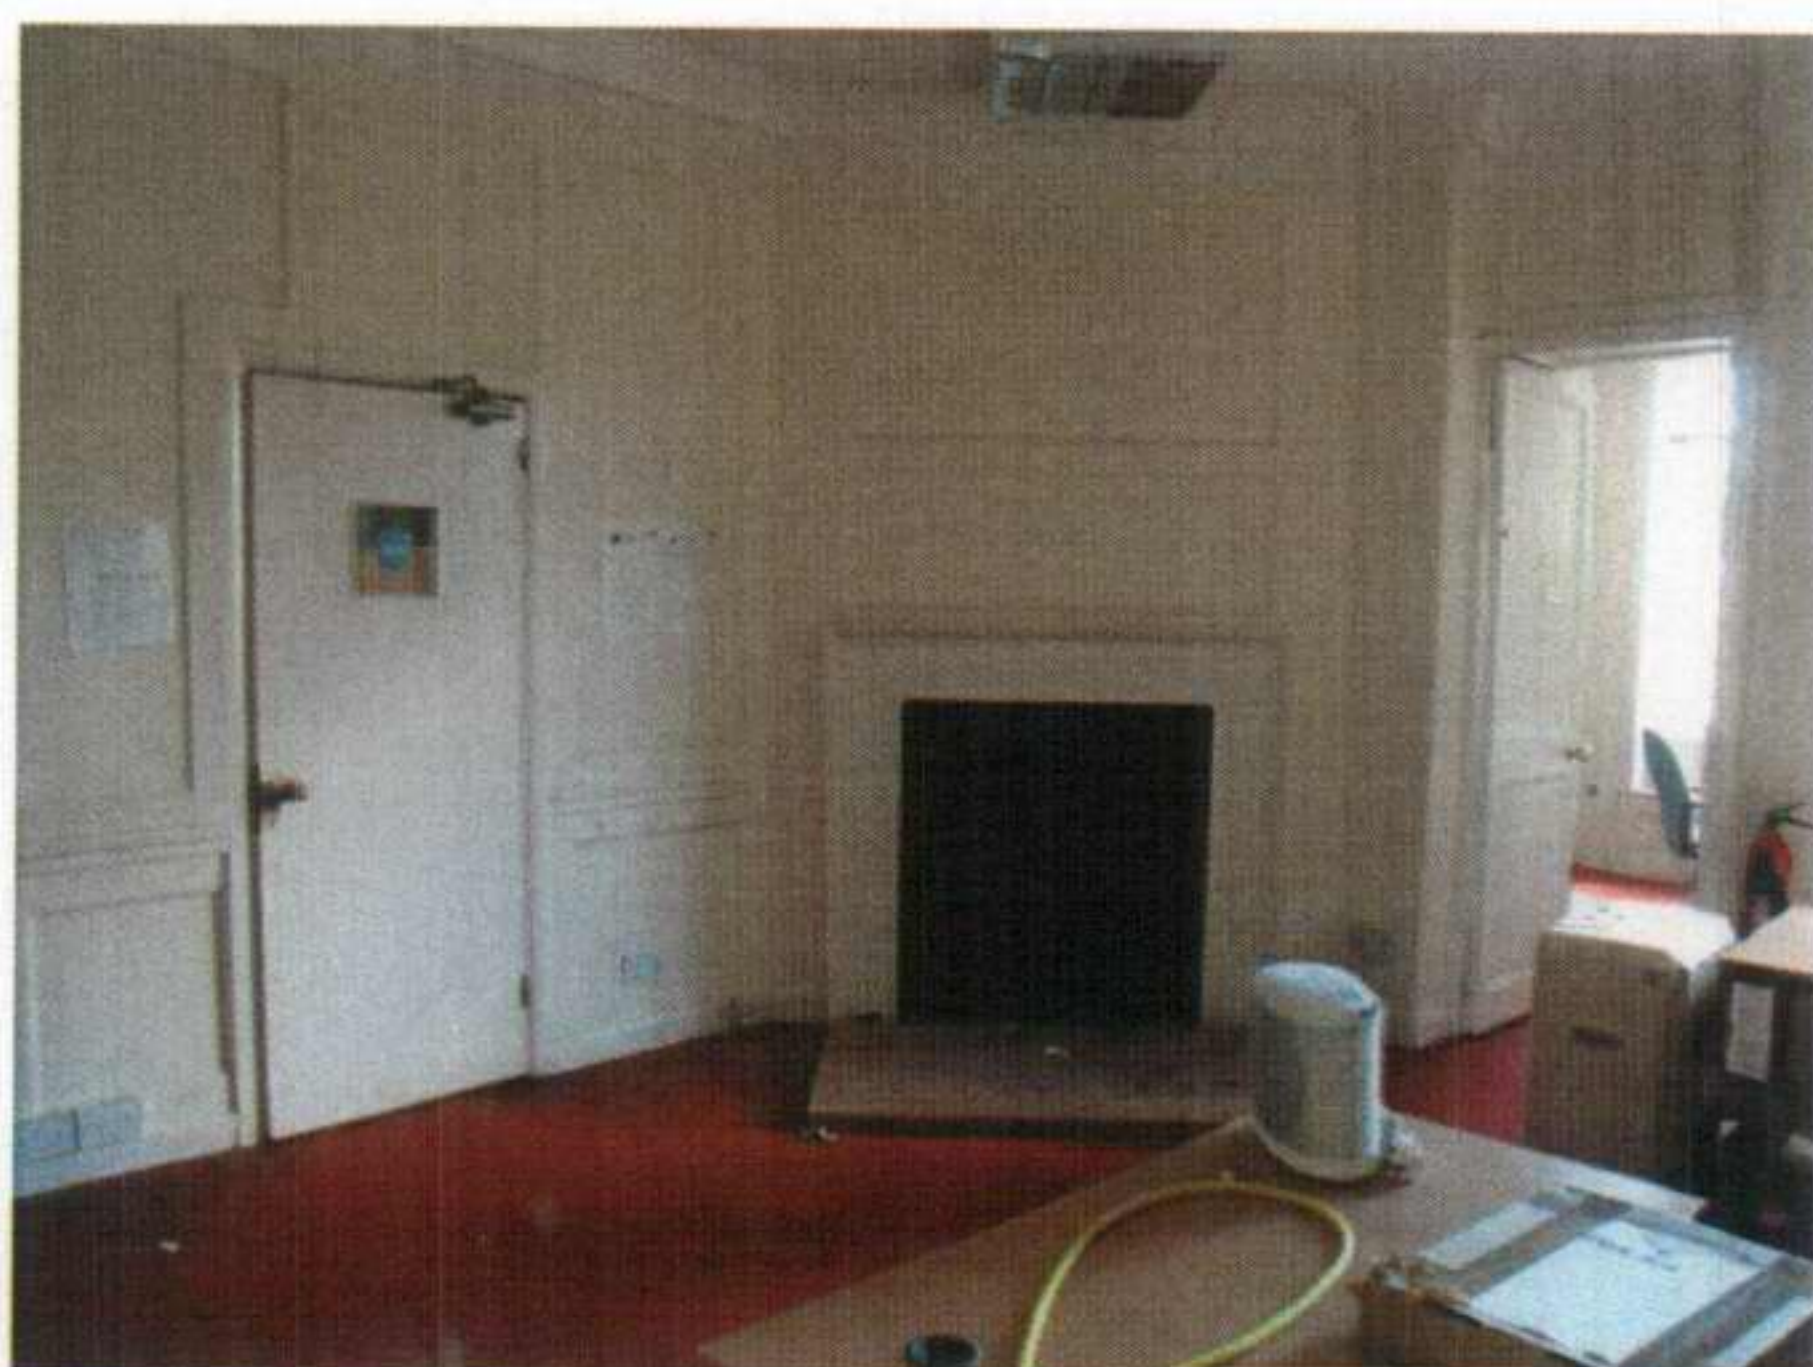
Figure 9  
Room S10. Party wall and panelling to be reinstated.
