## **APPENDIX II PHOTOGRAPHS**

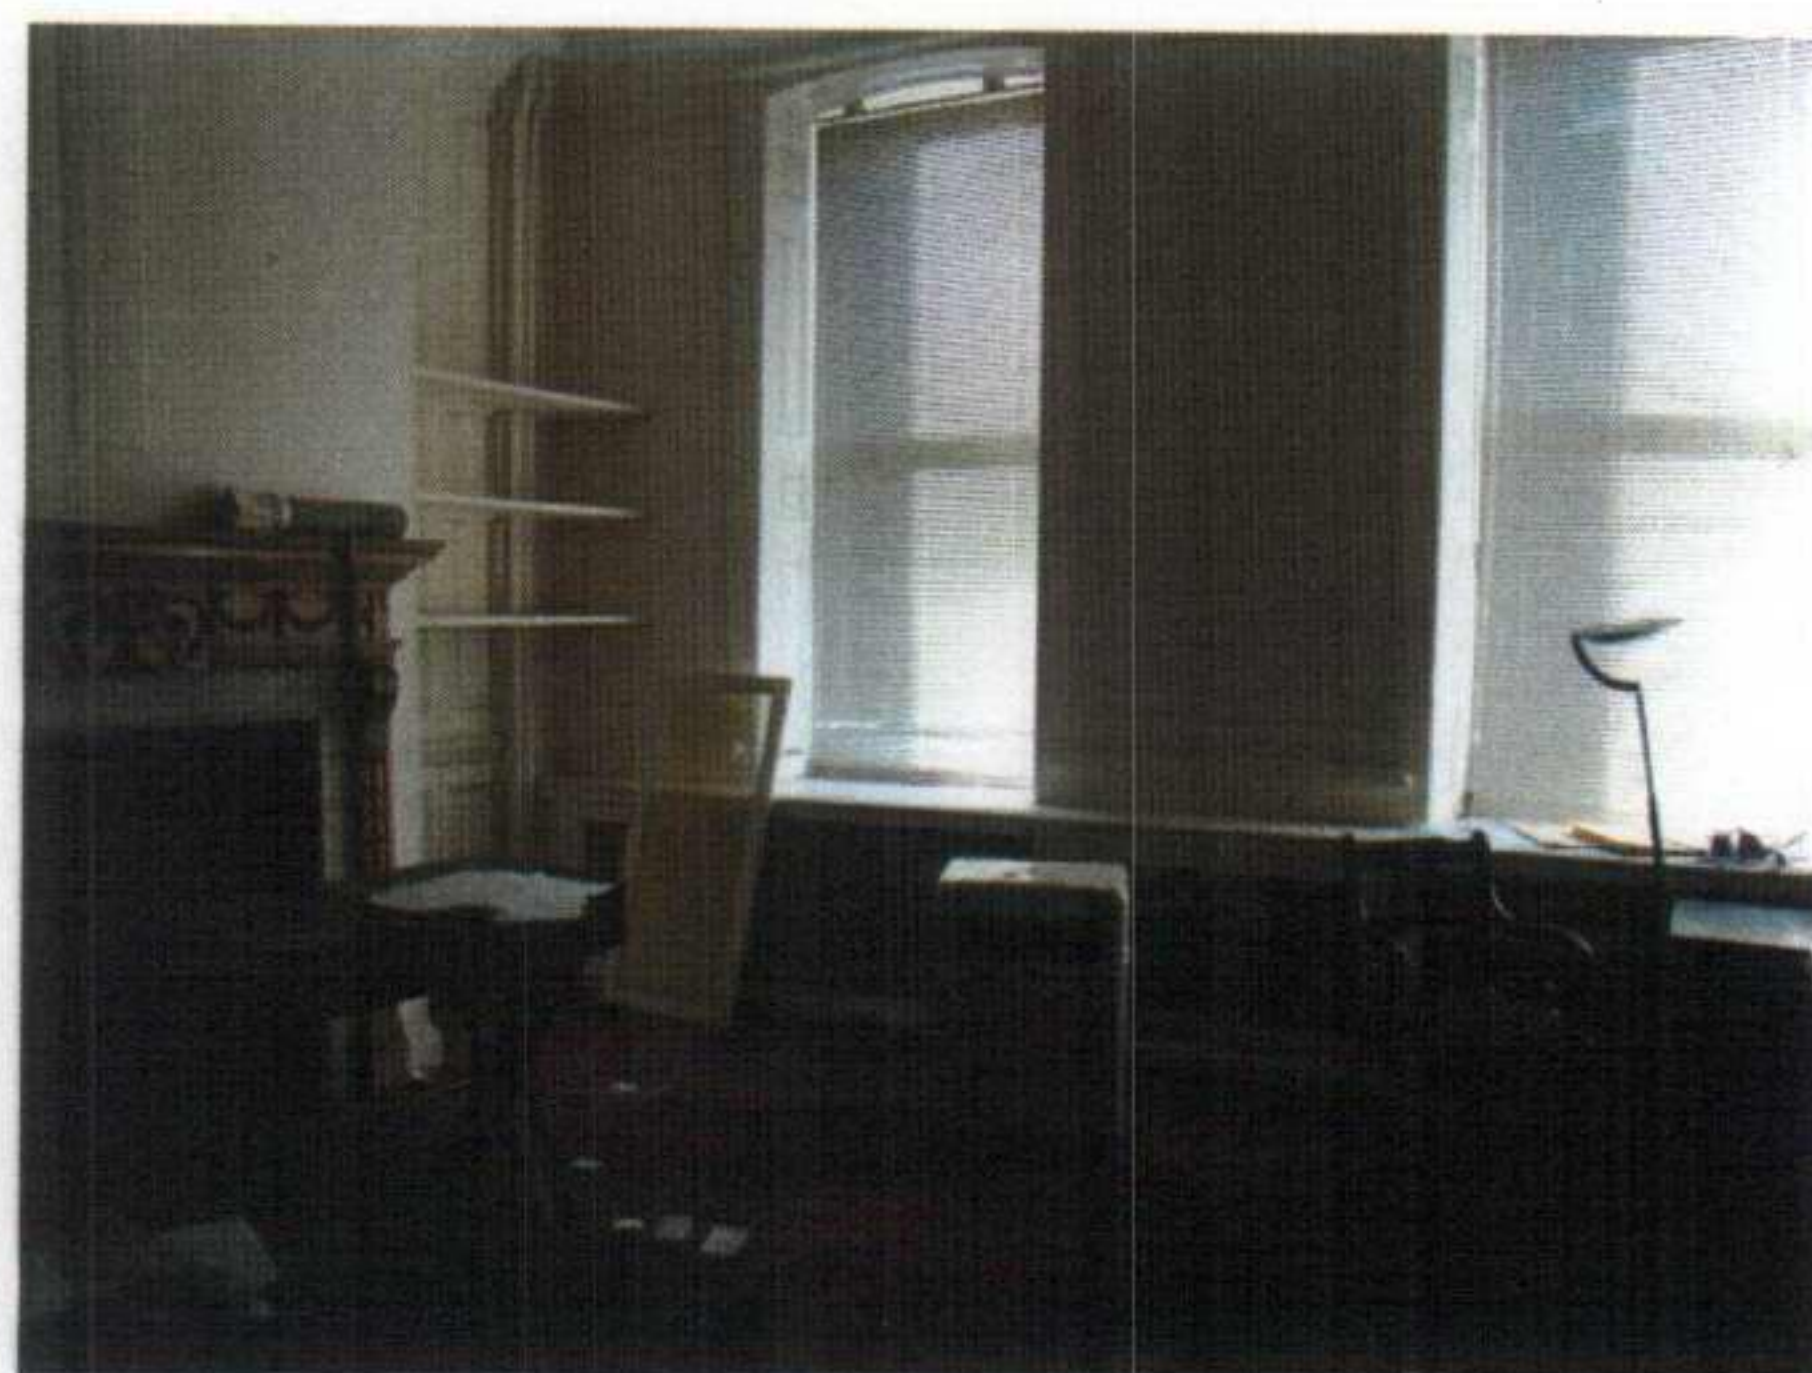
Figure 10  
Room F4, heating pipes to be re-routed within risers. Radiator casings to be removed.

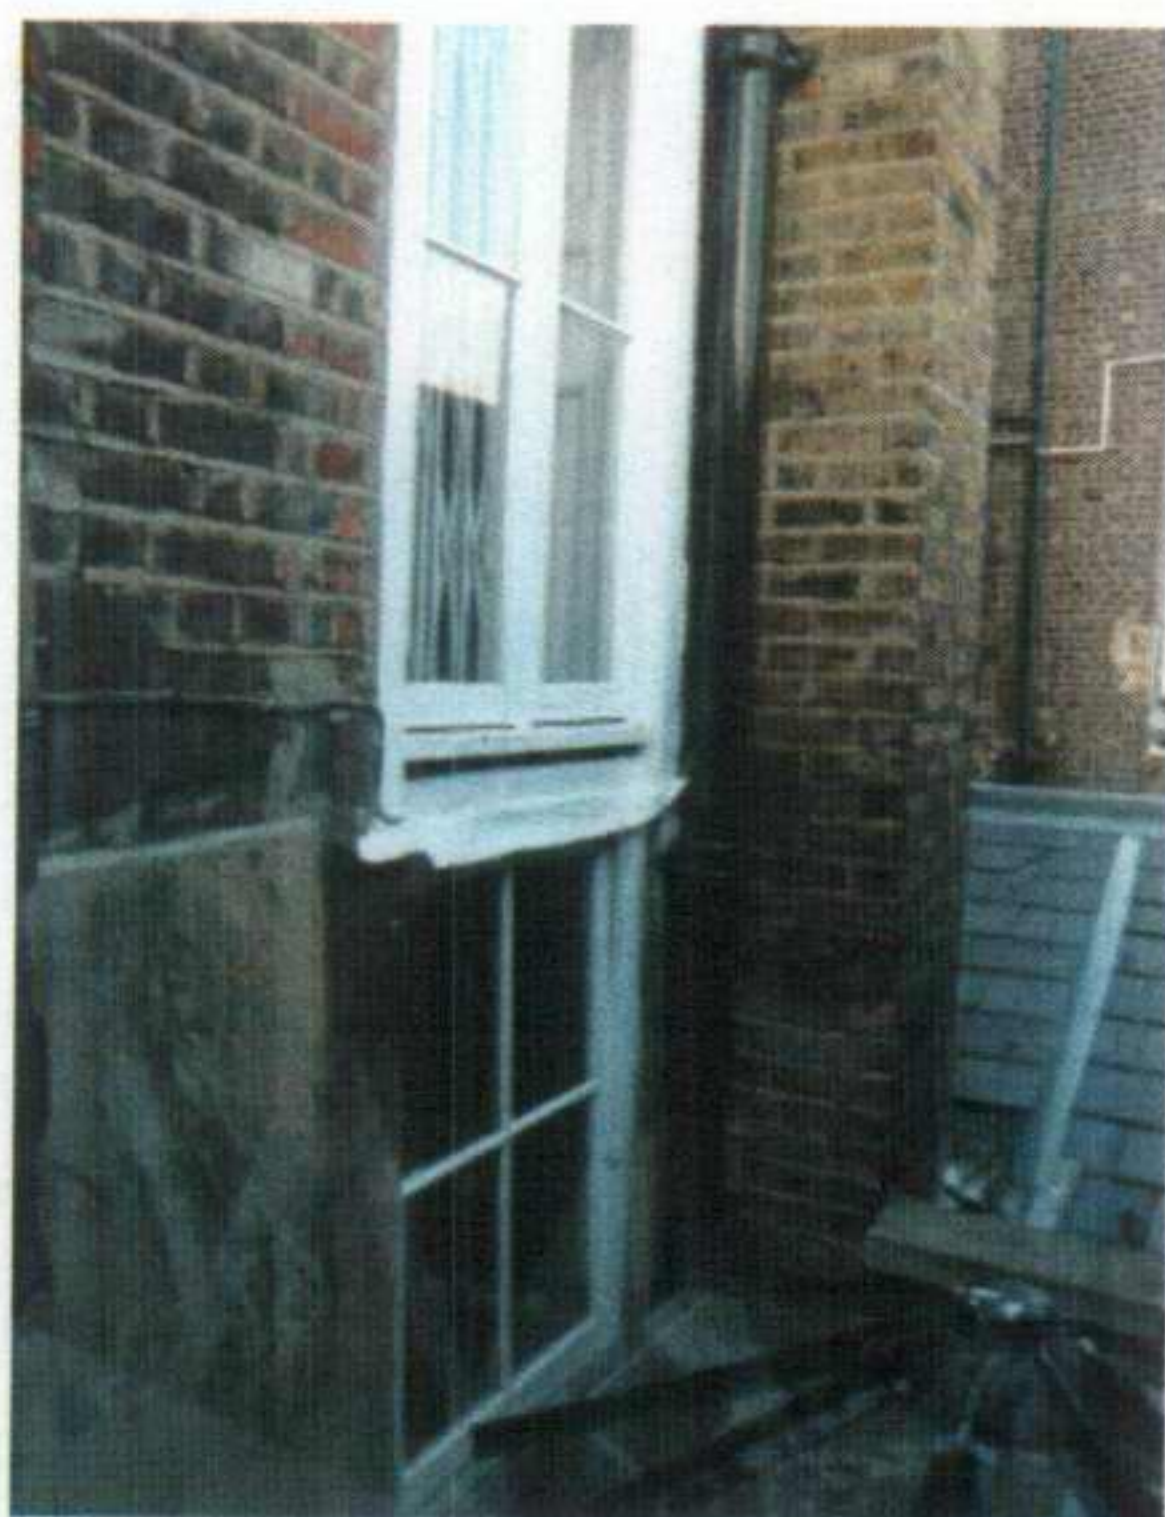
Figure 11  
Window alterations to rear of no.12. Low level window to remain, new sash window to upper level. Render to be carefully removed

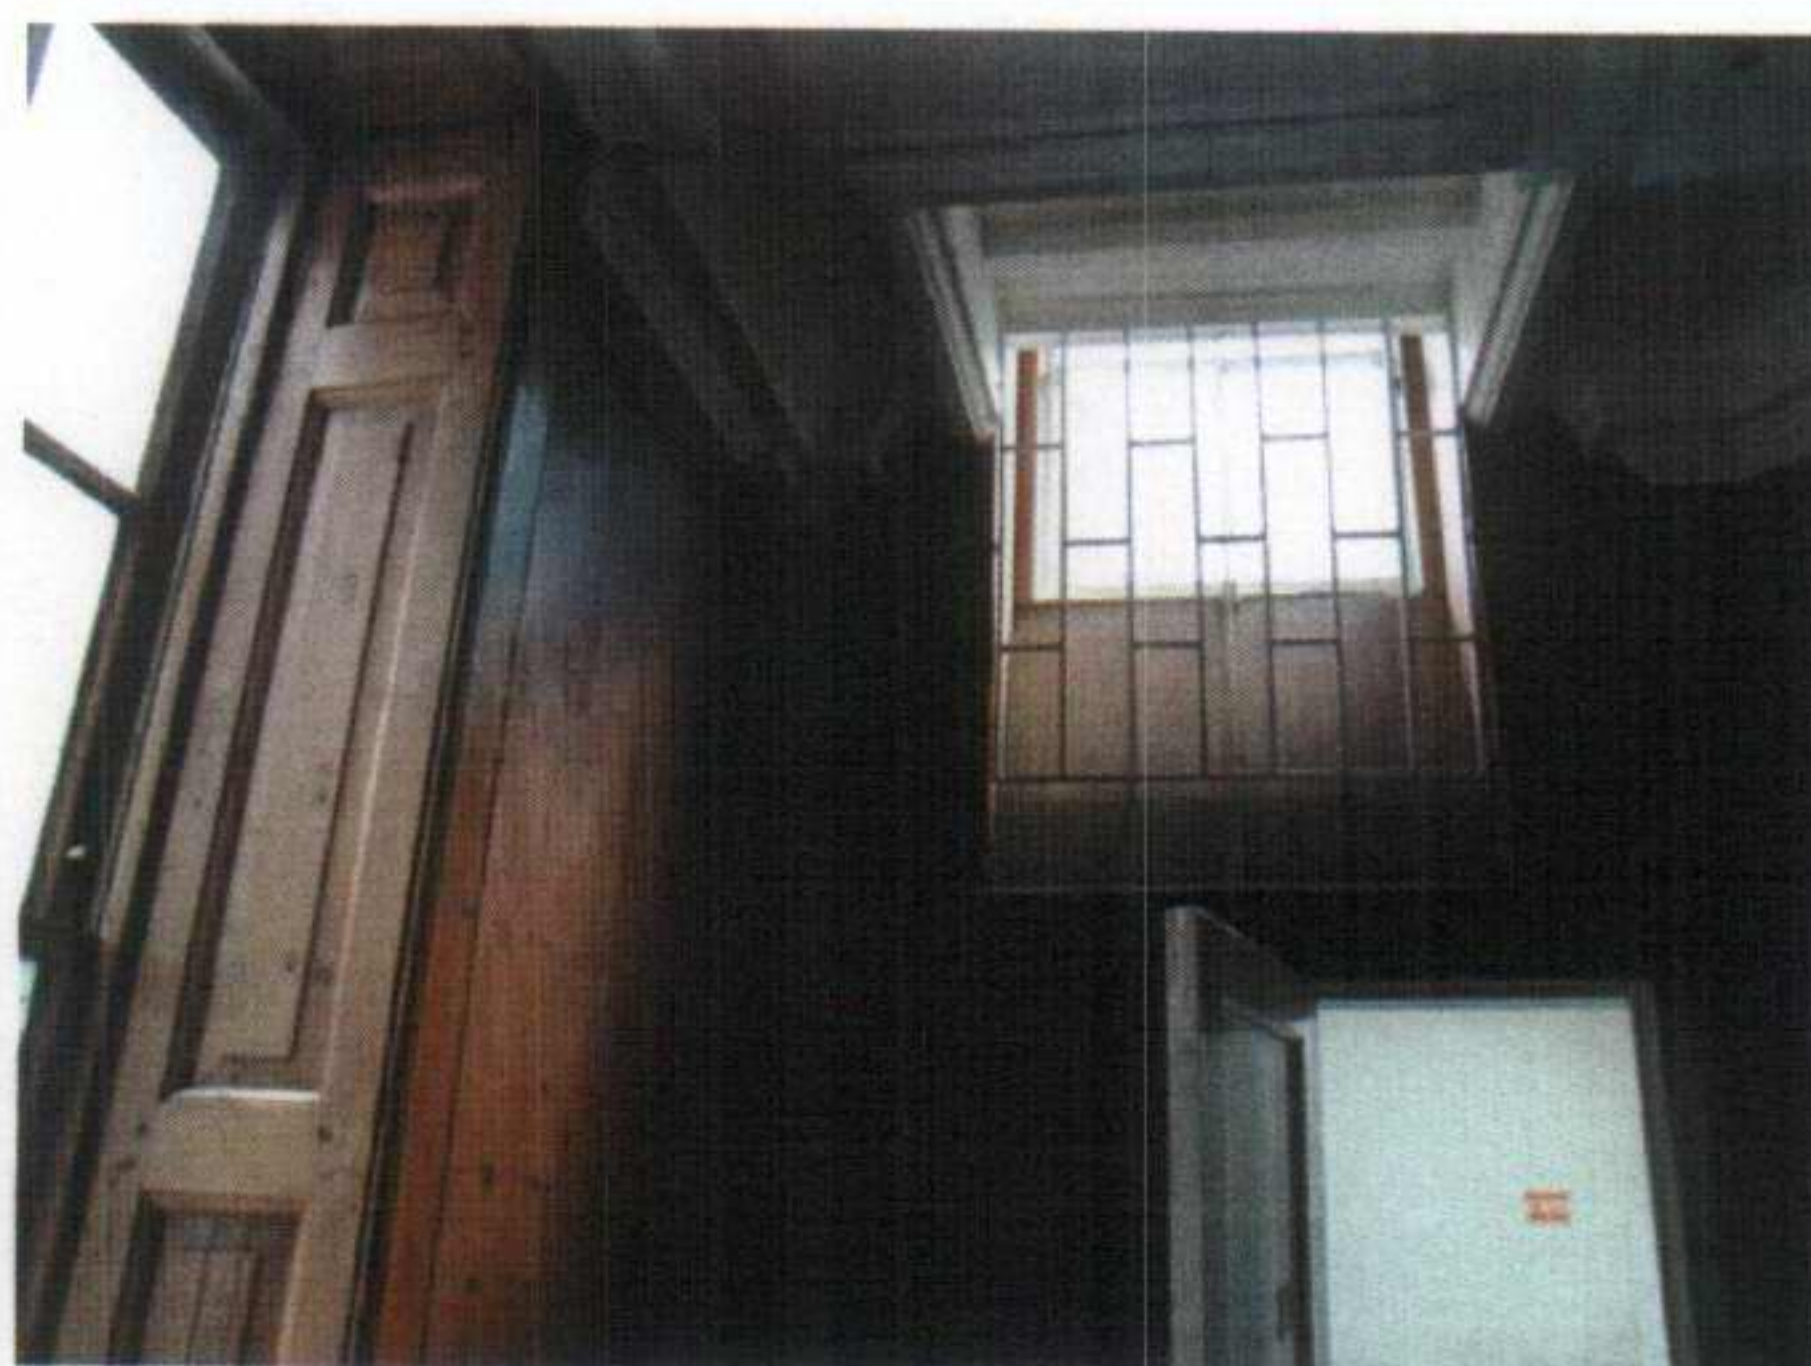
Figure 12  
Interior of Figure 11 showing upper level window and gib door below.

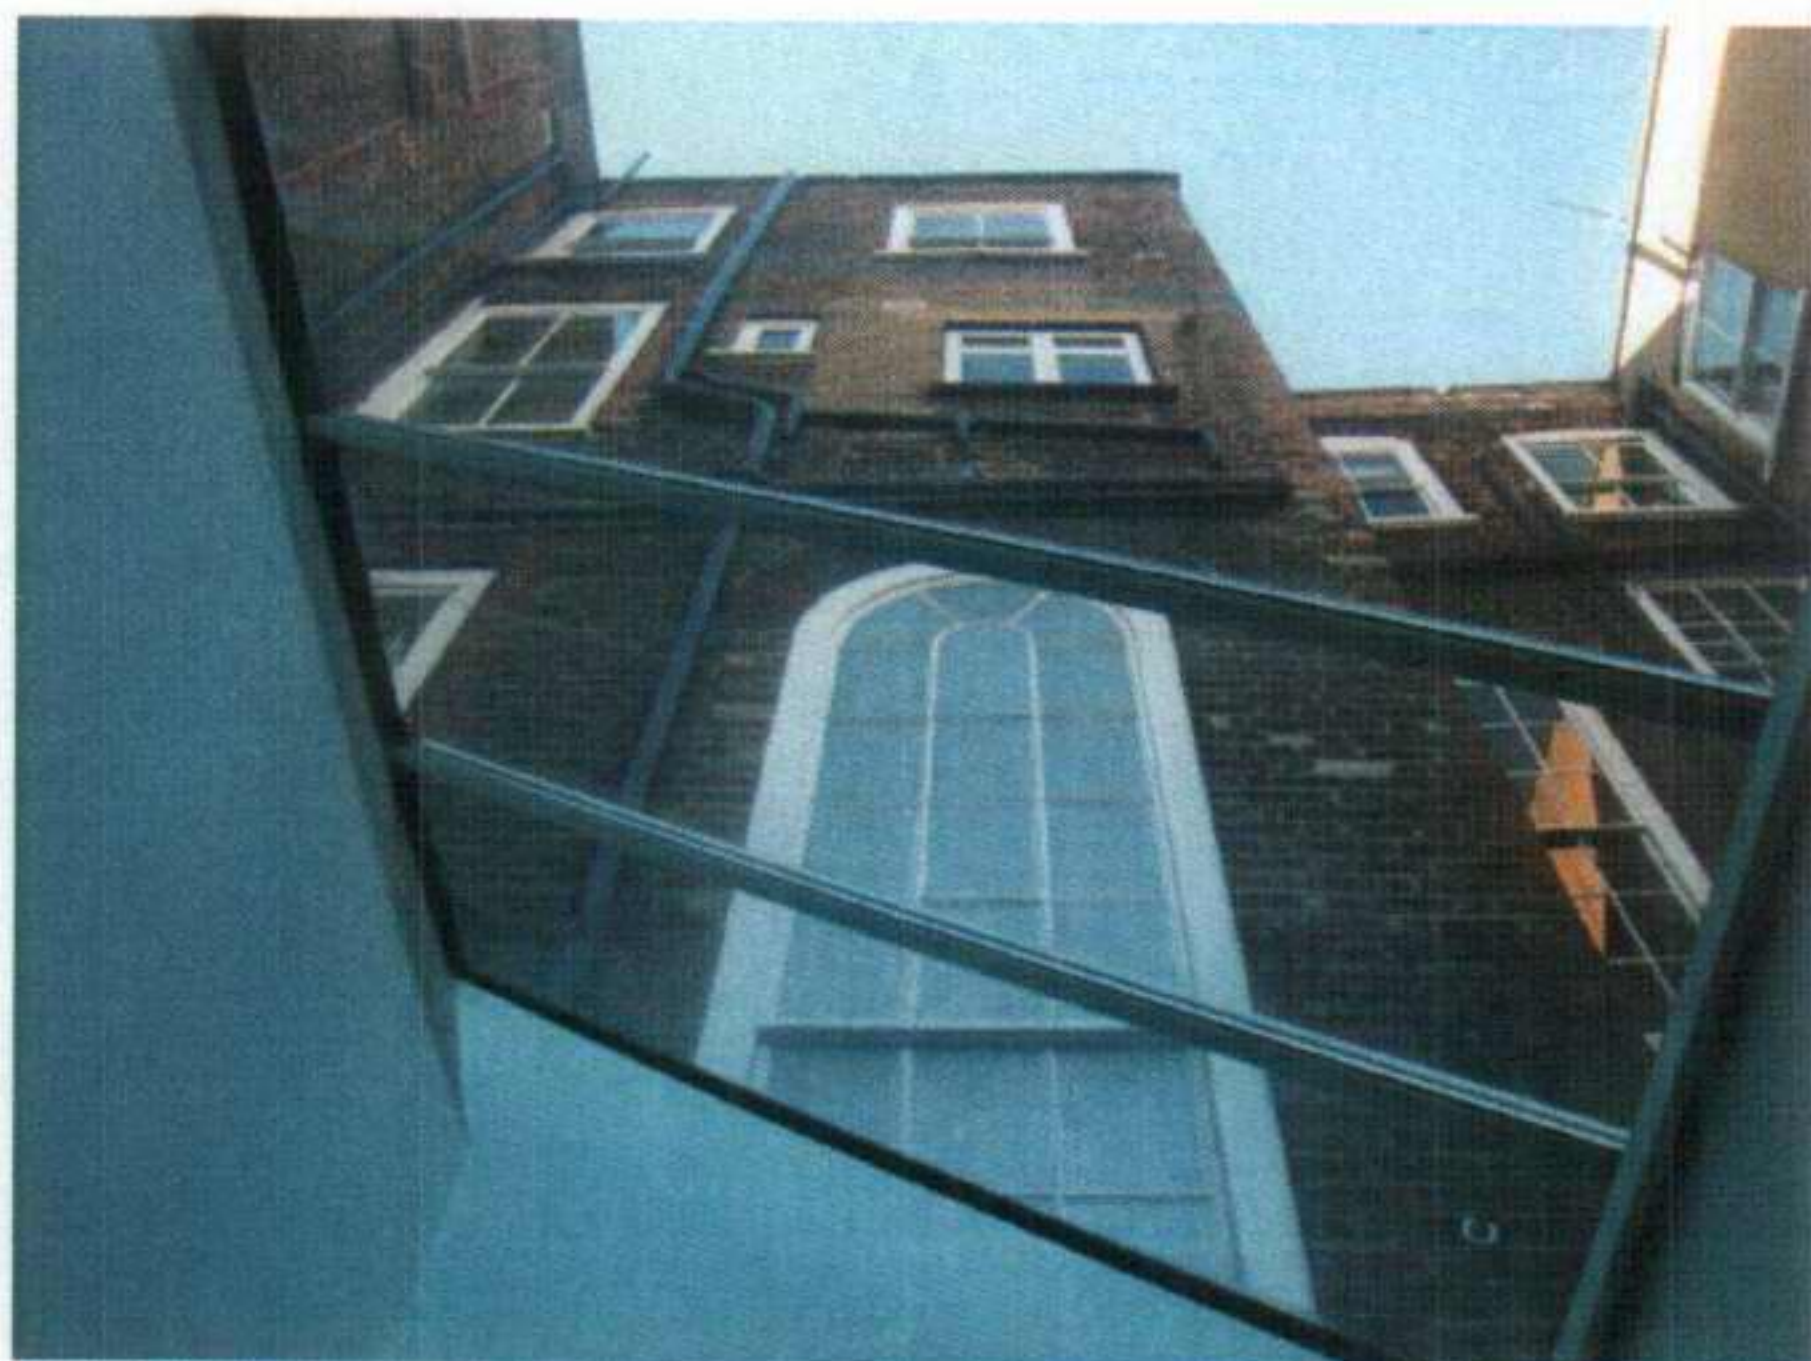
Figure 13  
Rear elevation to no.12 showing existing arched window to stair and window alterations above. Original window configuration to be reinstated.

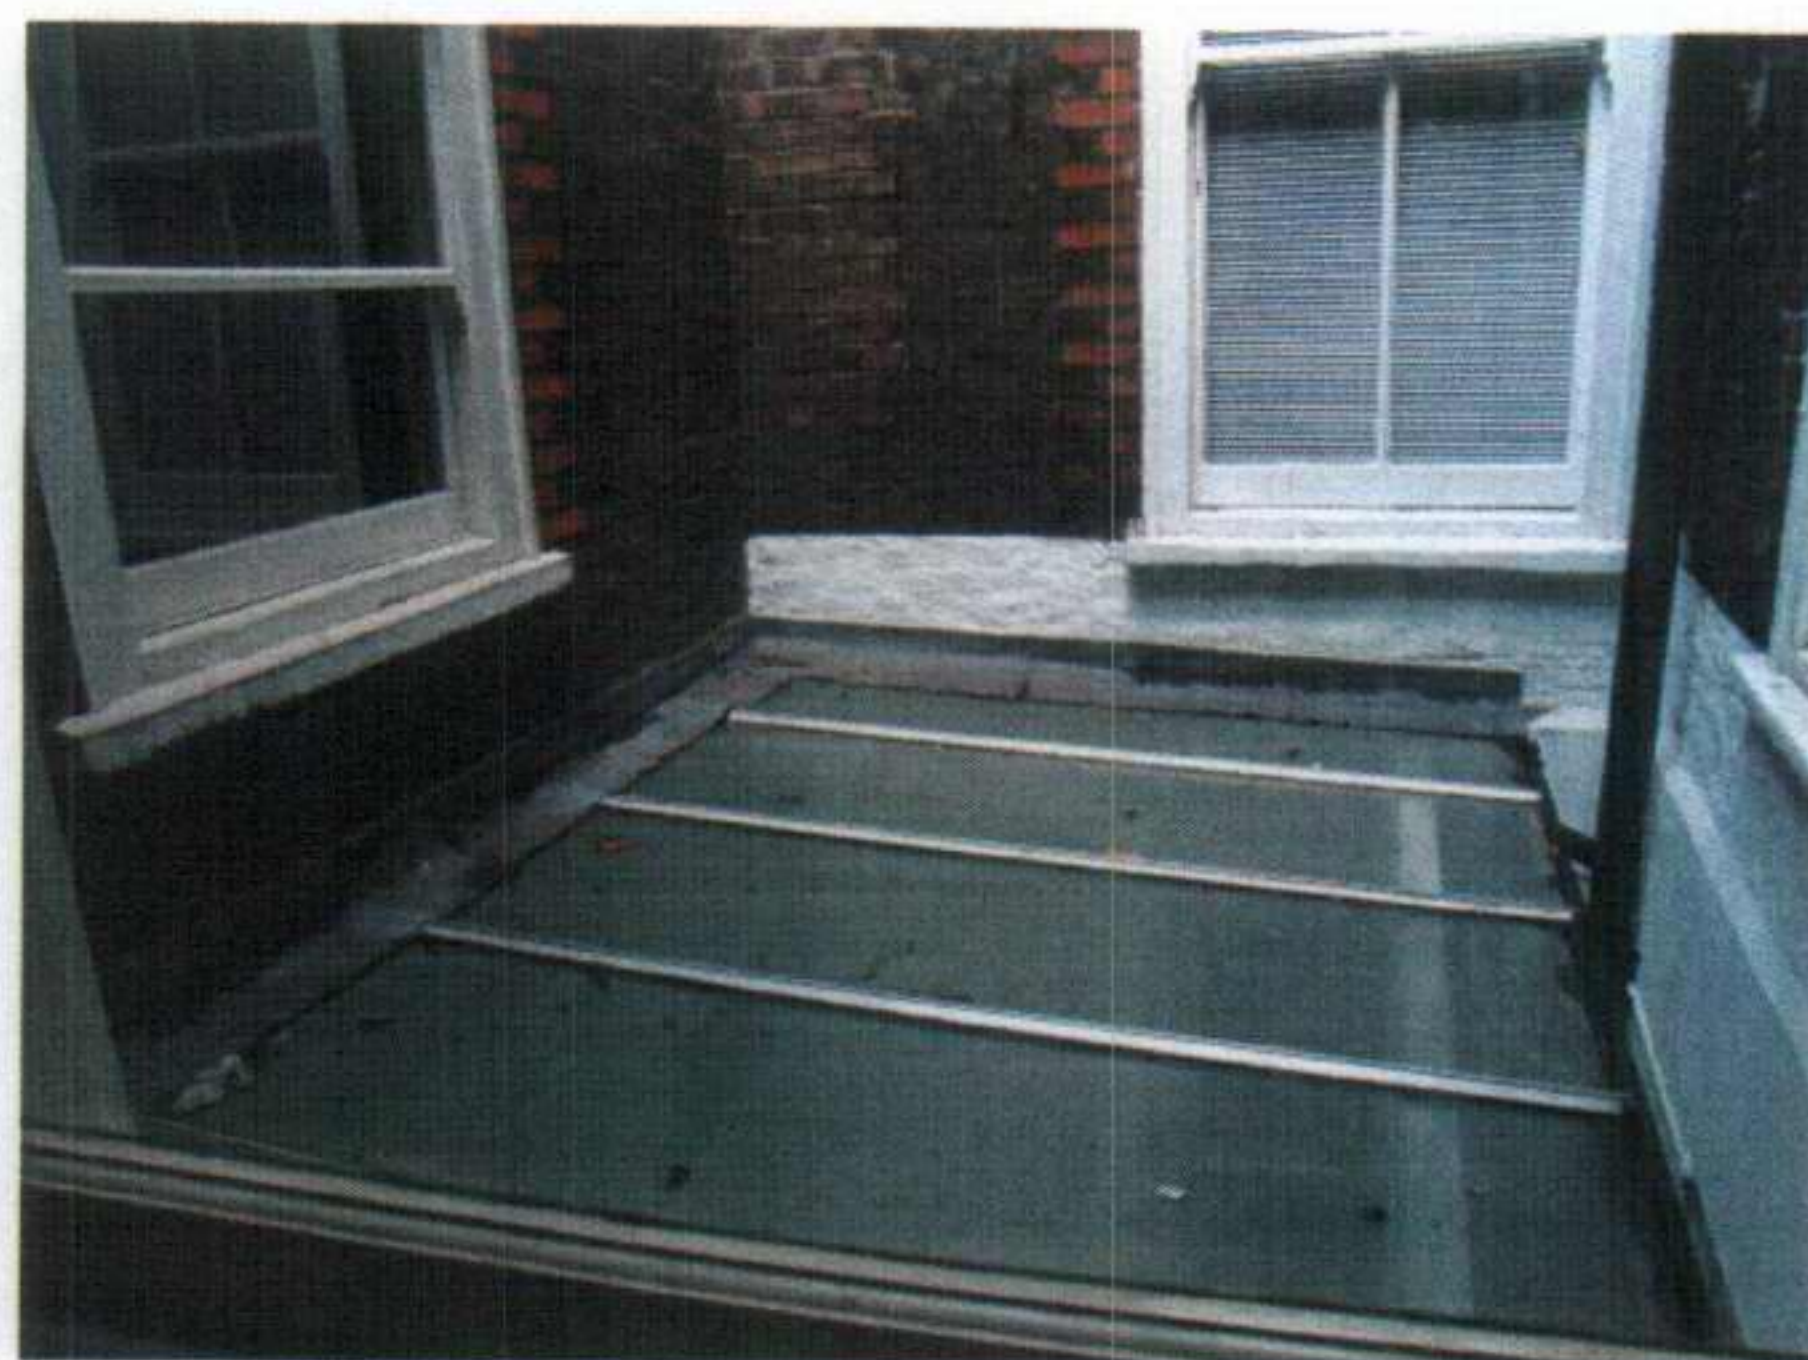
Figure 14  
Remove glazed roof to existing lightwell to no.11

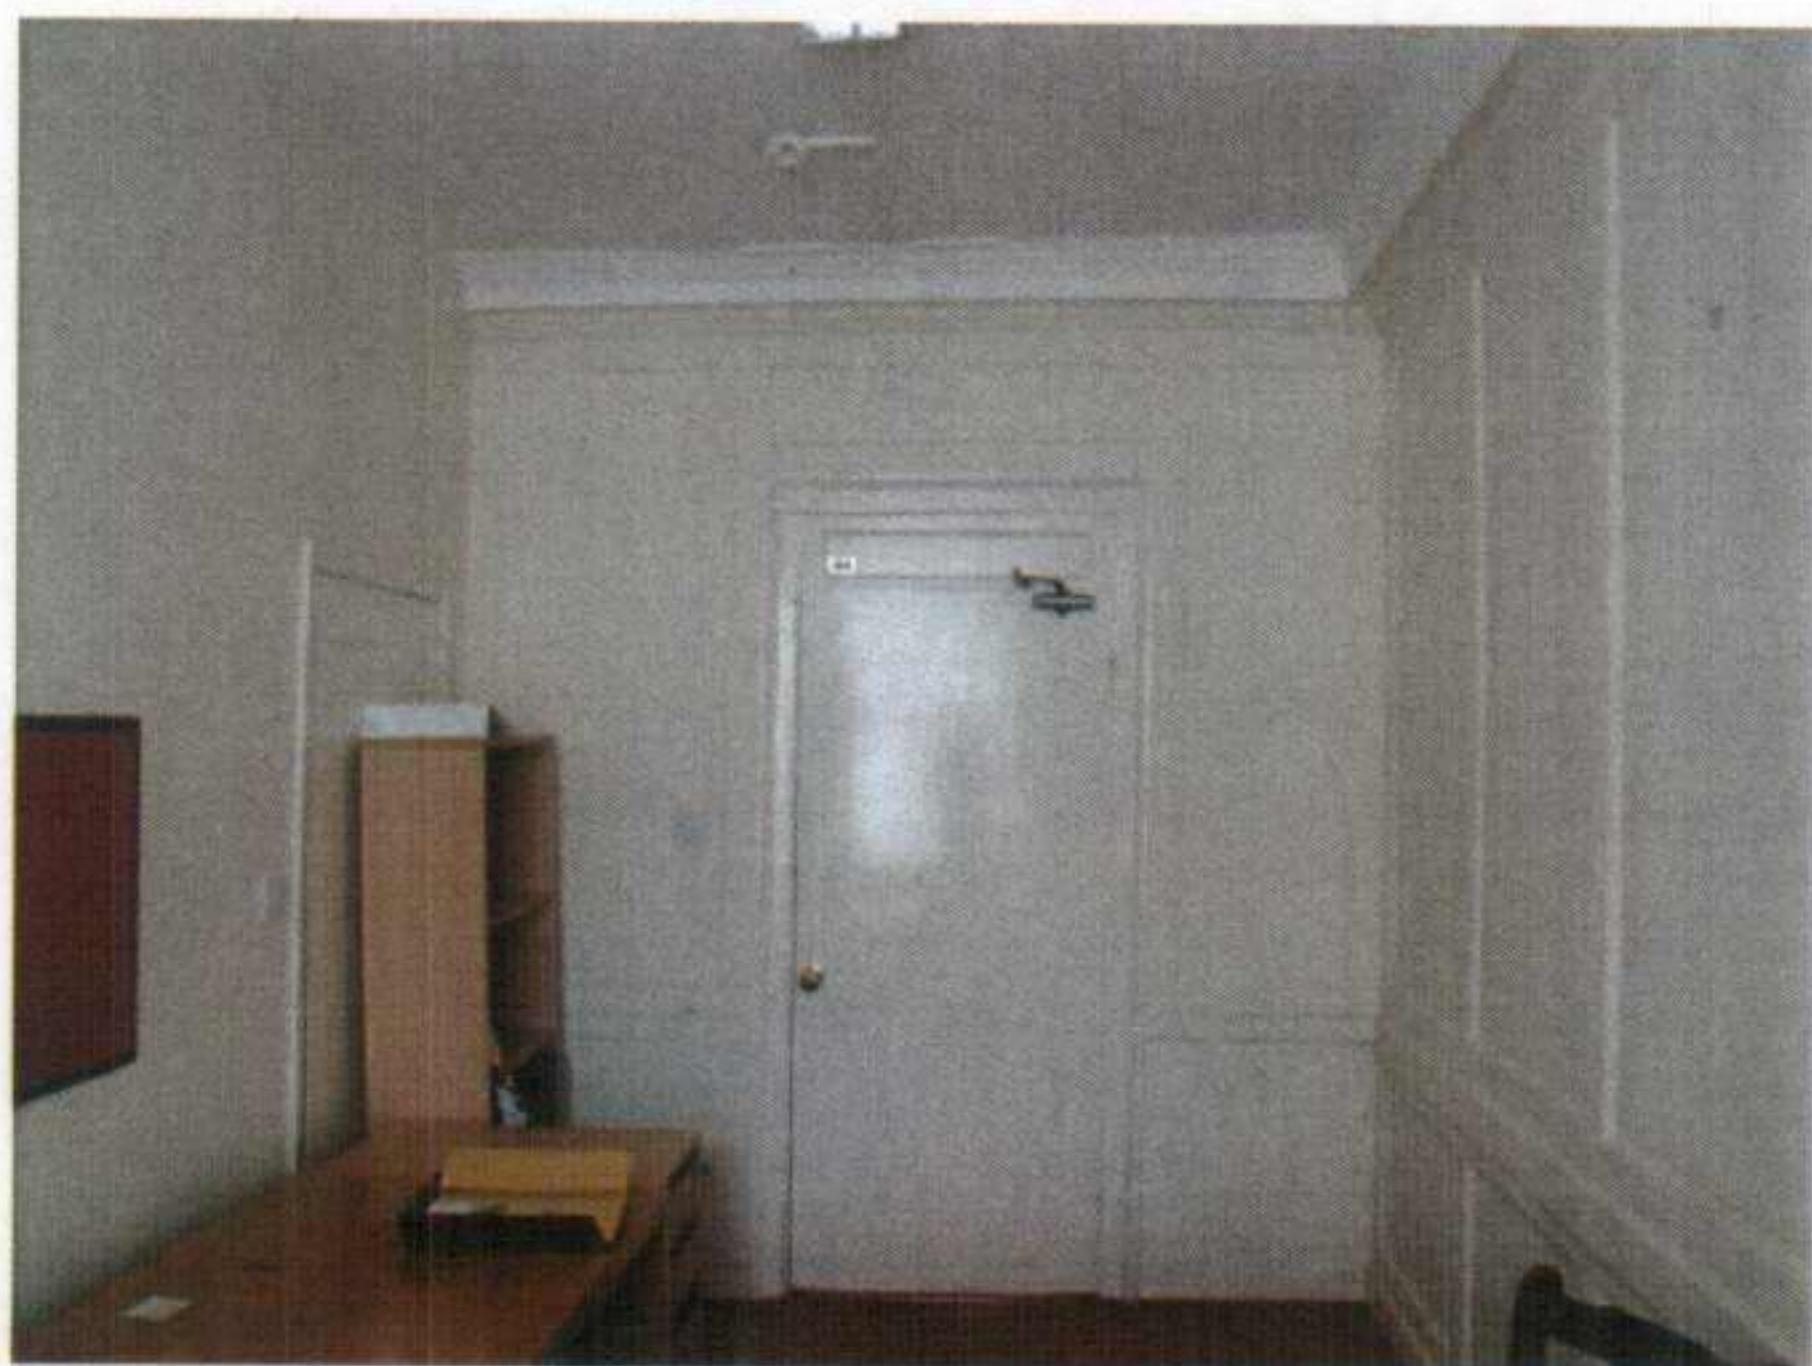
Figure 15  
S12, part of existing modern partition to remain to form bathroom. No panels below dado on doorway wall and doorway altered. Modern panelling to wall on RHS of photo

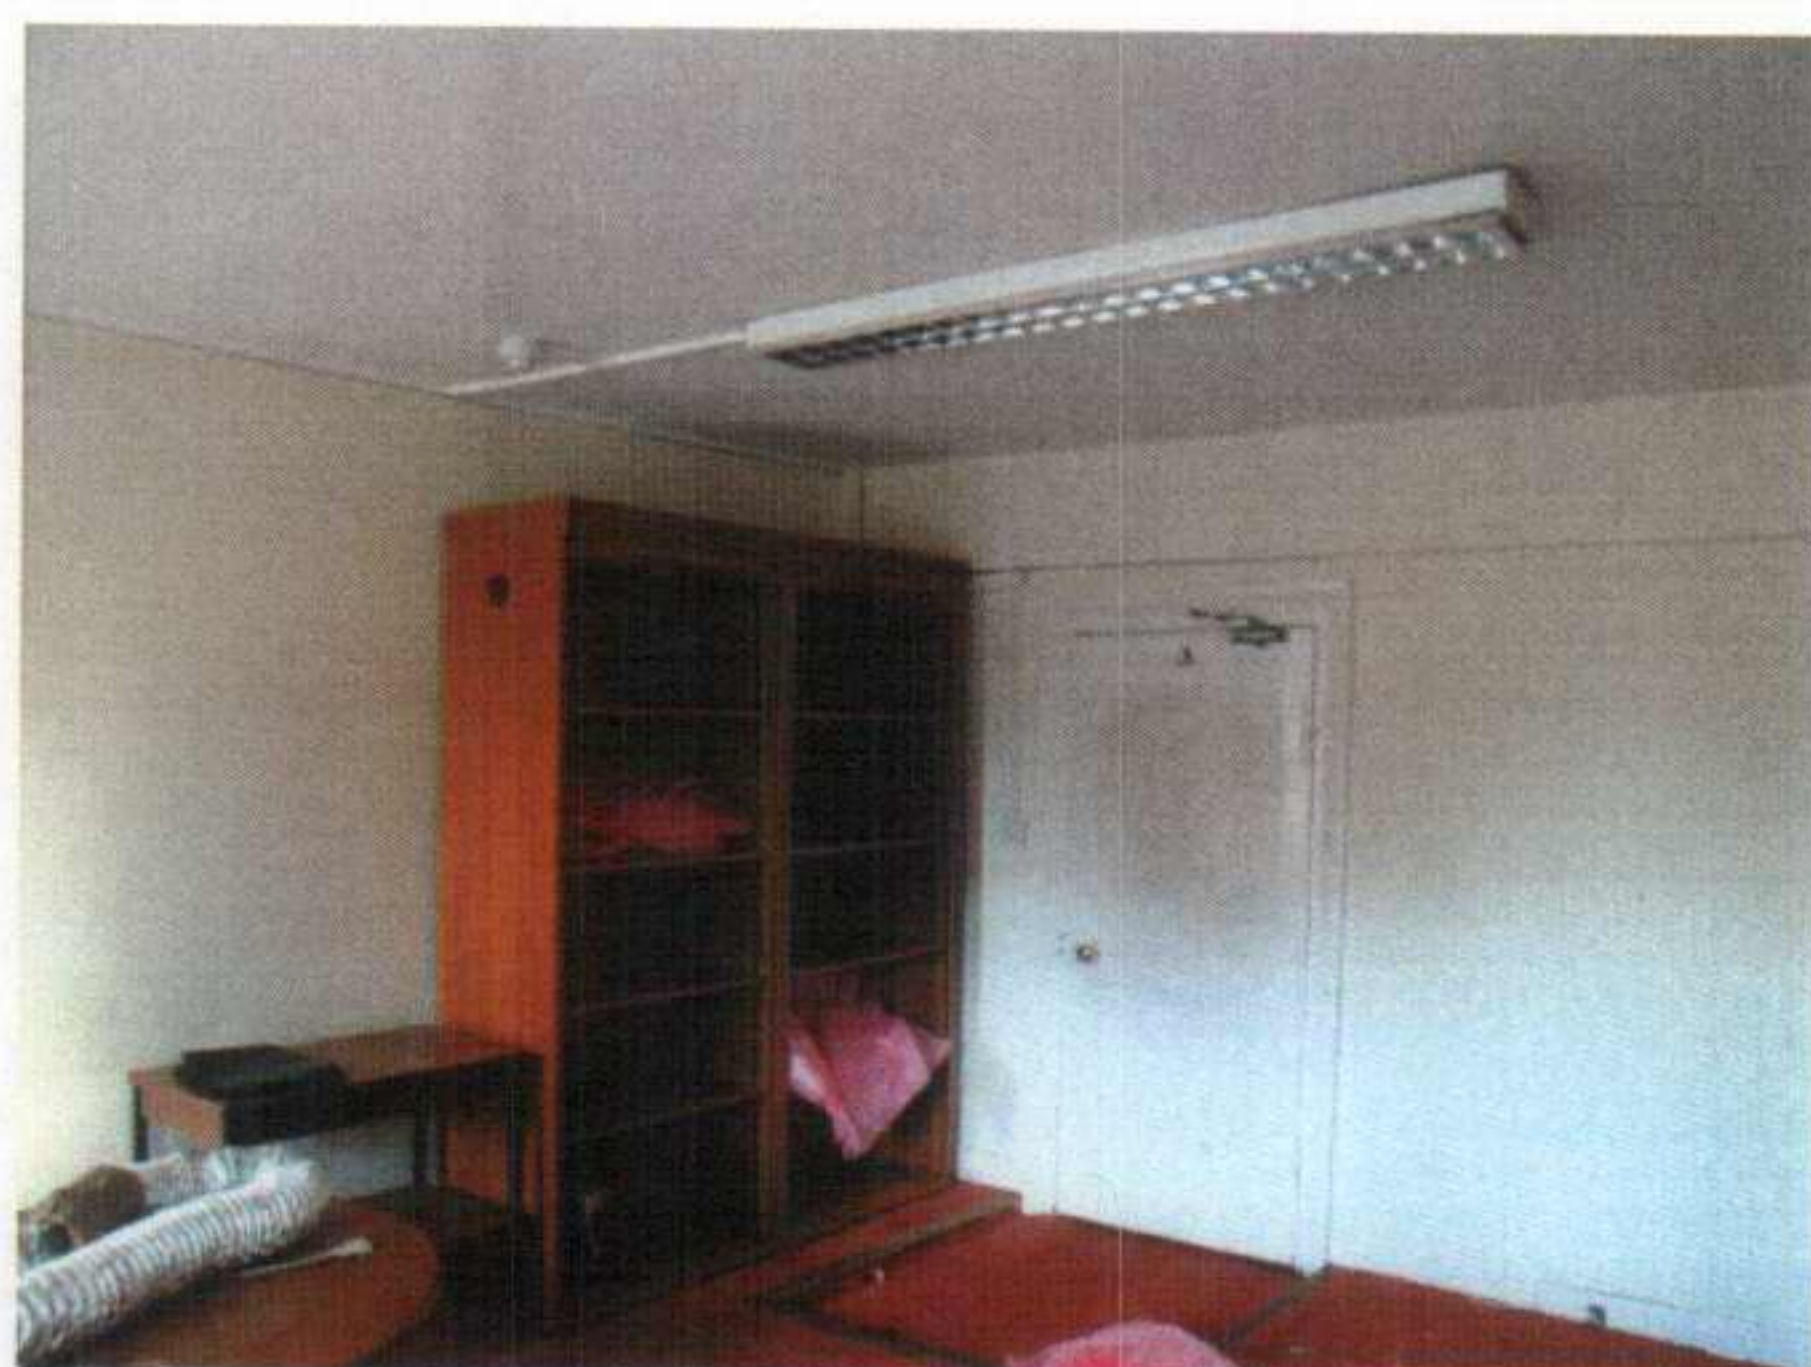
Figure 16  
Room T3 showing raised floor.

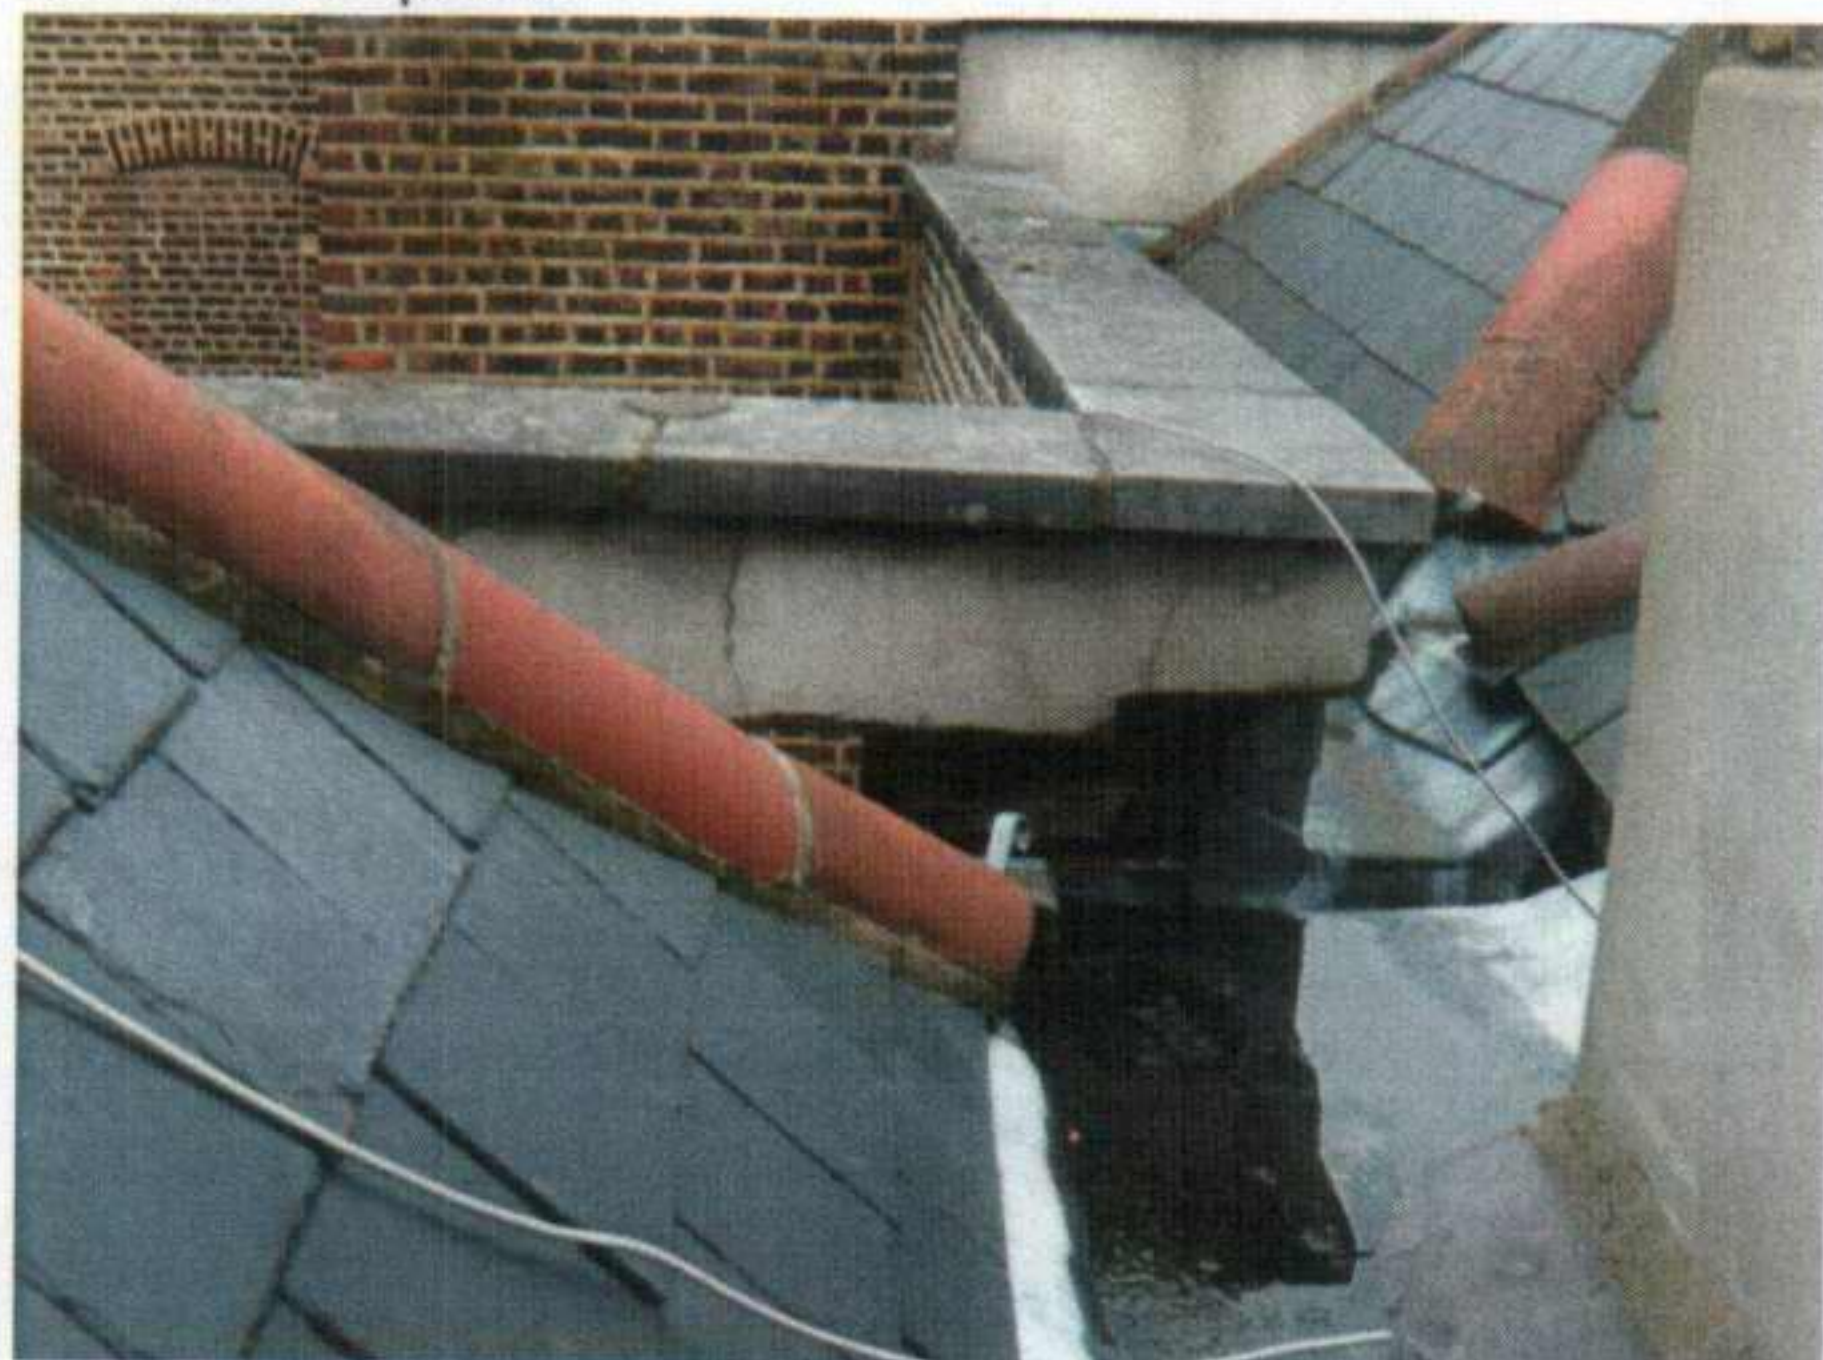
Figure 17  
Parapet repairs to be carried out.

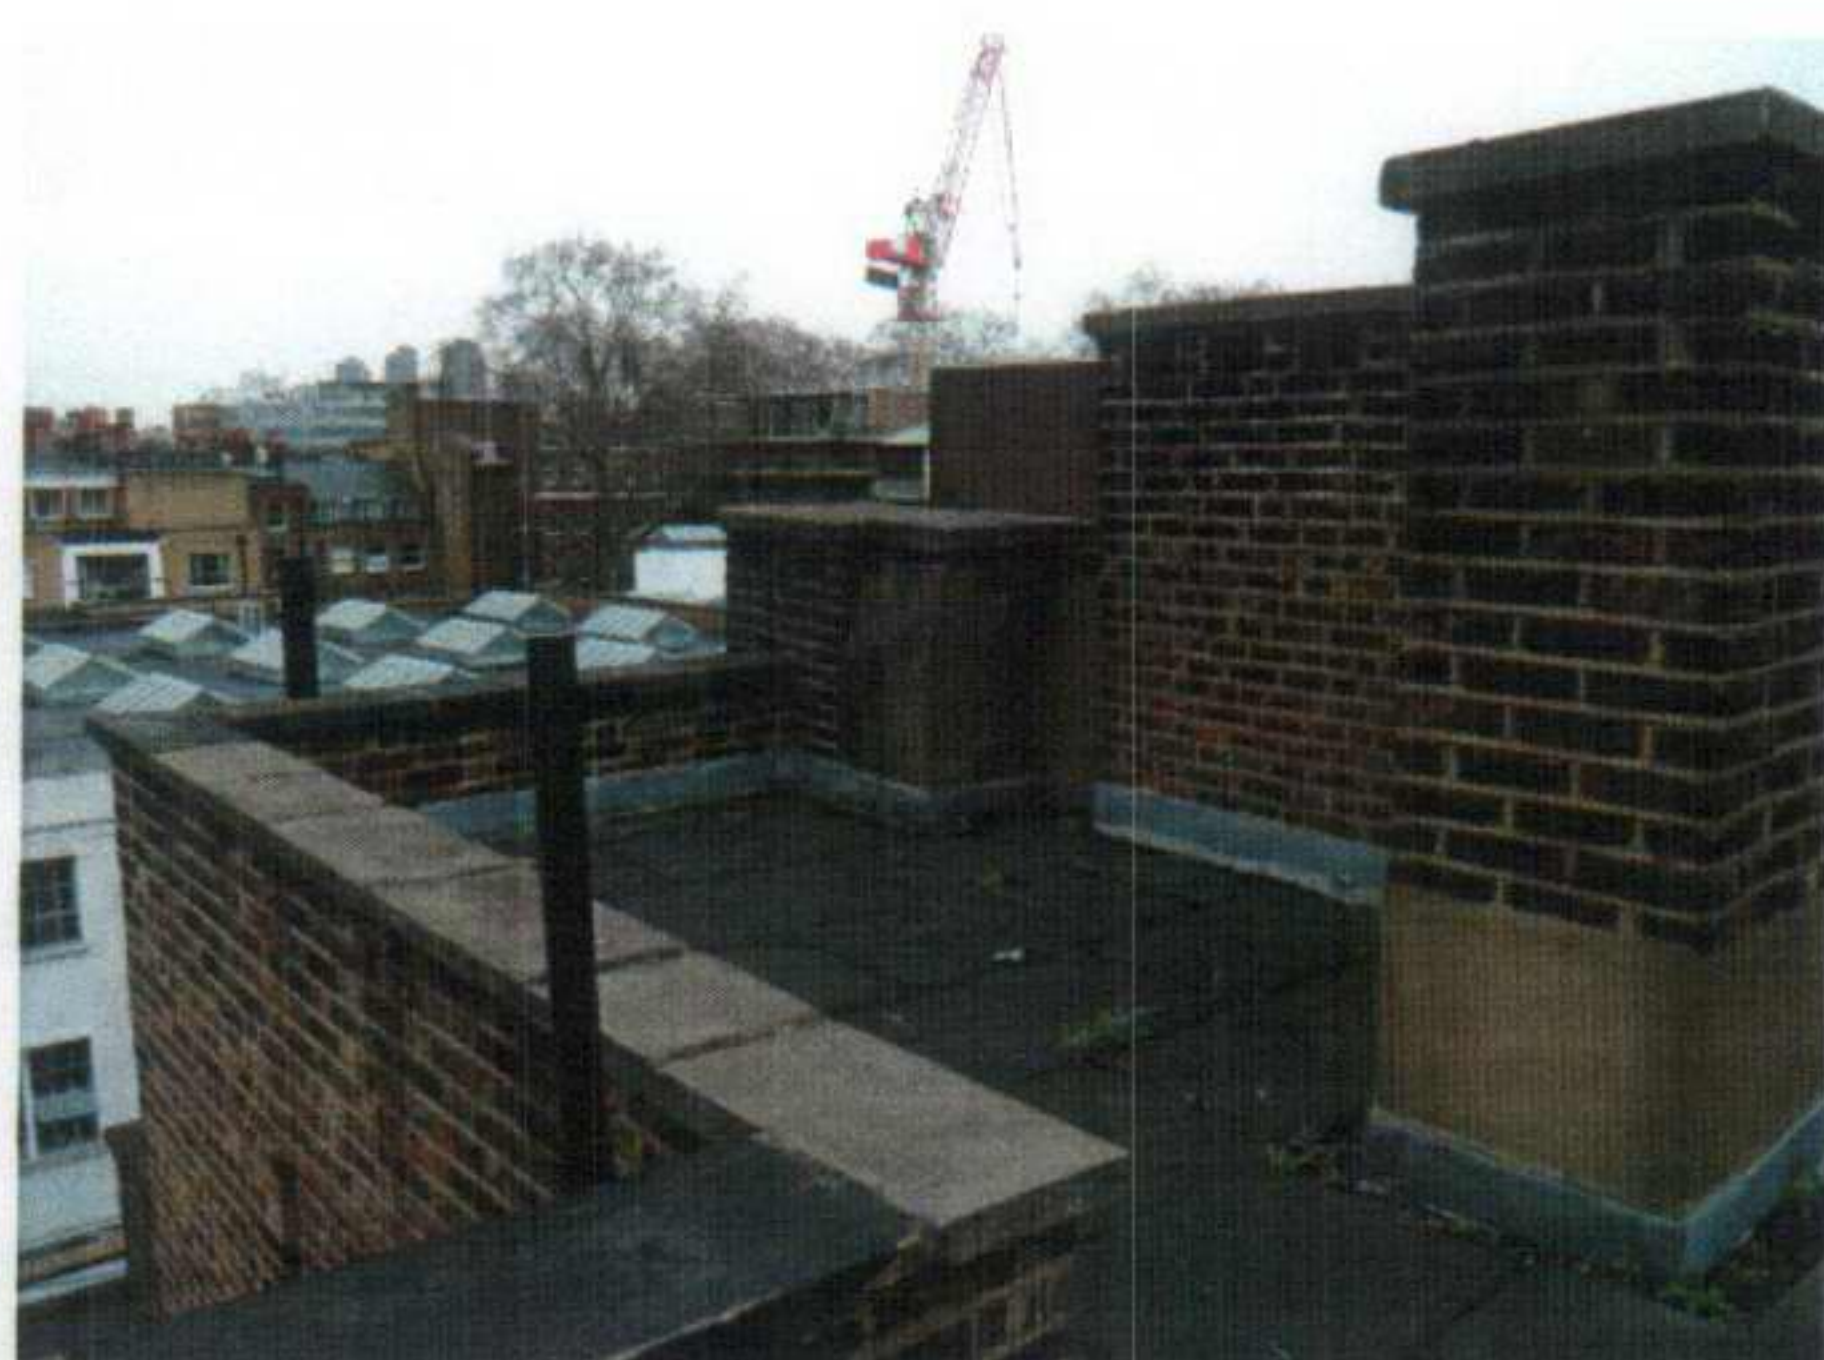
Figure 18  
Previous refurbishment to roof of no. 12
