## **APPENDIX II PHOTOGRAPHS**

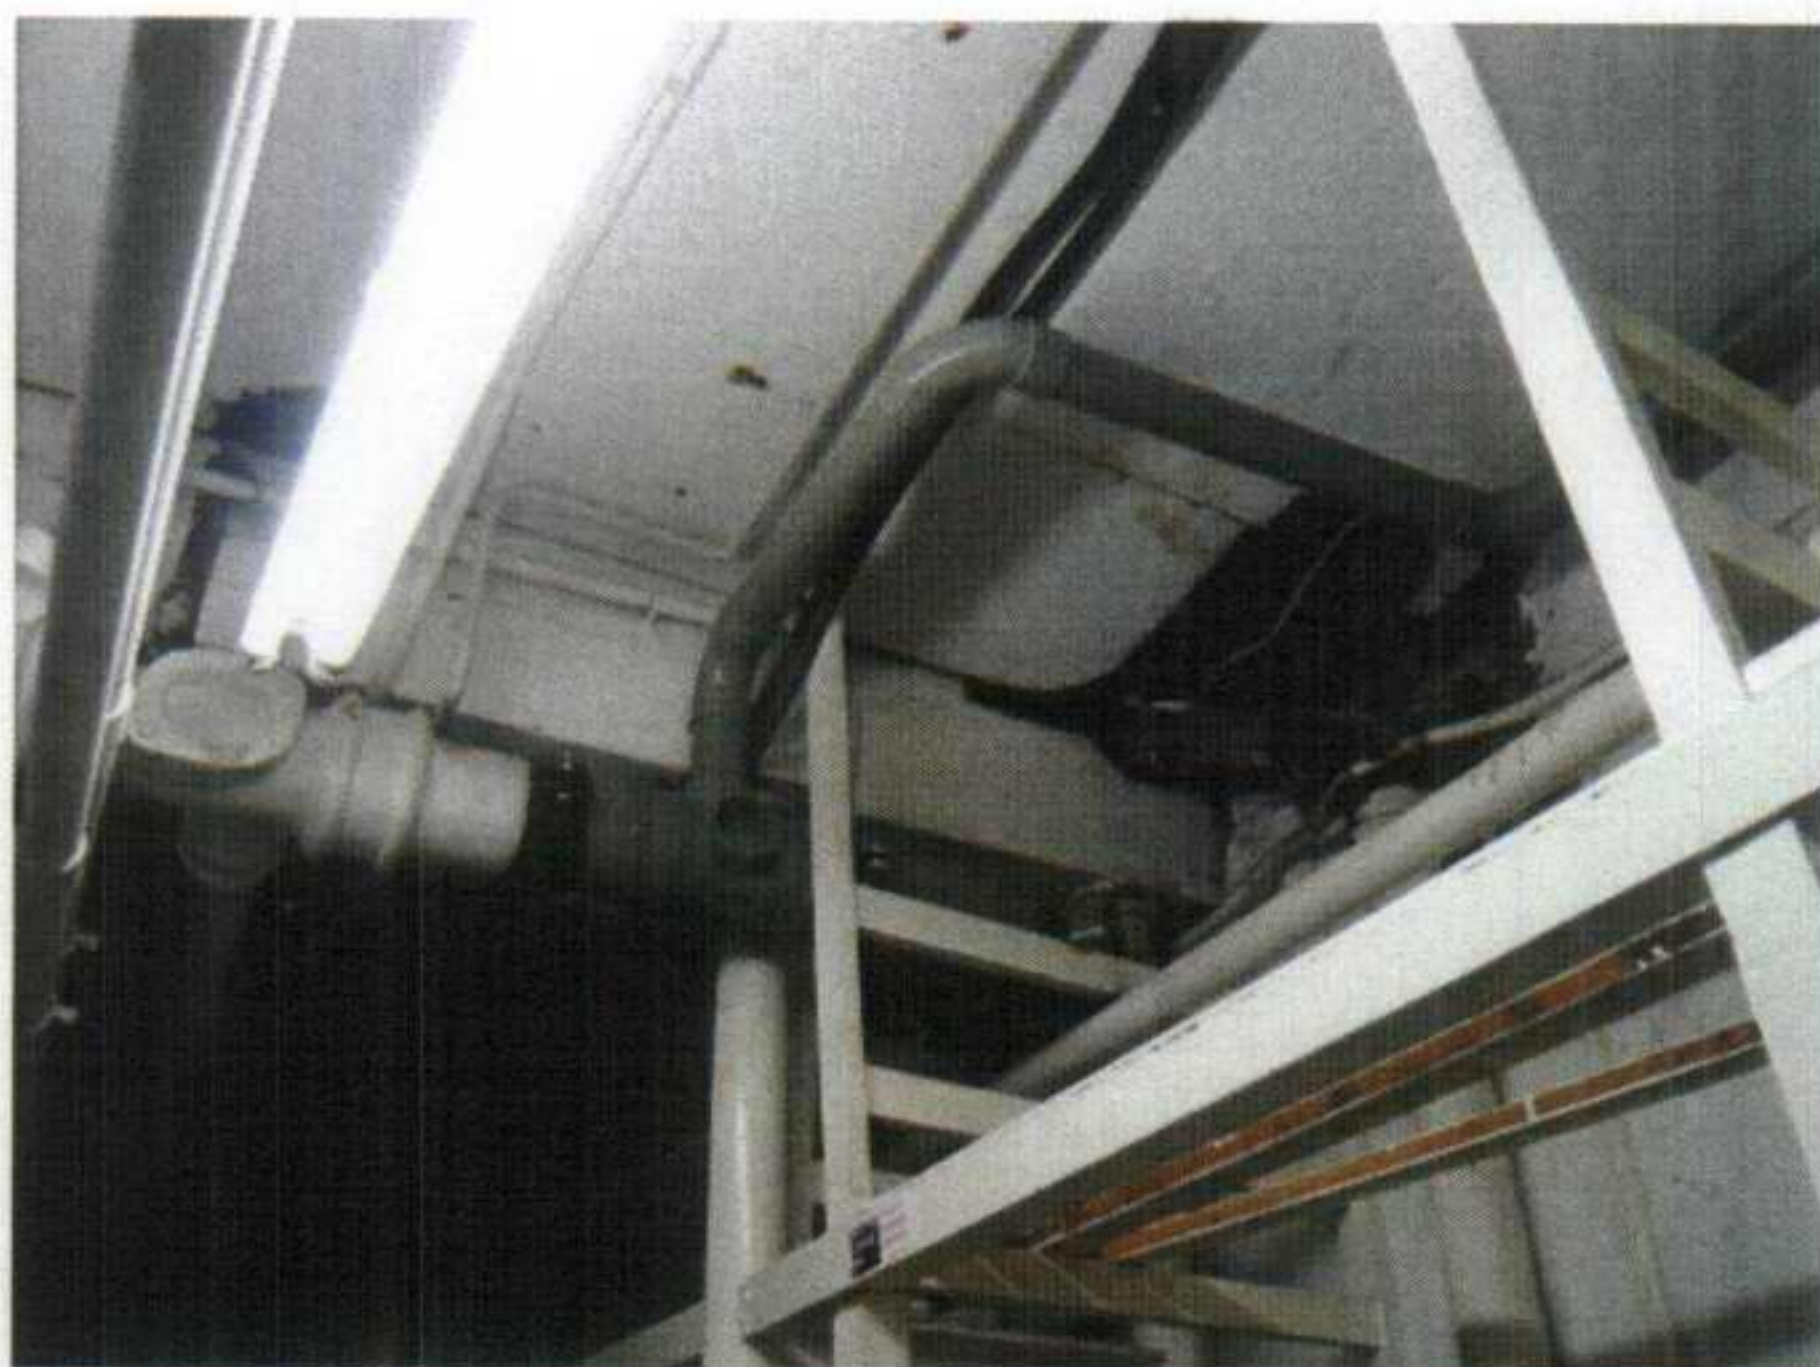
Figure 19  
Room B22 Extensive ducts and pipes to be re-ordered and removed where possible.

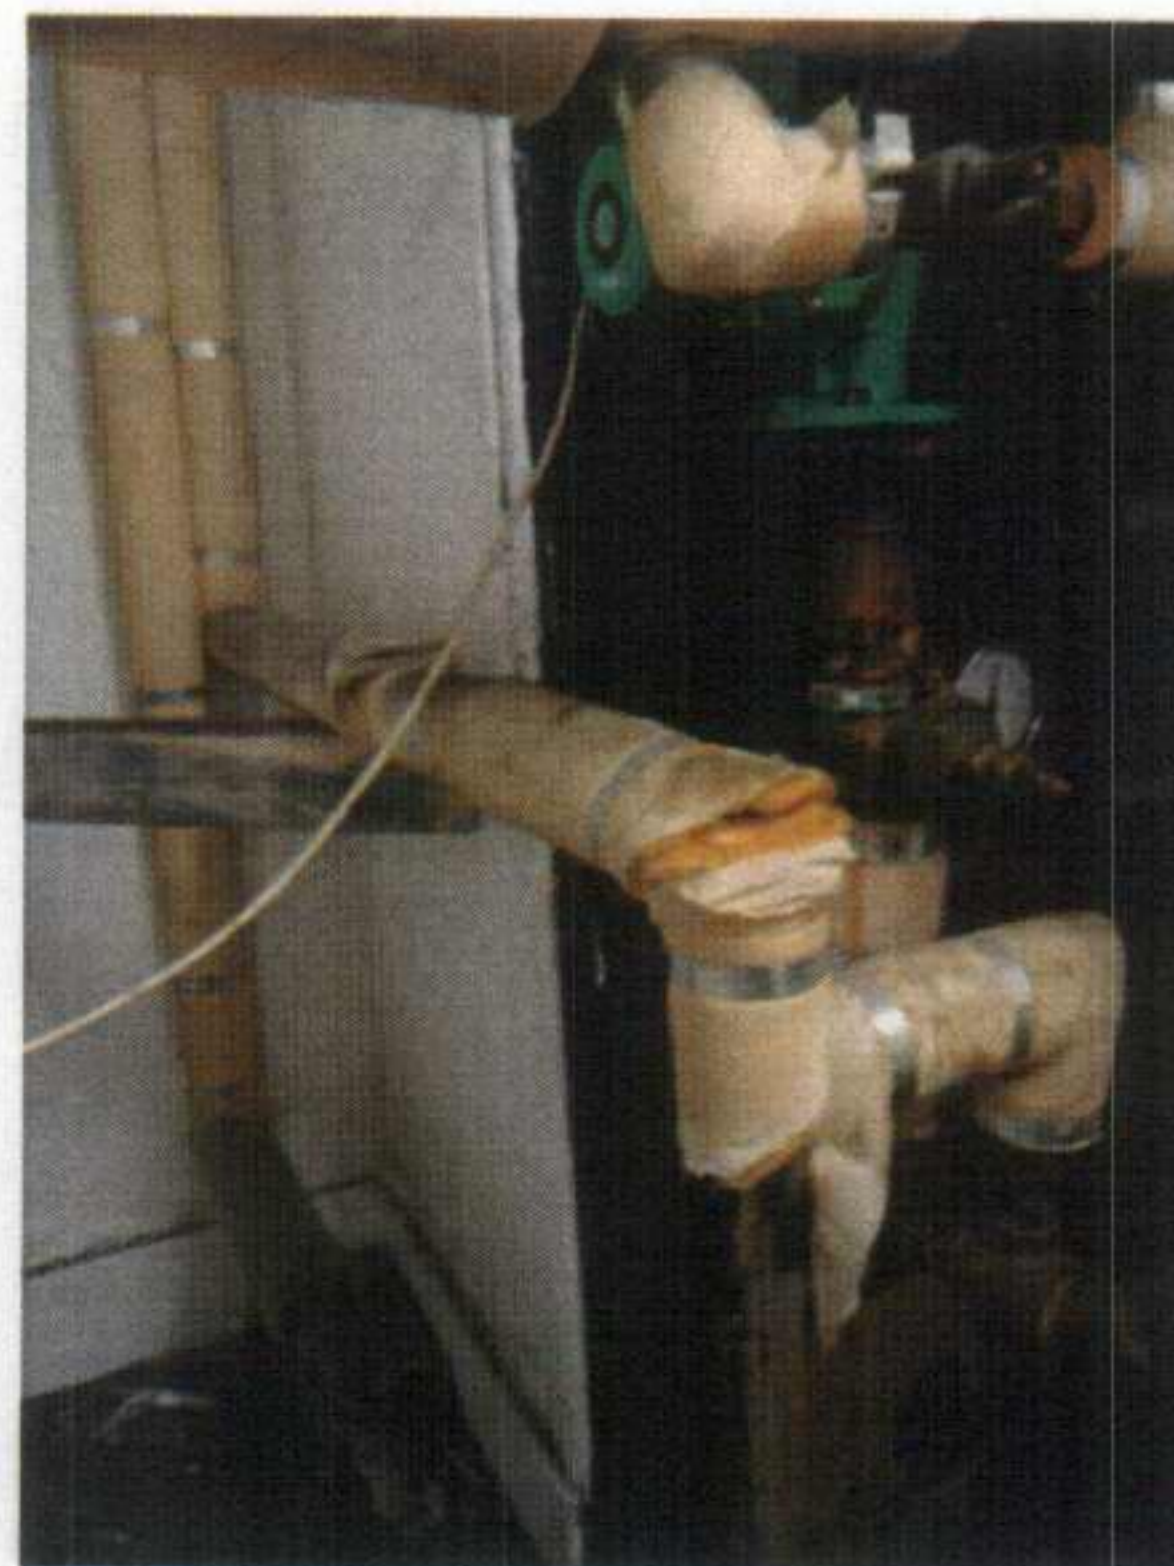
Figure 20  
Room B3, pipework around existing range to be removed and range refurbished and exposed.

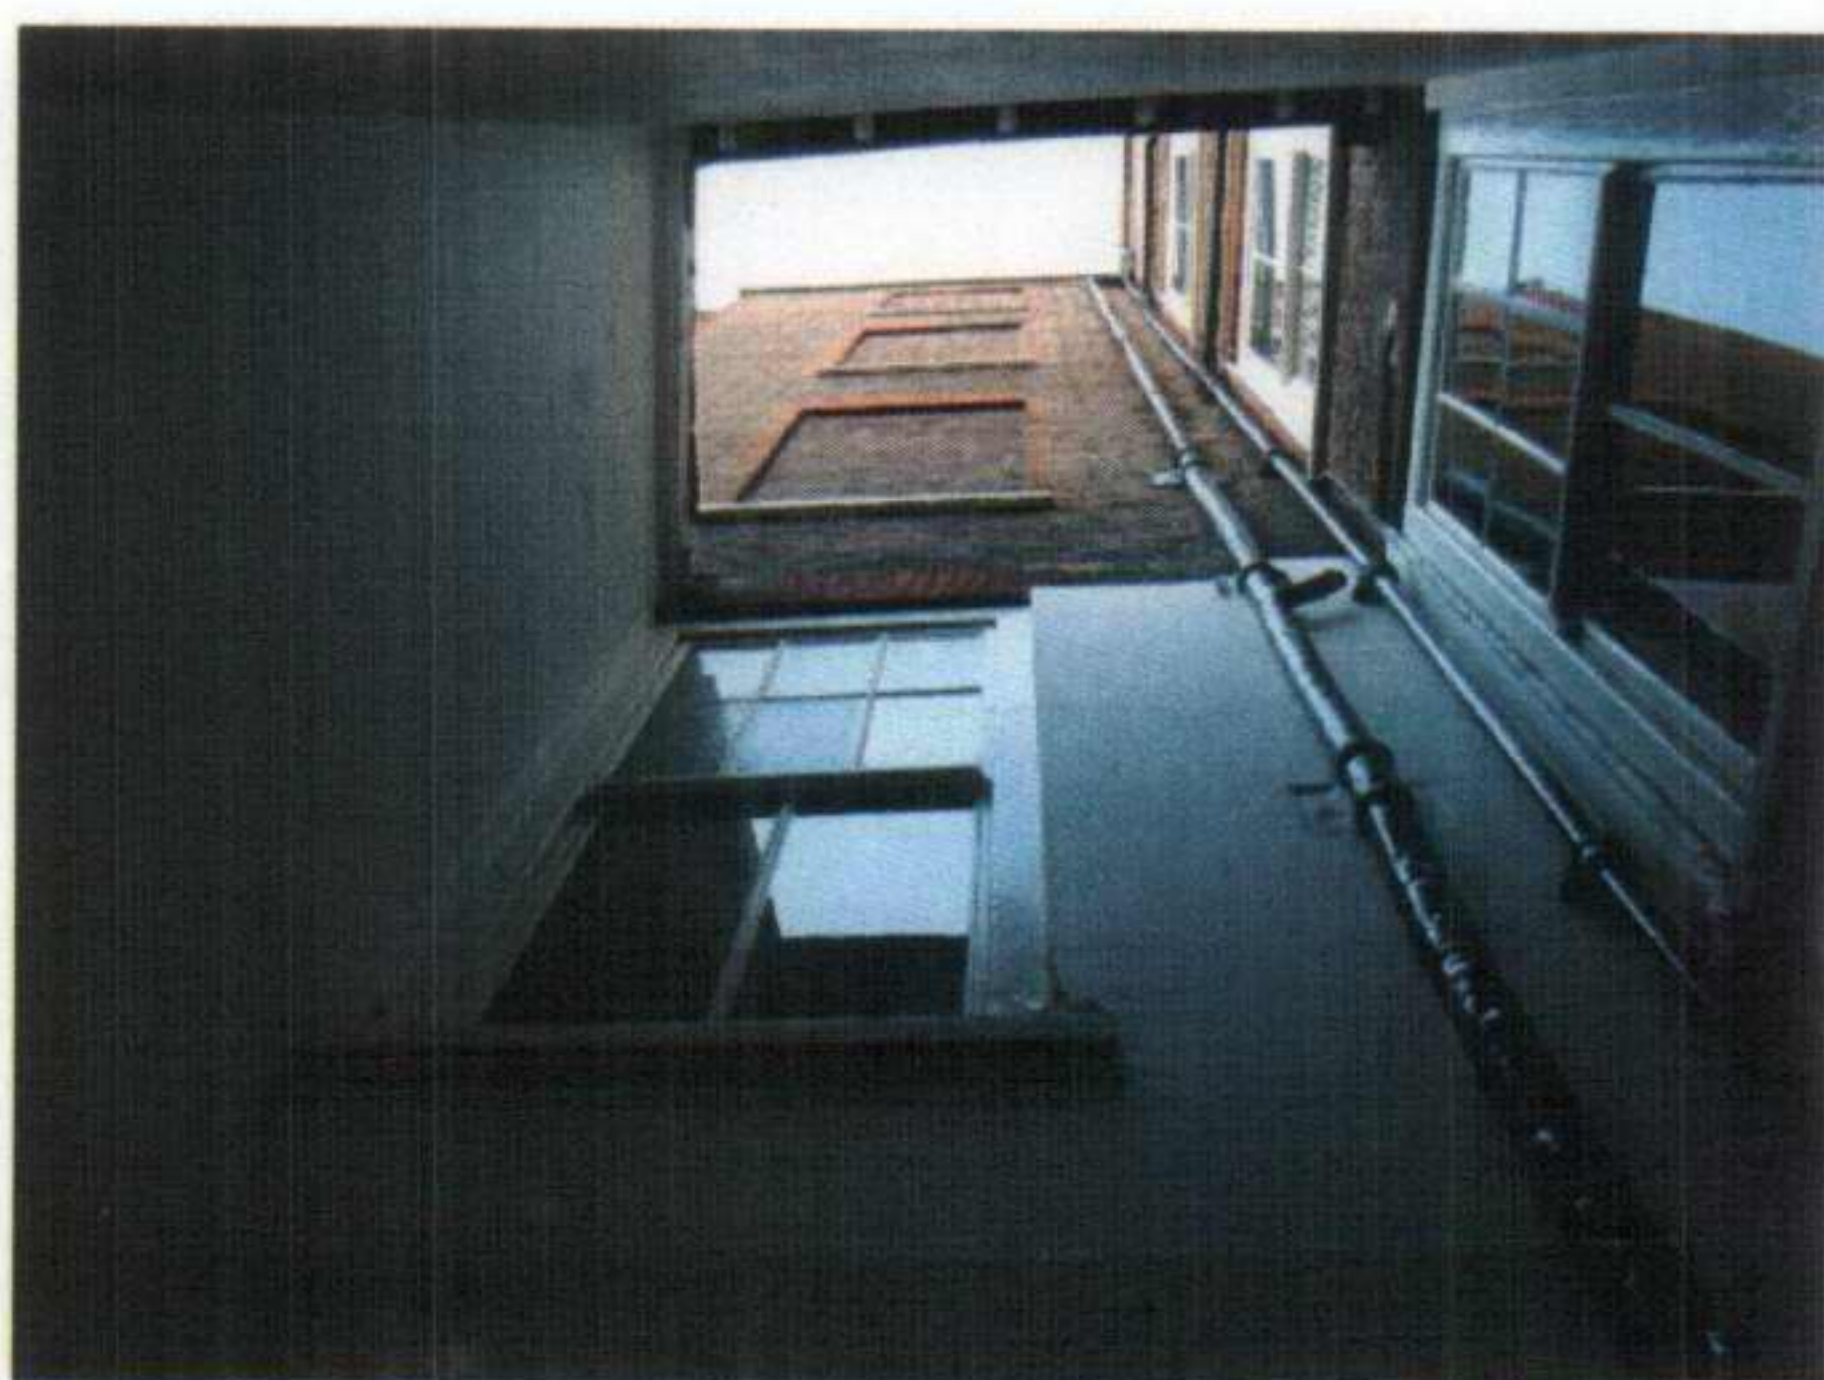
Figure 21  
Existing lightwell No 12

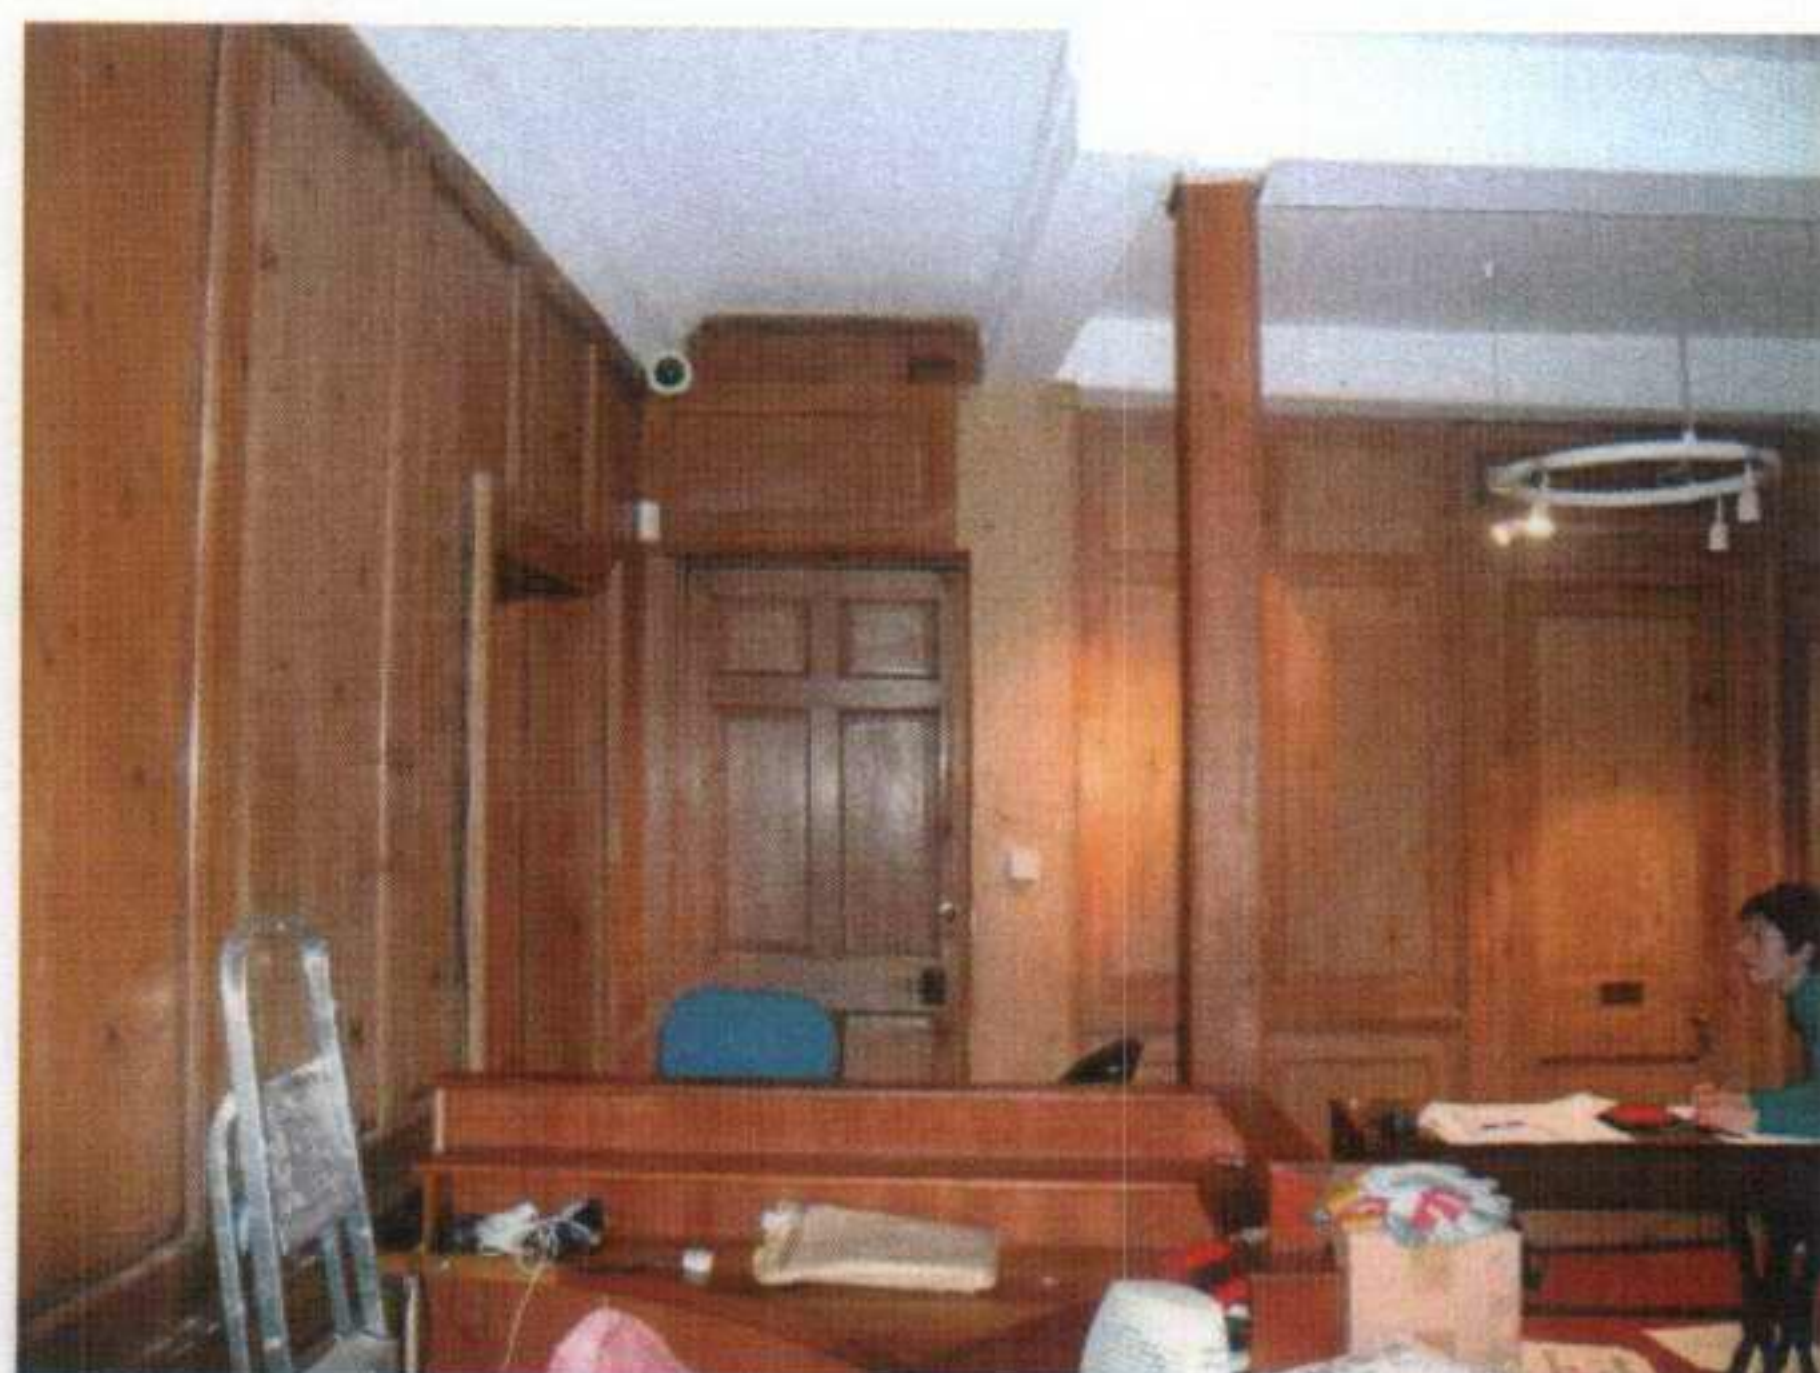
Figure 22  
Stripped panelling to G6. Column to be removed and new beam inserted. Panelling to be re-painted.

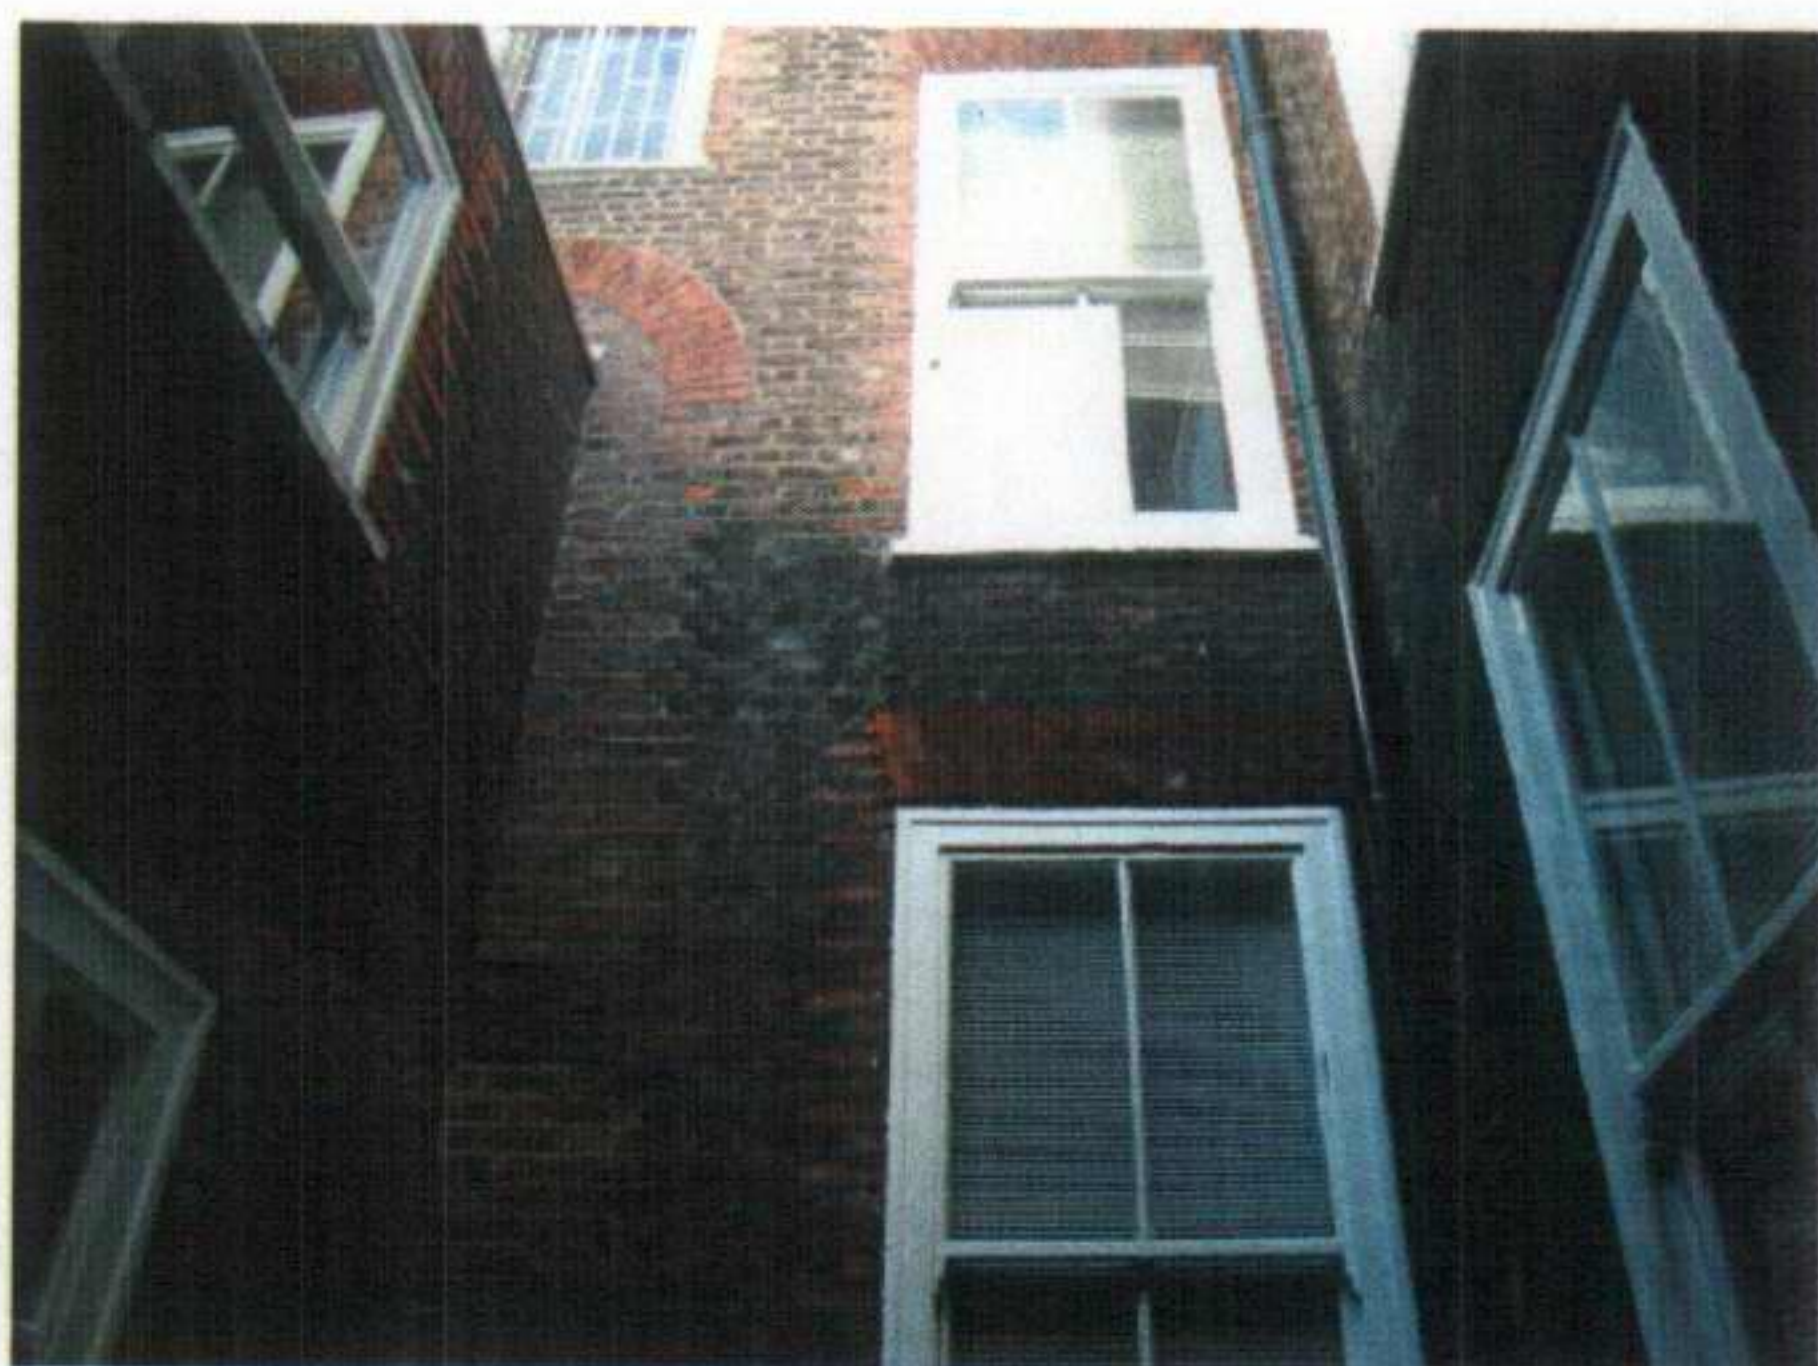
Figure 23  
View of existing two storey extension and existing lightwell to no. 11. Original bricked up window locations also visible.

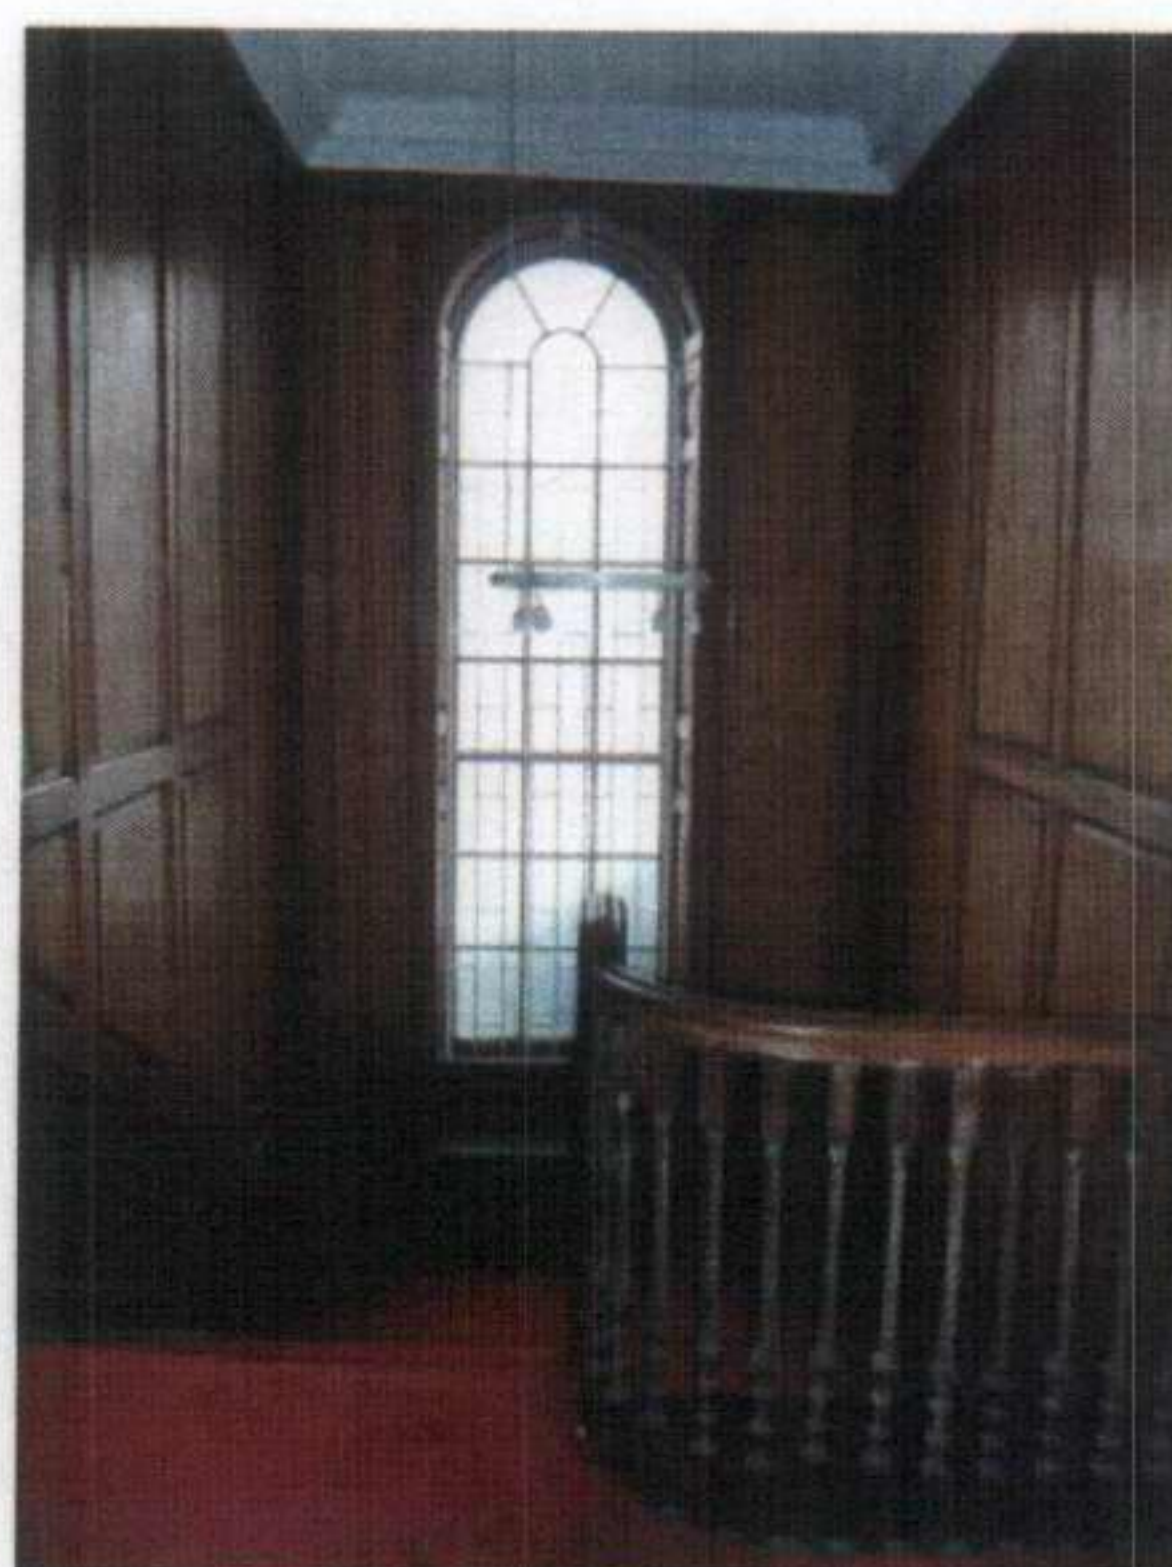
Figure 24  
Existing arched window to stair of no. 12
