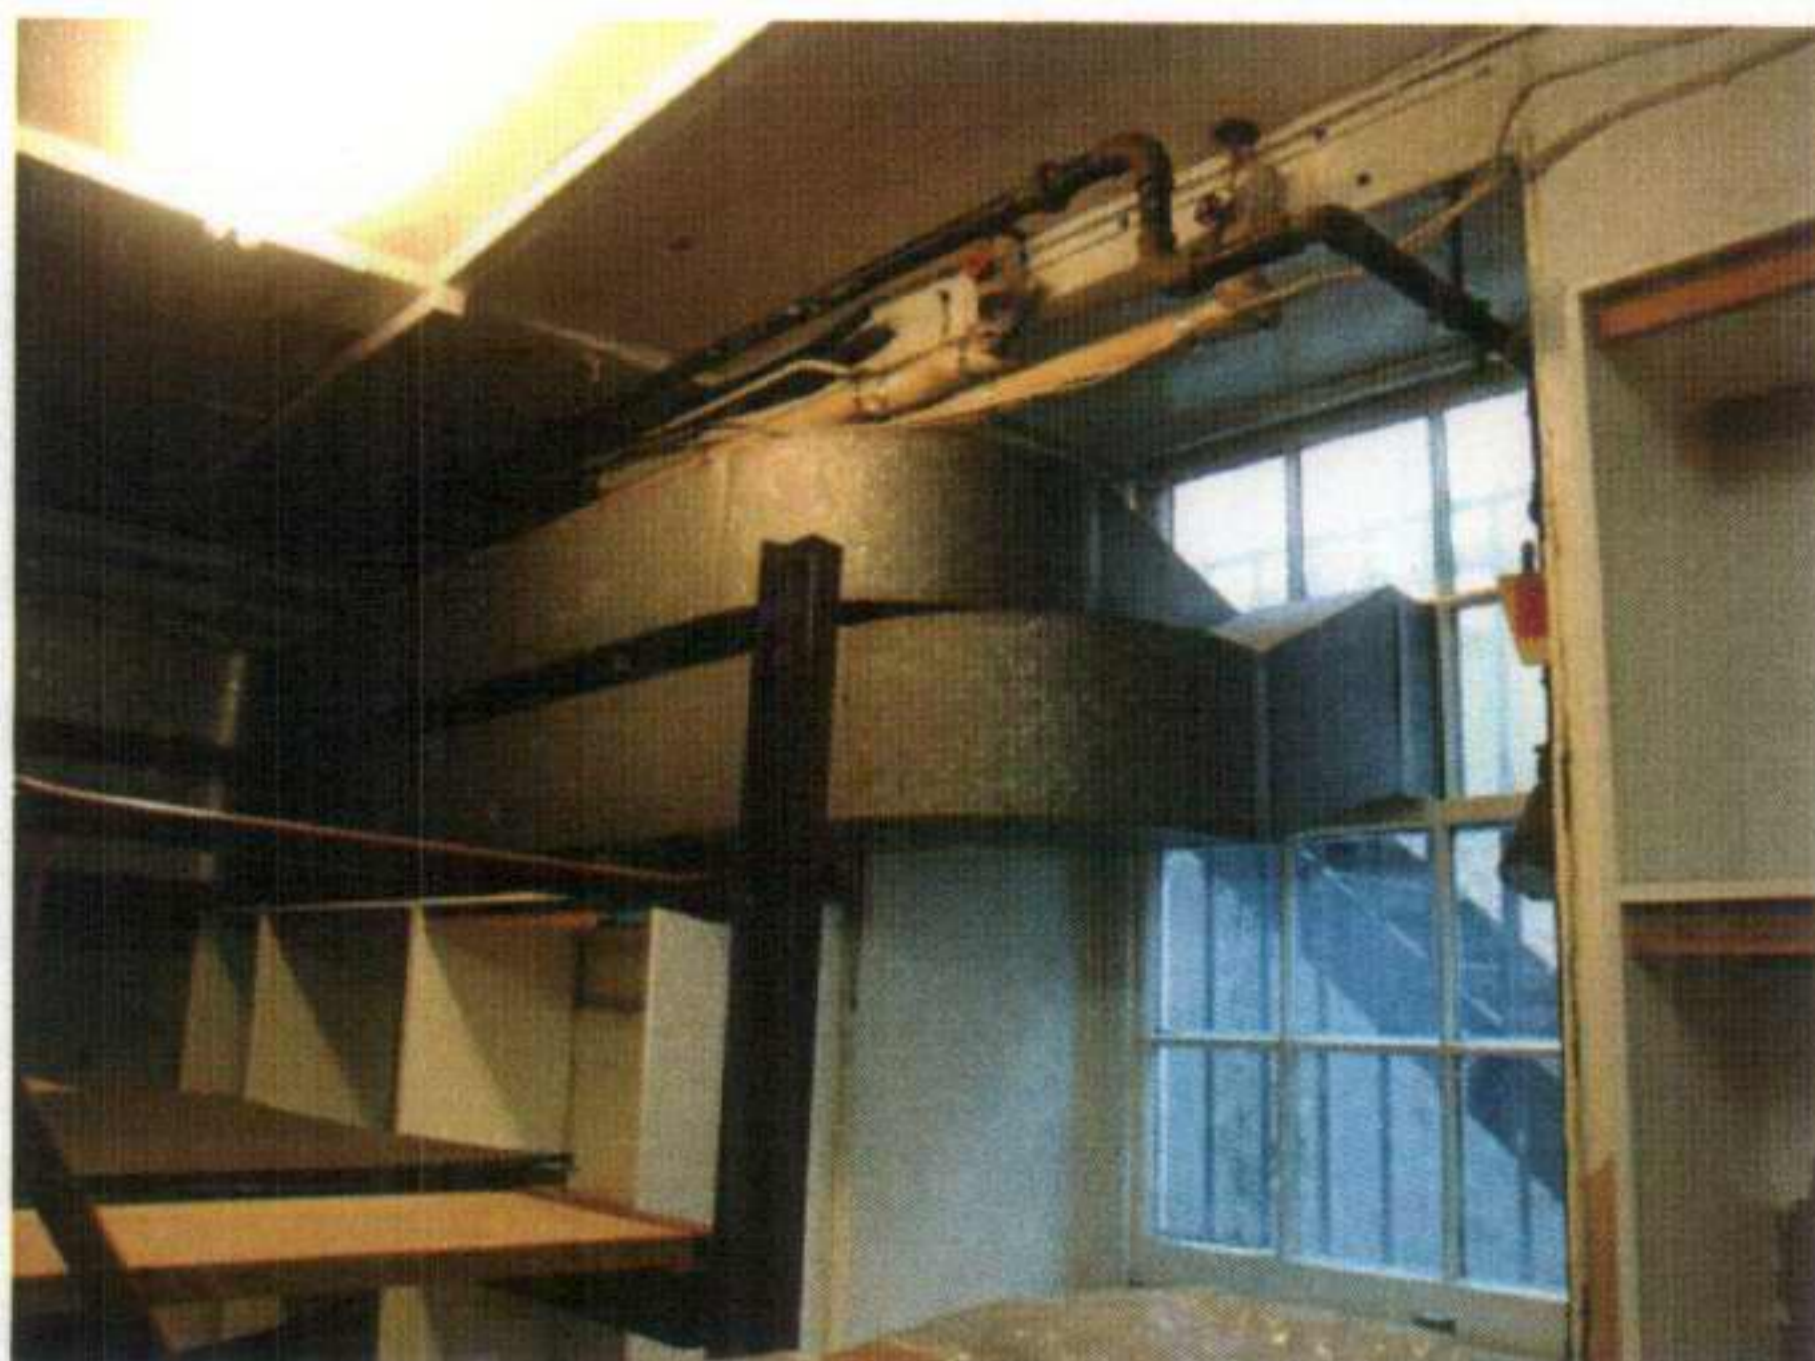
Figure 25
Room B4, extensive ducting to be removed and windows overhauled and glazing reinstated.

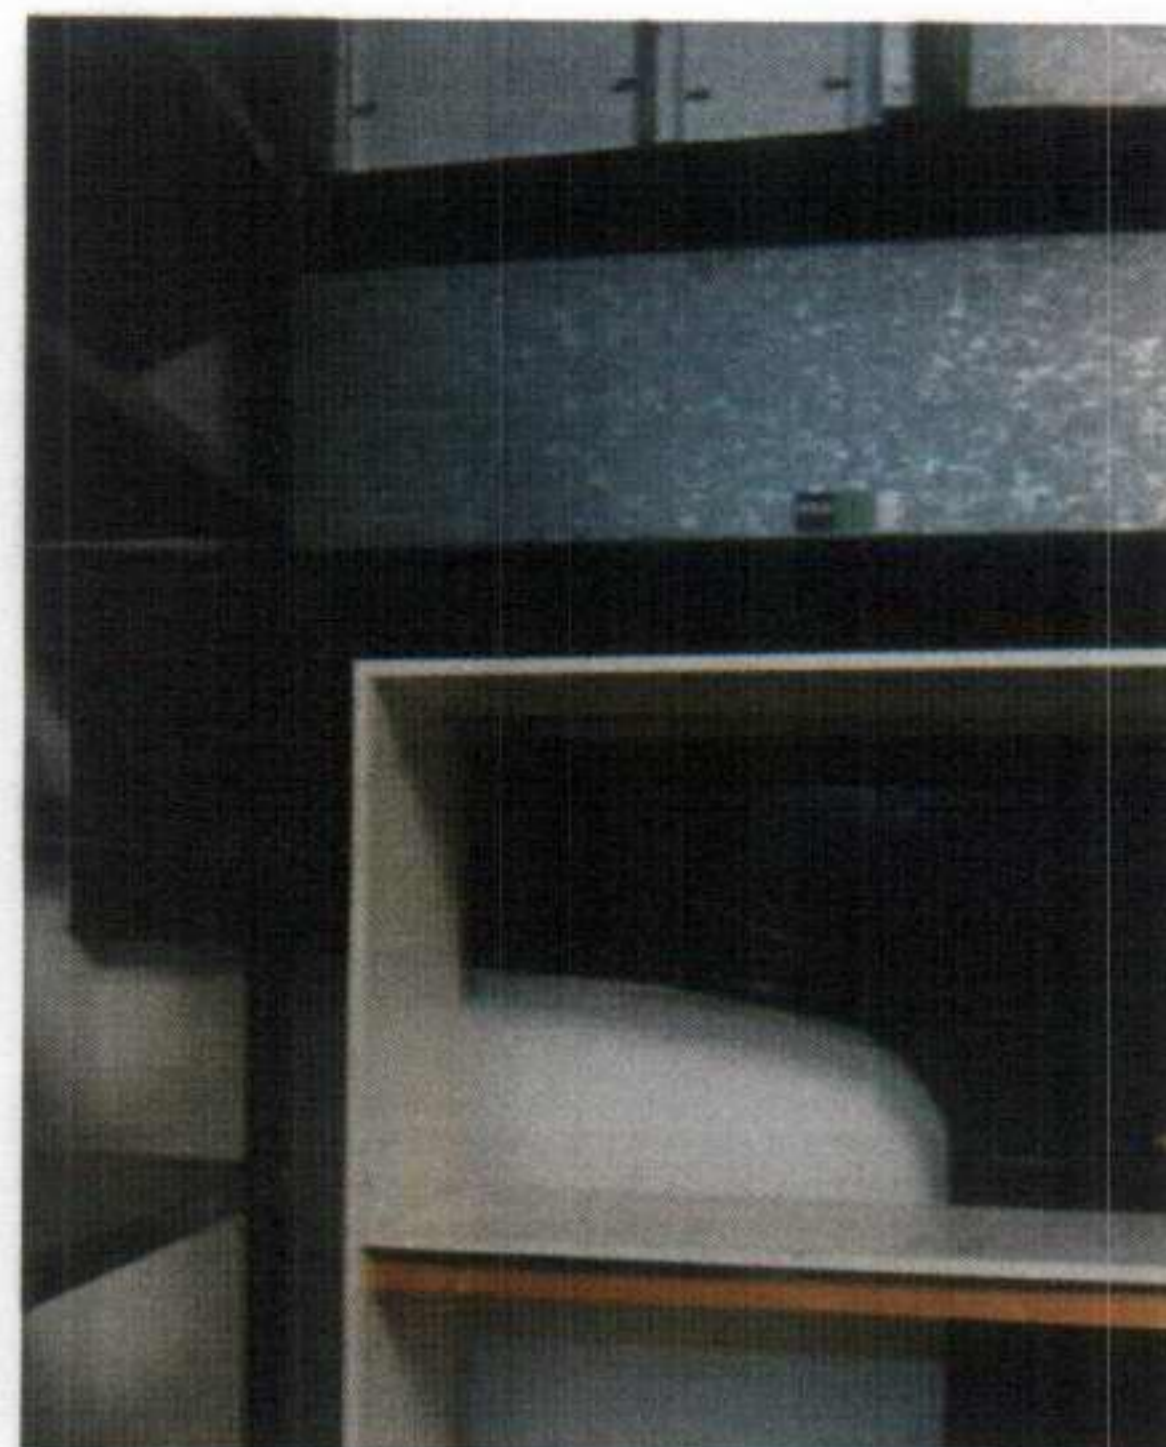
Figure 26
Ducts and pipework to be removed and existing range restored.

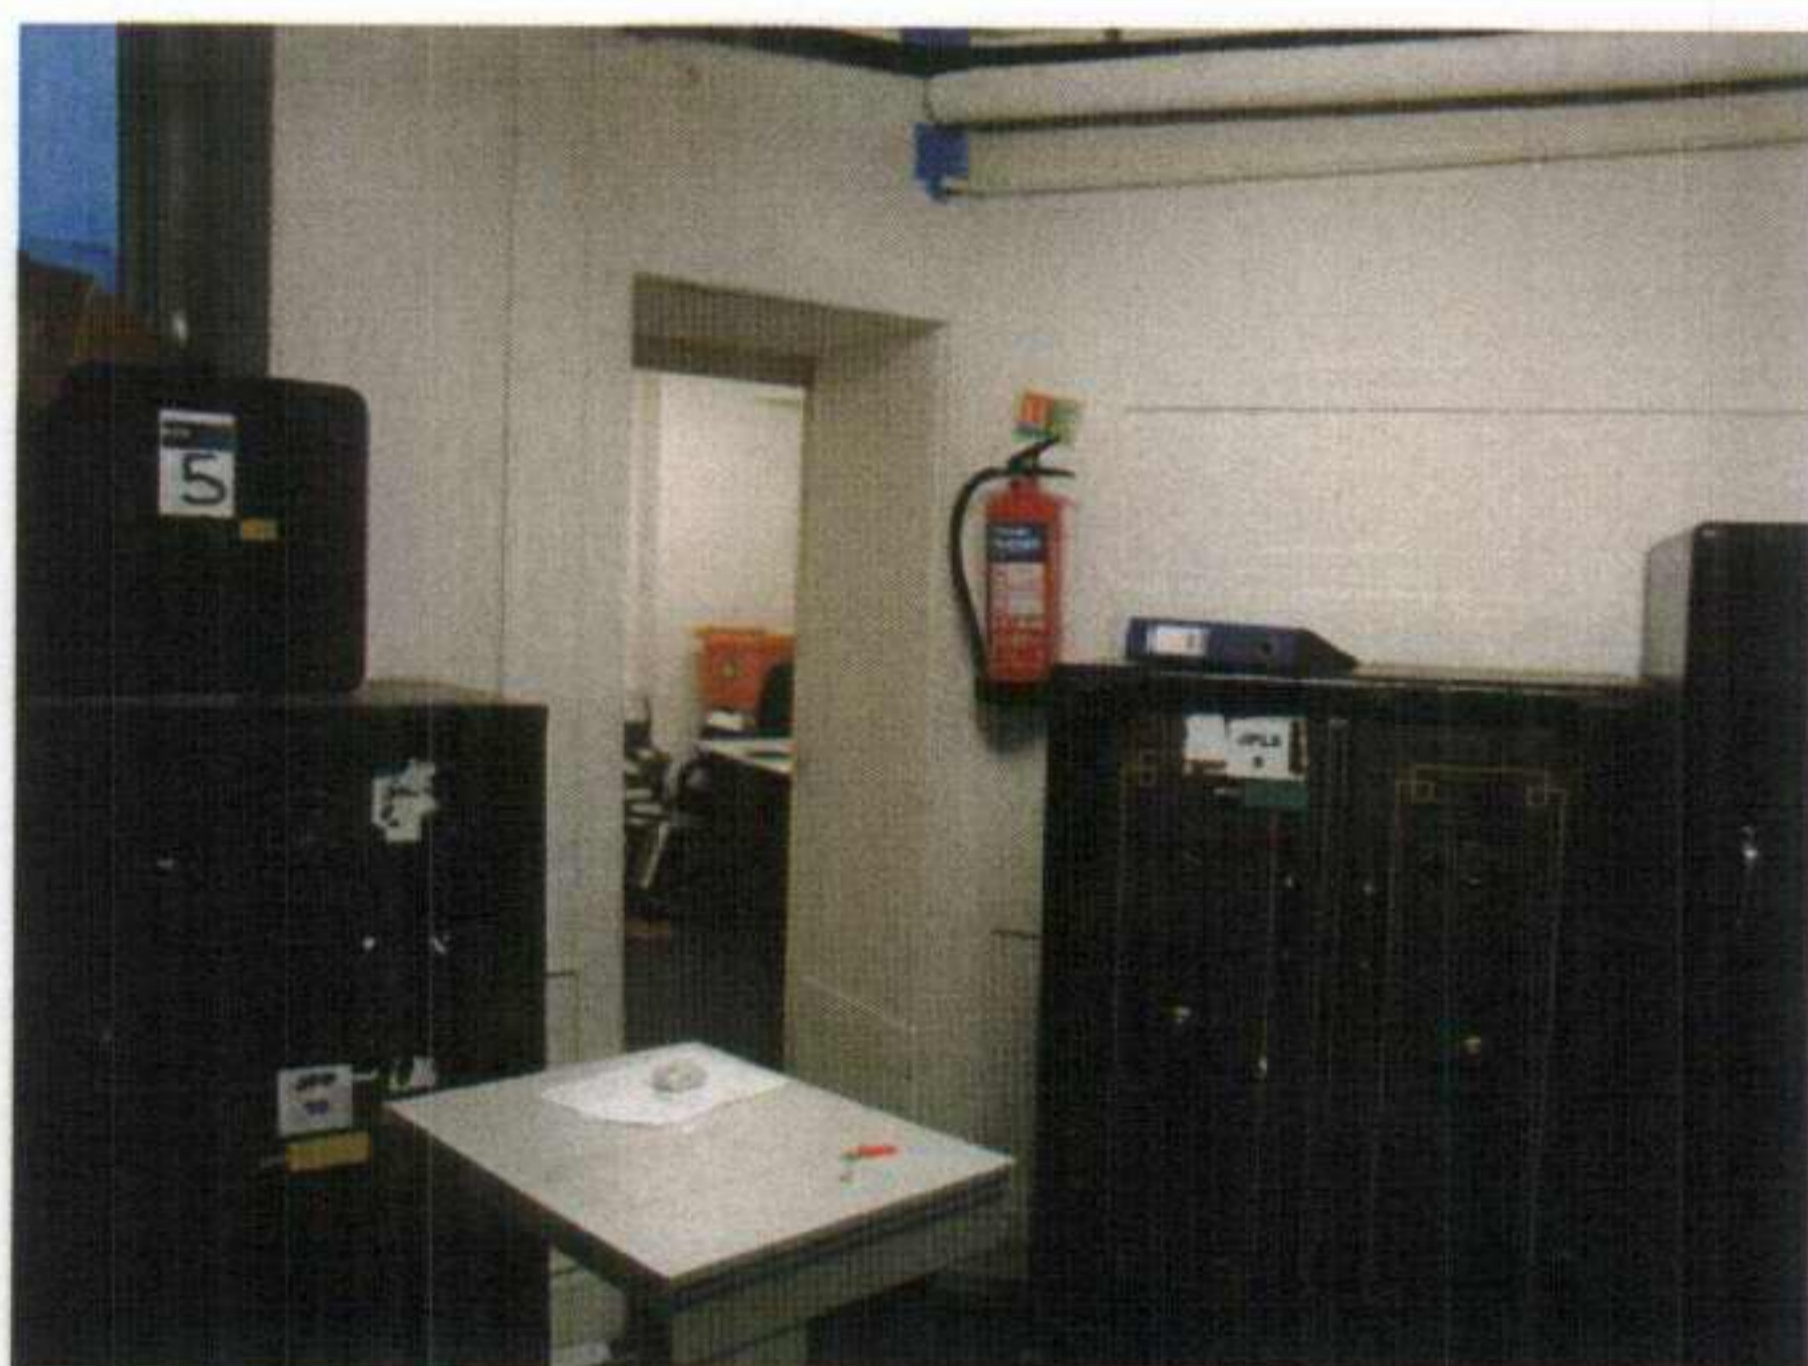
Figure 27
Evidence of simple panelling to B6 and possible fire surround behind.

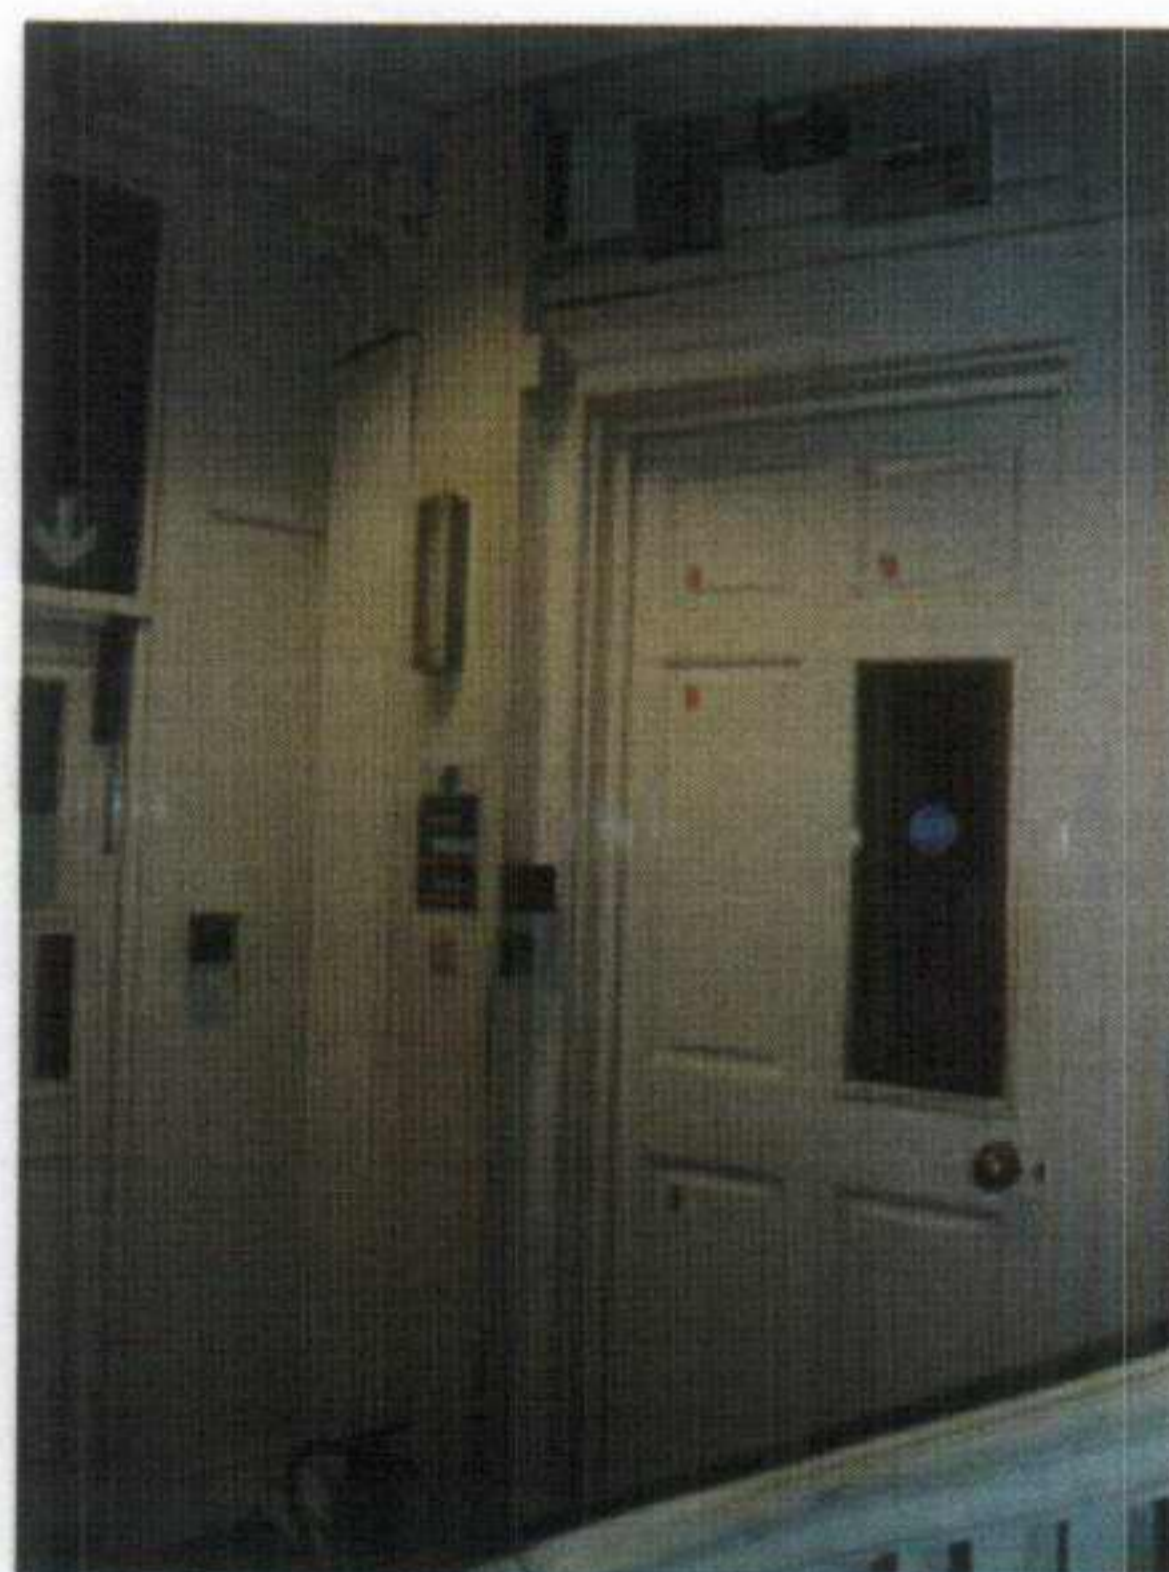
Figure 28
Riser in stair to no. 11 to remain. Glazed panel in door to be reinstated as solid panel.

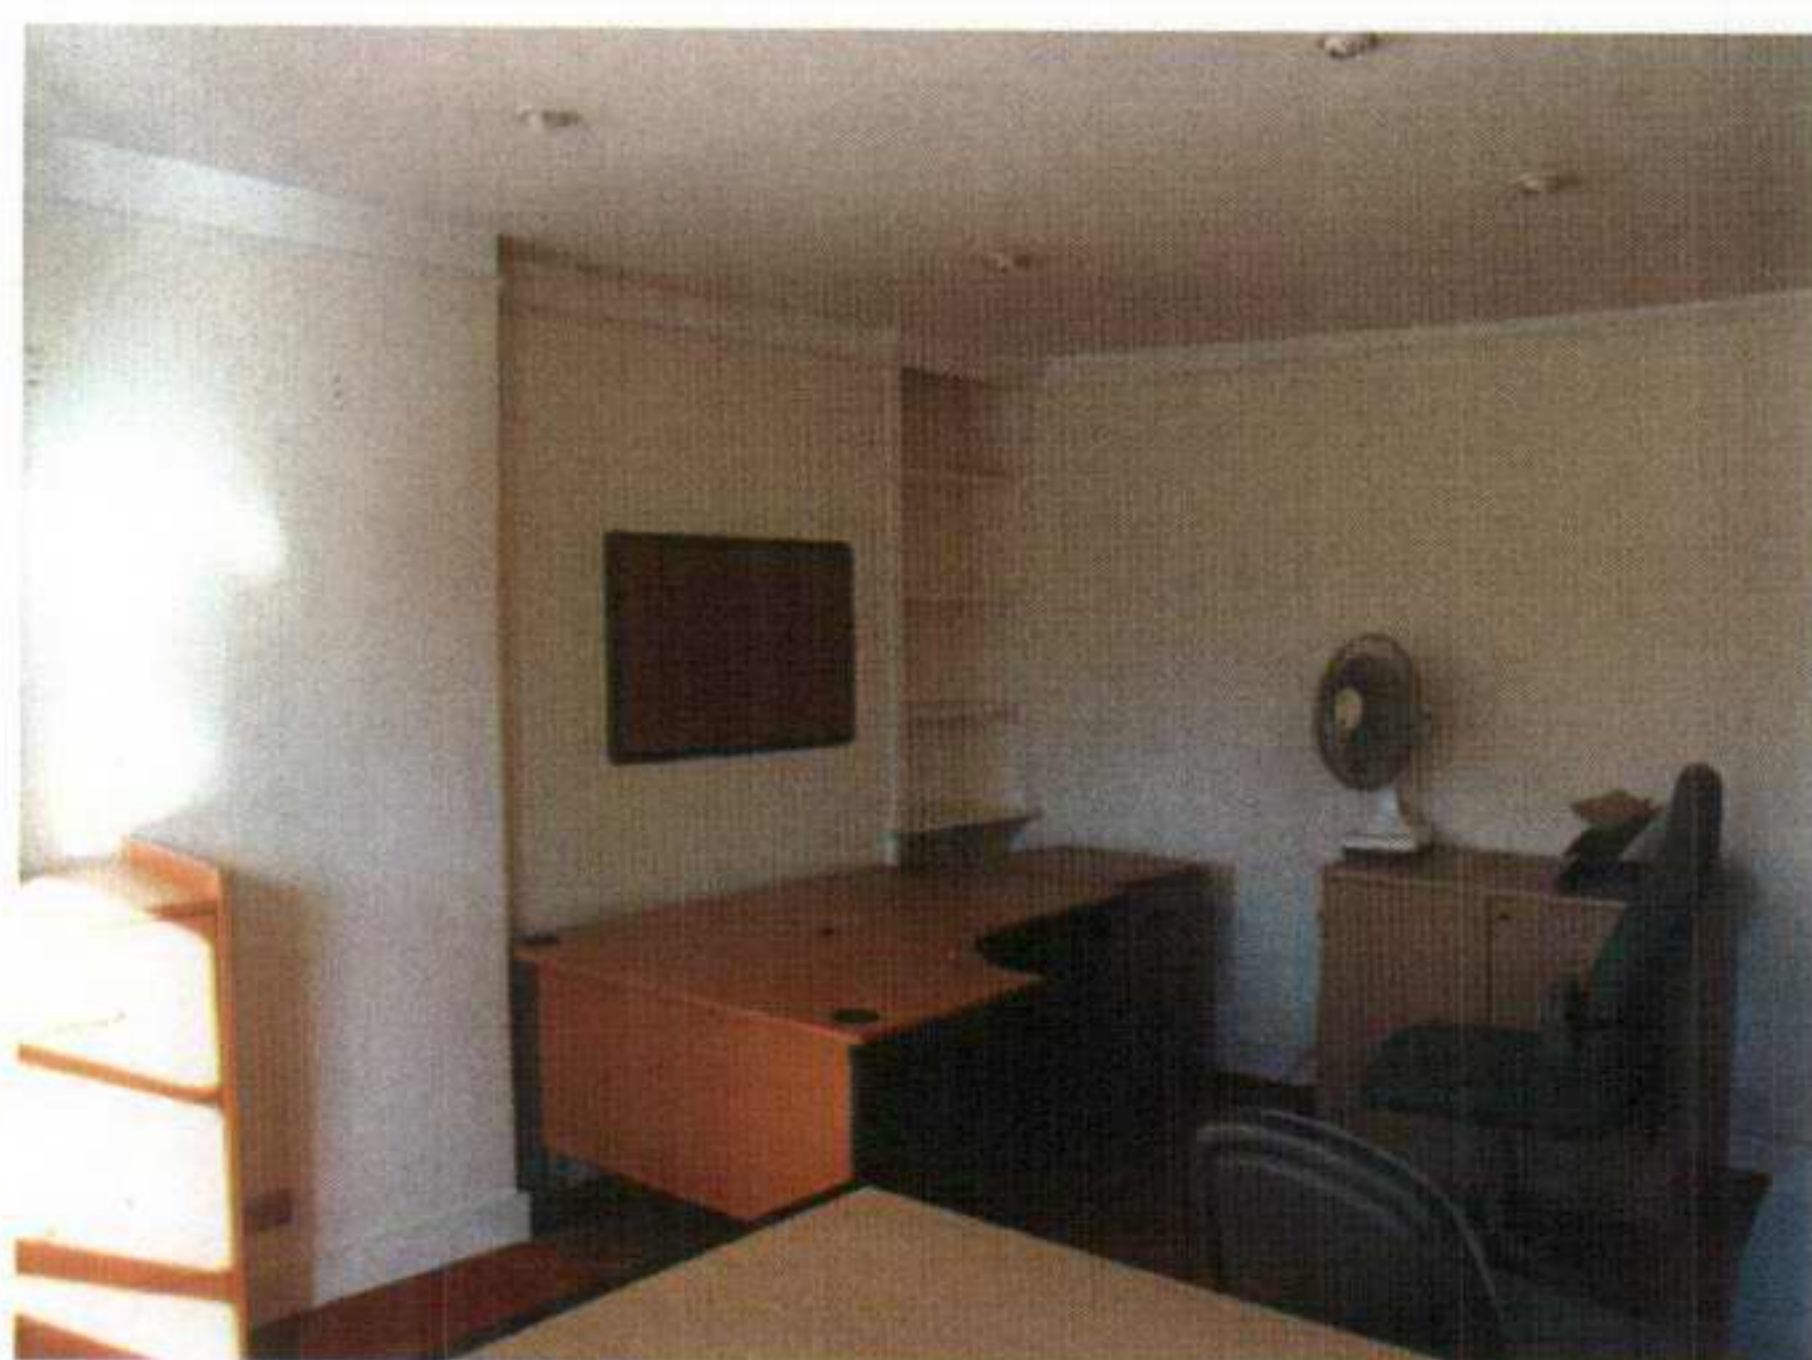
Figure 29
New riser position behind cornice at third floor level in recess

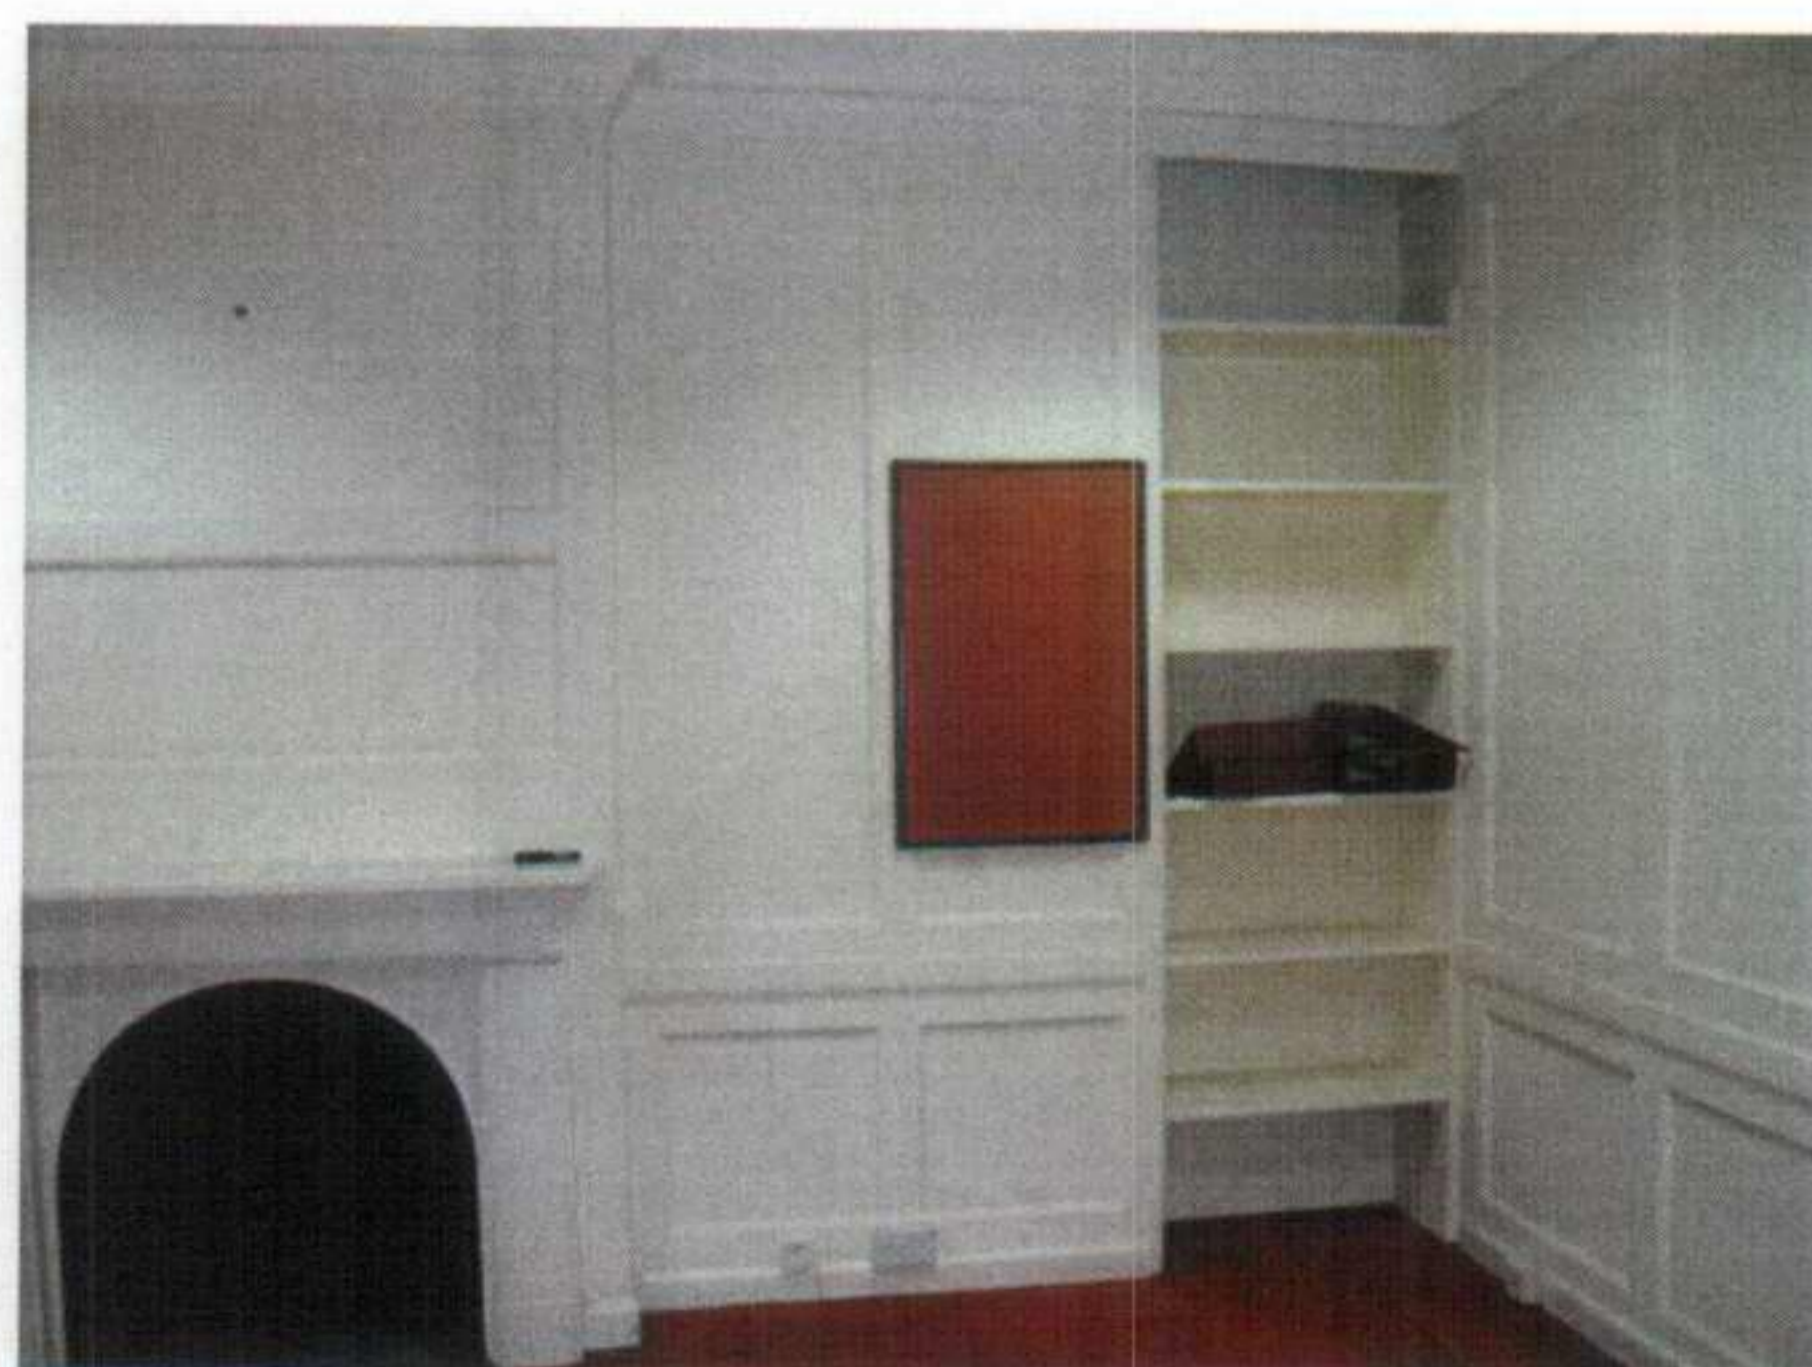
Figure 30
New riser position behind cornice in recess to second floor

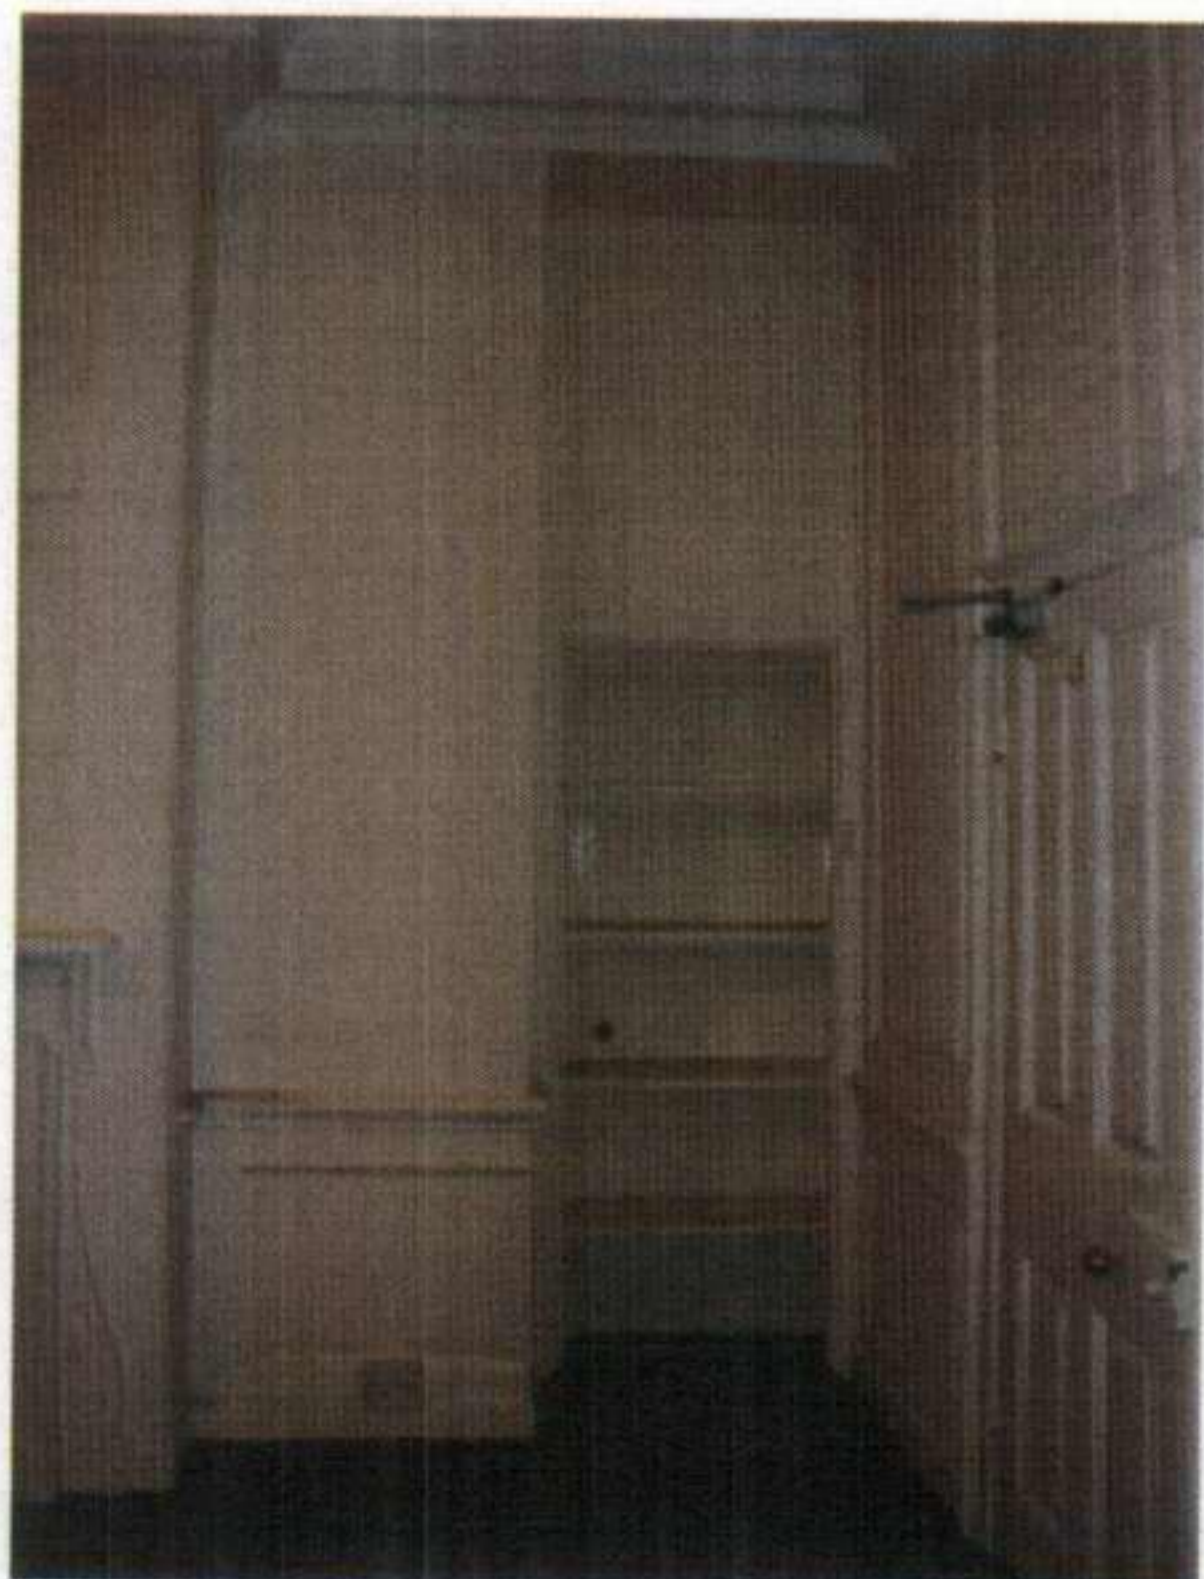
Figure 31
New riser at first floor level to no. 11. Party wall to be blocked up and panelling reinstated in front of riser.

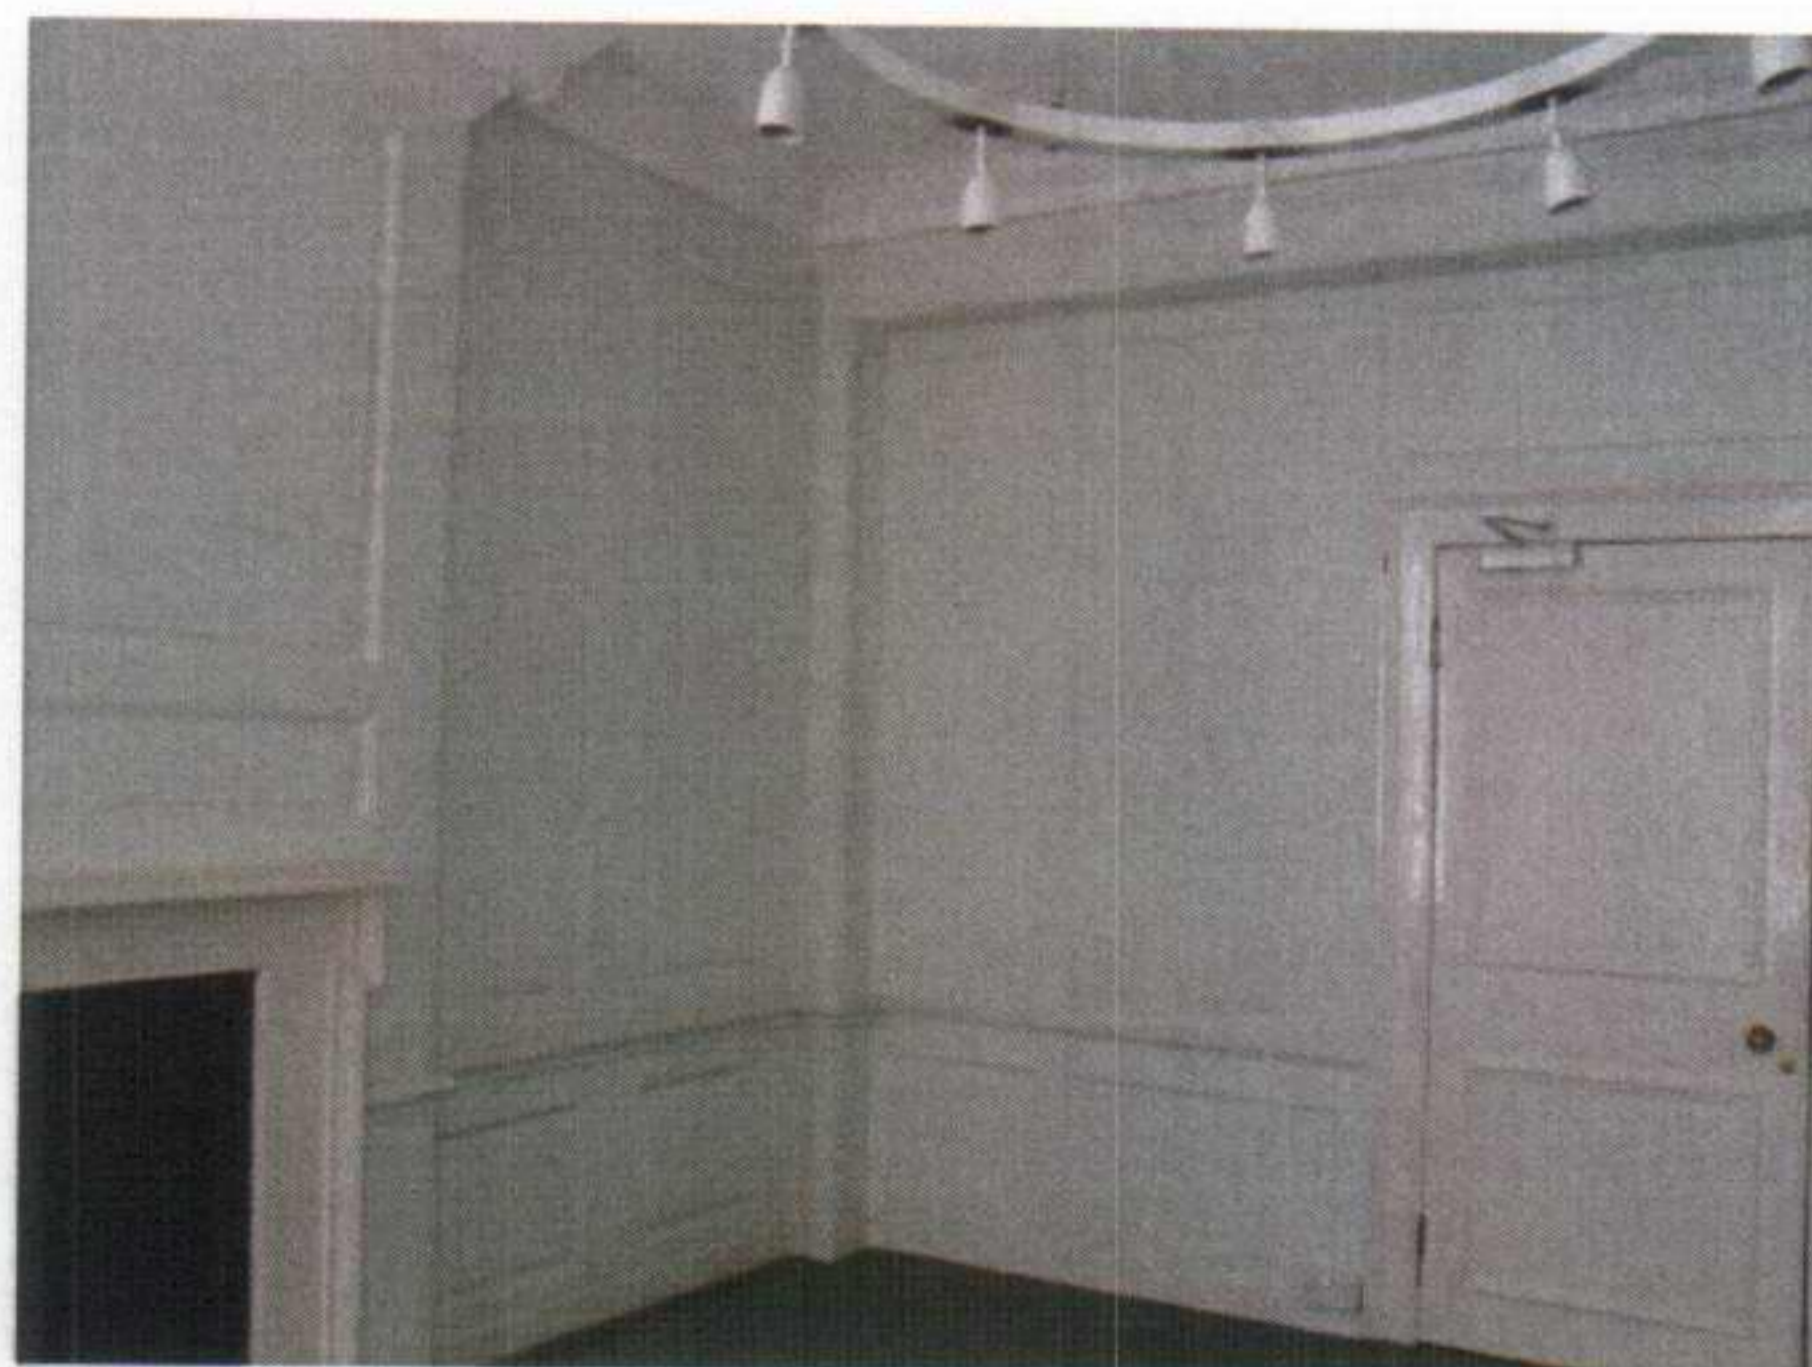
Figure 32
New riser at ground floor behind existing panelling. Possible access panel to be formed.

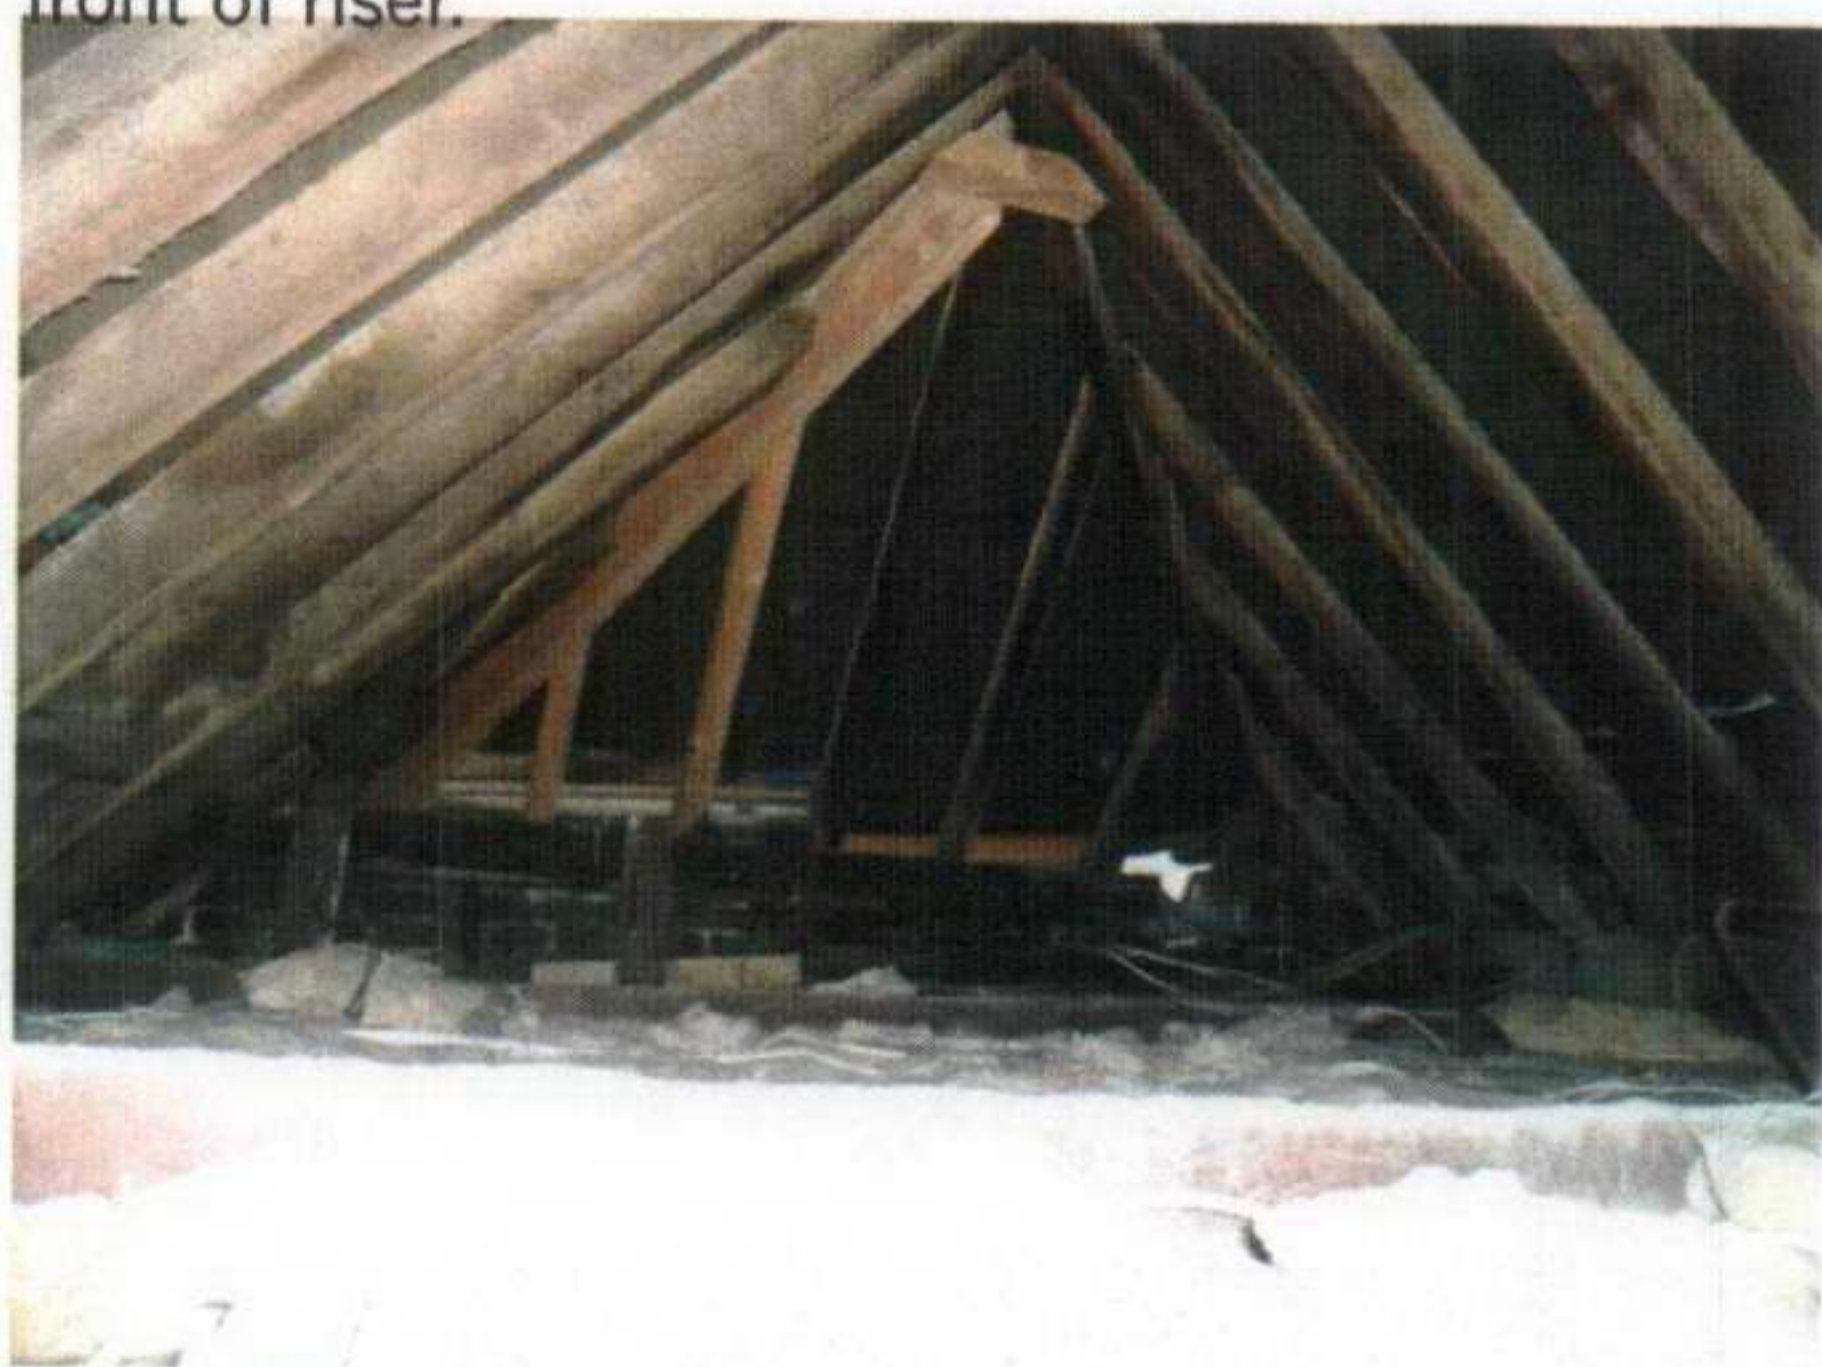
Figure 33
Existing roof space to no. 11. Conservation rooflights placed in between rafters.

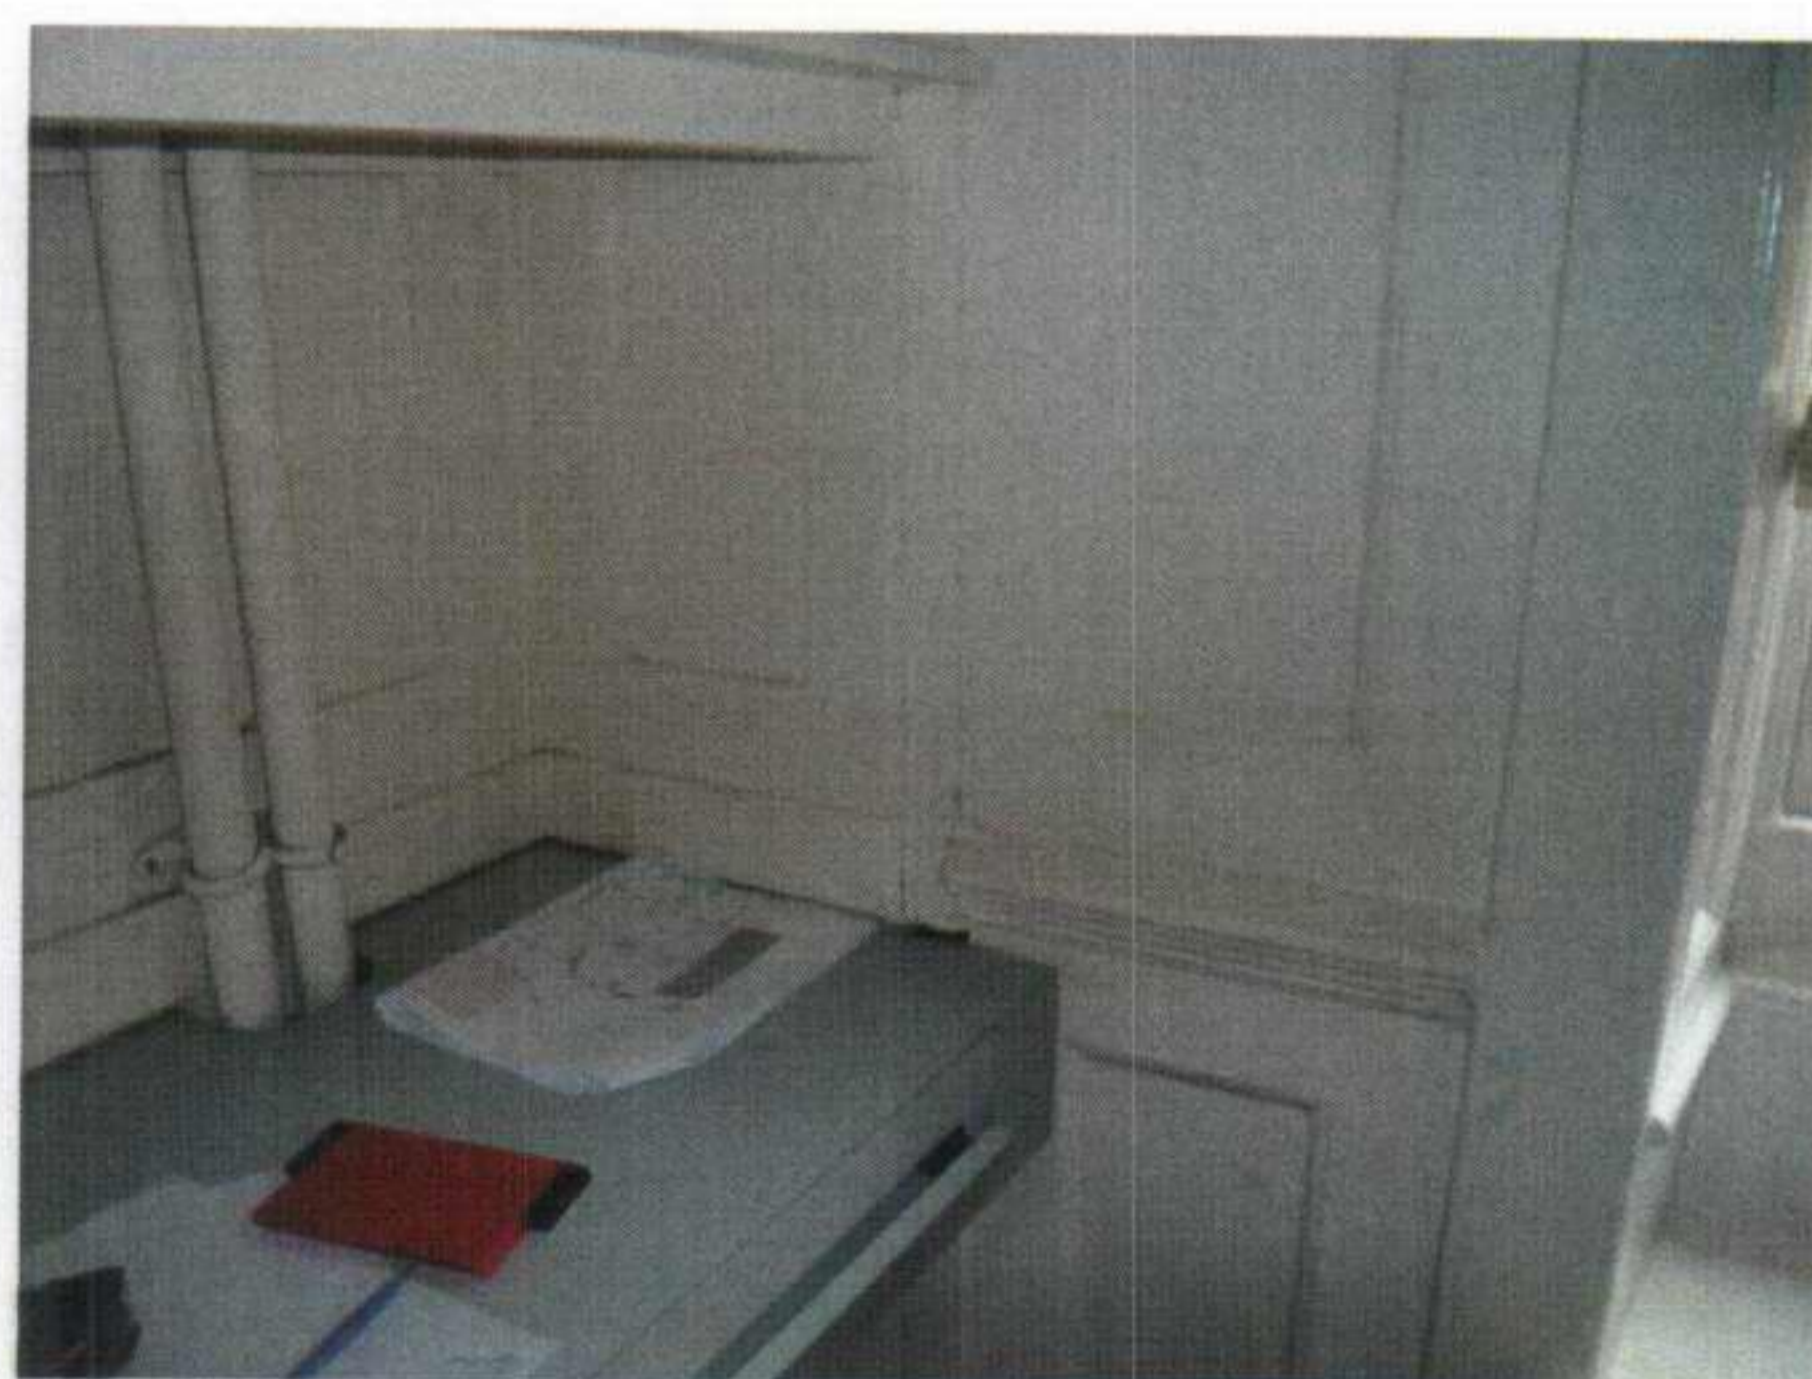
Figure 34
Simple panelling in recesses. Cupboard doors to be reinstated.
