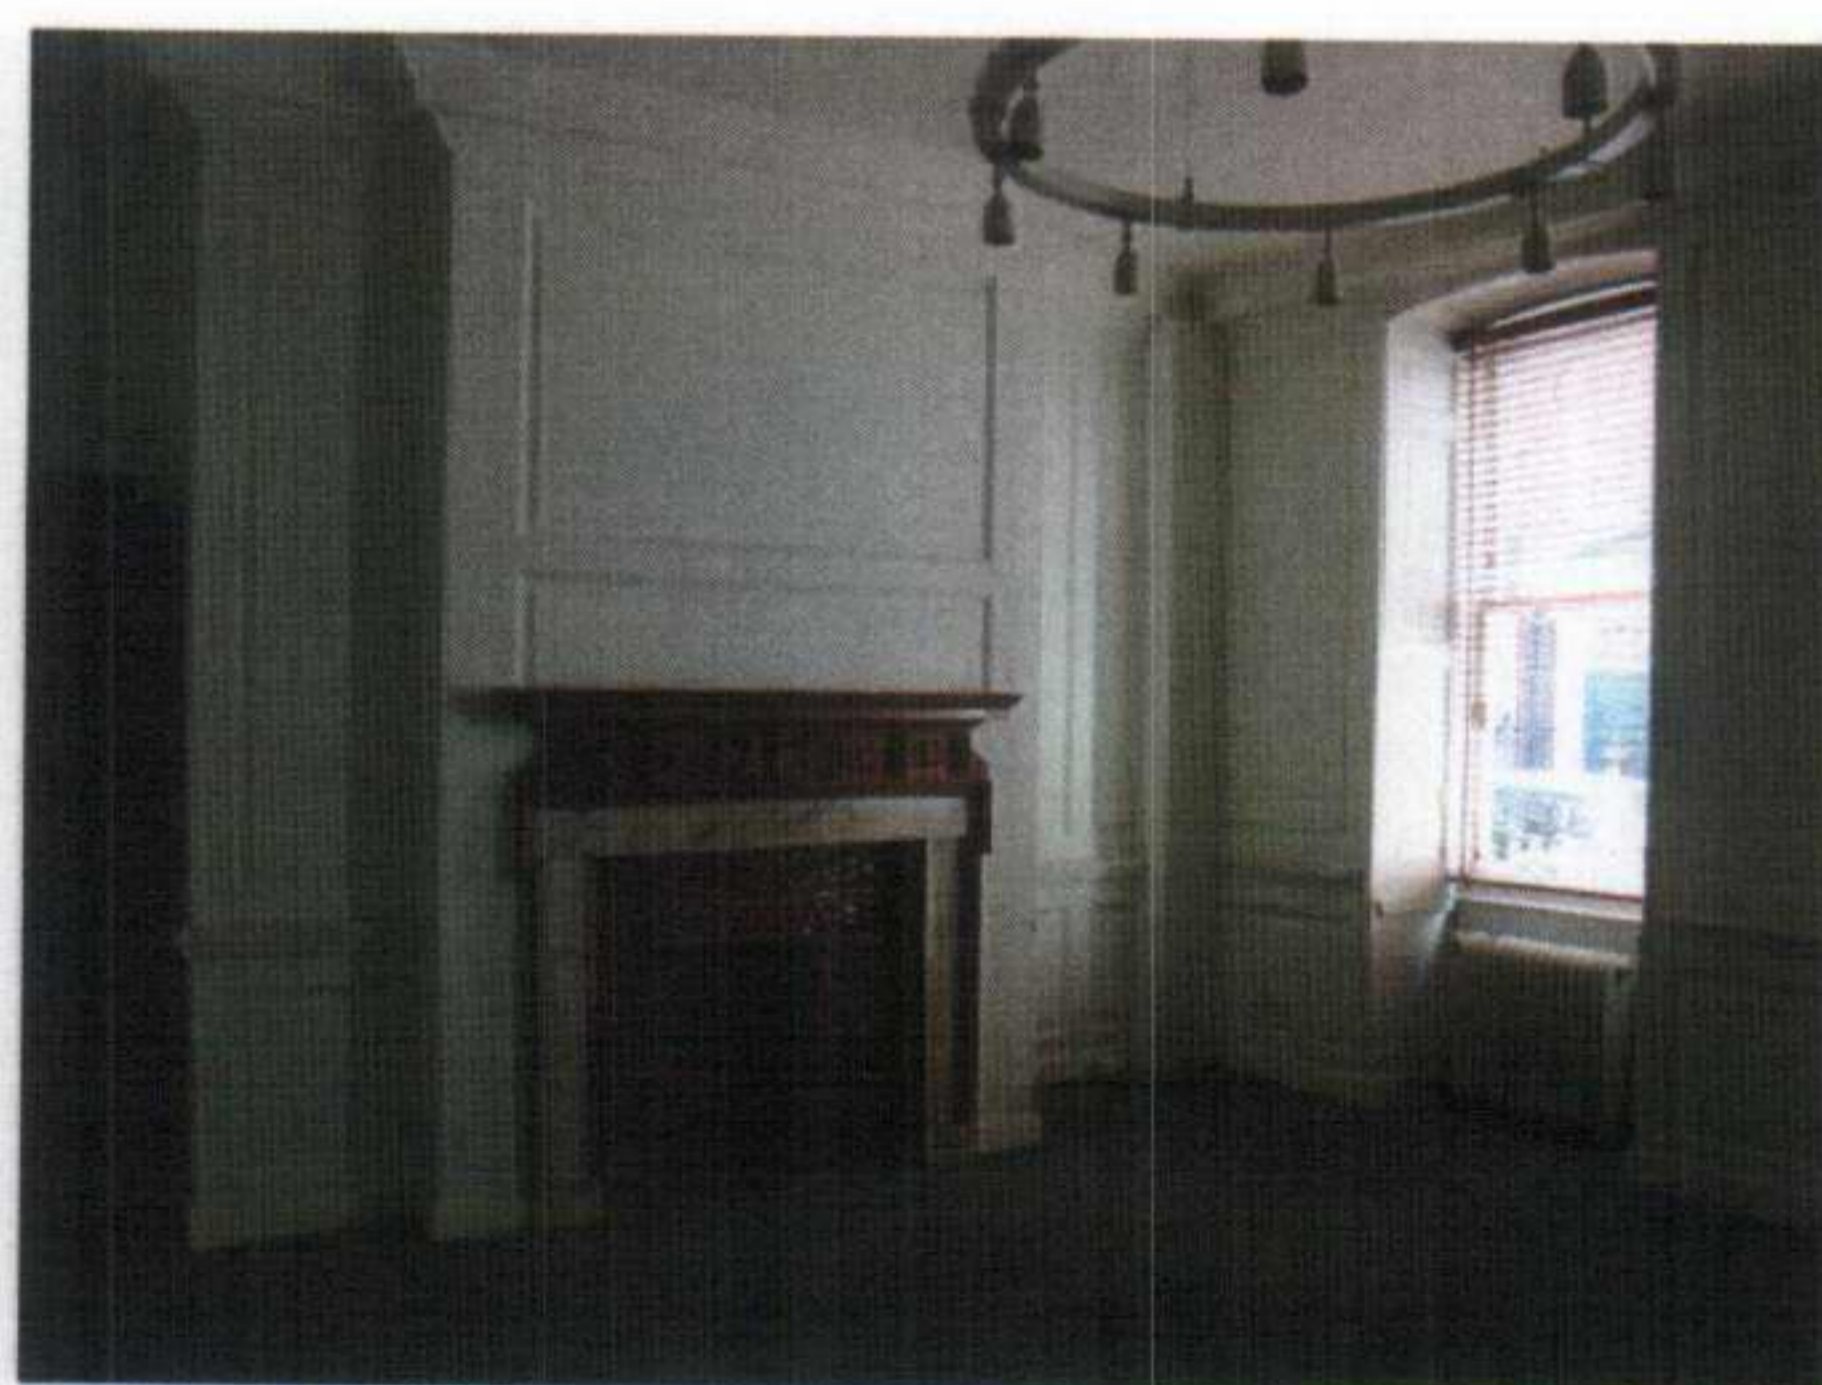
Figure 36
Room B6, duct to corner to be removed, modern tiled insert to fire surround to be replaced with appropriate insert.

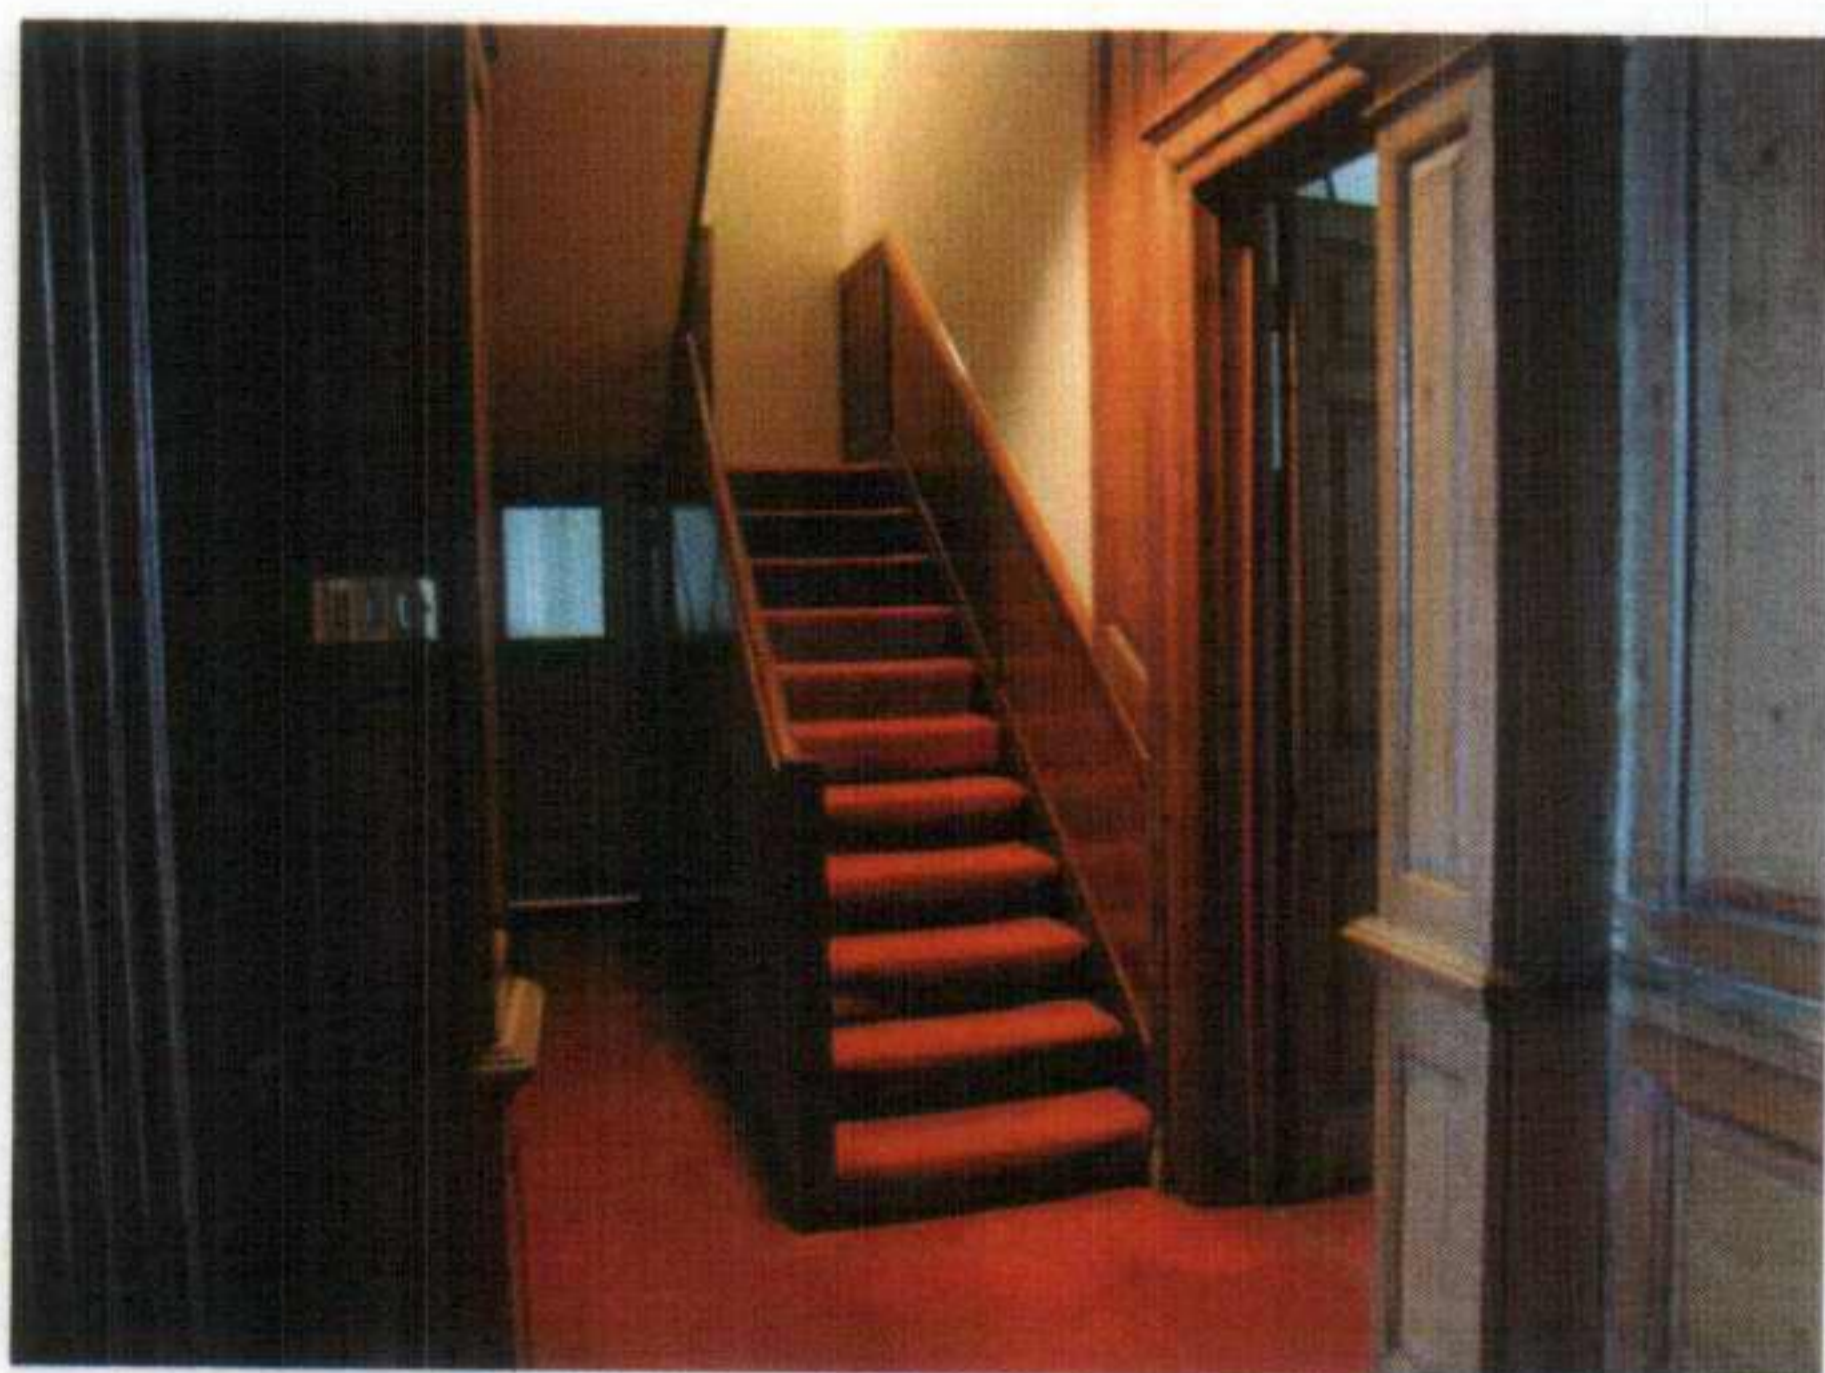
Figure 37
1920's staircase to no.12. Balustrade to be replaced with polished oak handrail and glass panels below.

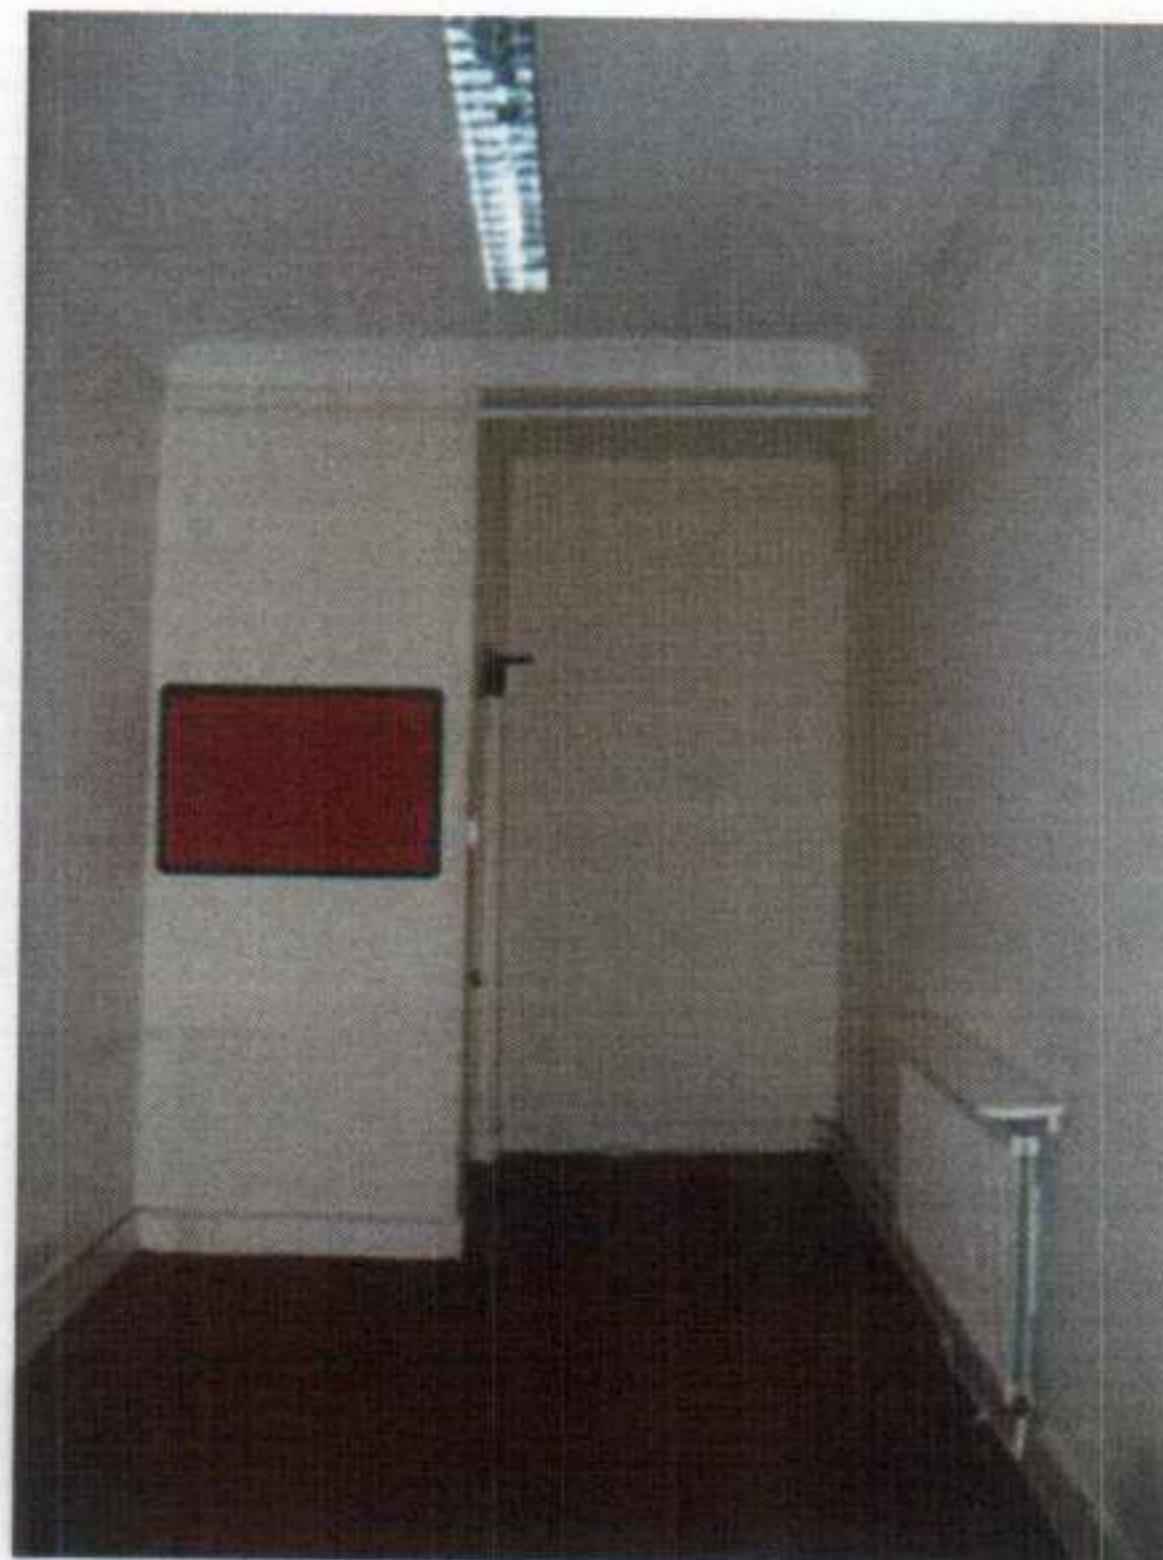
Figure 38
Room S5, No panelling, proposed new bathroom and dressing room to be formed within space.

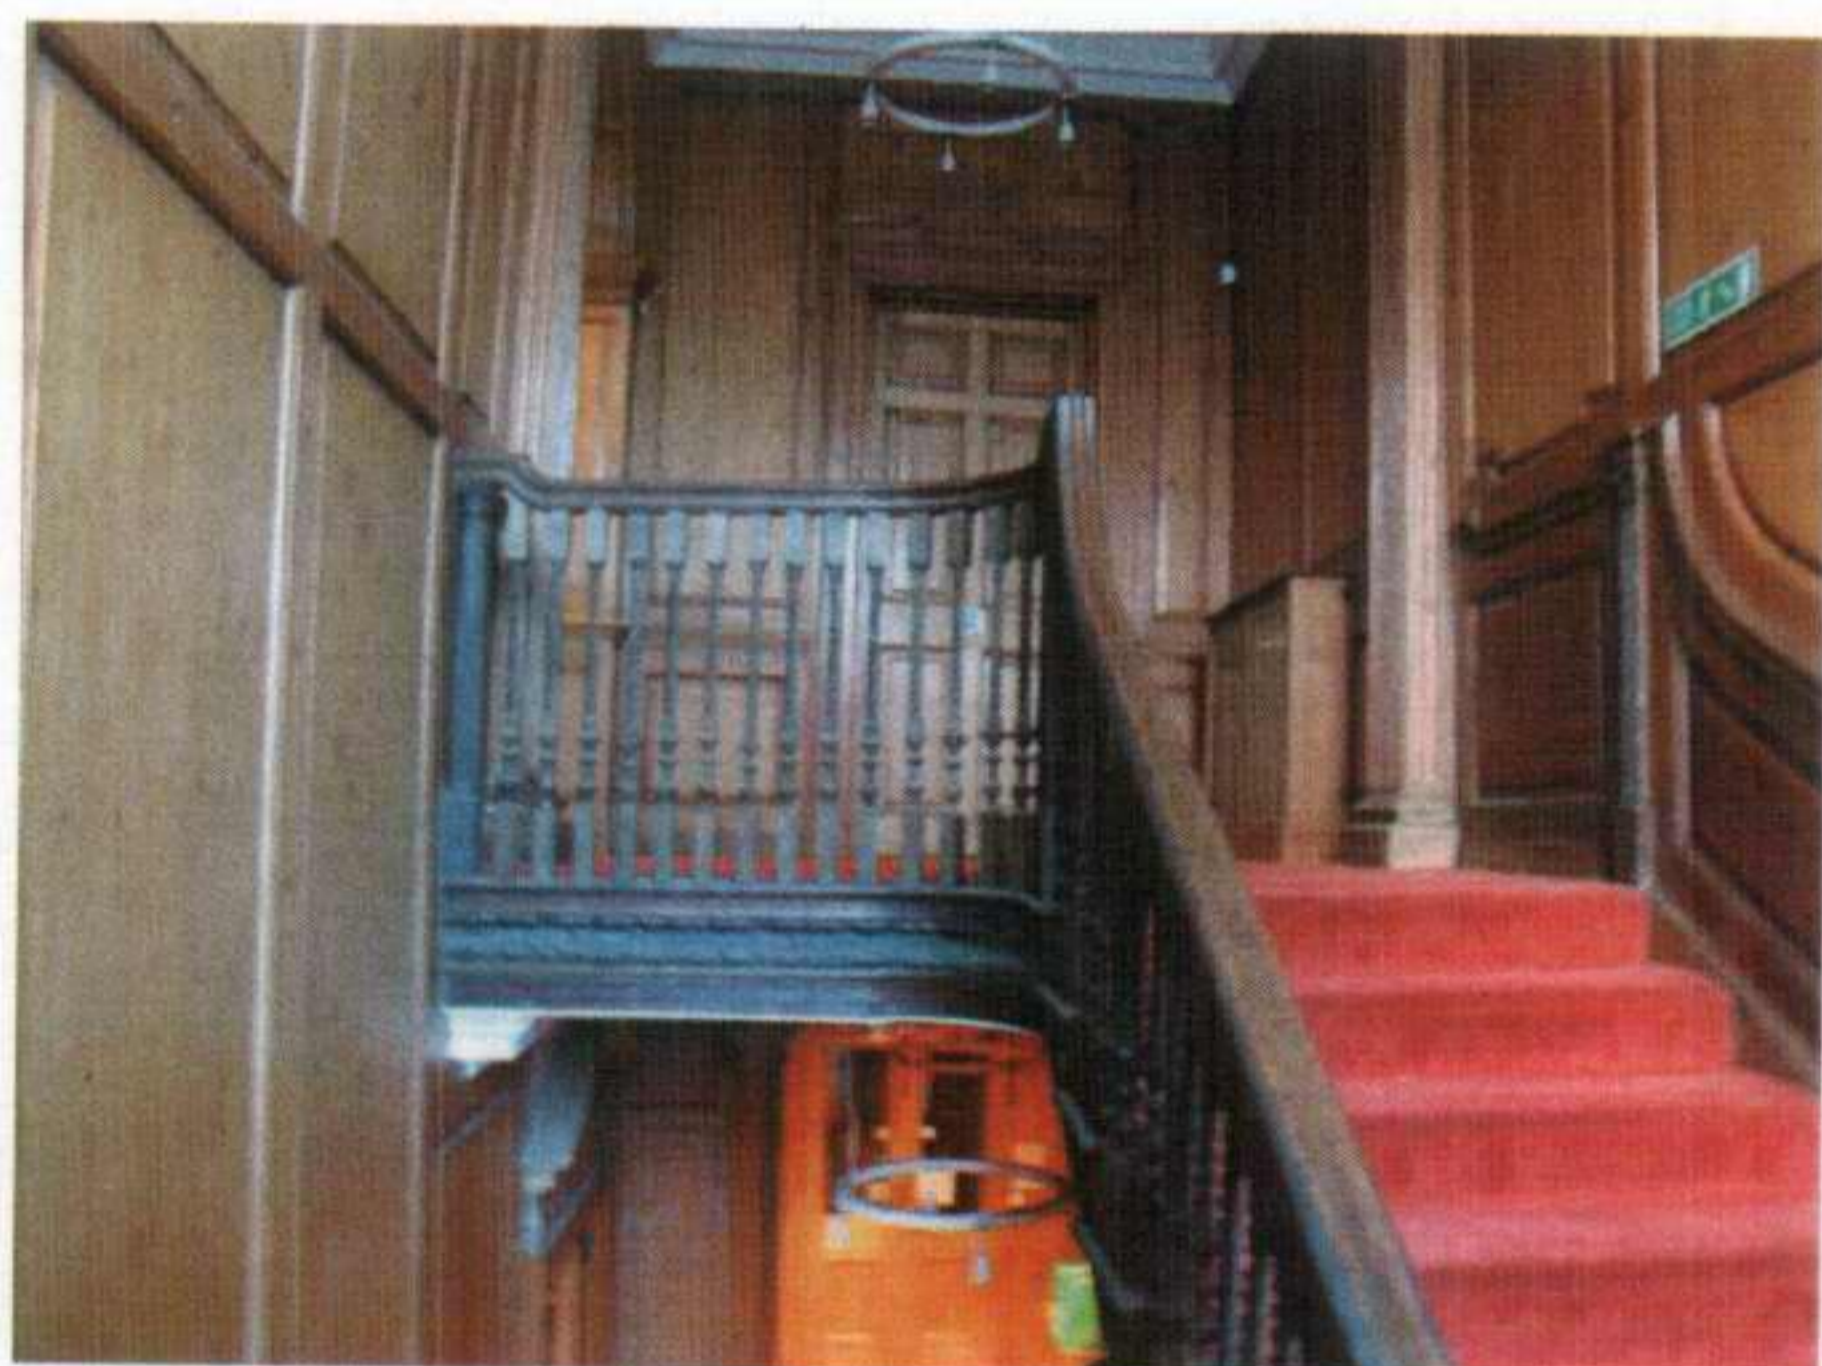
Figure 39
Polished oak balustrade, handrail and below dado panelling to stair to no. 12. Stripped panelling above dado to be re-painted.

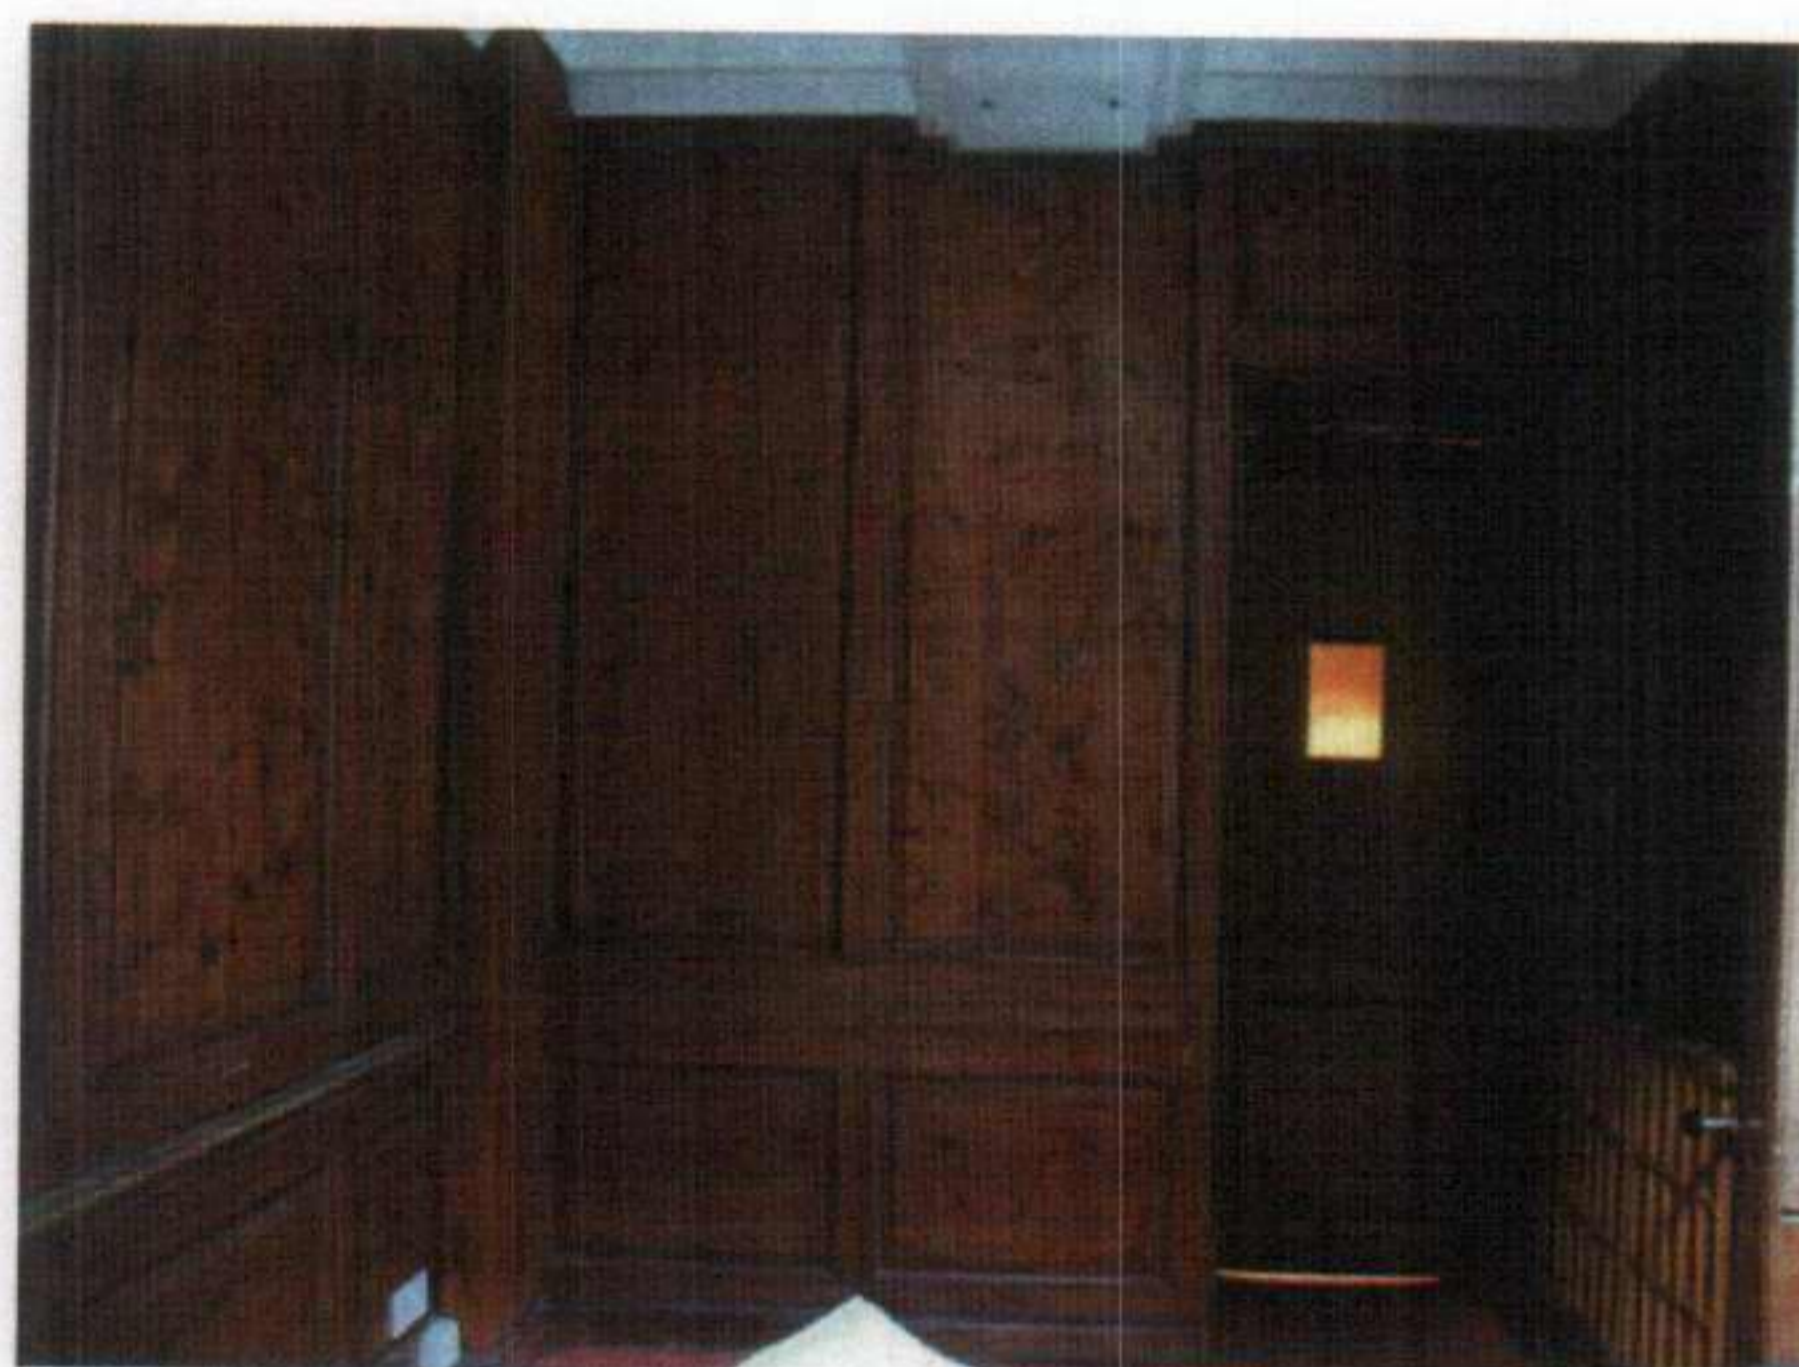
Figure 40
Room S7 stripped panelling to be repainted. Riser position to remain

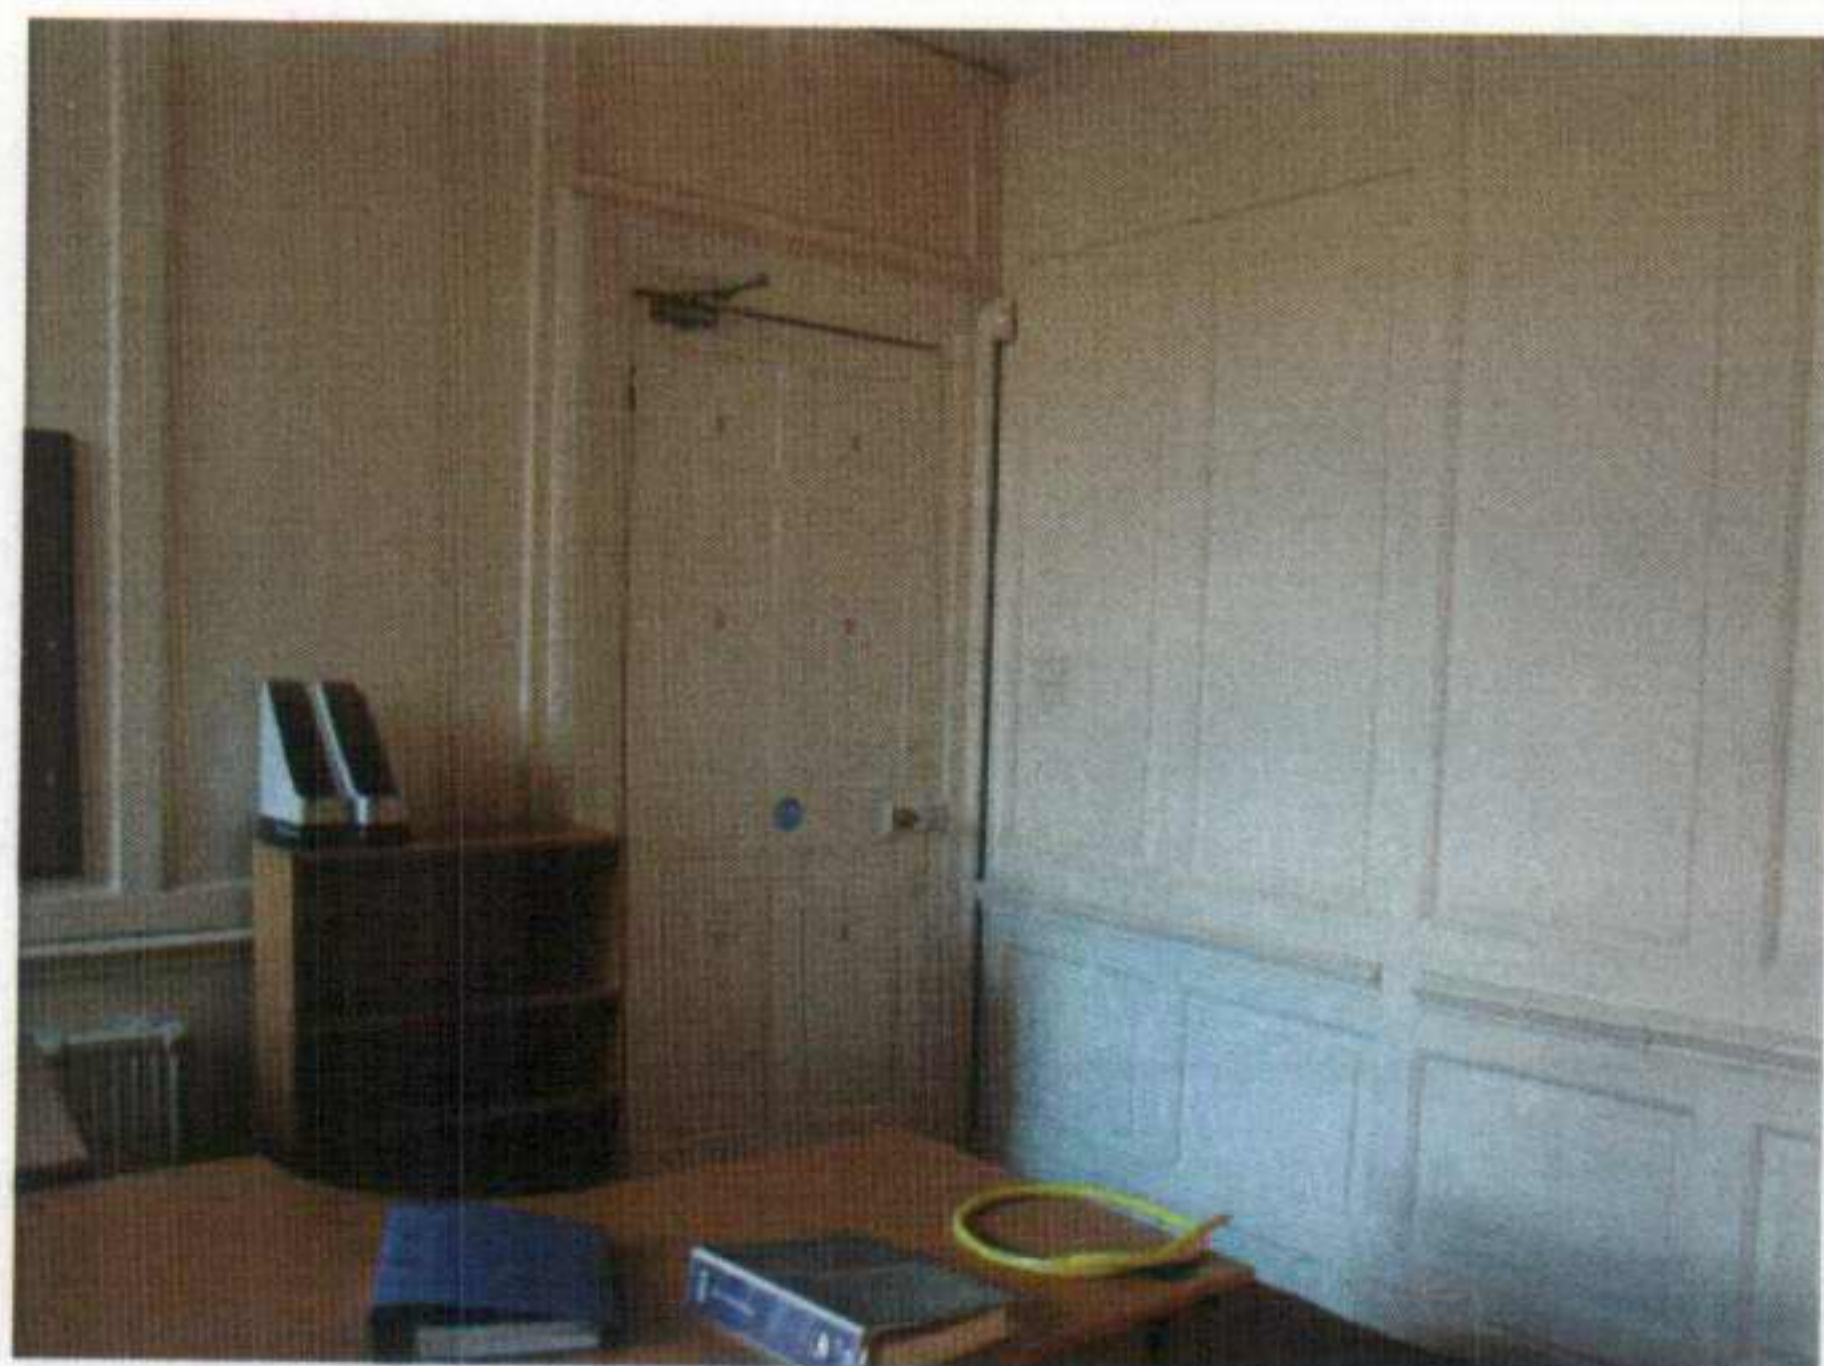
Figure 41
Room F19. Where overpanelling occurs, panels to be carefully removed to see if any original panelling remains below.

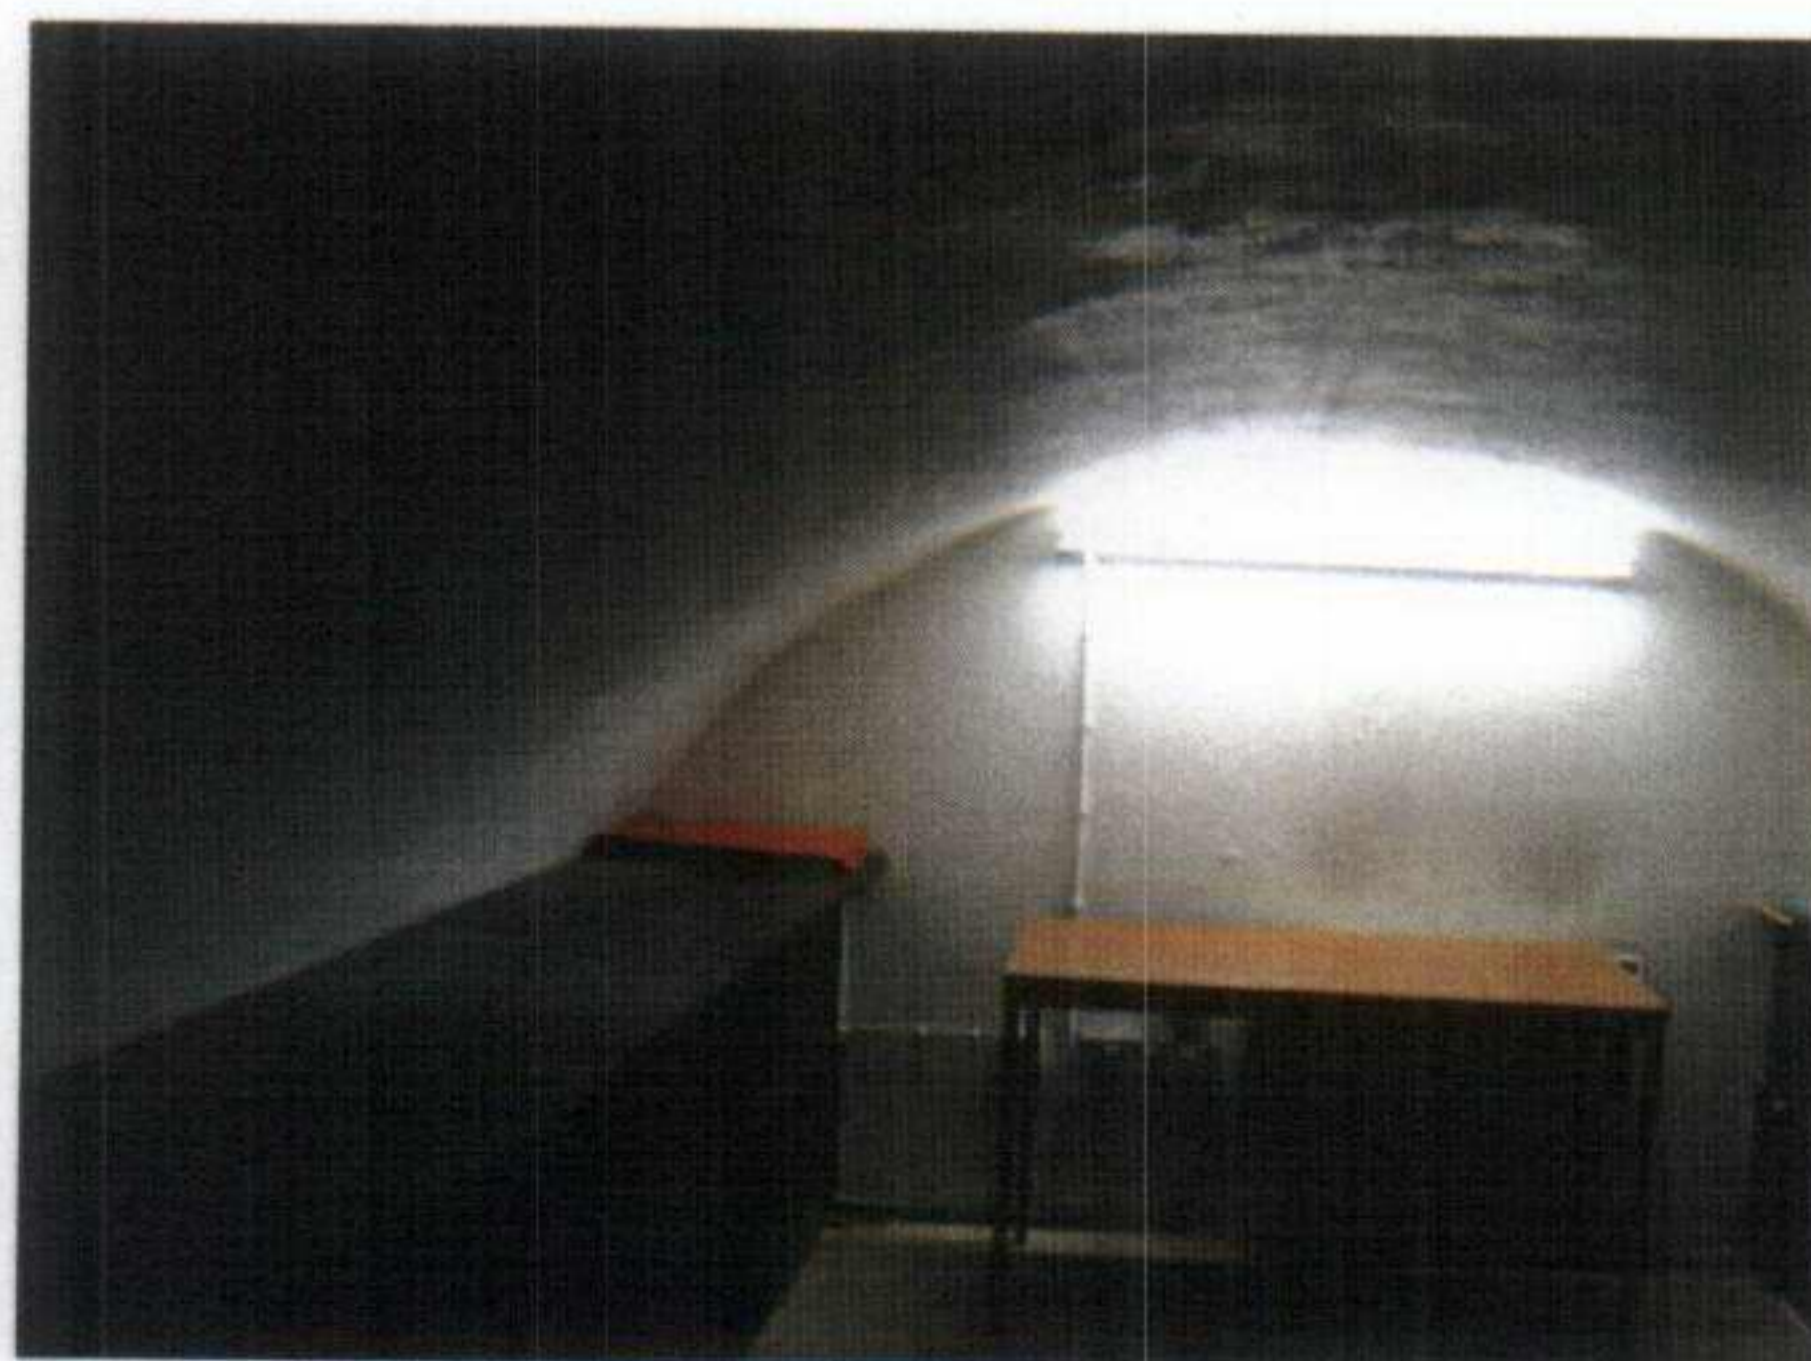
Figure 42
B25, existing pavement vaults, recently refurbished

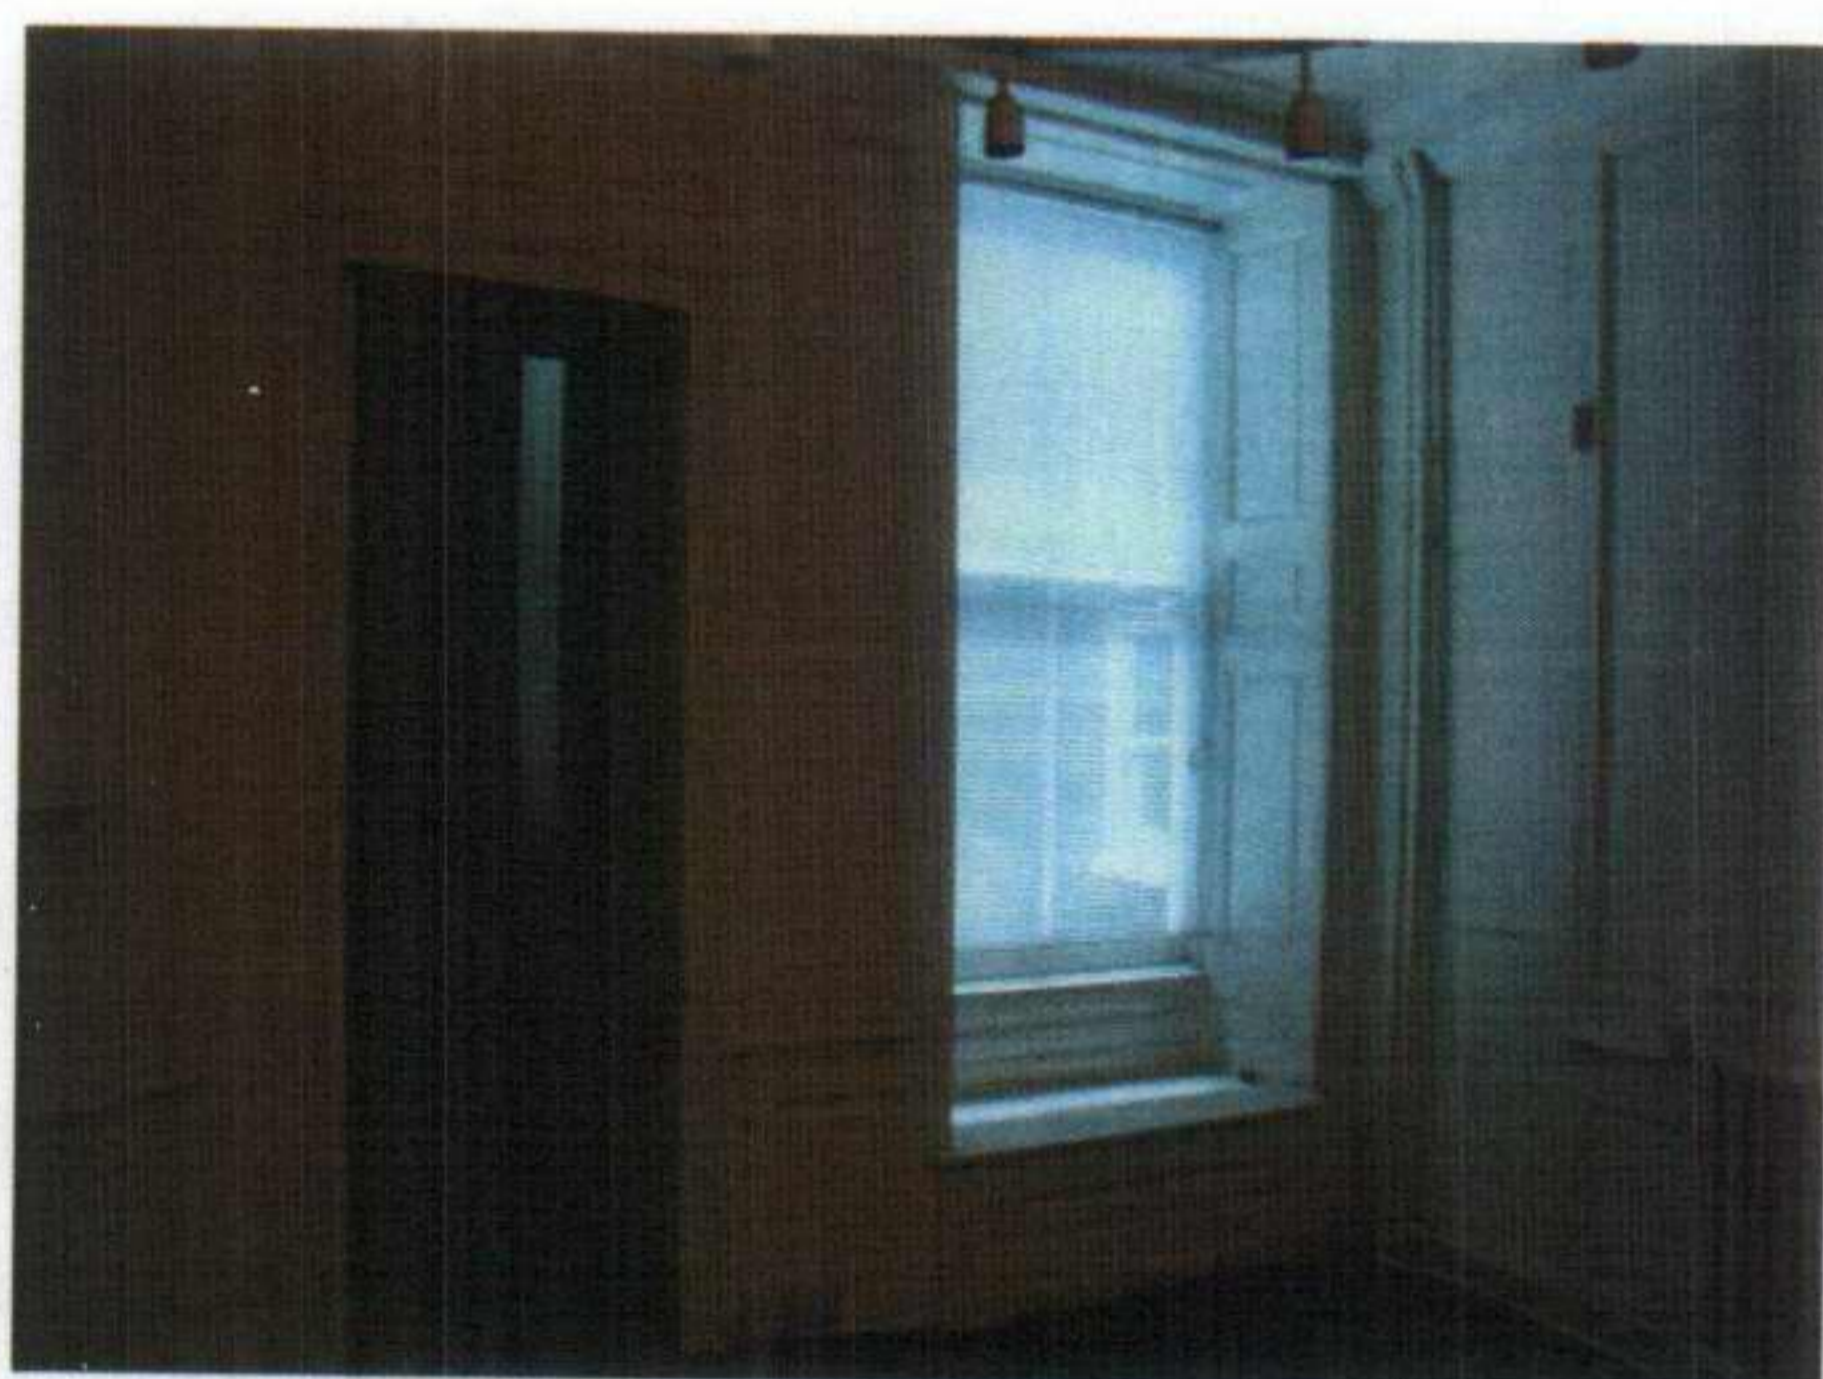
Figure 45
Room G20, pipes to be removed and existing door re-opened from stairway to basement

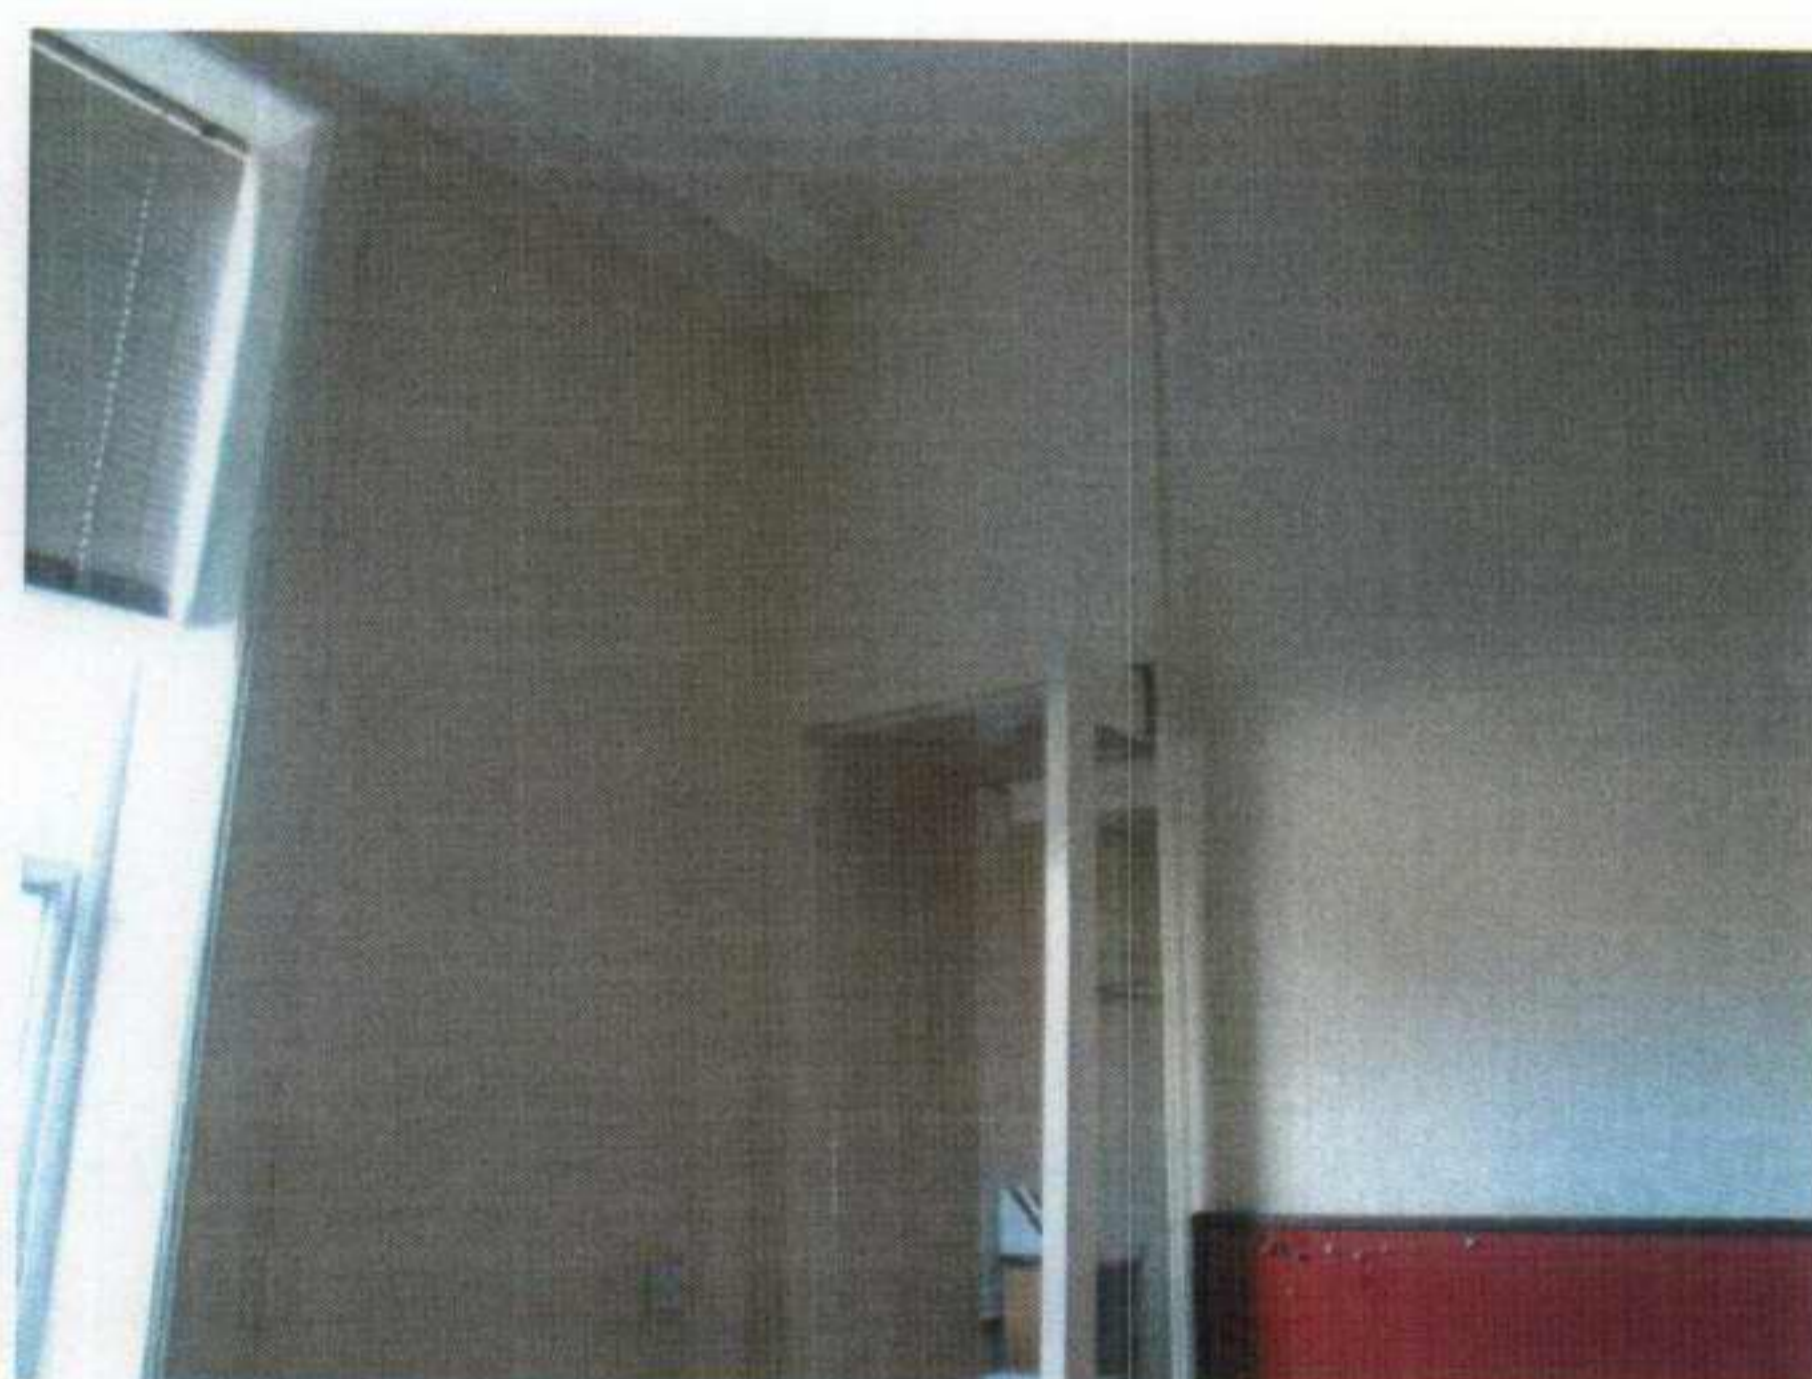
Figure 46
Riser located on plain walls to room F18
