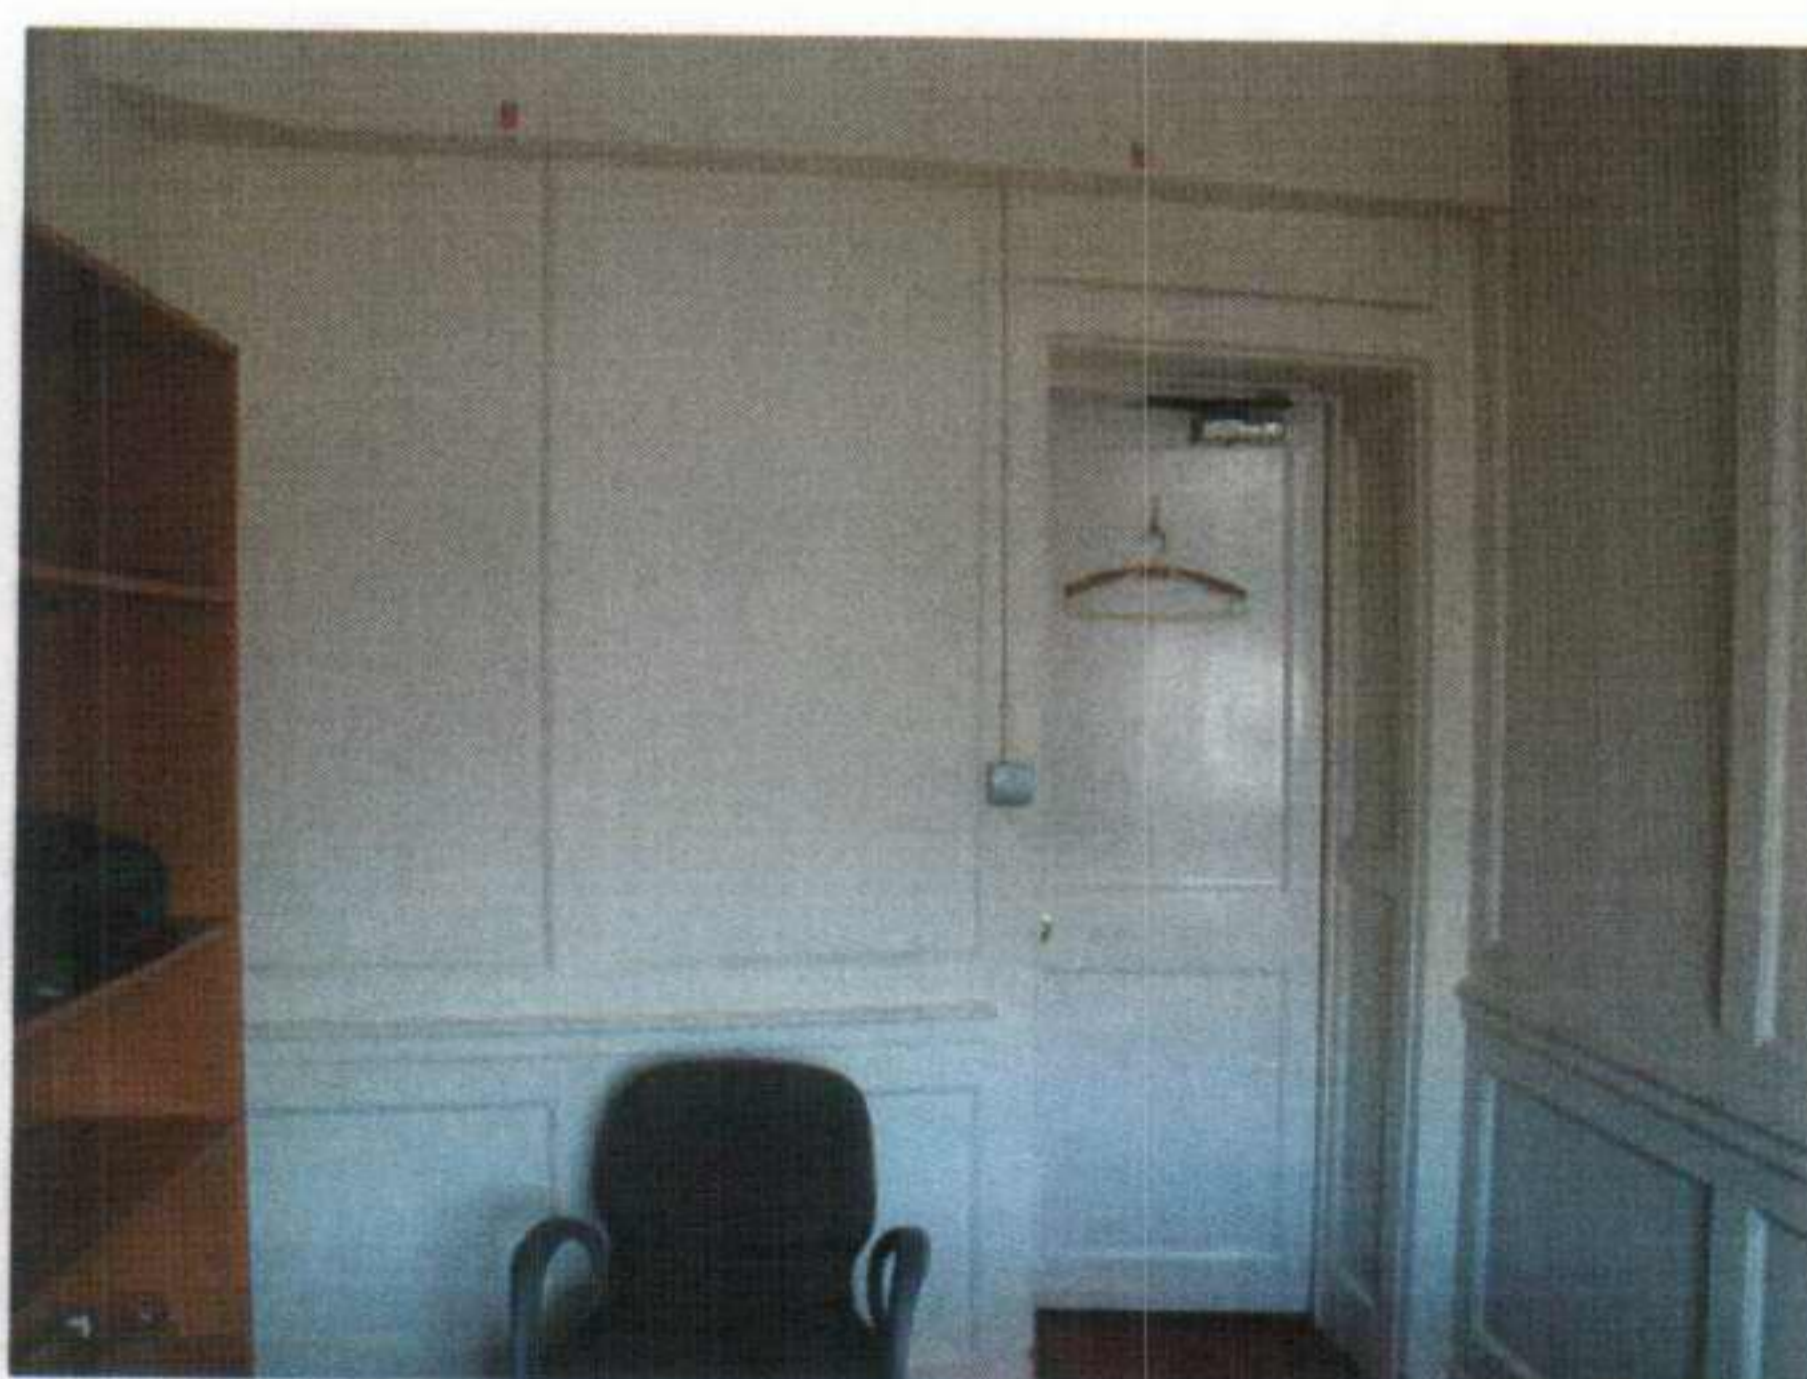
Figure 48
High level ducting to be removed and riser located in corner to room S7
