TREE SURVEY and ARBORICULTURAL METHOD STATEMENT

A report to accompany a Planning Application for
development on land at 19 Greenaway Gardens, London,
NW3 7DH

Report by Dr Martin Dobson

5 November 2007

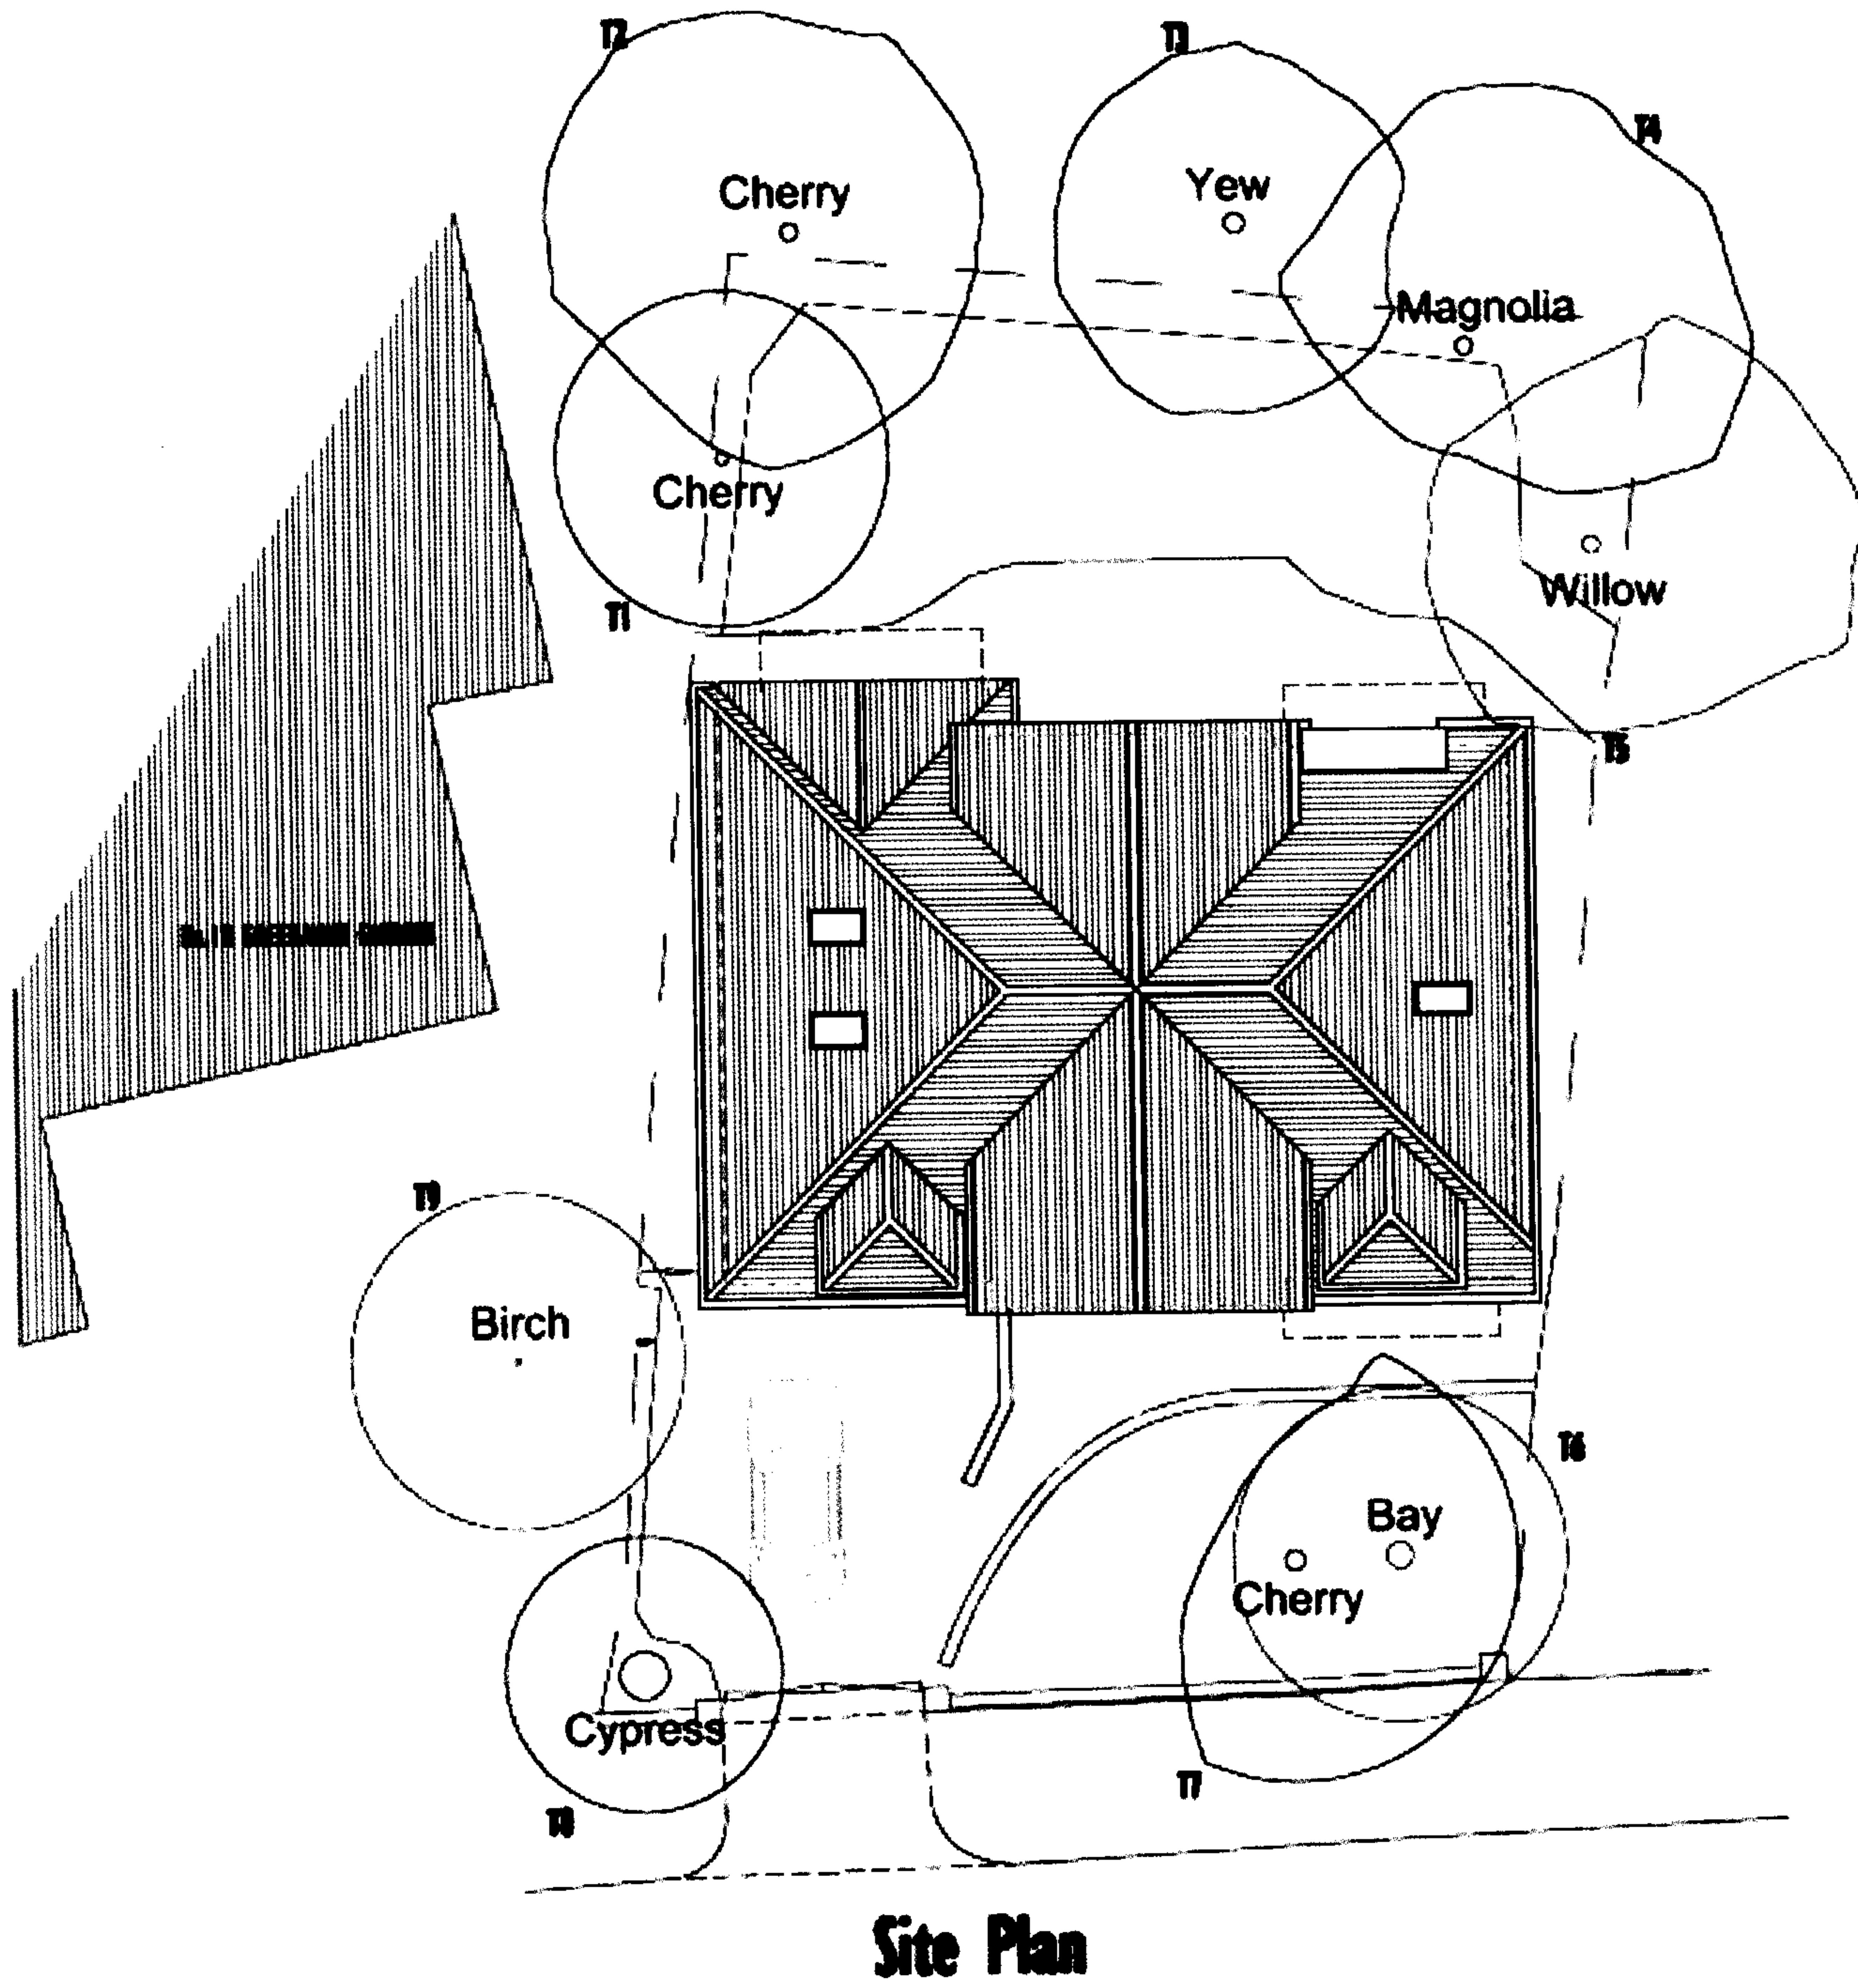
APPENDIX MD2

- 3.1 To the rear of 19 Greenaway Gardens there is a modest sized garden mostly laid to lawn with some trees and shrubs at the edges near to the boundary with properties to the left, right and rear. T1 is a young Cherry with a trunk that bifurcates near to ground level. Its crown has been cut back so that there are few low branches which grow out over the rear garden. It has little public amenity value since it is small and relatively insignificant, but it provides screening

between the garden and the neighbouring property at No. 18. T1 has been given a C grading indicating that it is considered to be of low quality and value. T2 is a Cherry in the garden of the property to the rear. Again, it is of little importance other than for screening and has been given a C grading. The Yew T3 is also in the garden to the property backing onto No. 19 and since it is young and relatively small has been graded C. The Magnolia T4 has been cut back very substantially in the recent past and is now a relatively small tree. It has little amenity or screening value and hence has been graded C. The Contorted willow T5 is a larger tree and provides greater scale and thus screening. Since it can be seen from outside the property and thus has some amenity value it has been graded B.

- 3.2 To the front of the property there is a paved driveway to the left (when viewed from the road) and a planting bed to the right contained by a retaining wall on the house side. The planting bed contains a number of shrubs and two trees. The Bay T6 is a substantial tree and tends to dominate the front garden. It is evergreen and therefore provides year round foliage and screening. Since it is of reasonably good form and is visible from the road it has been graded B. The Cherry T7 which is also in the front planting bed appears to be past its prime. Cherry trees tend to be relatively short-lived and their appearance can easily be harmed through injudicious pruning, as is the case here. The tree has been graded C. The Cypress is a large specimen which has previously been topped to contain its size. It dominates the entrance to the drive and will become a nuisance in the foreseeable future due to its substantial growth rate and due to the propensity of its roots to disrupt paved or tarmacked surfaces. The tree may need to be removed in the foreseeable future as it is not well suited to its position and it has therefore been graded C. The Birch in the front garden of the neighbouring property at No. 18 is a healthy young tree with useful future landscape potential and has been given a B grading.

Site survey drawing showing tree numbers and BS5837 colour codes (A – Green, B – Blue, C – Grey, R - Red),

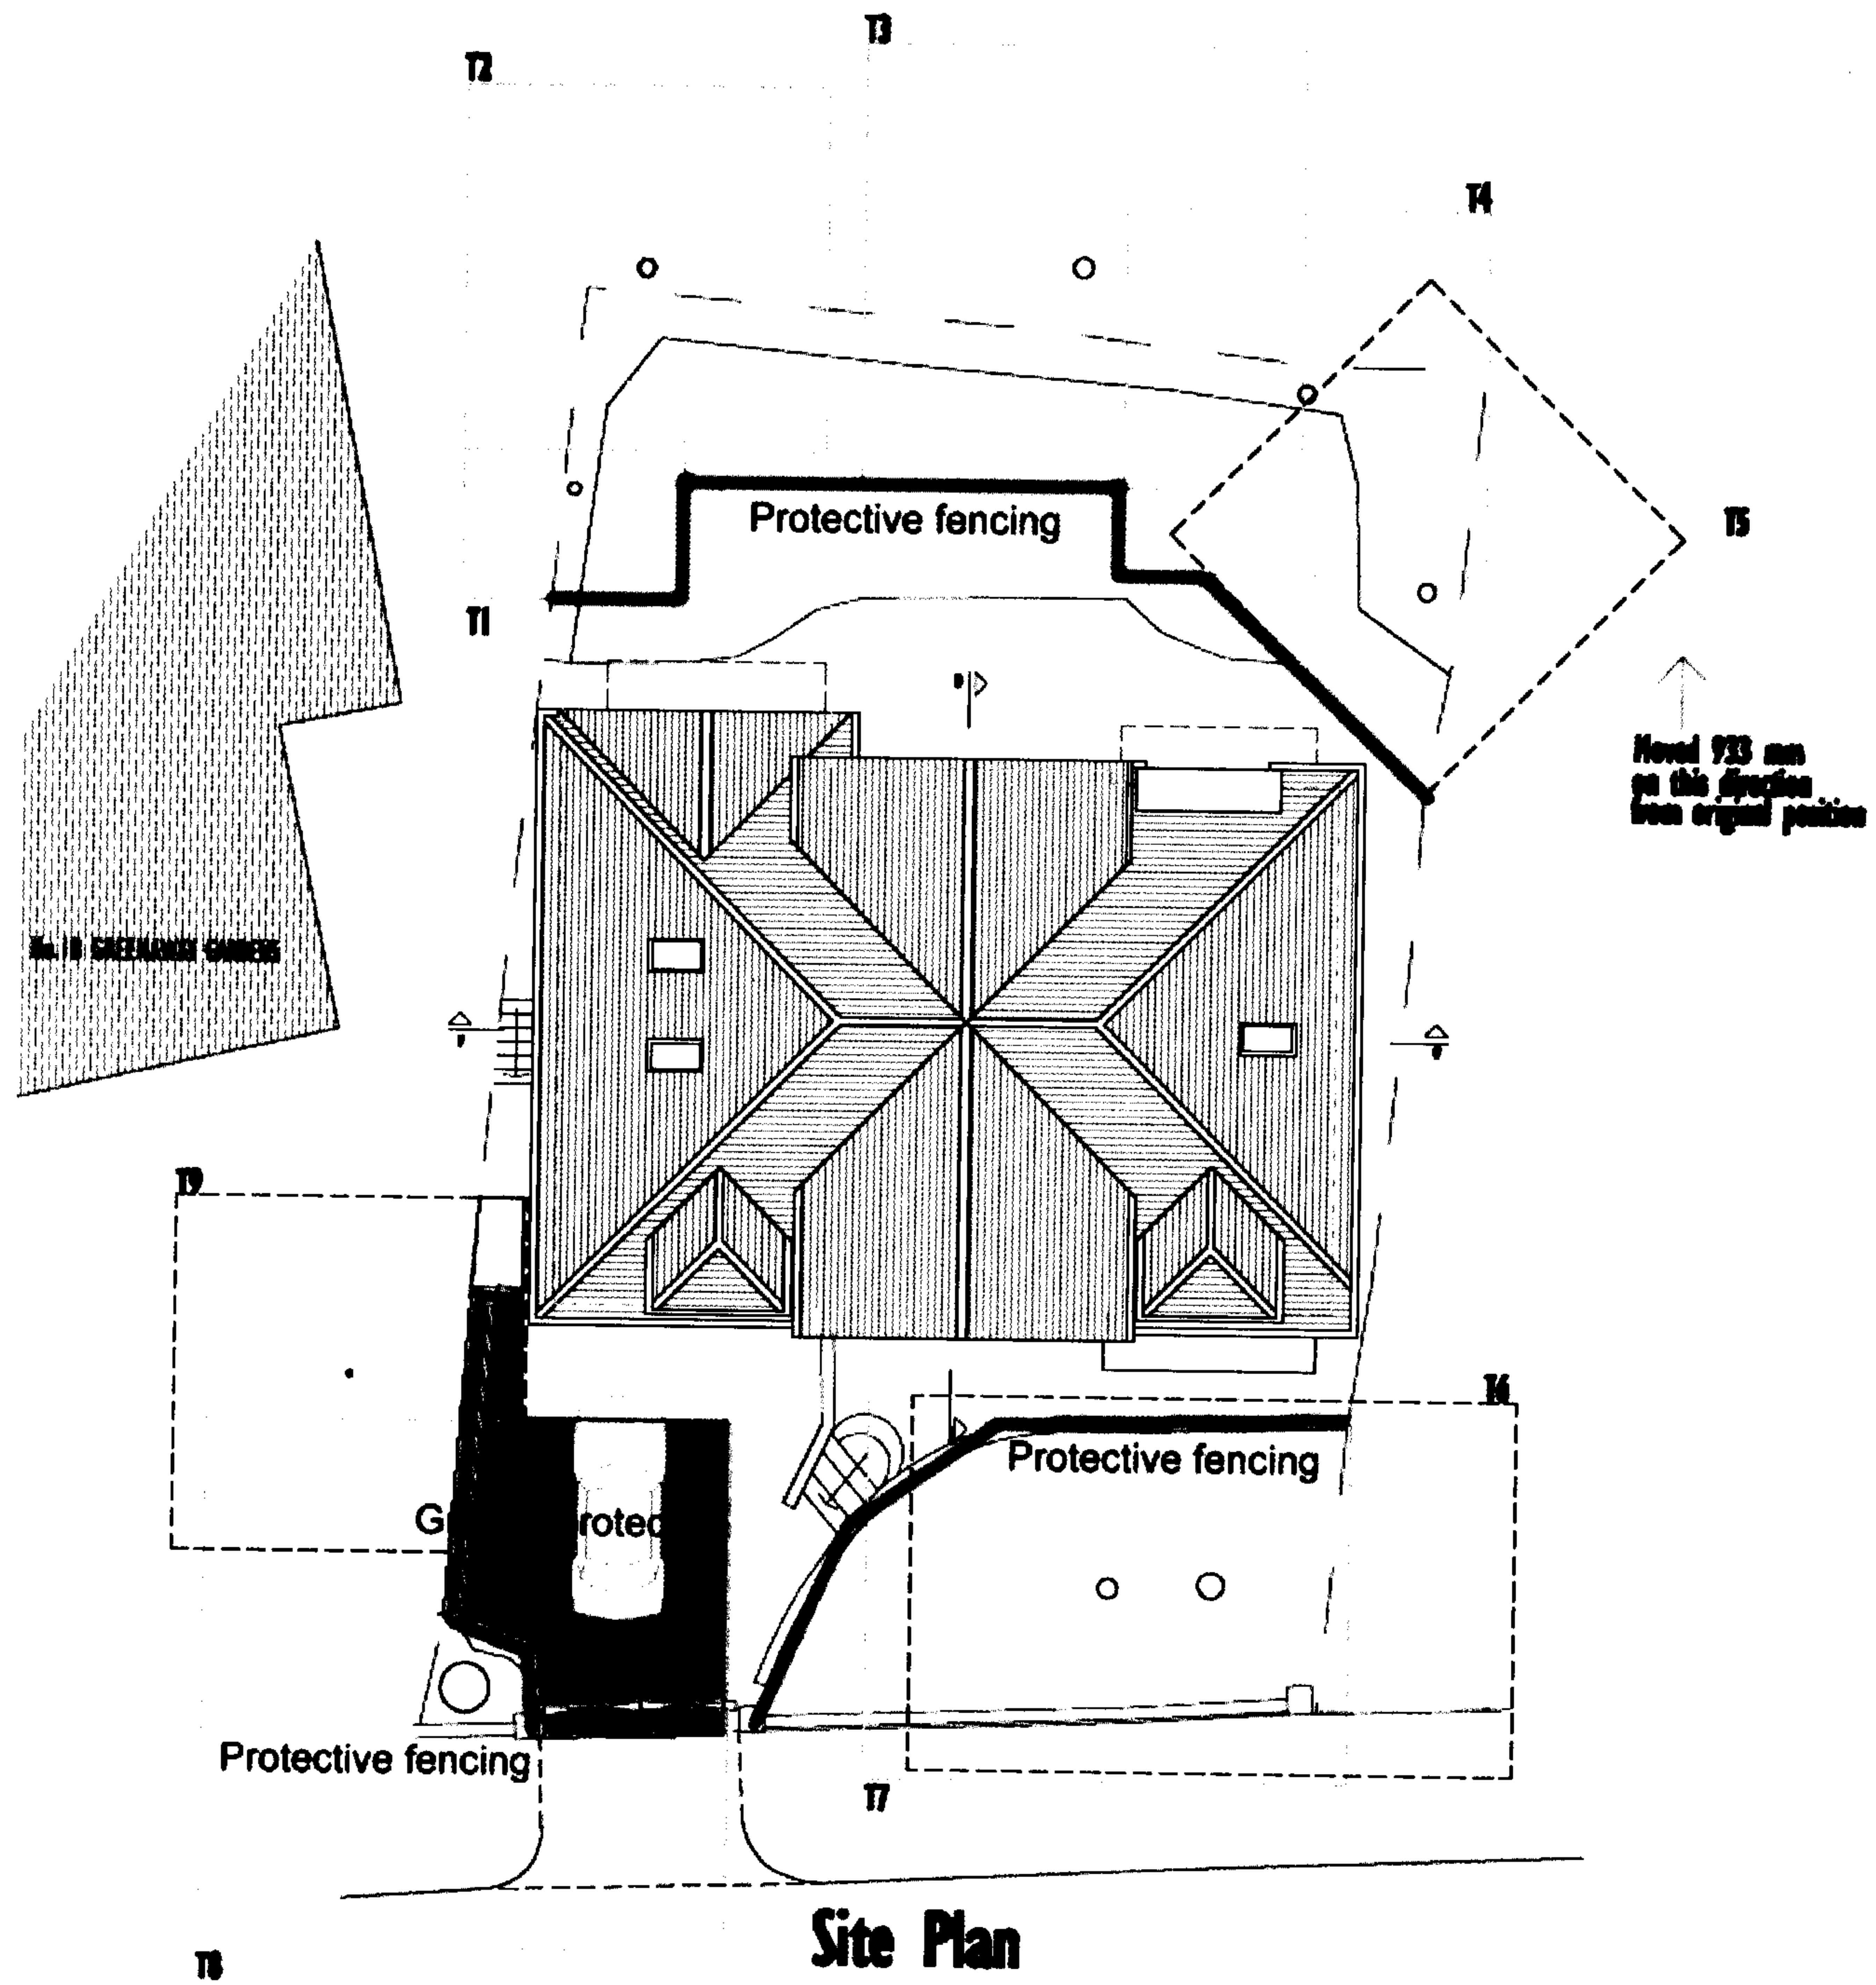
APPENDIX MD3

- 4.5 The British Standard permits at paragraph 5.4.2 (a) that for open grown trees it may be possible to '*offset the distance from the trunk to the edge of the root protection area by up to 20% in one direction*'. Since the root protection area of the Willow (T5) comes close to the proposed excavation the root protection area has been moved by 20% to the east along the east-west axis, but has not reduced its area.

- 4.6 The British Standard permits at 5.2.4 that the shape of the root protection area may be changed from a circle or square but that its area should not be reduced. Given the position of the 1 m tall retaining wall near to the Bay (T6) and Cherry (T7) the most appropriate way of protecting roots of these trees would appear to be to protect the entire raised bed. It is likely that the most significant roots will be contained within the bed and few will be found at the lower level underneath the paving leading to the front door. Thus, the protection areas for each tree have been displayed as rectangles and the fencing has been positioned such that it encompasses the entire planting bed. Even so, roots outside the fencing should be protected in that the ground is covered with paving and will thus resist compaction.

- 4.7 For the Cypress (T8) and Birch (T9) the ground, and consequently roots, is protected by the paved driveway surface. Fencing is therefore not considered necessary, other than to protect the trunk of the Cypress, as it is not proposed to remove the driveway during construction. The bearing capacity of the drive will be assessed by digging a trial pit prior to construction activities commencing. If the paving and sub-base is found to be less than 300 mm thick an additional temporary 'load suspension layer' will be installed above the drive. The load suspension layer will be custom designed by an engineer and will comprise of a 100 – 200 mm thick cellular confinement system such as Geocell or Cellweb. The cellular confinement system will be placed above the existing driveway and be filled with sand or aggregate. Steel sheets will be placed above the cellular confinement system as a wearing and load spreading surface.

Proposed new layout and positions of root protection zones (dashed lines), protective fencing (thick black line) and ground protection zones (purple).

- 5.1 The sequence of events on site is described below and methods necessary to avoid damage to tree roots and/or branches are detailed.
- 5.2 Before any construction work takes place on site the protective fencing and ground protection will be installed in the positions shown at **MD3**. This will be approved and checked by a competent arboriculturist.
- 5.3 Once tree protection is in place then excavation and construction can begin. Fencing should not be taken down under any circumstances during construction unless with the express approval of the Council.
- 5.4 Once construction has demonstrably finished (to the satisfaction of a competent arboriculturist) the fencing and ground protection may be removed in order to allow final landscaping to be undertaken. Landscaping should not involve any changes in soil levels or the digging of any trenches.
