# 21 CHURCH ROW LONDON, NW3 6UP

# DAMP PROOFING INVESTIGATIONS

PREPARED BY STEPHEN LEVRANT HERITAGE ARCHITECTURE LTD

JULY 2007

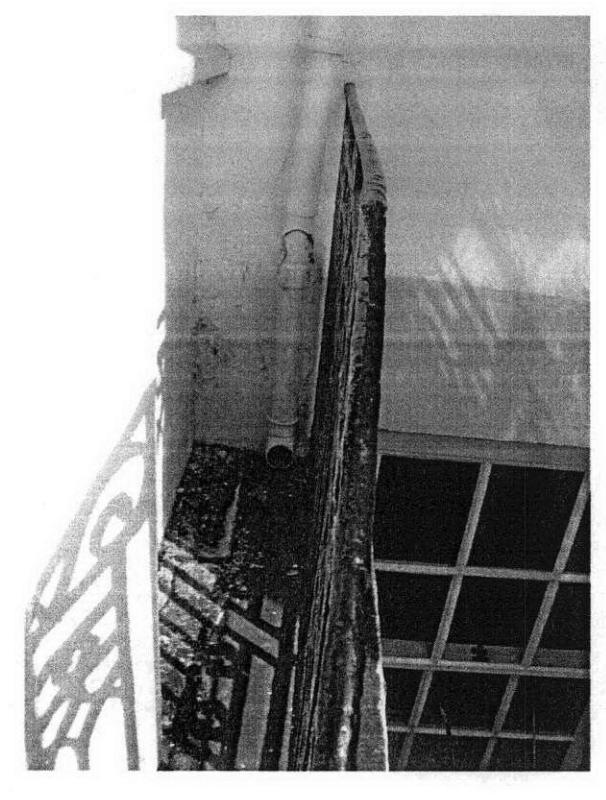
Area 1: RWP adjacent to enclosed rear porch, joints broken, open joints on paving flags.

Carefully cut off render plinth behind RWP and clean off.

Lay DPM "Bituthene " or similar, and turn up the wall plinth.

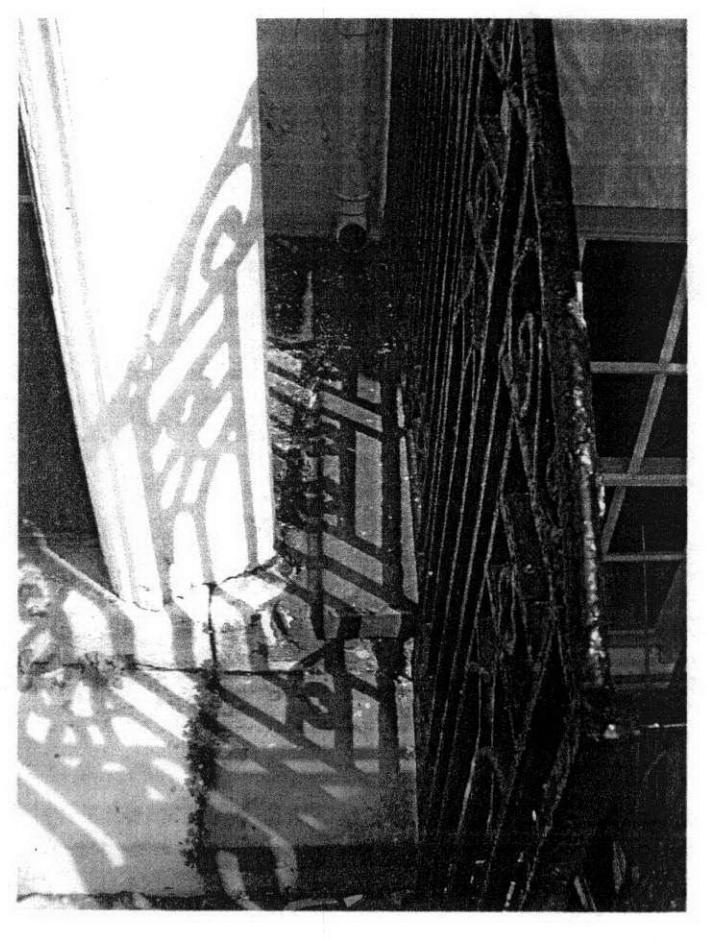
Area 1: Open and damaged joints, vegetation. The corner contains a cast iron column rendered into the walling.

Carefully break out existing joints and lift the flags.

Re-lay existing stone flags and seal at joint with porch base, using in elastomeric mastic.

Repoint joints flush with 1:2:4 cement/lime/ sand mix.

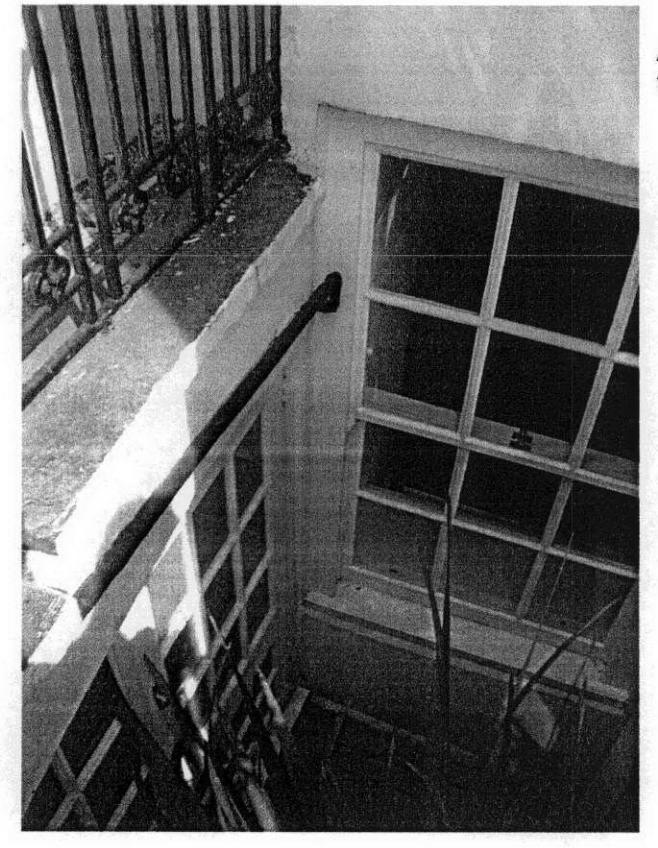
Area 1: Water supply pipe protruding through basement masonry.

Remove duct covers and examine substrate to check for any leak on cold water garden supply pipe.

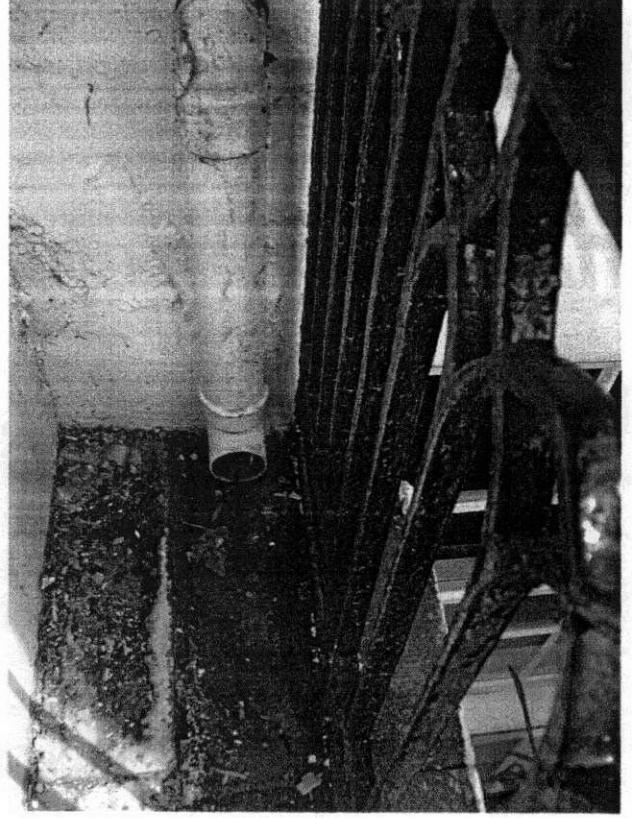
Area 1: Rear porch. Broken RWP shoe, and joints, damp behind paint film.

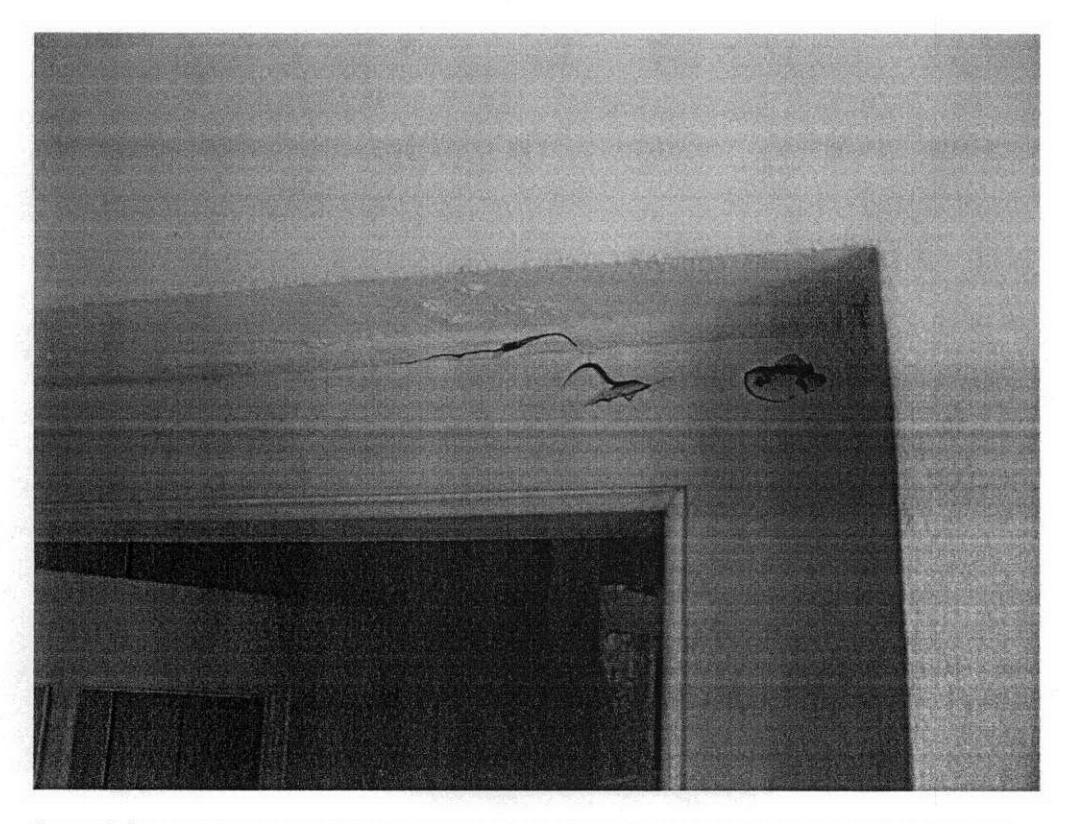
<u>Damp manifestation</u>: Severe rot decay to door frame (non-original) particularly at the head, and at the foot of the frame on one side. Indications of some damp ingress at high-level adjacent to the door but not widespread or virulent eruptions. High meter readings in the timber door frame; zero or very low at high-level on the surrounding rendered finish.

Area 1: Internal advanced dry rot above door head, in vicinity of RWP outlet above.

Remove door and frame set aside door for refixing as per listed building consent. Examine the substrate fixing to the door frame to determine, or confirm, routes of water ingress.

Supply and fix new hardwood door frame to match existing fixed to grounds by specialist to ensure dampproofing continuity.

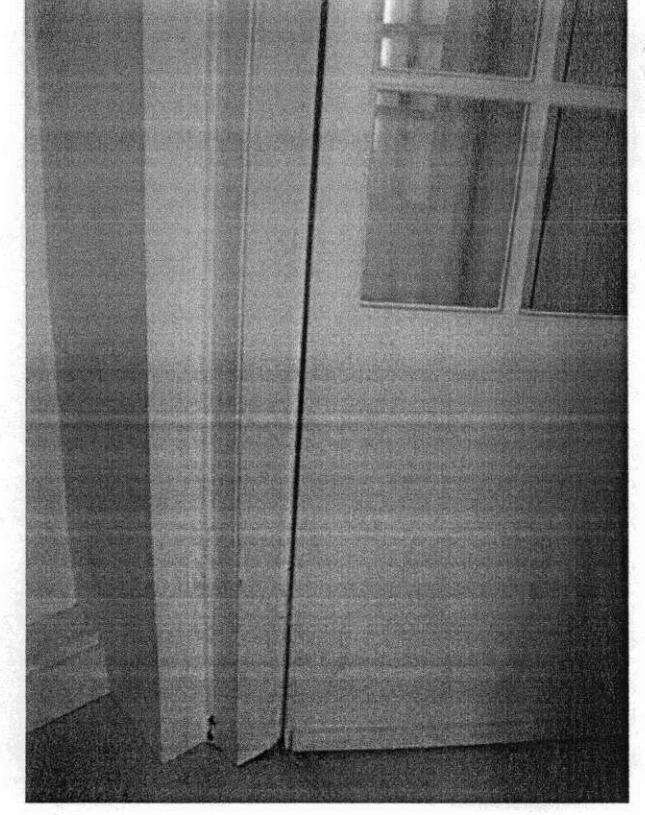
Area 1: Dry rot decay at base of door frame.

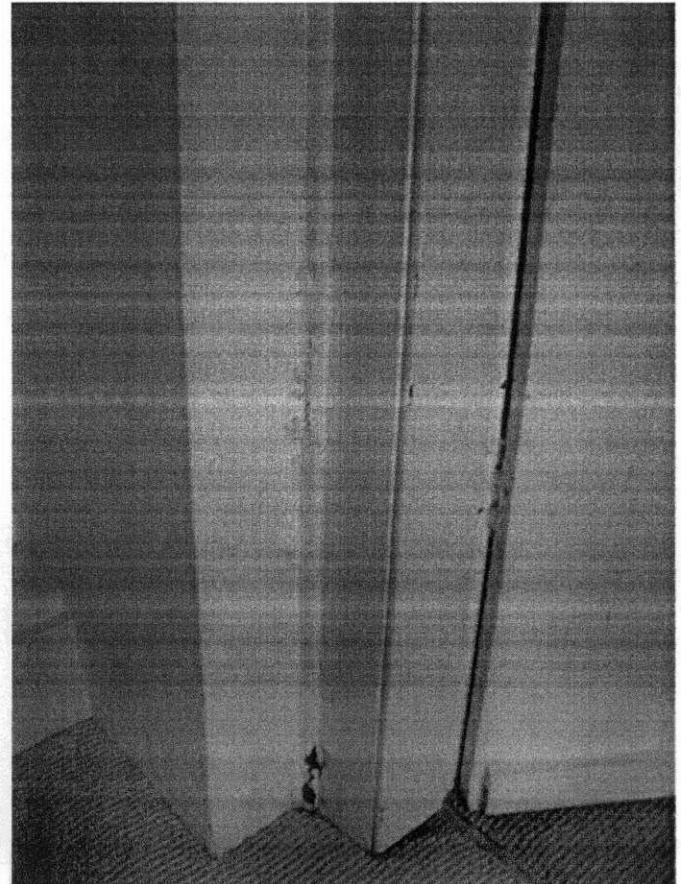
Area 1: Rot decay at base of door frame.

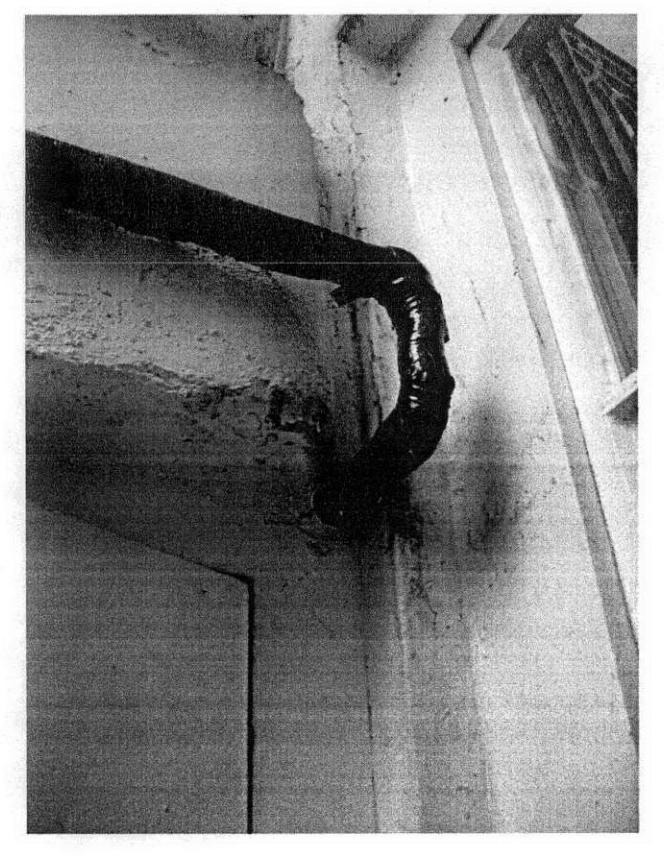
Area 1: Garden hose supply pipe through masonry. Note previous repairs and damp.

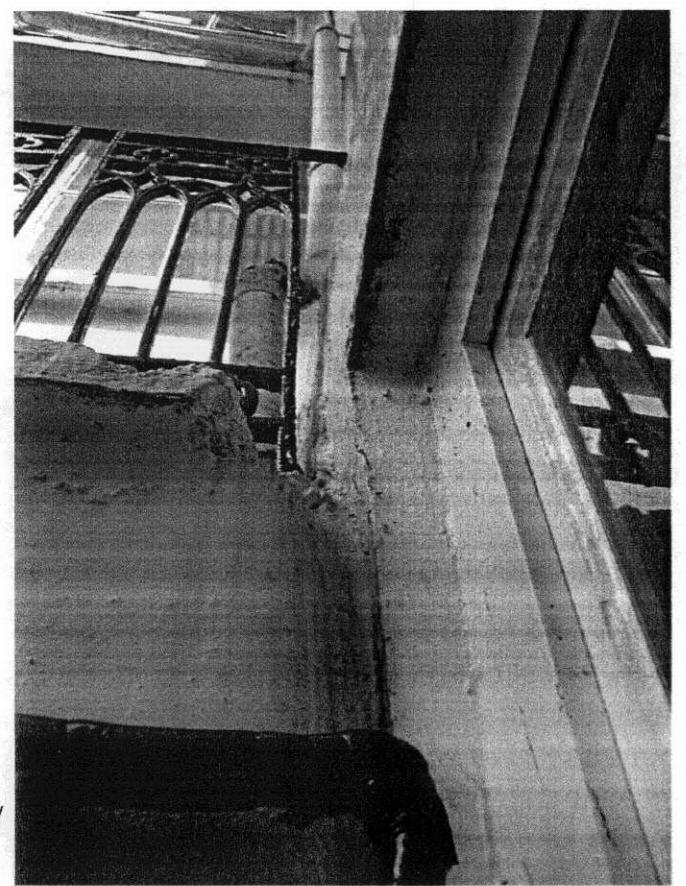
Area 1: Broken flag immediately adjacent to RWP outlet.

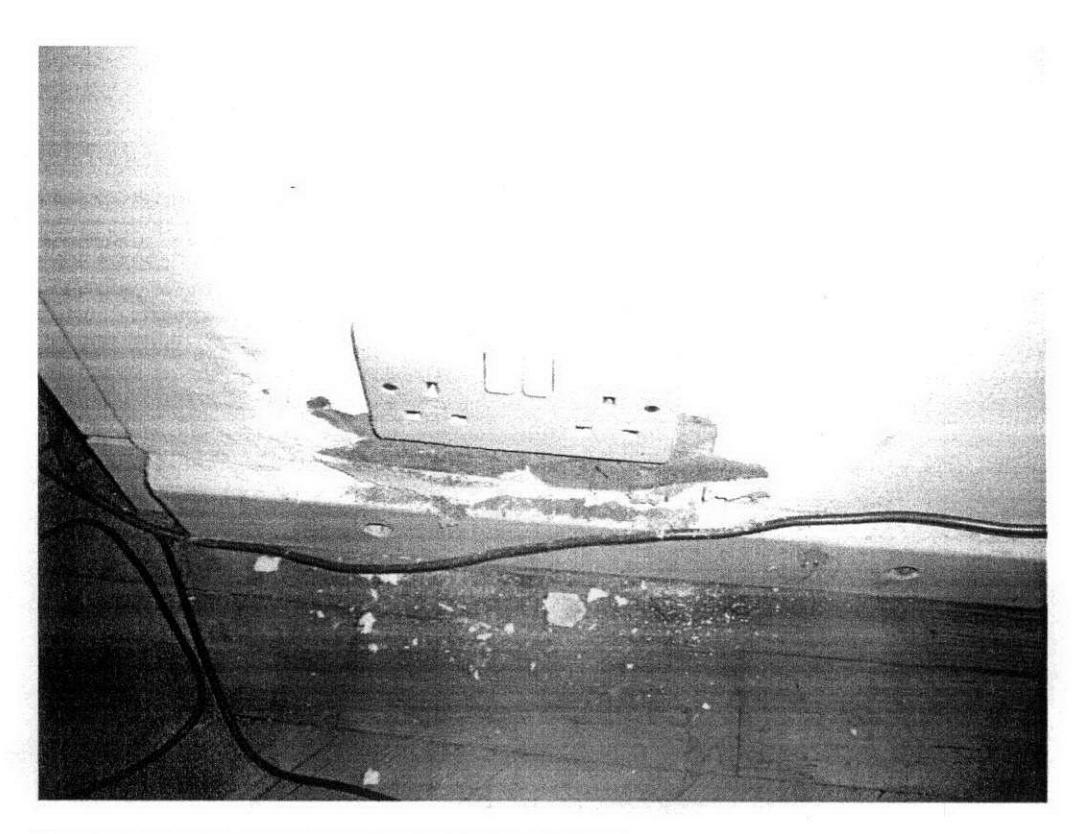
Signs of damp break out around electrical socket outlet at low level on chimney breast. High damp meter readings in the vicinity, but locally. Damp proof lining or other medium existing on the wall surfaces throughout.

Probable piercing of existing proprietary damp proofing medium due to fixing of socket outlet.

Area 3: Damp manifestation around socket outlet.

Remove area of wall finish to examine substrate.

Allow for local repairs to damp proofing medium to match existing and ensure continuity, including insertion of new fixing grounds as required. All by specialist.

Make good and redecorate throughout.

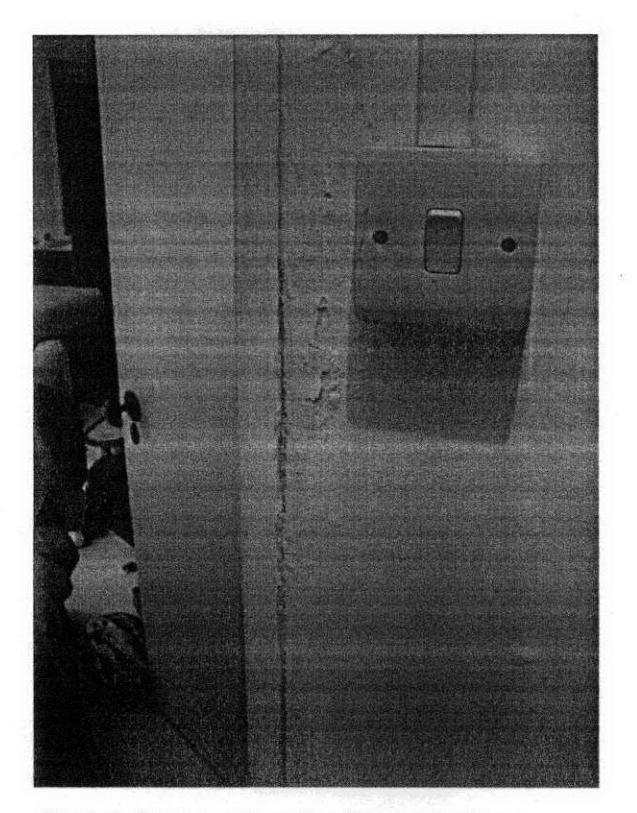
Area rendered throughout in hard cementitious, possibly proprietary waterproofing system. The adjacent boiler room has extensive pipe work and systems for the boiler and water distribution throughout the house. There is no indication of damp ingress from a higher level, nor any possible or obvious route from the exterior. There are signs in the boiler room of previous water ingress from pipe work or leakage. Probable cause; Pipework leakage possibly still active.

Area 4: Damp outbreak adjacent to door frame to boiler room.

Remove plaster around the obvious damp patch and allow for examination of substrate.

If possible, leave to allow a period of drying out.

Monitor the area for a period of three months; and check all pipework. Re-render and make good in matching proprietary damp proofing system. Redecorate as required.

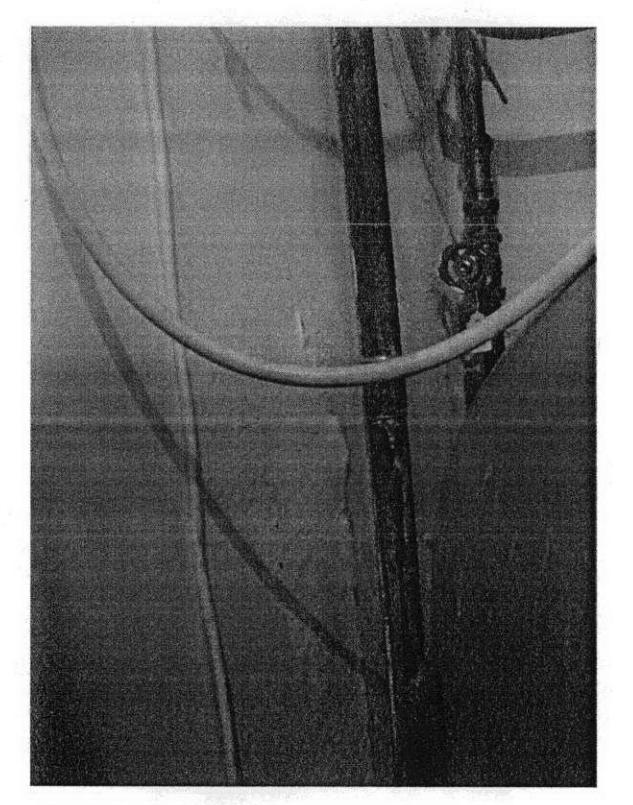
Area 4: Boiler Room, damp behind pipes. Signs of leakage in the past from pipe joints above.

Clean all previous signs of damp staining and run-off staining in the boiler room and pipework.
