Report on Investigations and Required Remedial Works To the Listed Buildings at the former Elizabeth Garrett Anderson Hospital

UNISON HQ, EUSTON RD NORTH London, WC1

December 2006 Ref: L051036

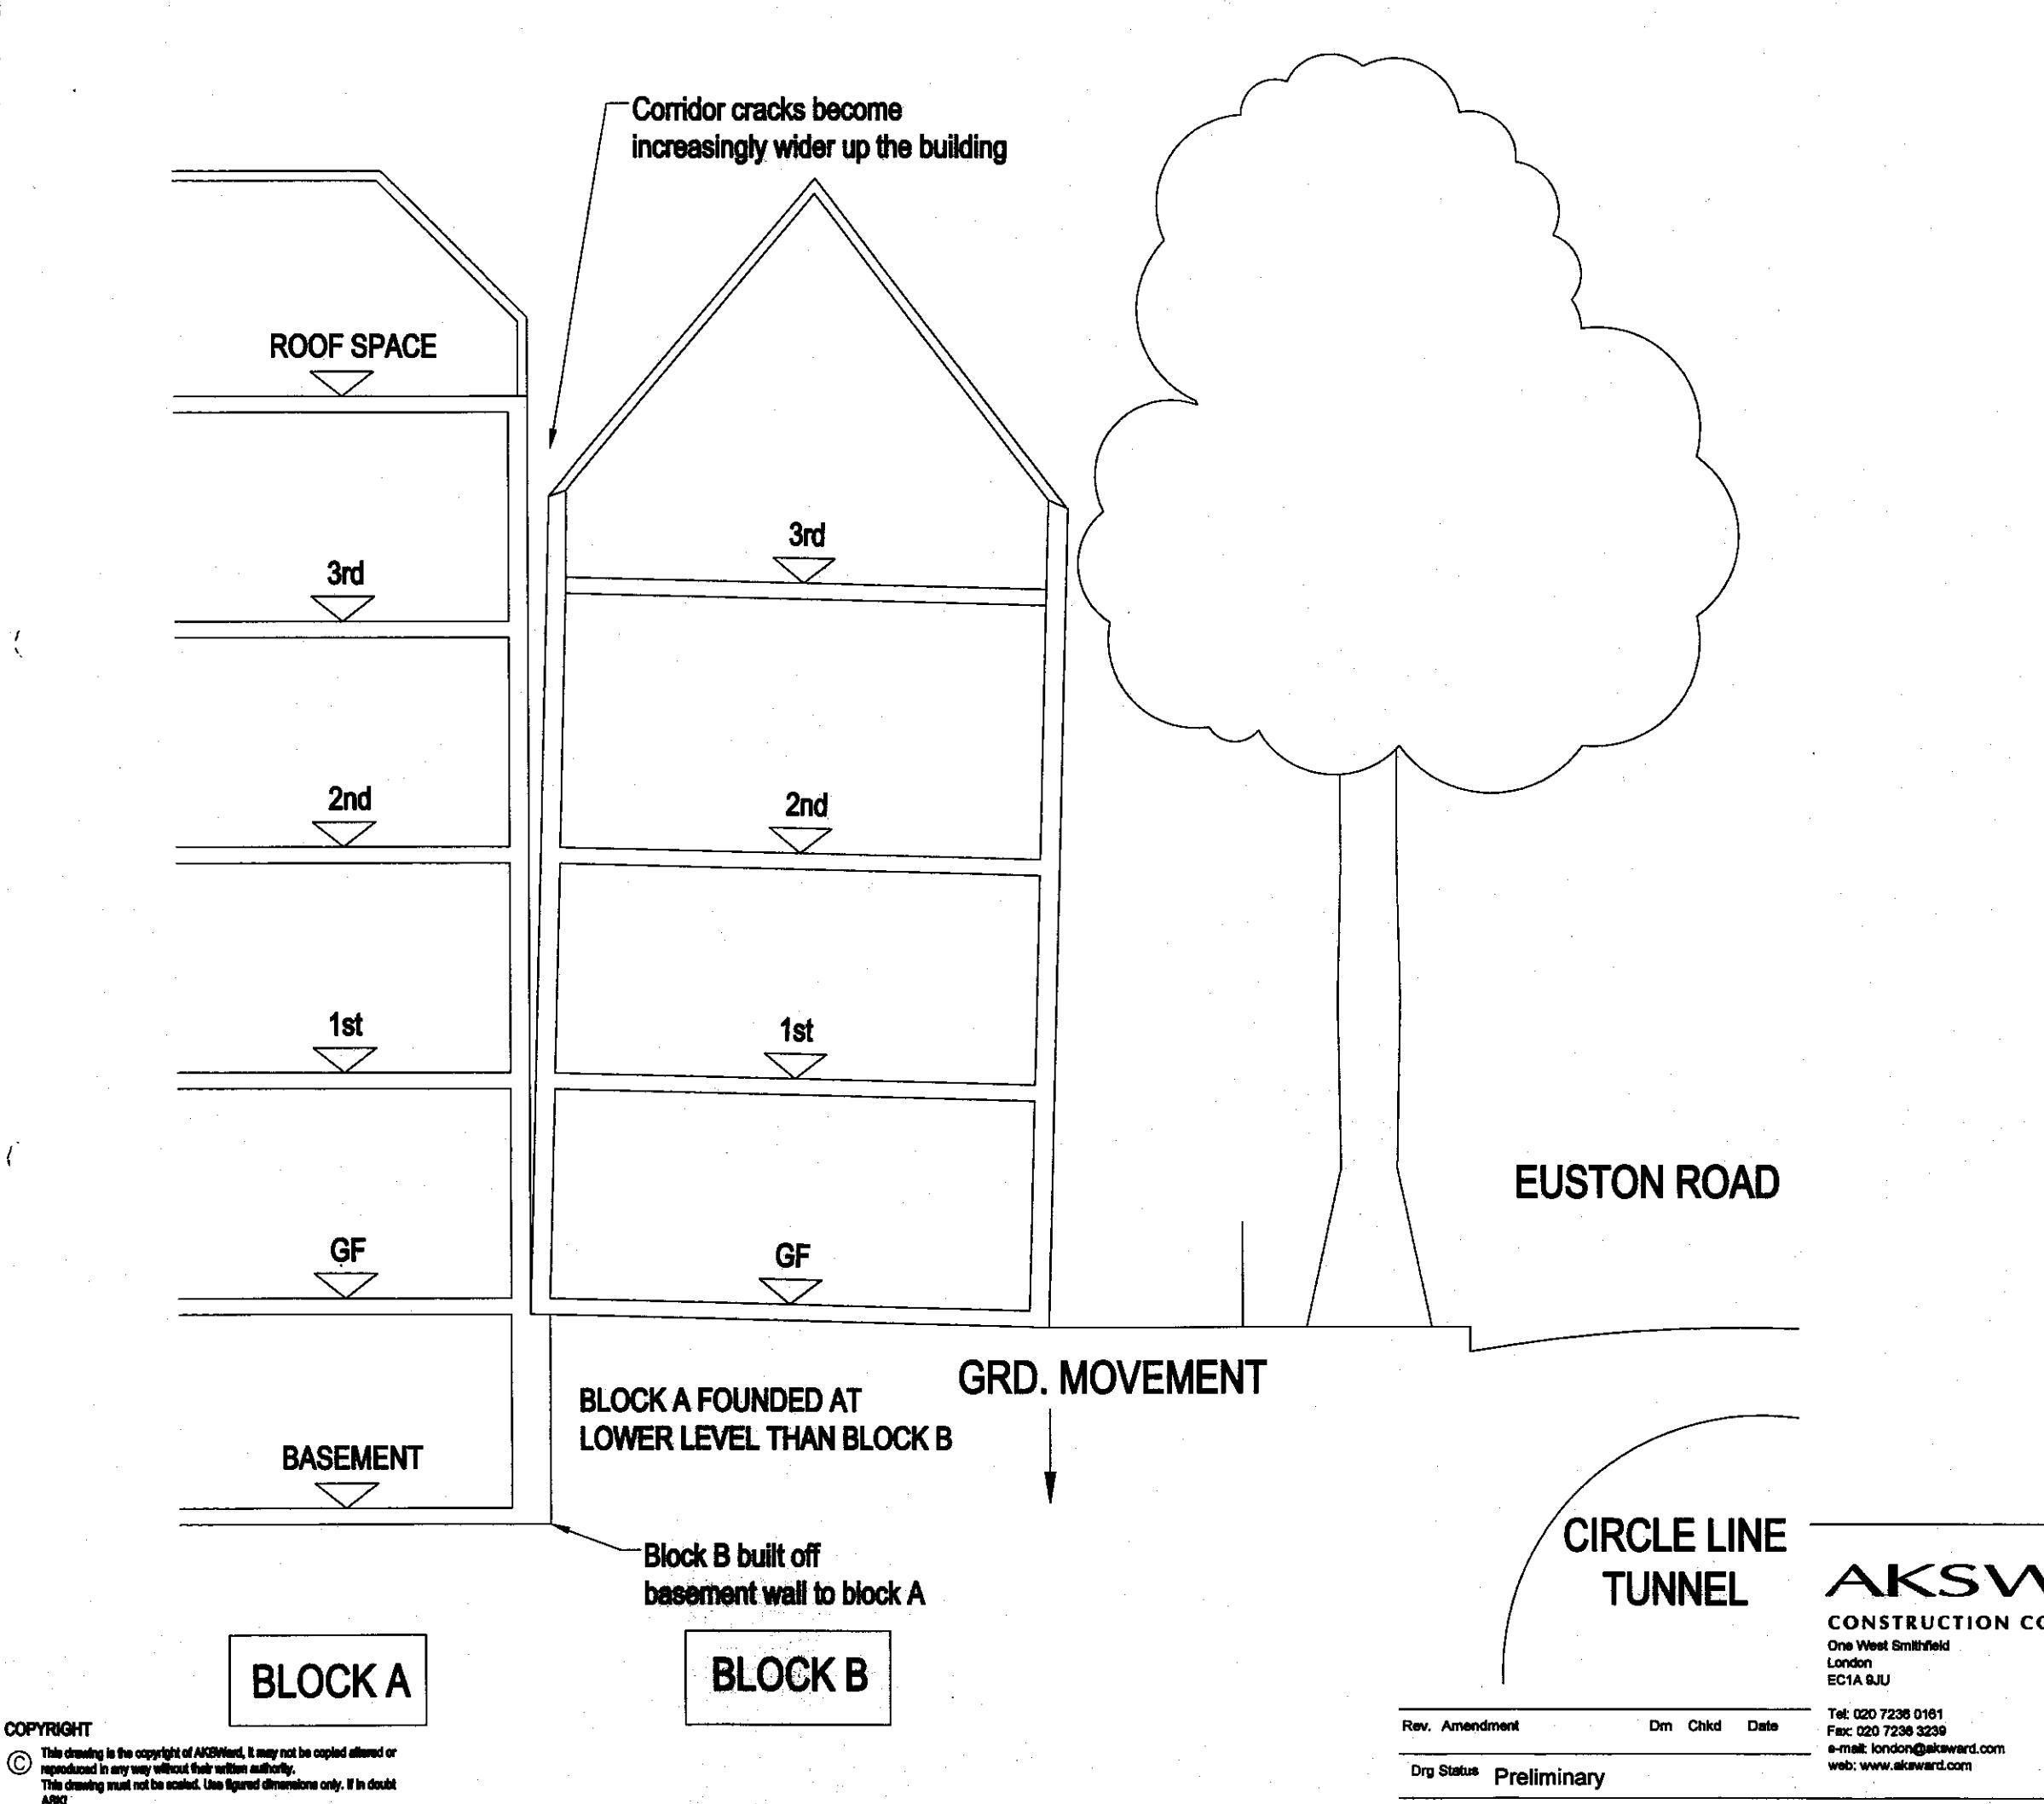
- 0	Project	UNISON HQ		
	Title	STELICTURAL MECHANISM	MOVEMEN	Π
E London	Scales	NOT TO SCALE		
Oxford Winchester	Review	ed Scheme	Date	NOV. 2006
	Review	ed Final	Date	
Sherborne	Project	No.	Drg No.	Rev.
· . · ·	1051	036	Fig. 2	P1

- Block A has a basement and is founded at a much deeper level, and is further away from the mature trees, consequently its foundations have been unaffected by the 6.4 clay movements which are constrained to the upper strata. The basement also extends under the link corridor and, critically, the northern part of block B is built off the basement walls. This has created a pivot point for the movement of block B and explains the crack patterns observed within the link corridor (cracks increasing in width up the building). This movement mechanism is described in figure 2 in Appendix A.

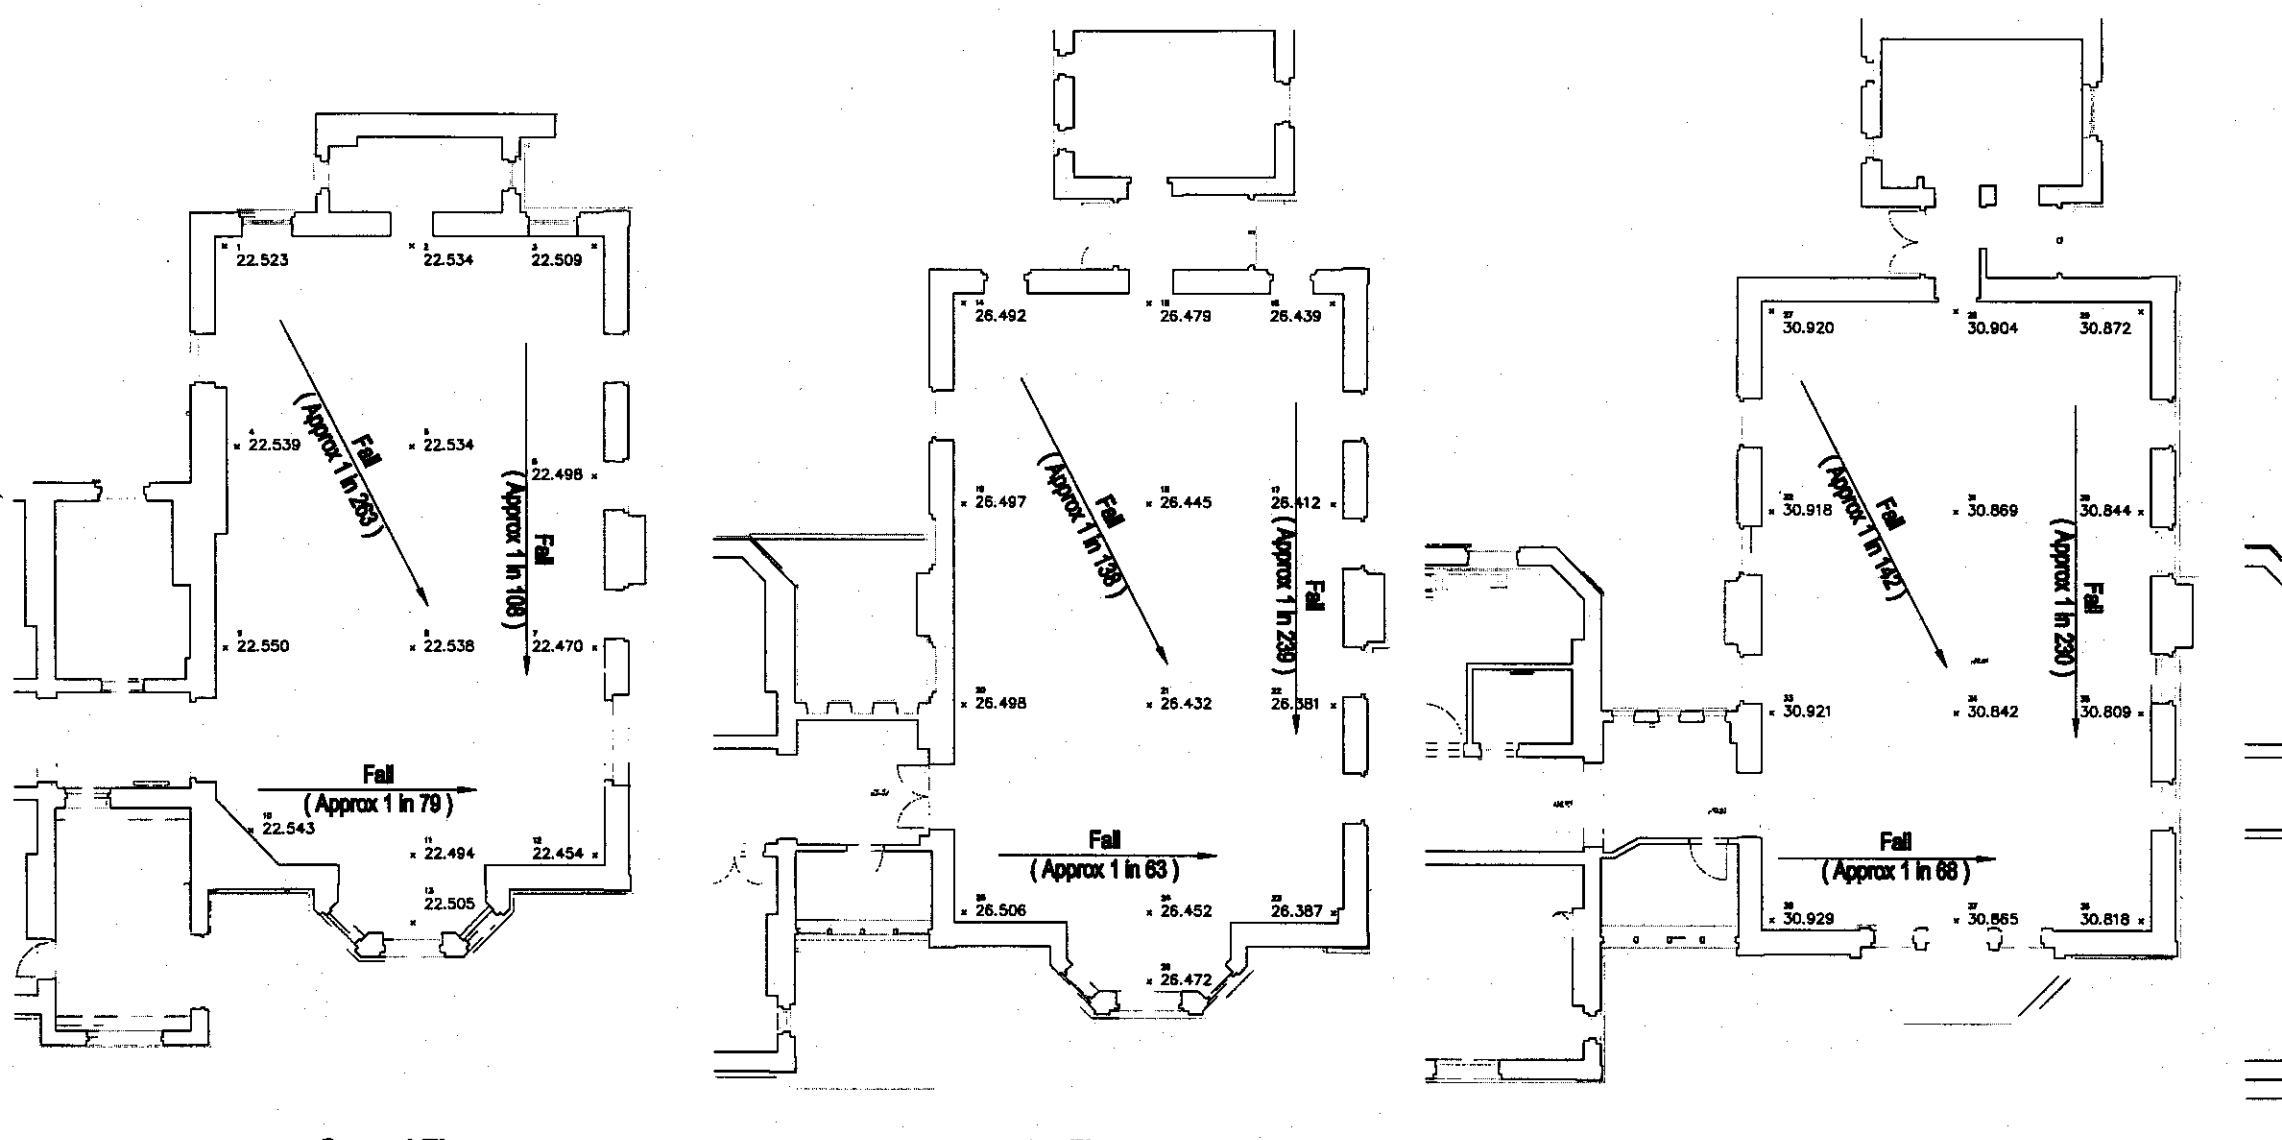
- 5.2 A level survey was conducted across the ground, first, second and third floors of block B. The results of this survey are presented in figure 3 in Appendix A. It can be clearly seen that these levels indicate that the southern portion of the building fronting Euston Road has subsided with respect to the Northern portion. The worst movement is towards the south-west corner (closest to the lime trees and where the foundations are known to be the shallowest).

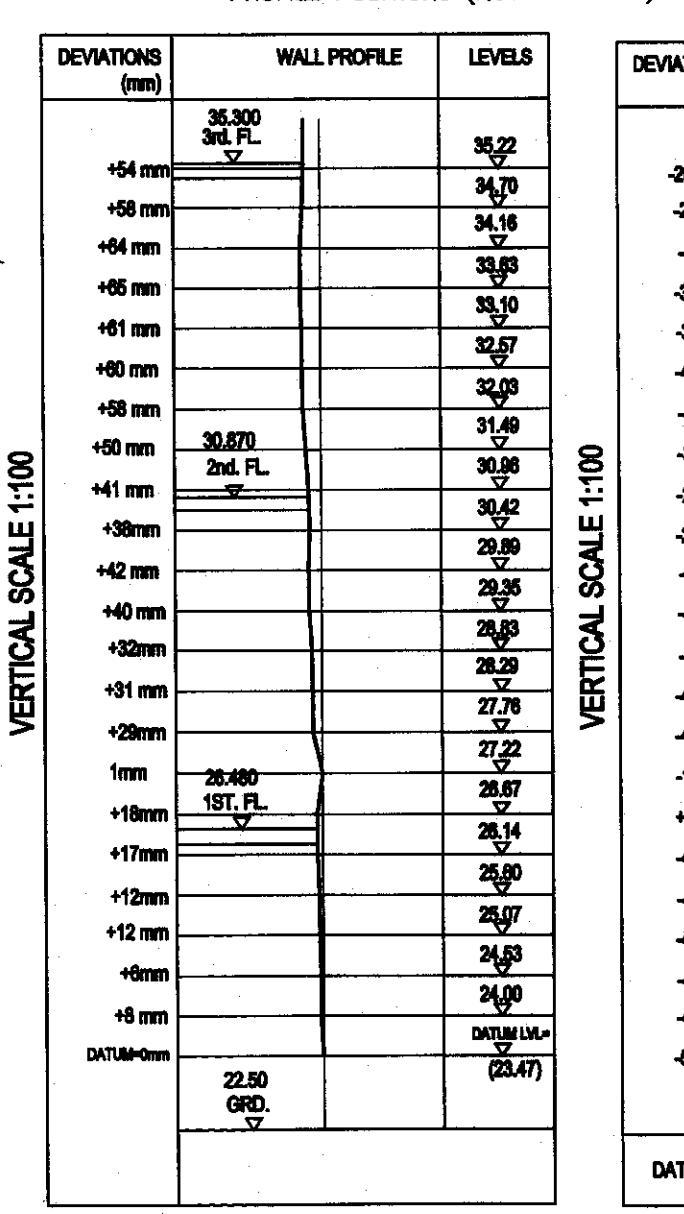
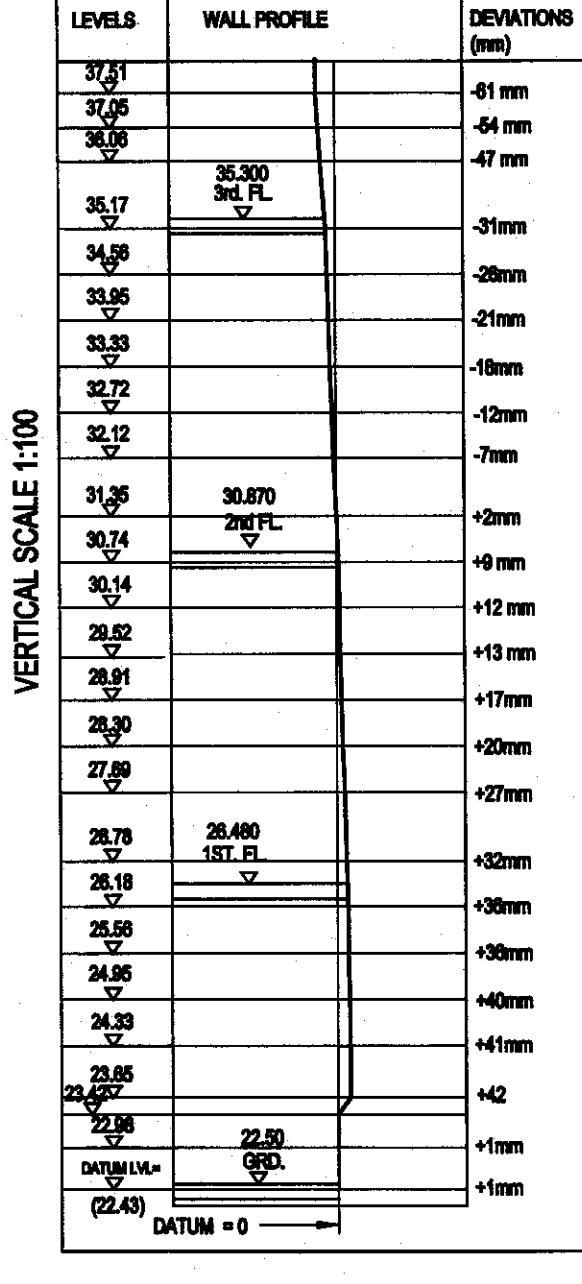
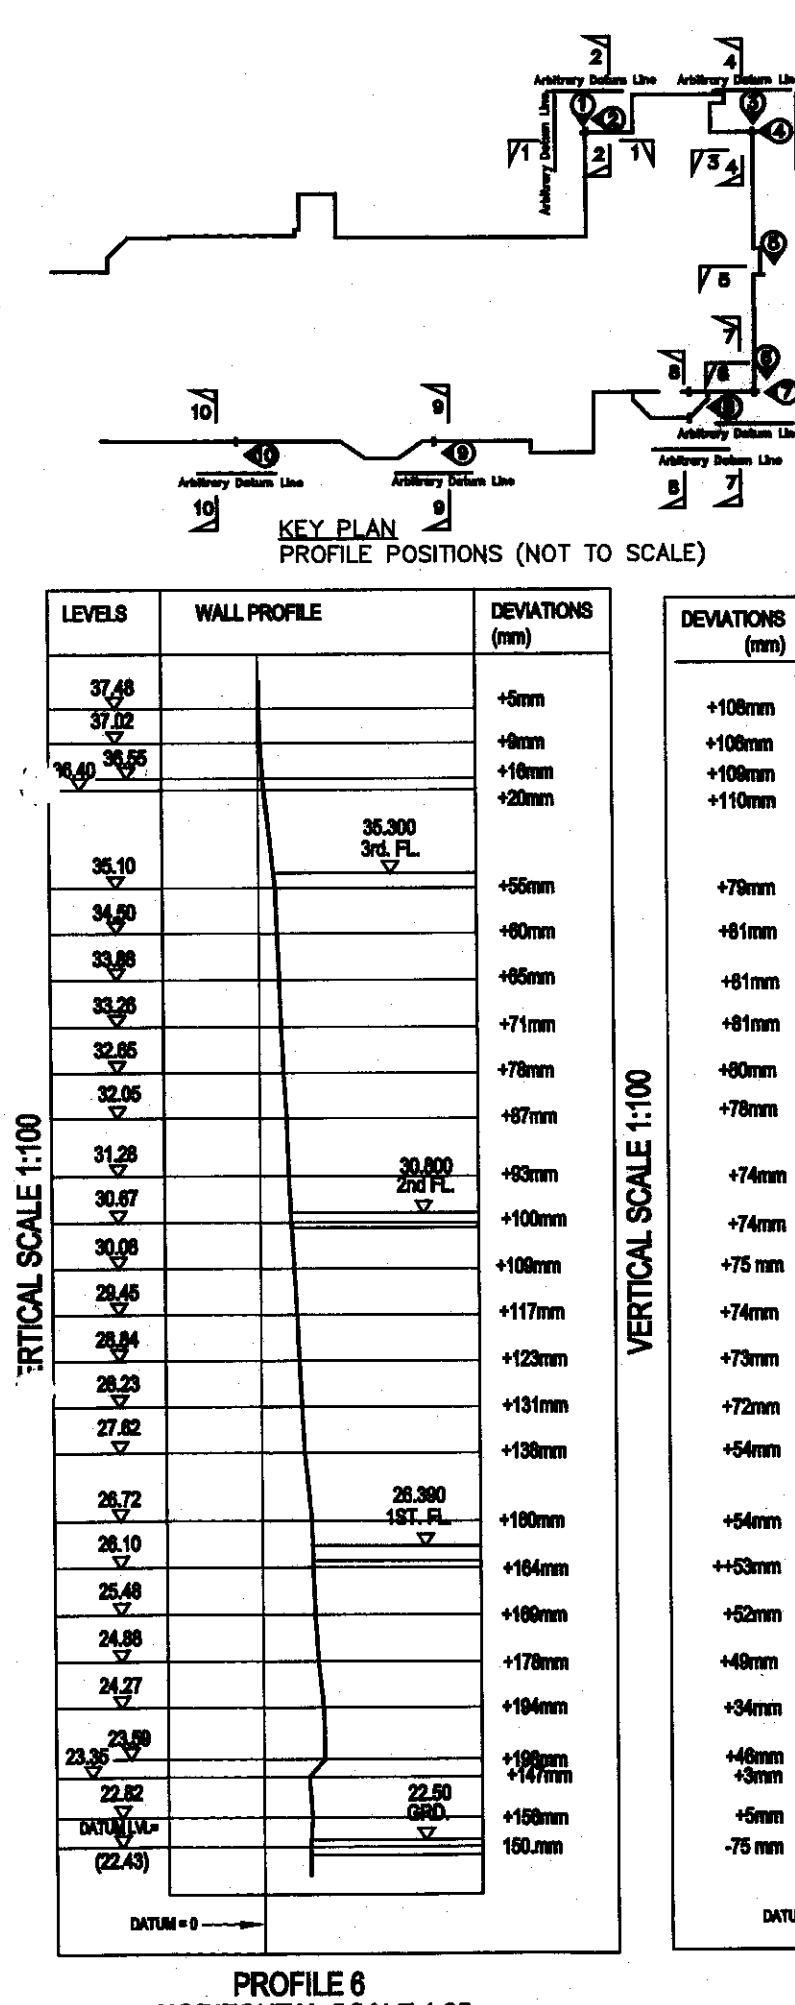
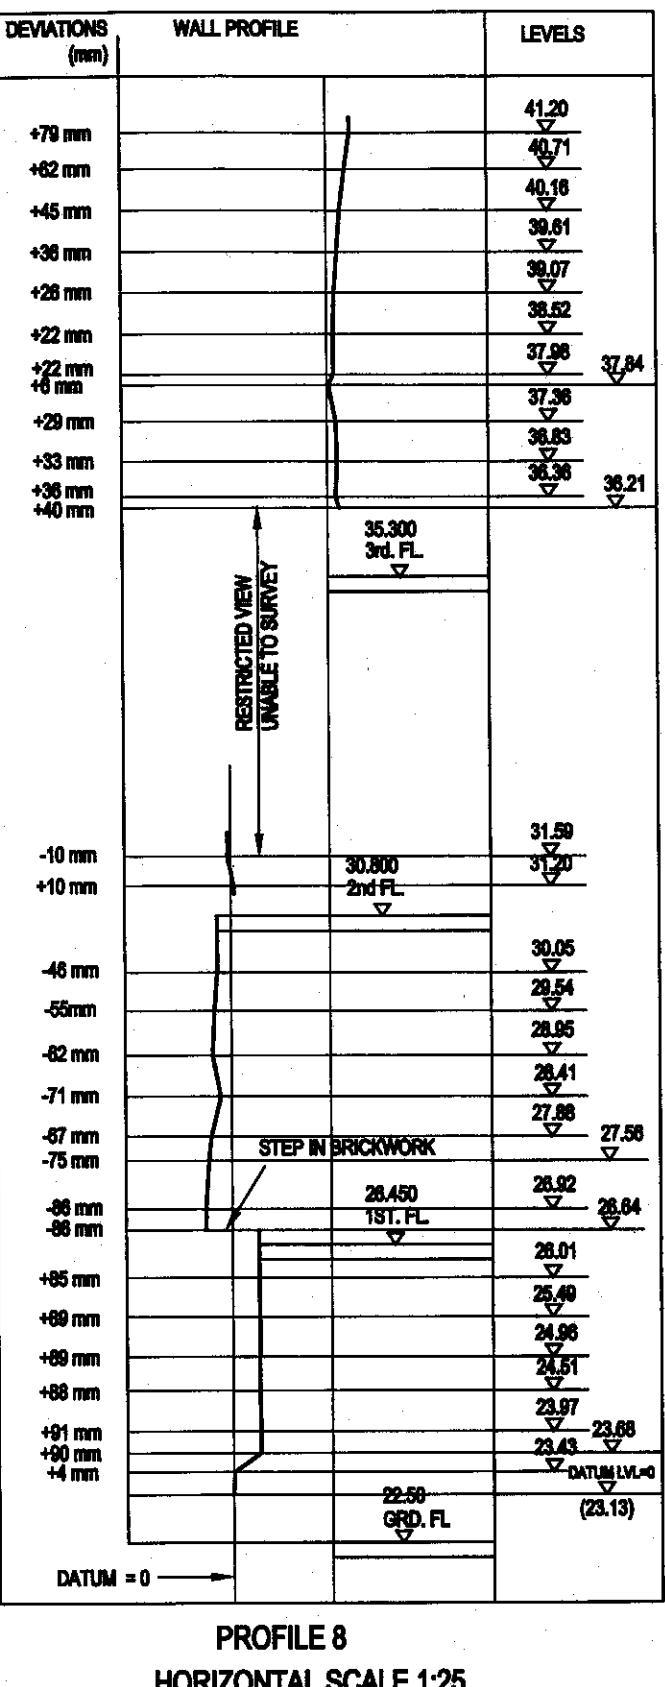
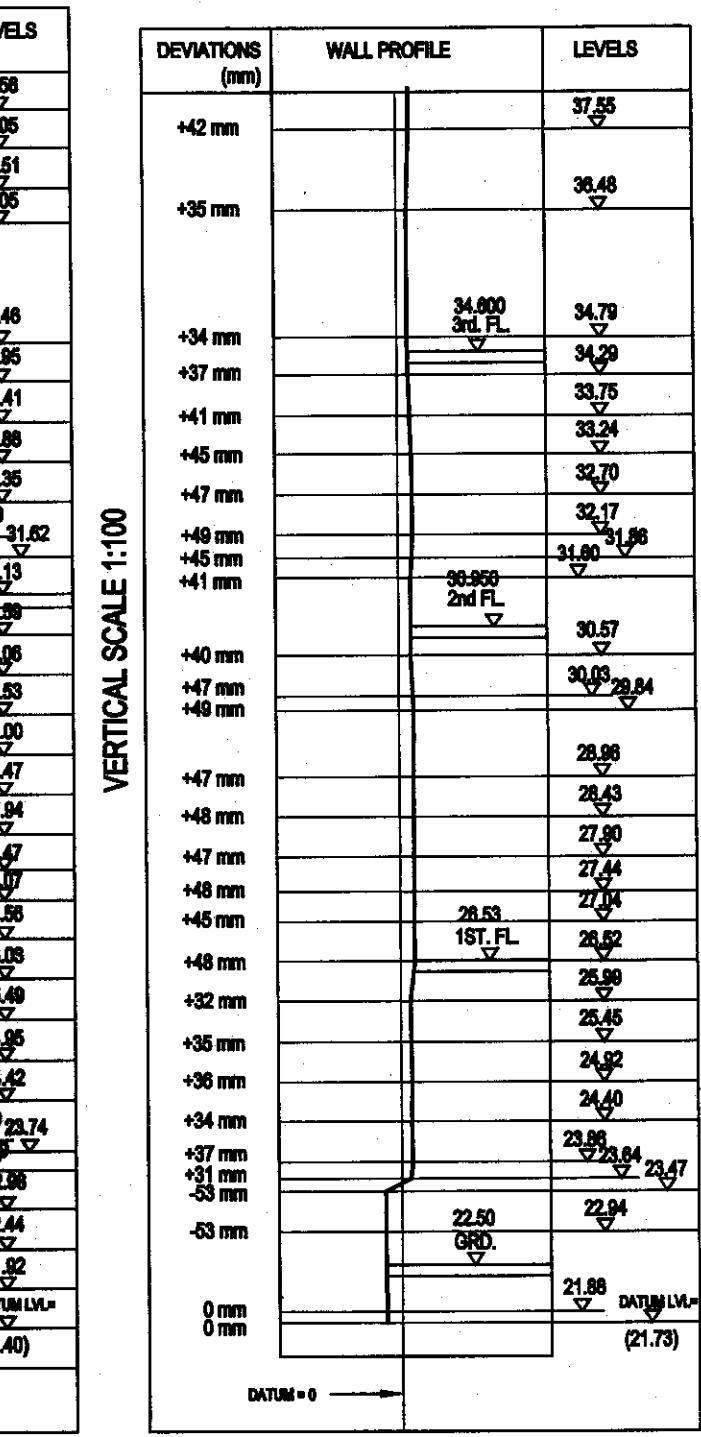
Project UNISON HO		
ard®	Tido WALL PROFILE		
ULTANTS	· · · · · · · · · · · · · · · · · · ·		
Landon	Scales AS SHOWN	· .	
C Oxford	Reviewed Scheme	Date	OCTOBER 2006
	Reviewed Final	Date	
C Sherborne	Project No.	Drg No.	Rev.
	L051036	FIG 4	· P1 ·
	•

The southern wall fronting Euston Road shows the highest degree of deformation being out of plumb by approximately 143mm; this equates to approximately 32% of 5.7 the wall thickness (450mm). It should also be noted that the wails are not free-standing walls as described within the CIRIA report; the walls are restrained at each floor level by the positive bearing of the floor beams. Therefore, it is considered that the main load-bearing walls are stable in their present condition providing that the cause of the movement (subsidence) is eliminated and that the walls are adequately tied into the floors. To ensure that the floors are adequately tied into the walls, at all levels and locations, it is recommended that a new system of floor-to-wall ties is installed.
