SCHOOL OF AFRICAN AND ORIENTAL STUDIES  
21 & 22 RUSSELL SQUARE

INITIAL LISTED BUILDING APPLICATION  
November 2006                      Revised 19.12.06

**21 & 22 RUSSELL SQUARE, LONDON, WC1**

**REPORT TO ACCOMPANY THE APPLICATION FOR LISTED BUILDING  
CONSENT**

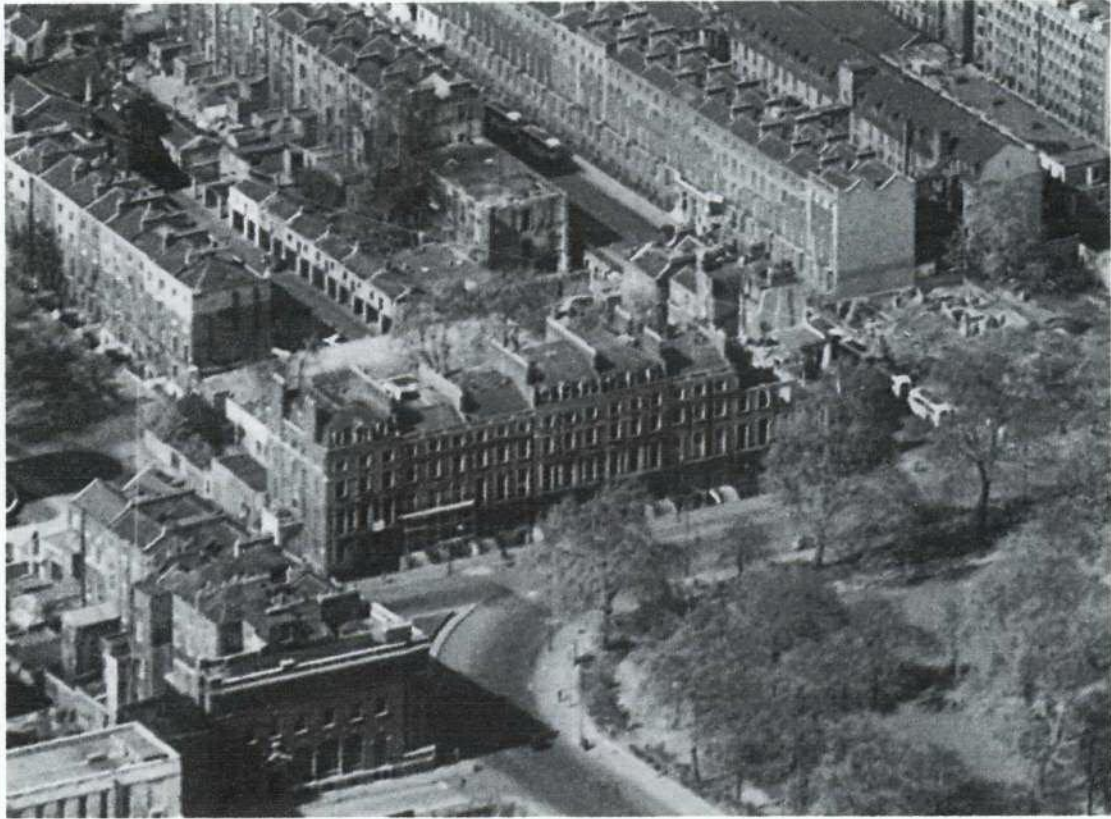
Ariel view of the 18 – 24 Russell Square terrace taken in 1940's

Number 21 is in the centre of the terrace being the left hand house with a mansard roof and dormers. The three properties to the right of number 21 are now demolished. Number 18 on the corner of Bedford way clearly has bomb damage.

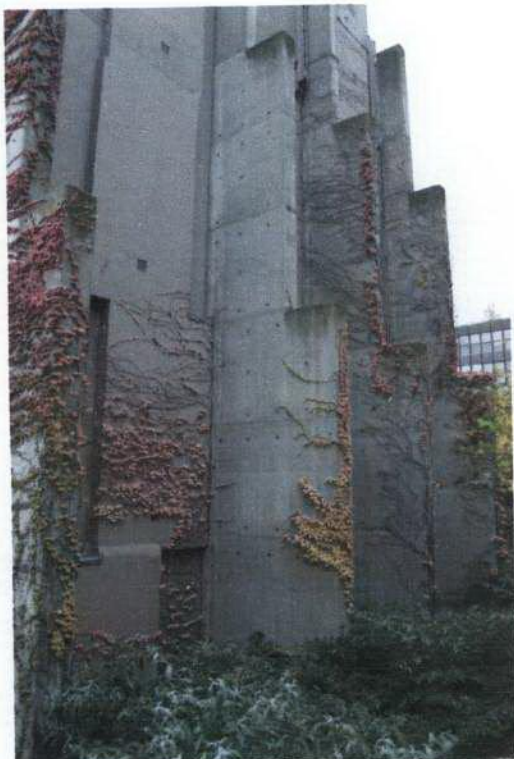
The external concrete buttressing supporting the flank wall of number 21 was built when the Institute of Education building was erected in the 1970's

Photo 3 External buttress to No 21

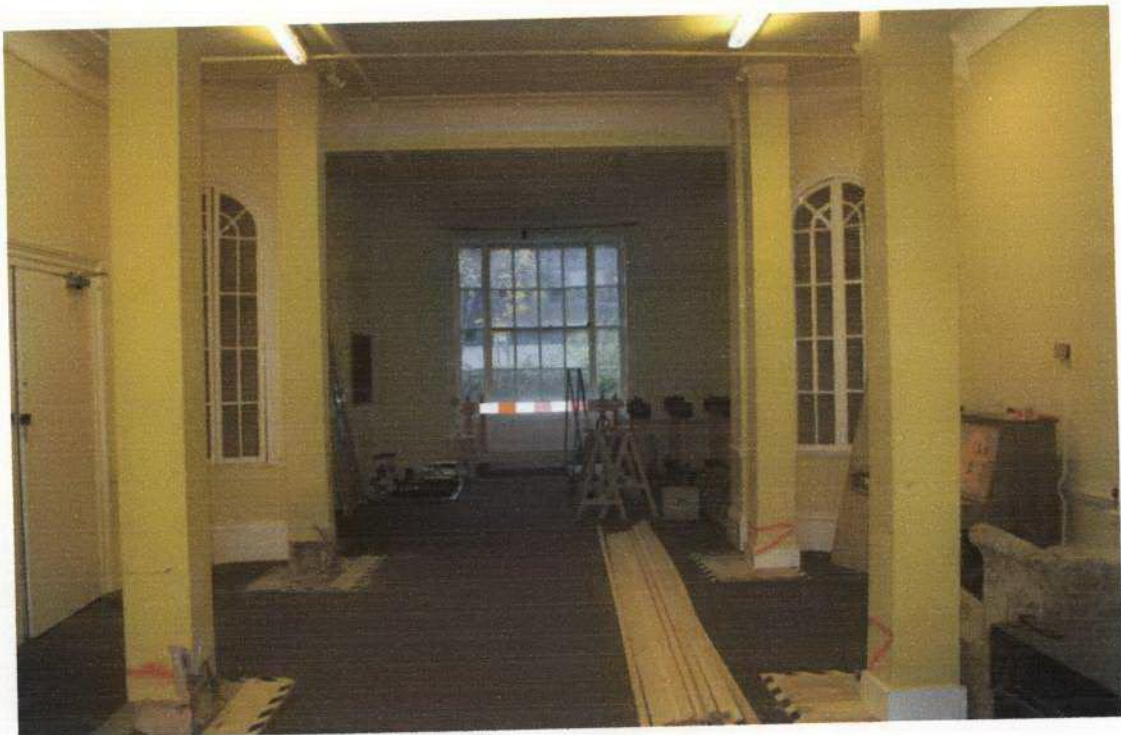
Photo 17 No 21 ground floor front and rear rooms.  
Note the four columns, added to strengthen structure, that are hoped to be removed.

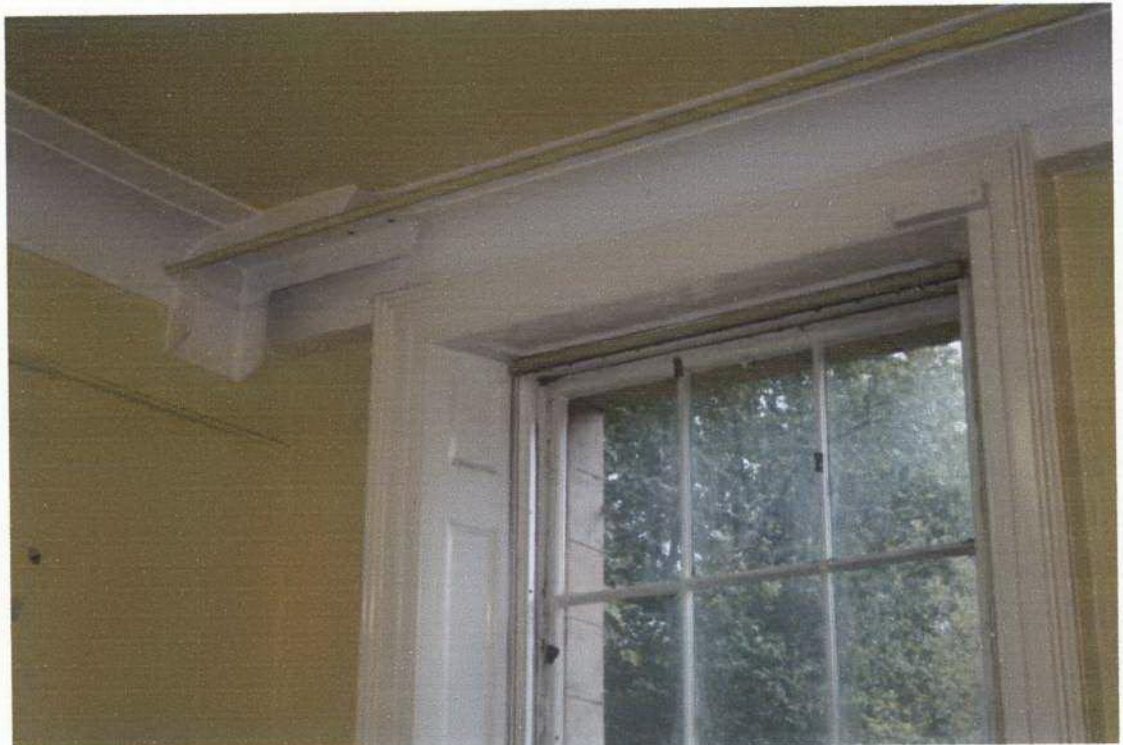
Photo 19 No 21 Ground floor front room strengthening and tie rod

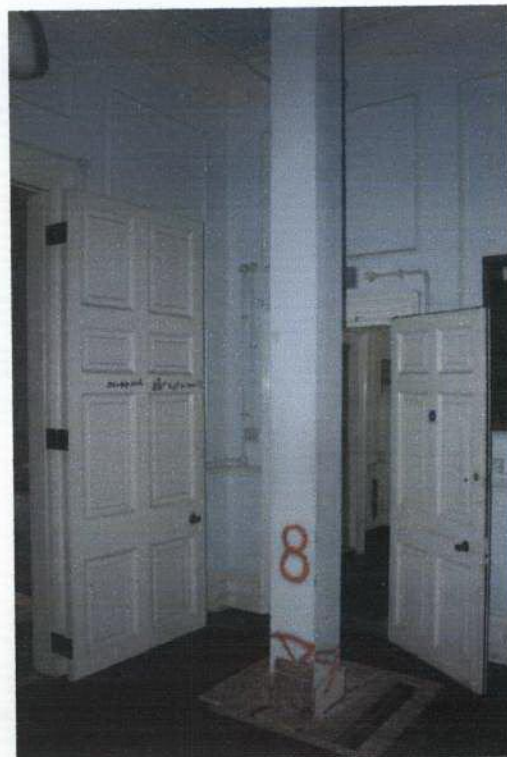
Photo 27 No 21 Rear room column/doors  
Note column to be removed

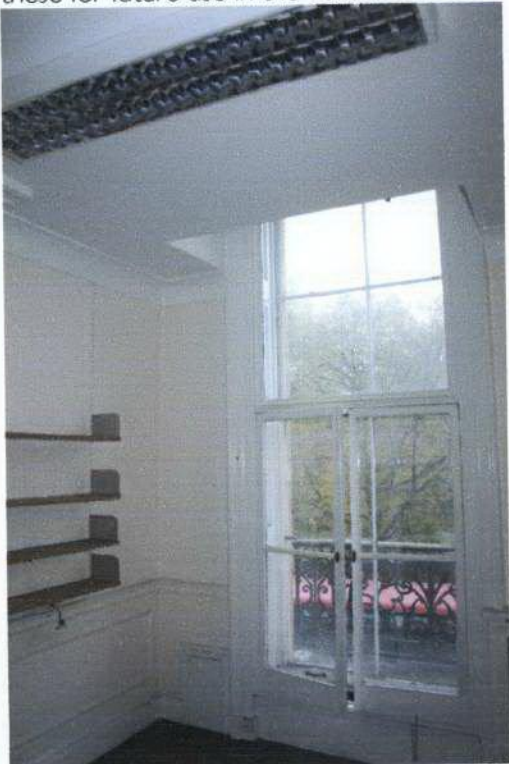
Photo 28 No 22 First floor front rooms  
typical modern false ceiling to be removed.

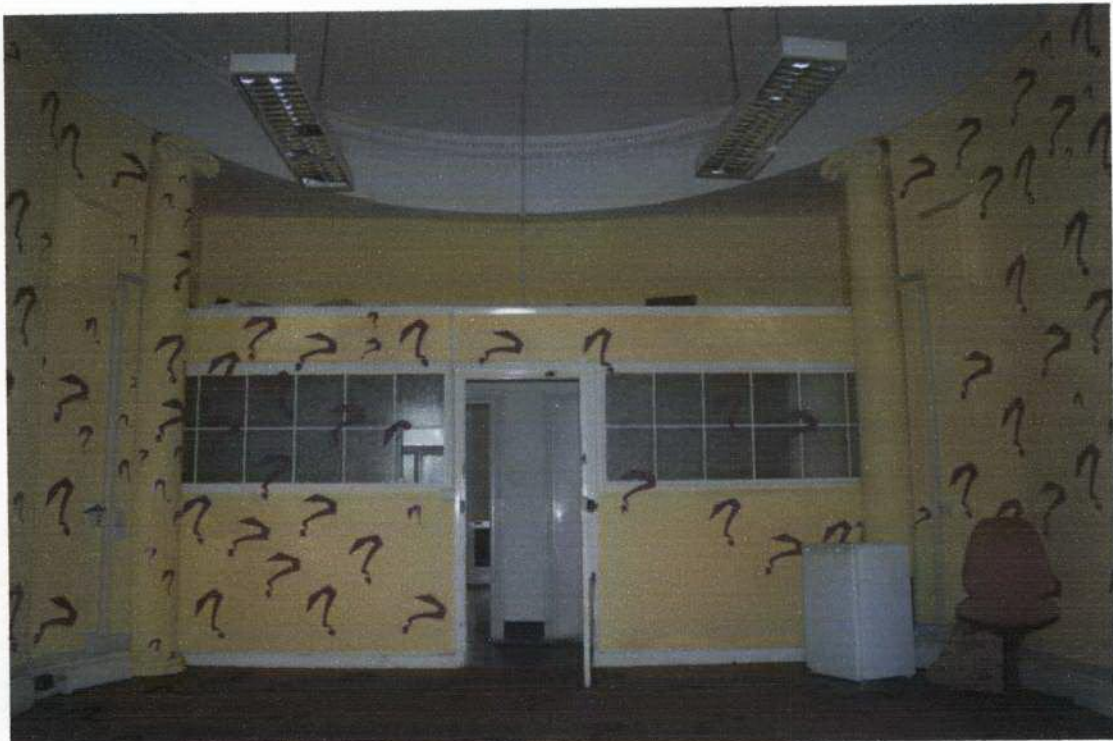
Photo 29 No 22 First floor Oval room showing modern partition  
Note: This is considered to be the most important room to be restored.

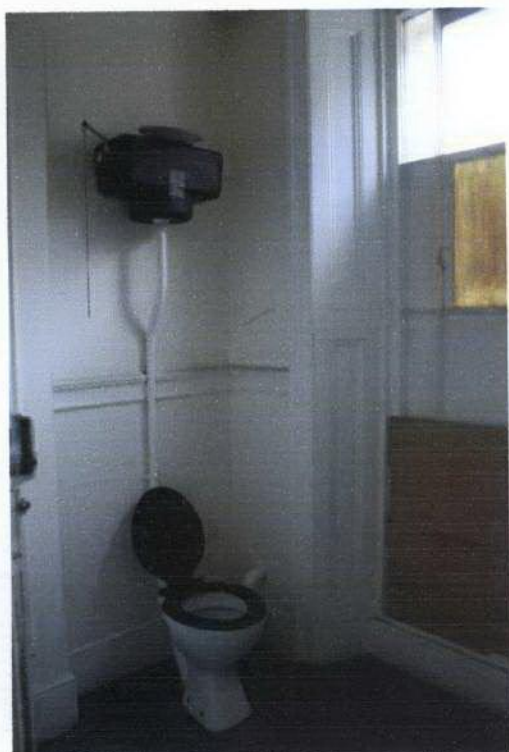
Photo 33 No 22 Landing WC  
(To be removed)

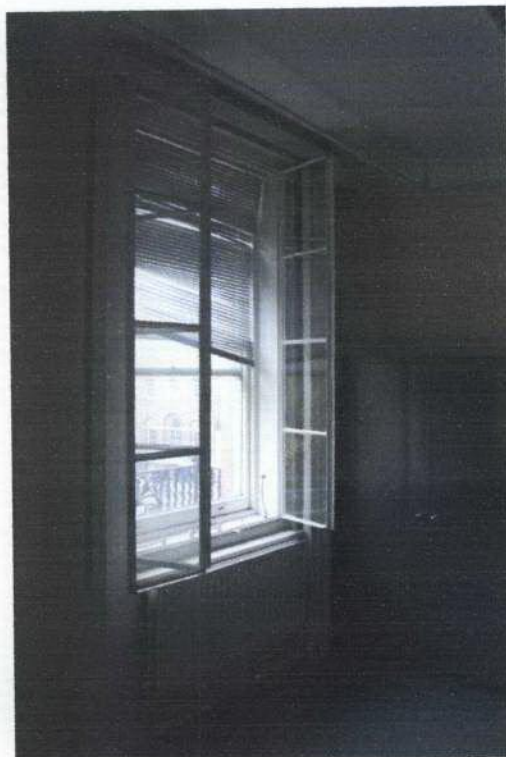
Photo 40 No 21 2<sup>nd</sup> floor front window  
Note Inner glazing to be removed.

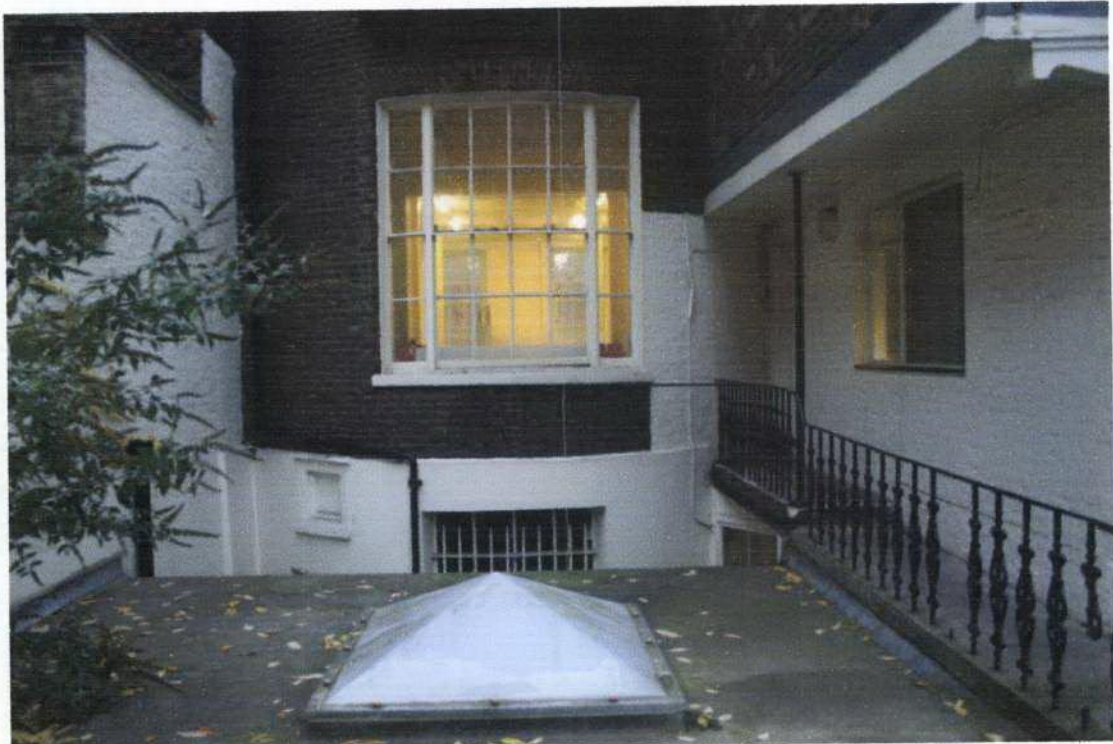
Photo 47 Roof of basement modern toilet block to be demolished
