mason navarro
P A R T N E R S H I P
Consulting Civil and Structural Engineers

**STRUCTURAL IMPLICATIONS
OF
PROPOSED
RESIDENTIAL CONVERSION**

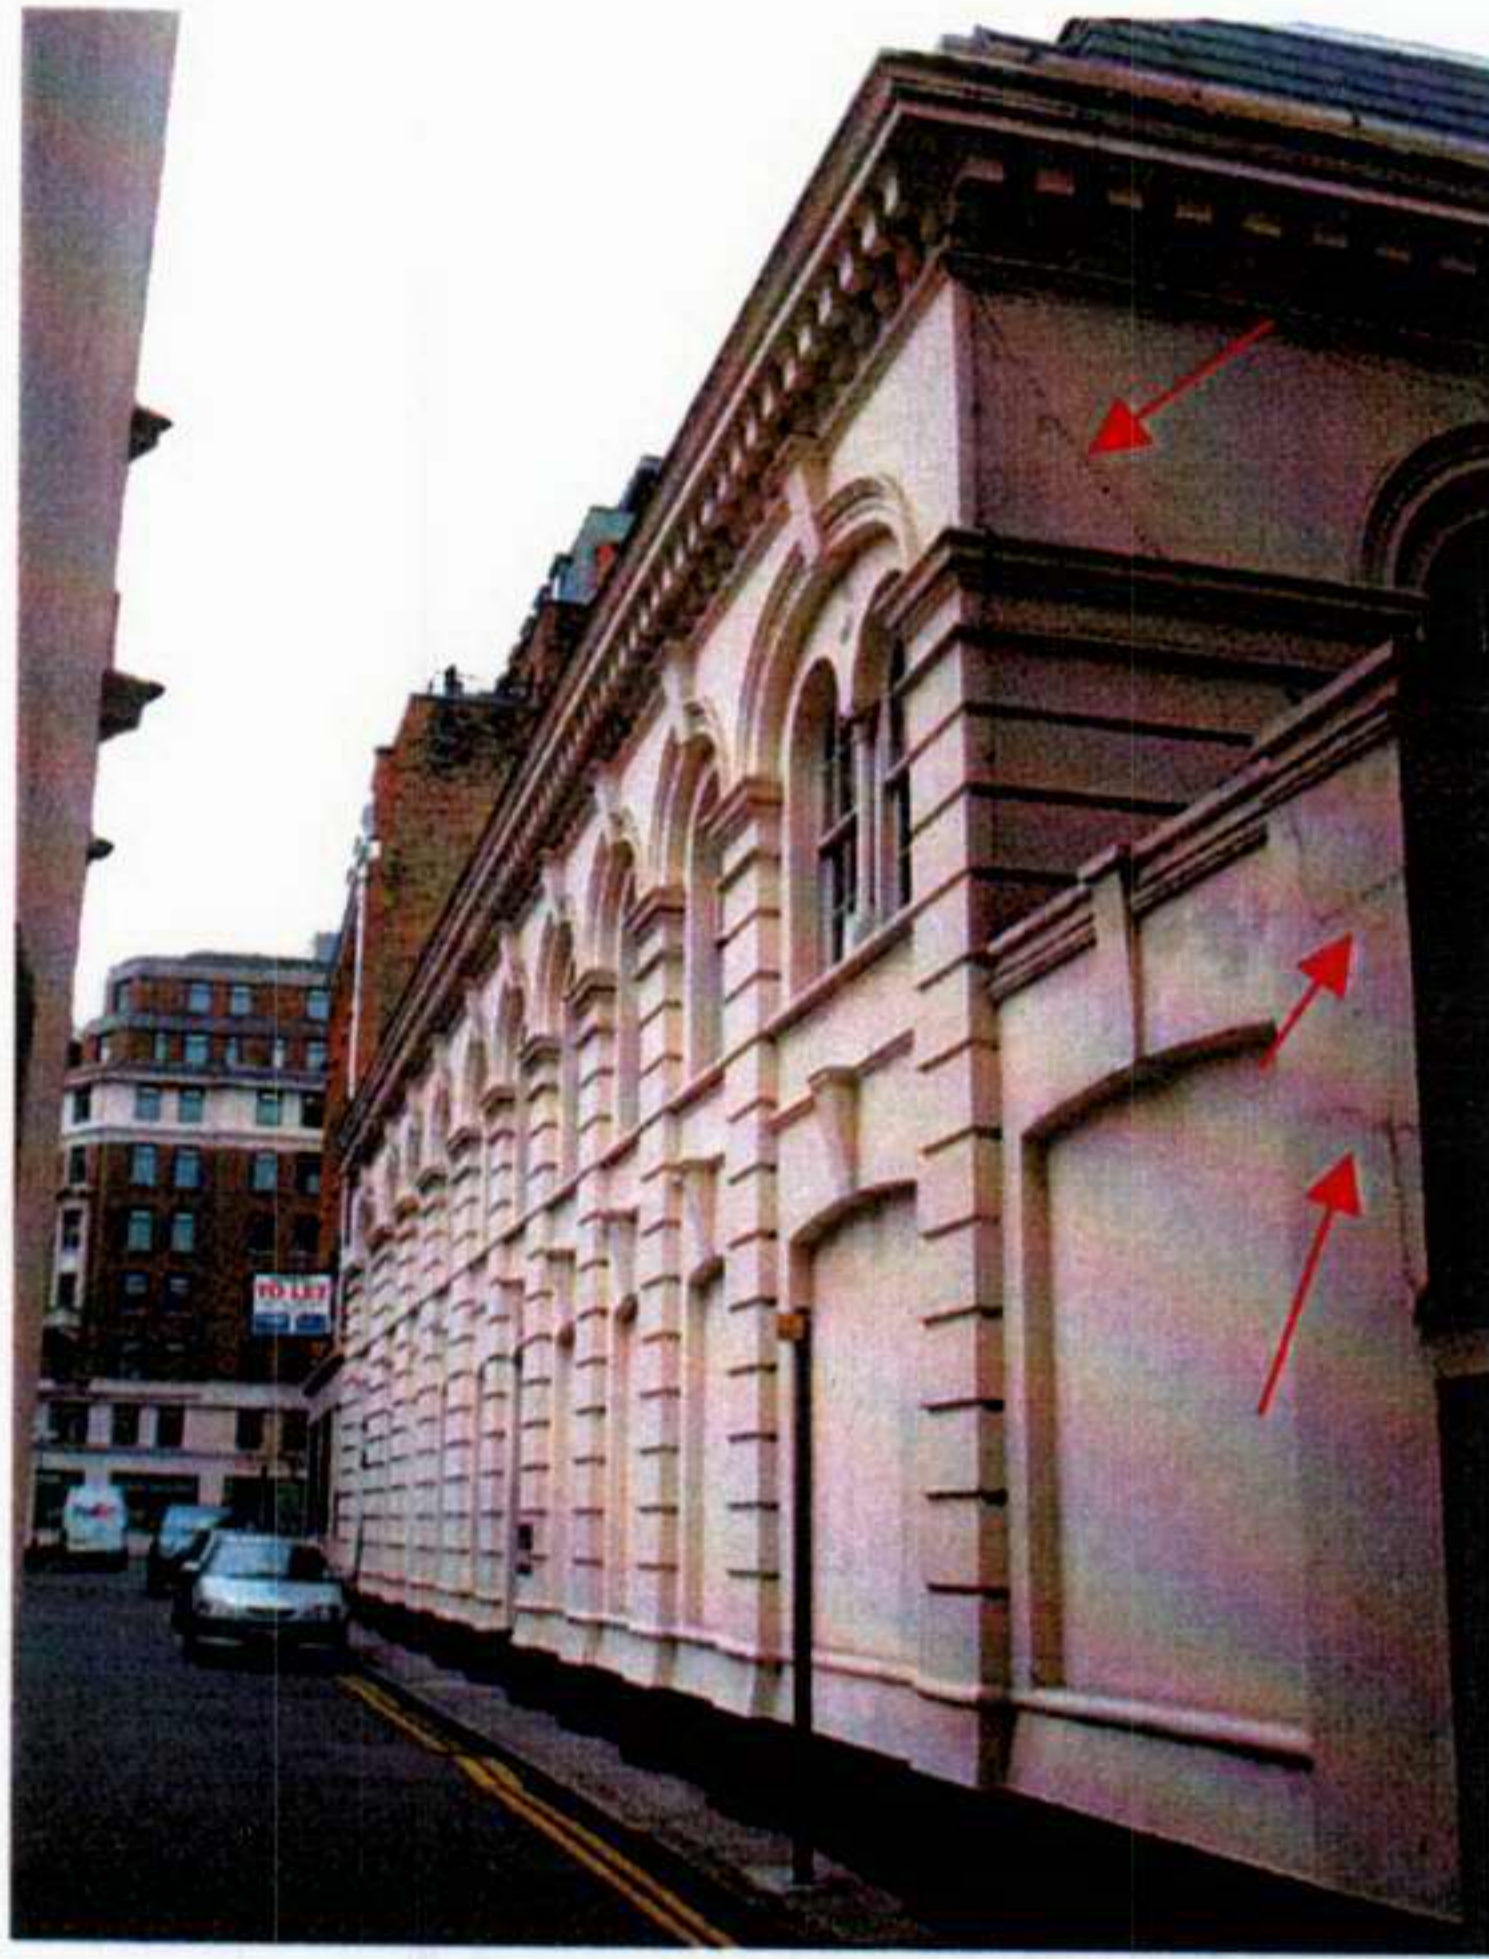
1. Right hand flank wall and front elevation.
Note to the cracking of render.

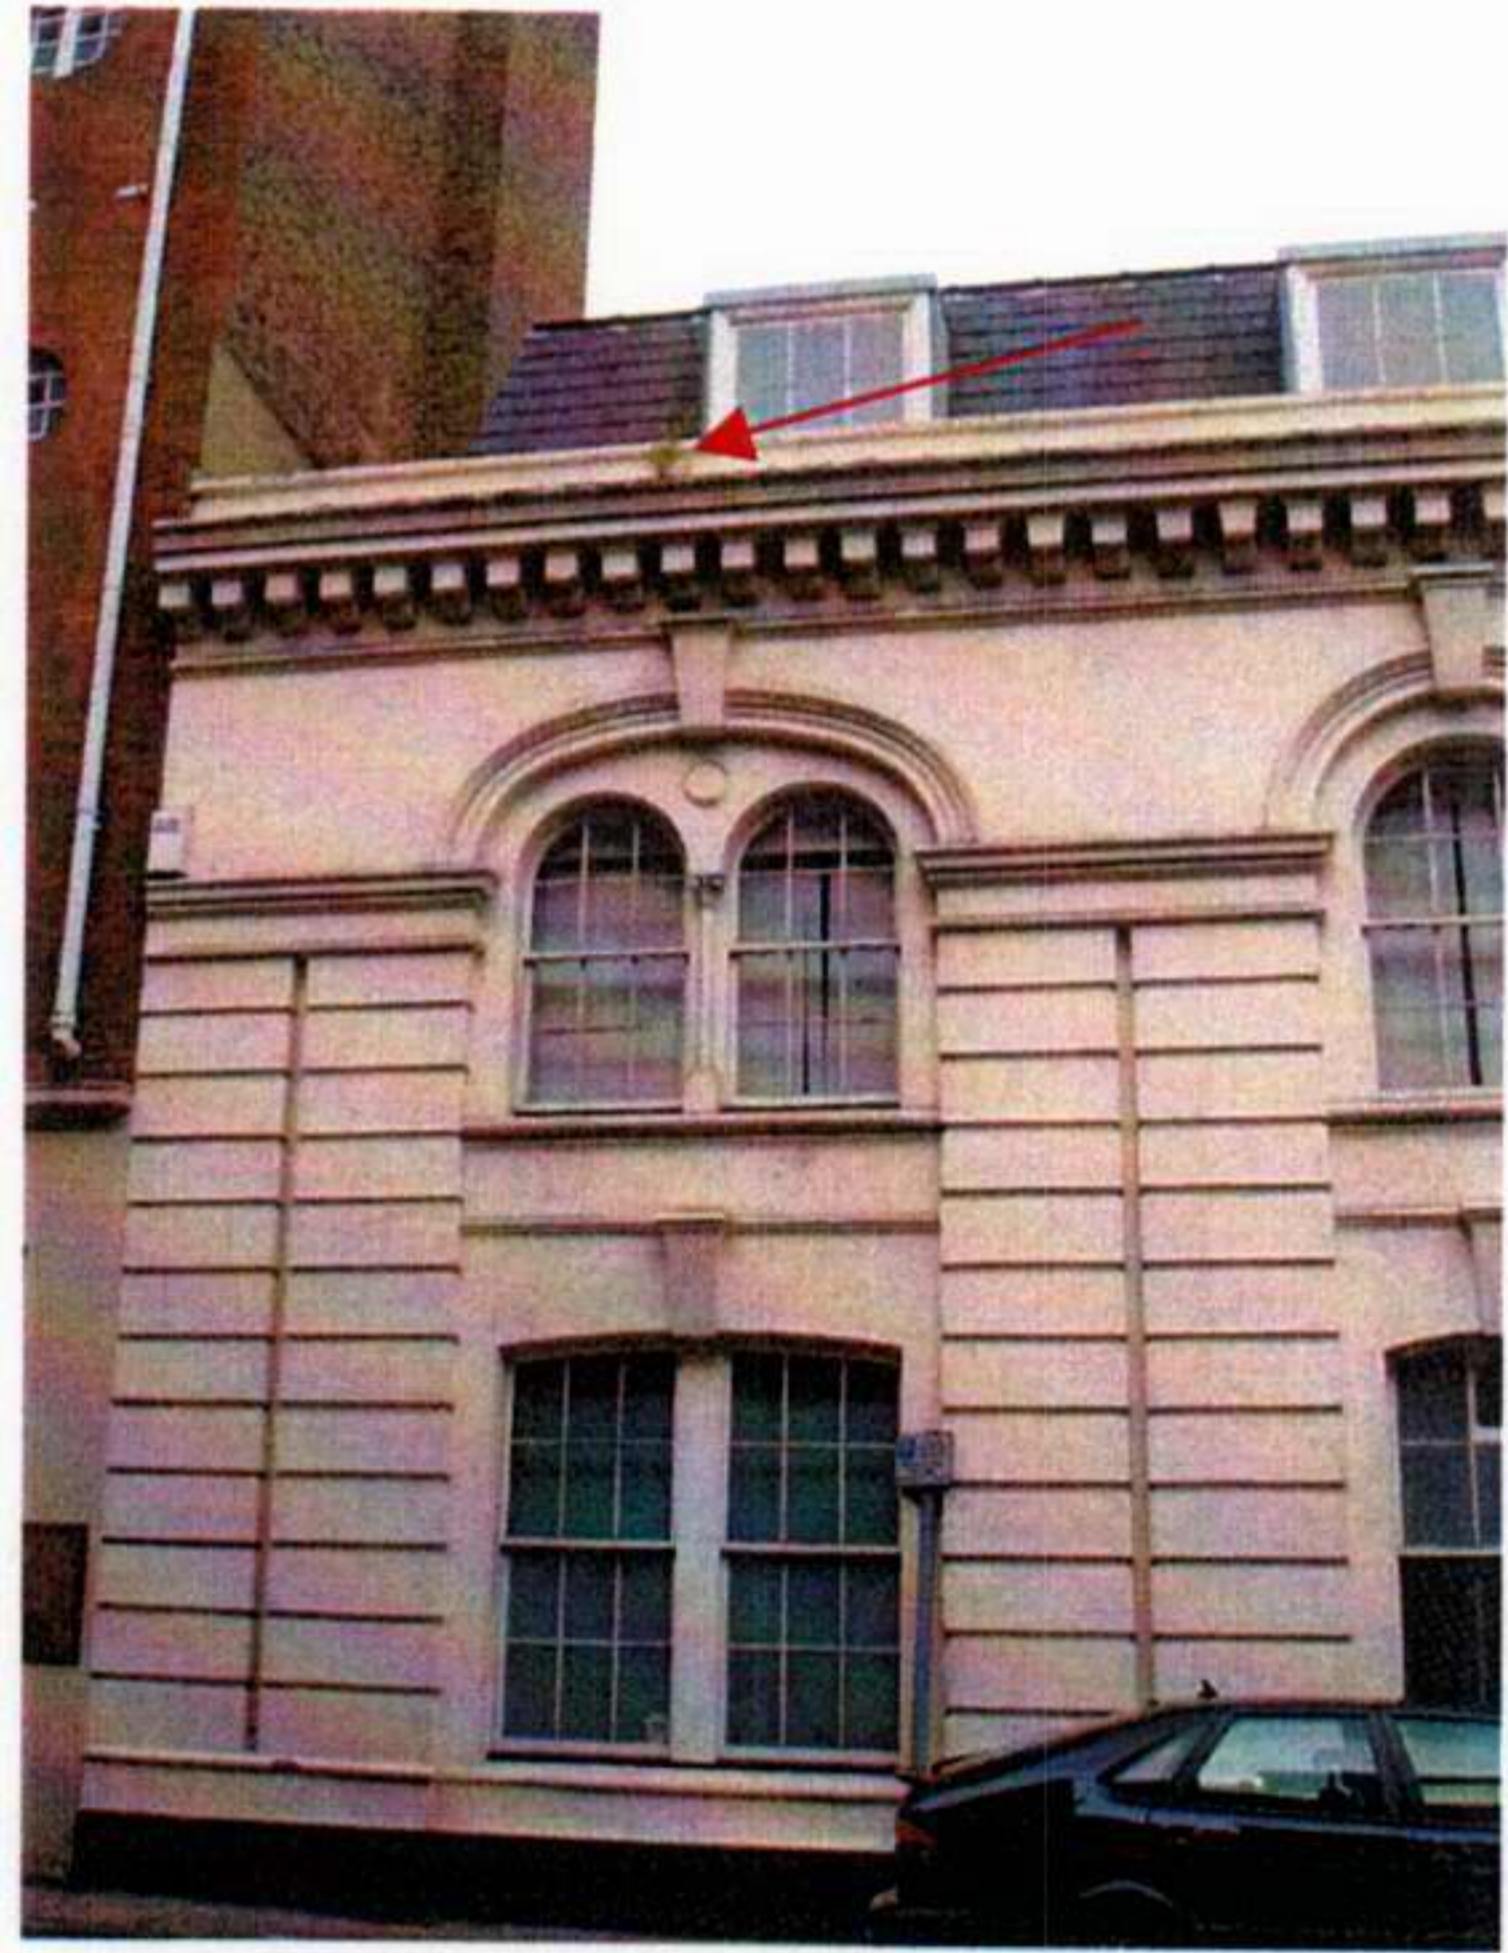
2. Left hand end of building.
Note the vegetation growing on the parapet.

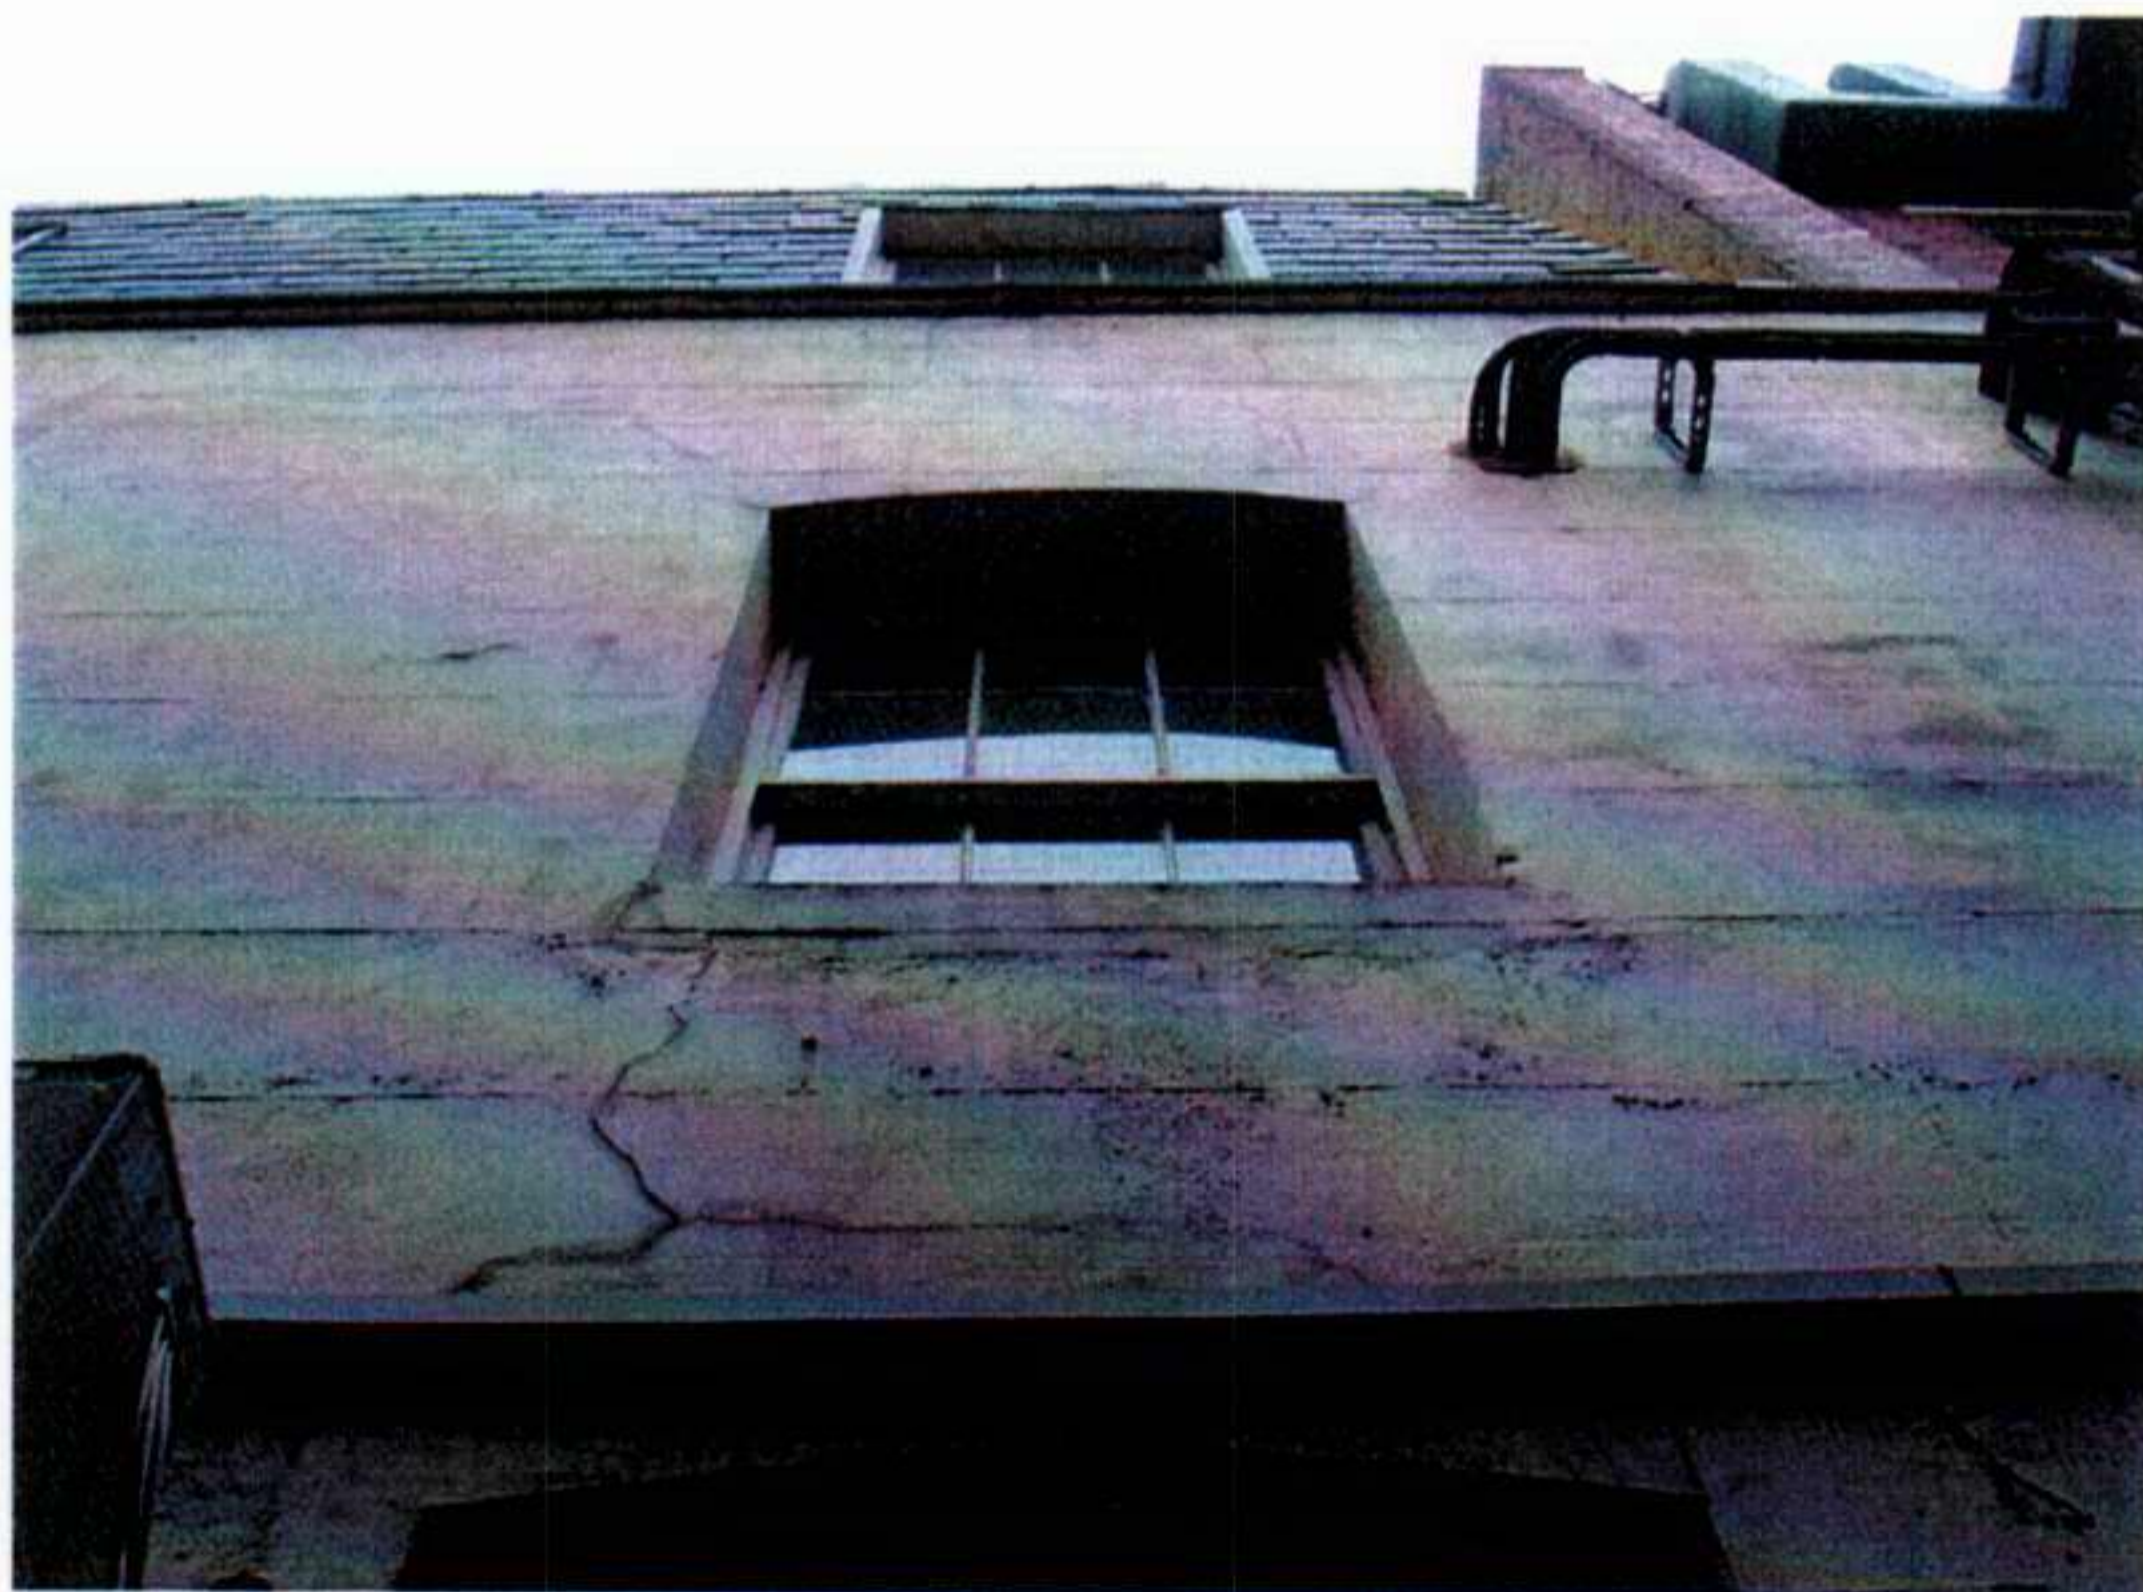
5. Hairline cracking of ashlar-render on rear wall.
