ARBORICULTURAL IMPACT ASSESSMENT REPORT:

55 Gloucester Avenue
Primrose Hill
London
NW1 7BA

Ref: JWA/55GLA/AIA/01

Date: 11th July 2014

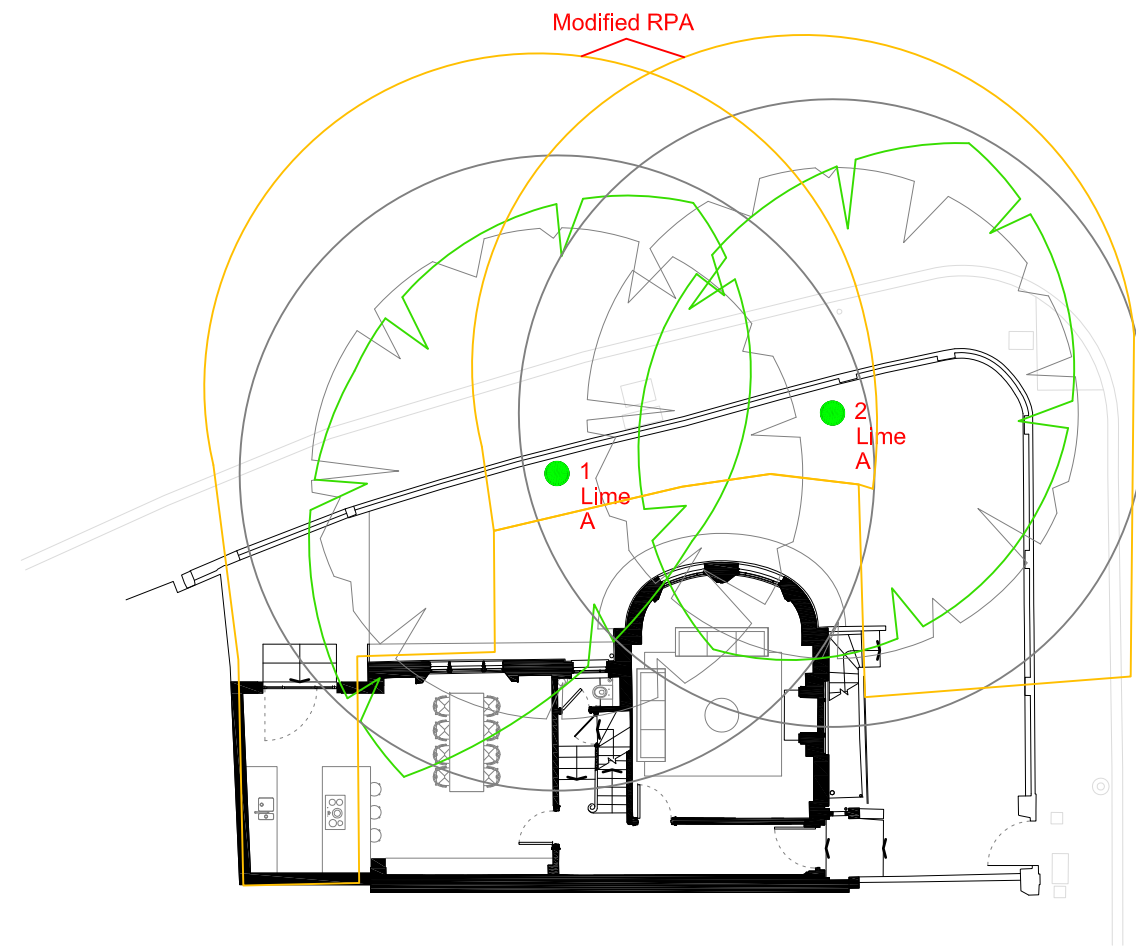
ARBORICULTURAL IMPACT ASSESSMENT PLAN

6.1.1 The principal primary impacts in the current proposals are theoretically low; comprising a potential 8.5% encroachment of T2's modified RPA from the garage demolition/removal of hardstanding. The construction of the extension would occur on the on the existing garage site, where colonisation of significant roots from T2 is unlikely. The plotting of RPA on this site is complicated by the amount of hard landscaping / existing structures present: the greater part of the roots are likely to lie within the soft verge. Trial pits are recommended to provide a more definitive statement of root spread. Subject to their results, precautionary mitigation has been recommended to reduce the impact to any discovered; these comprise the manual demolition of the existing building and removal of hard surfaces, with supervised manual excavation of the new foundations and pre-emptive root pruning if required. The proposed steps to the extension should be constructed (in the presence of roots) using minimal-dig construction techniques, potentially using the existing sub-base.

6.3.1 The demolition of the garage building should proceed manually and inwards in a “pull down” fashion. Hard surfacing should be lifted with caution using an airspade, ensuring to roots that may be lying beneath the surfaces are protected.

6.3.2 The limits of excavation within RPAs will be undertaken manually; any roots encountered will be cleanly pruned back to an appropriate junction with a sharp pruning saw or secateurs back to a junction. Roots larger than 25mm diameter may only be cut in consultation with an arboriculturalist

6.3.3 Any new hard surfaces will require a no-dig construction technique, either using a cellular confinement system with no fines aggregate for the sub-base or simply building upon the existing sub-base without disturbing the ground below. Choice of construction method will initially depend upon root penetration within the existing sub-grade. The key principle is not to excavate in the presence of roots and to provide a porous surface to promote healthy soil water relations for future root growth.
