TREE SURVEY and ARBORICULTURAL METHOD STATEMENT

Report to accompany a planning application for development at
86 Canfield Gardens, London, NW6 3EE

Report by Dr Martin Dobson

3 June 2012

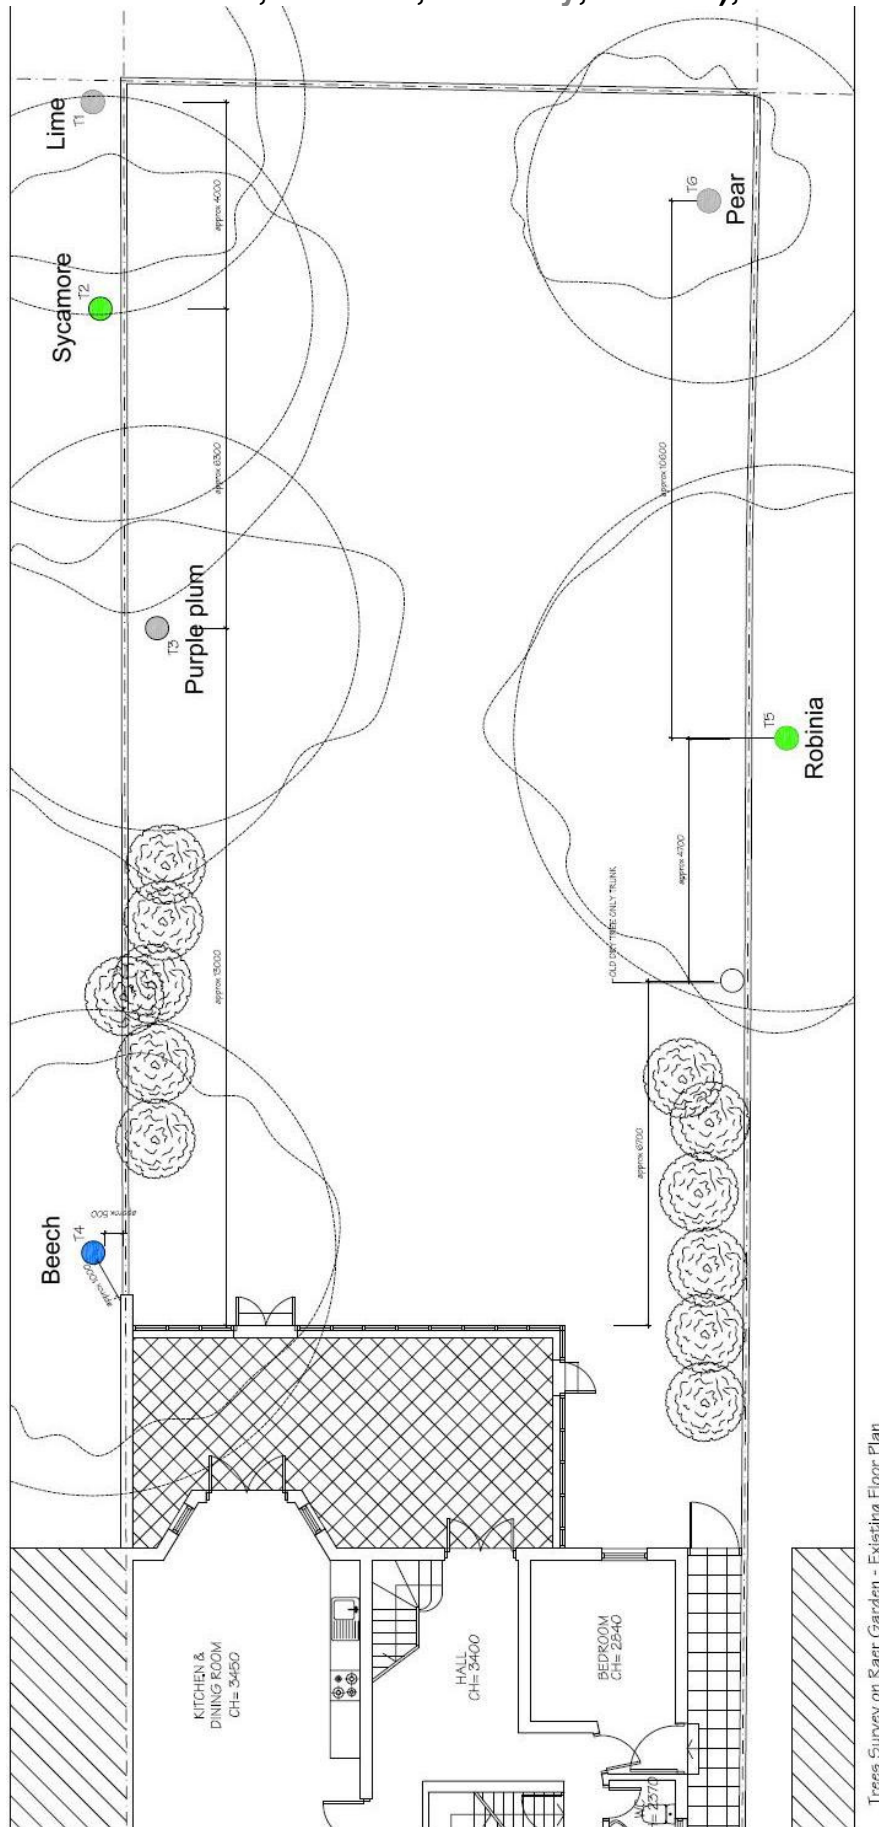
APPENDIX MD2

- 2.2 The site survey drawing appended at **MD2** shows the positions of the surveyed trees and gives a reasonable indication of the comparative branch spreads of the trees. The drawing has been colour coded as follows:

Site survey drawing showing tree numbers and BS5837 colour codes (A – Green, B – Blue, C – Grey, U - Red),

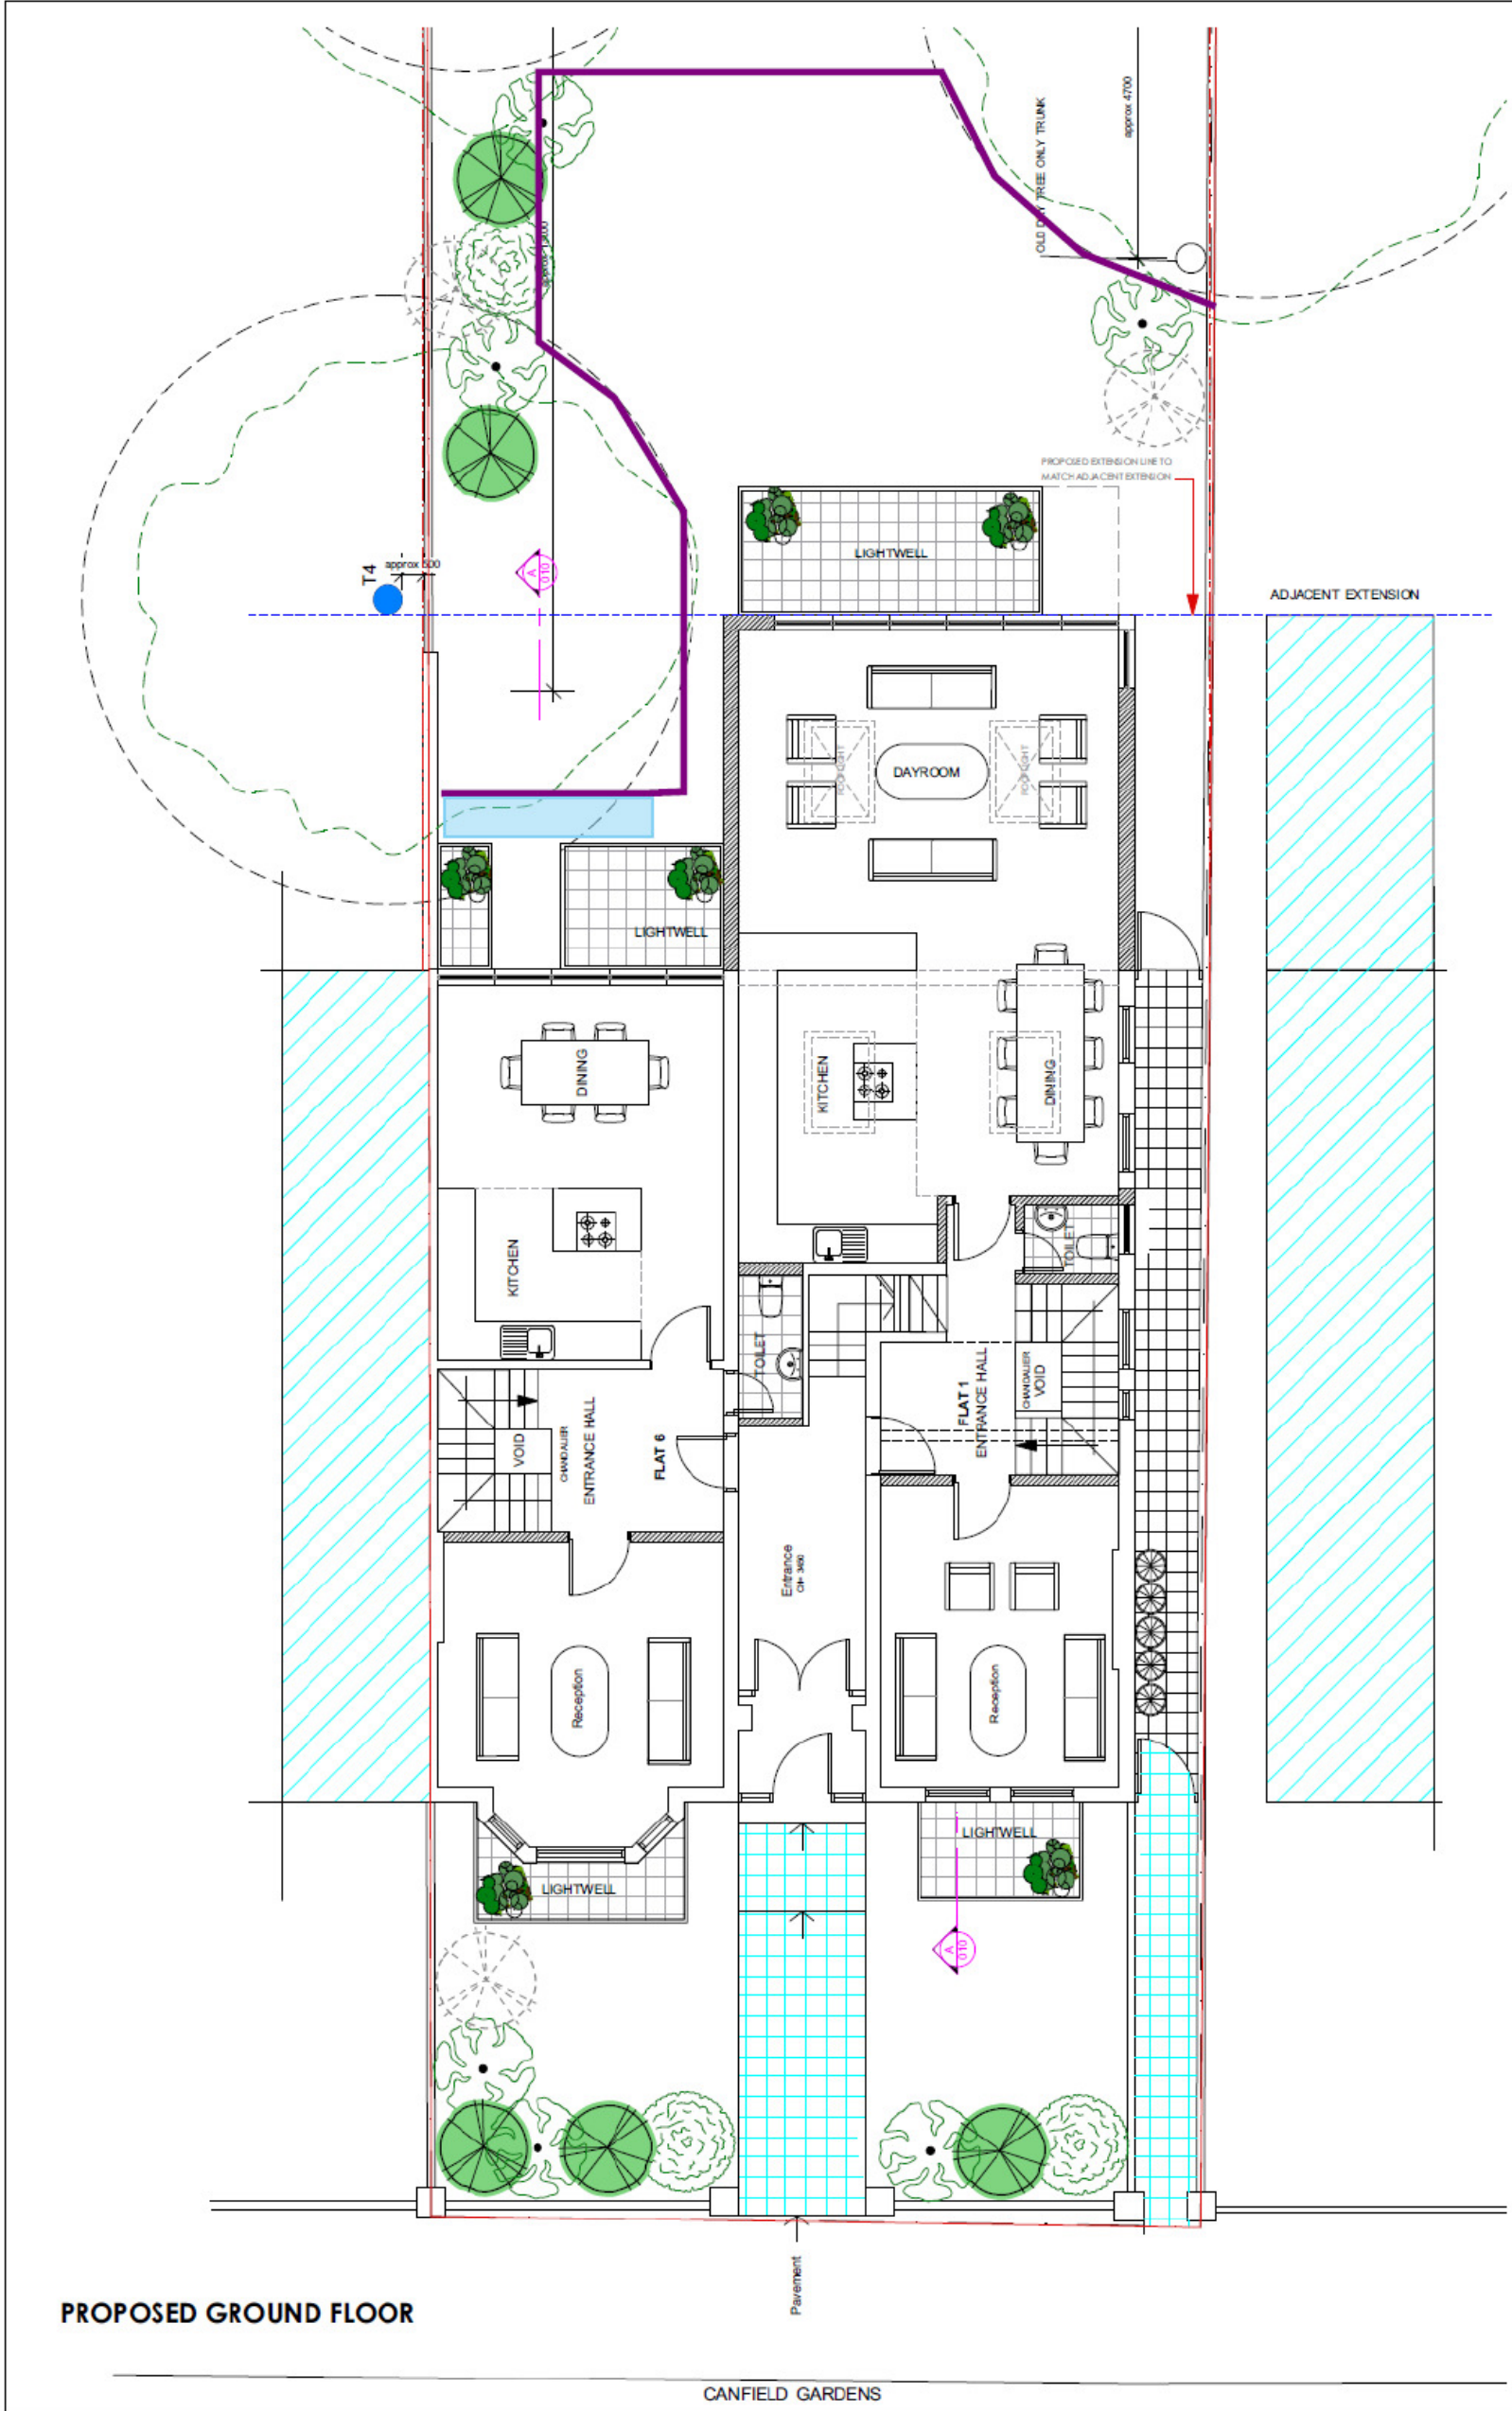
APPENDIX MD4

Proposed ground floor plan showing and positions of root protection areas (dashed circles), protective fencing (thick purple line) and ground protection (blue shading)

- 5.1 The sequence of events on site is described below and methods necessary to avoid damage to tree roots and/or branches are detailed.
- 5.2 Before any construction work takes place on site the protective fencing and ground protection will be installed in the positions shown at **MD4** and **MD5**. This will be approved and checked by a competent arboriculturist before building contractors are permitted onto the site.

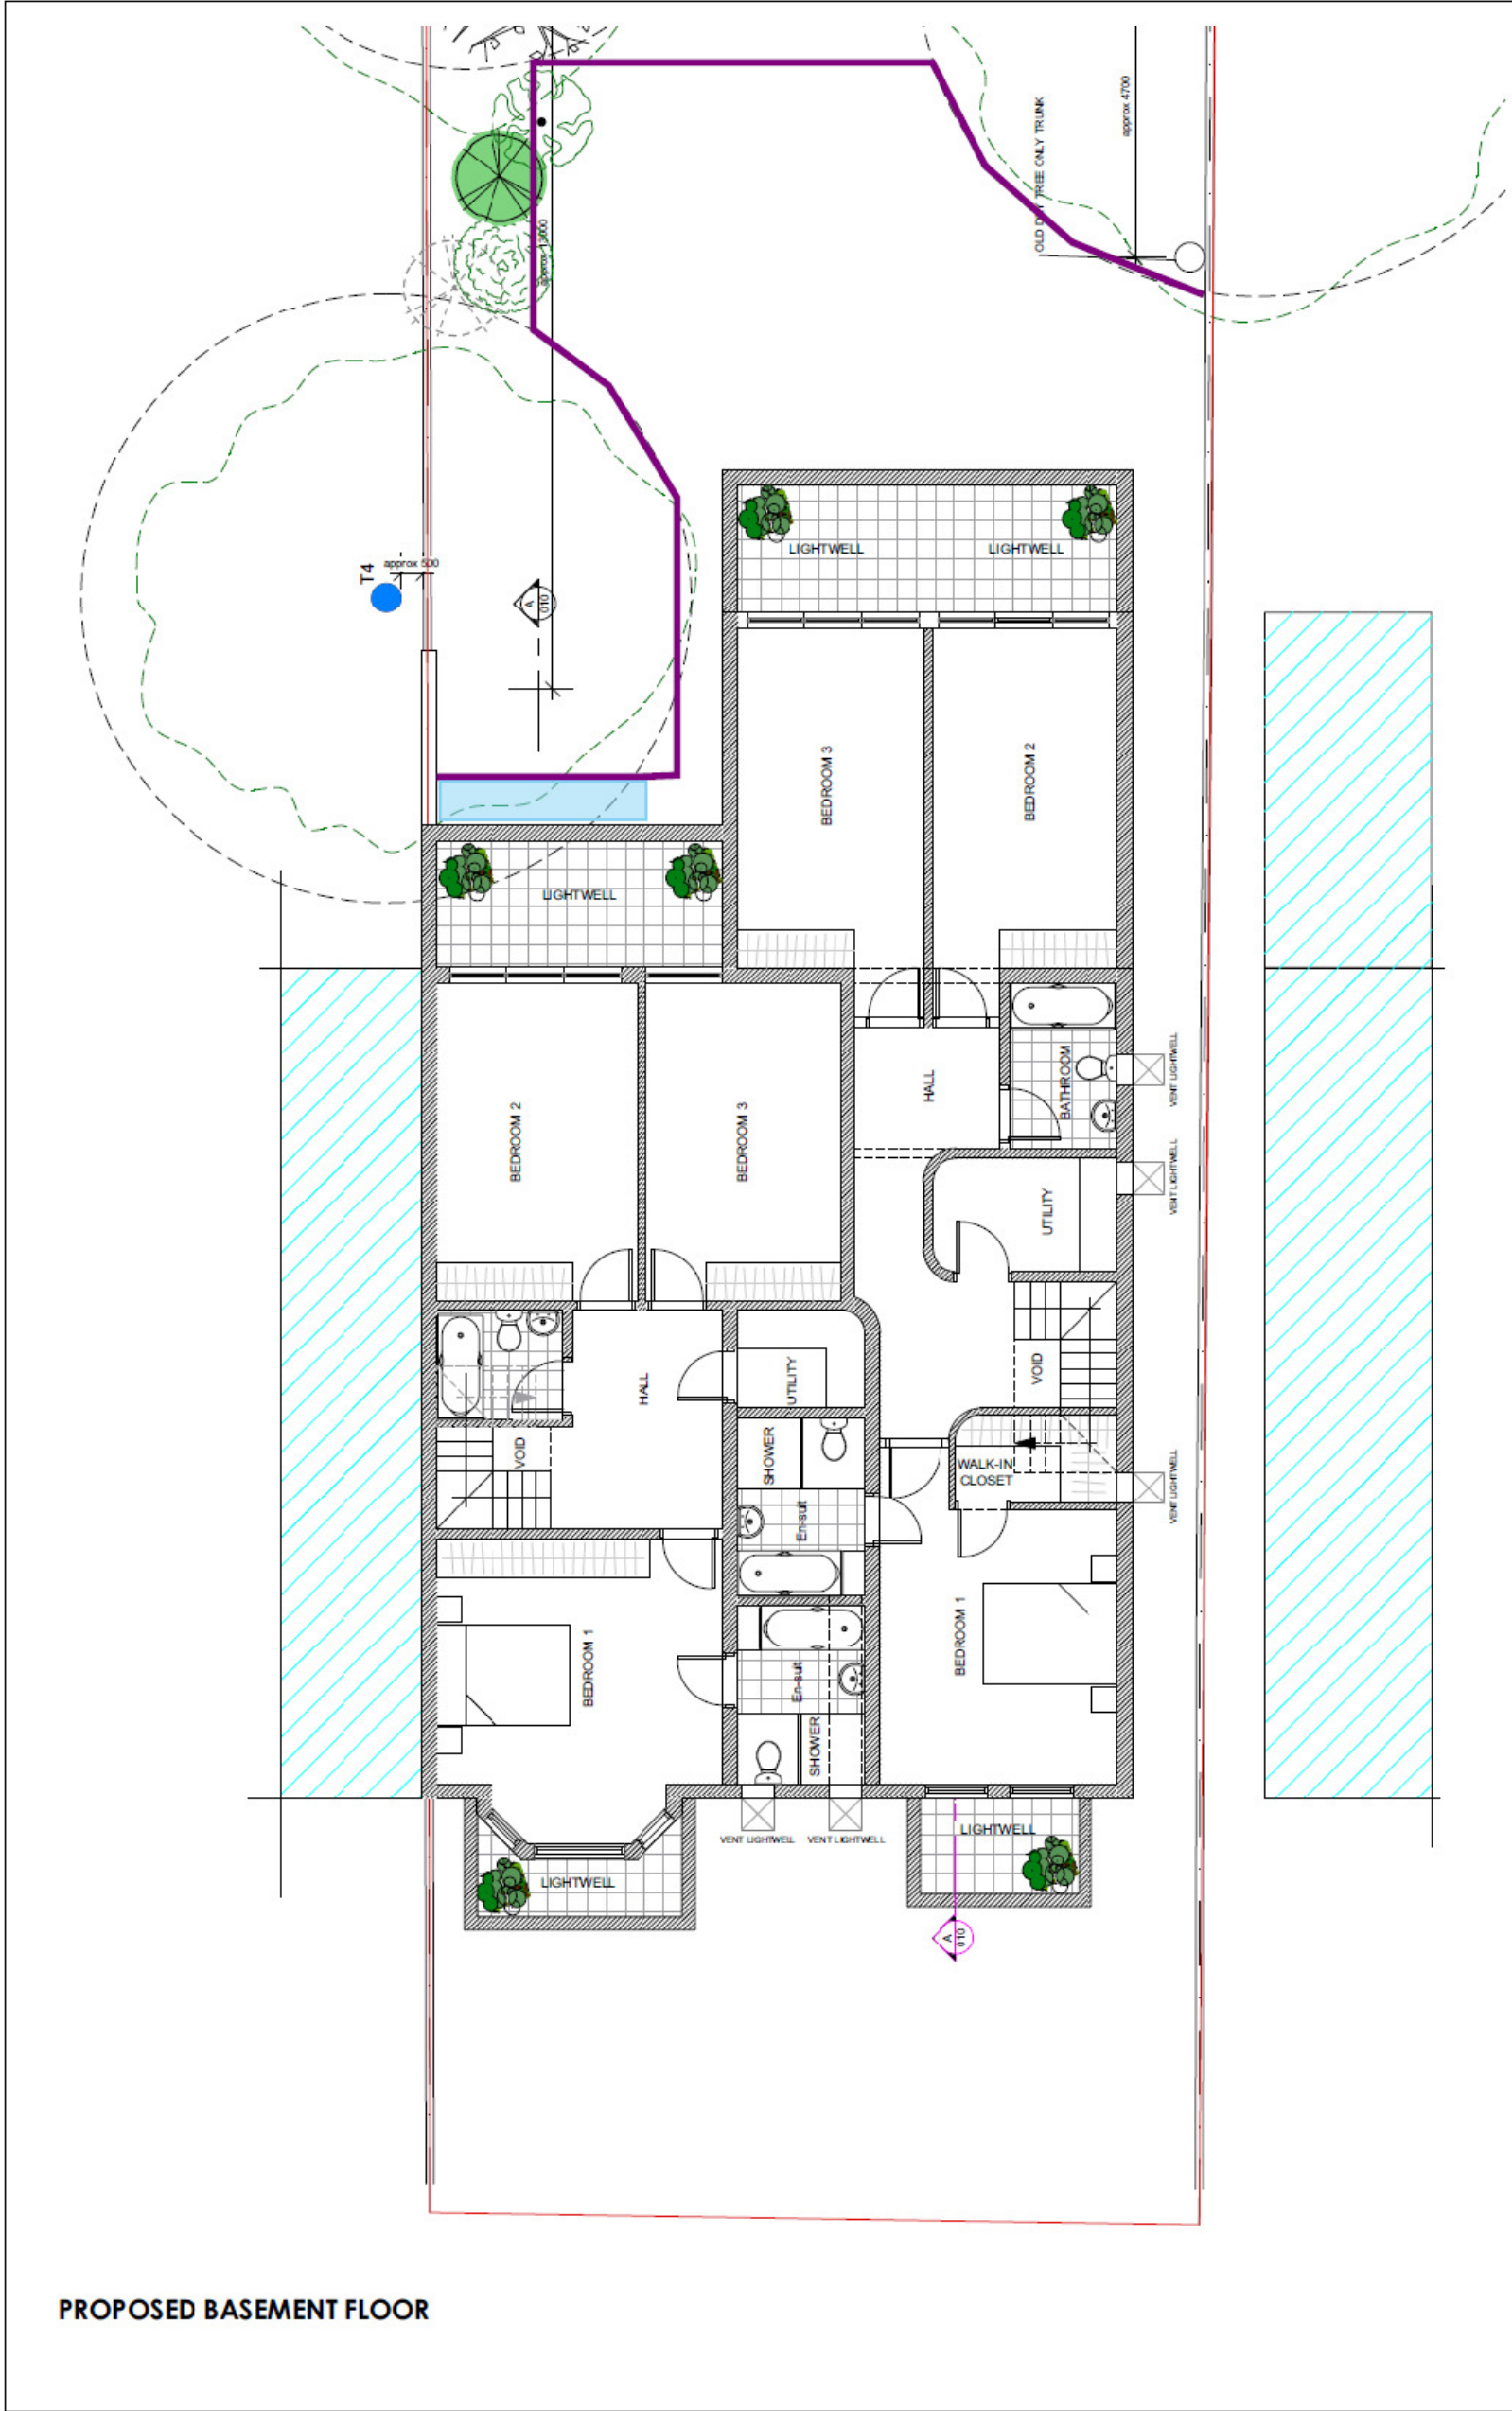
APPENDIX MD5

Proposed basement floor plan showing and positions of root protection areas (dashed circles), protective fencing (thick purple line) and ground protection (blue shading)
