Arboricultural Report

Picus Decay Investigation Report

32 Elliot Square London NW3 3SU

22nd September 2014

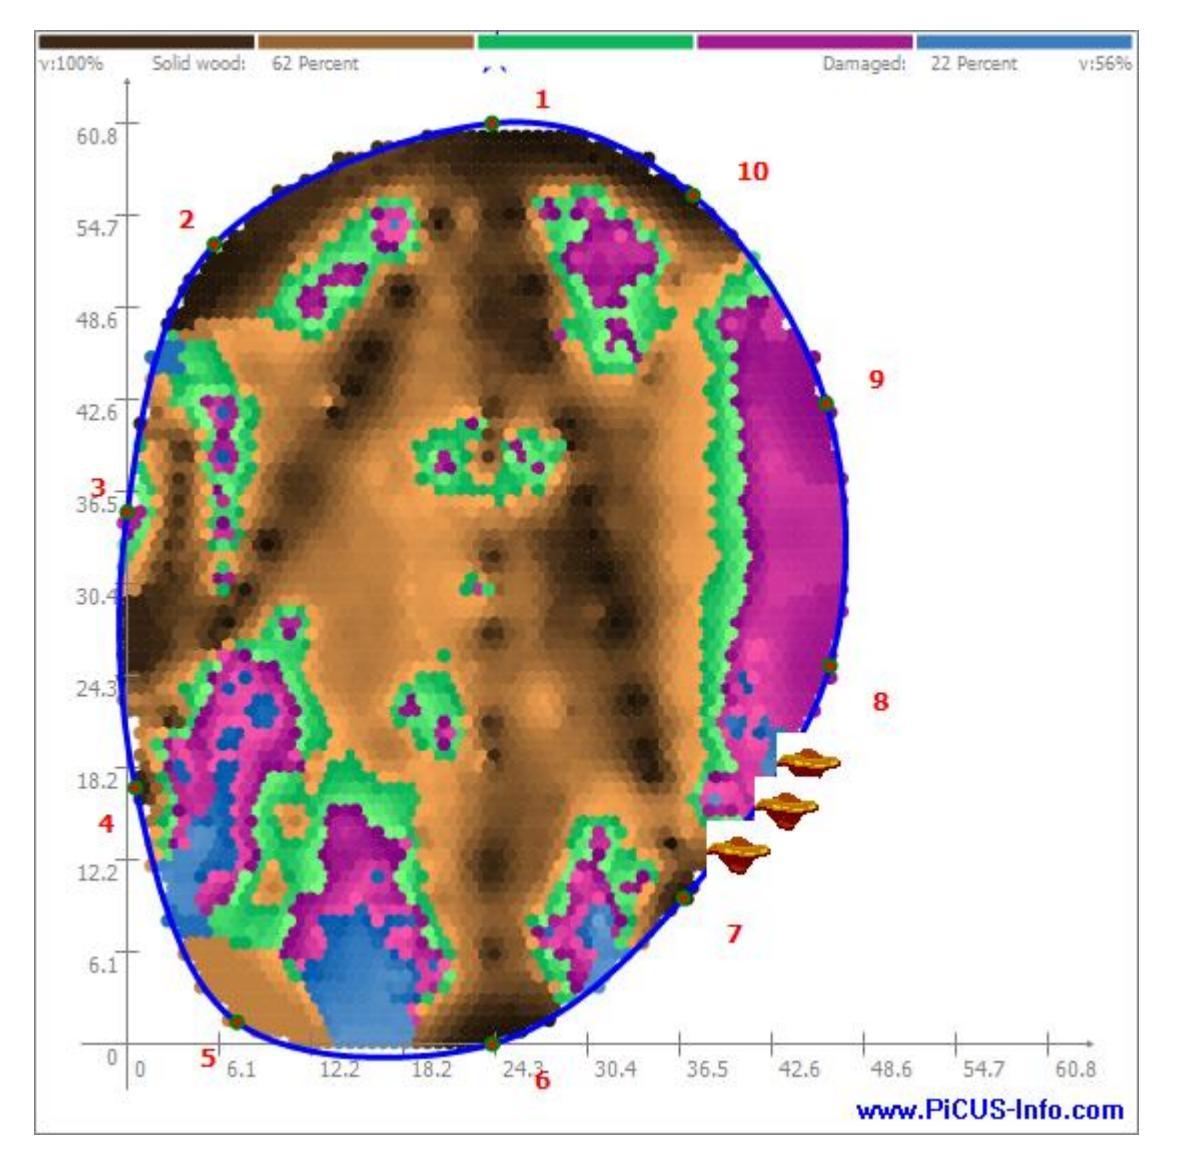
Image 2: PiCUS tomogram showing the consistency of the wood at 16cm from ground level. Sensor point one is to the North. The location of the *Ganoderma* fungal fruit bodies is indicated by the icons.

- 4.1 The soil level around the trunk appears to have been raised in the past, which appears consistent with the pattern of decay. This type of decay, extending from the outer edge toward the centre of the stem cannot be compensated for, as the tree is unable to produce reaction growth to adapt to the wood degradation.

- 5.1 The PiCUS tomogram shows a significant degree of decay in the stem, particularly around the circumference of the trunk.
- 5.2 Crown reduction work could not guarantee the safety of the tree, and would further reduce the tree's ability to compensate for the decay already present. It is also likely that the decay present in the tree will increase with time, so for these reasons the removal of the tree is recommended.
- 5.3 The tree is the subject of a Tree Preservation Order, so the local authority must be contacted for permission prior to any works being undertaken.

6.1 Due to the overall poor condition of the tree, the decay revealed in the PiCUS tomogram, the type and pattern of decay in the stem, the tree's inability to produce reaction growth to compensate for the area affetcted by decay, the unknown levels of decay below the fungal fruit bodies, and the likelihood that the situation will contnue to deteriorate with time, it is recommended that the tree is removed and replaced.

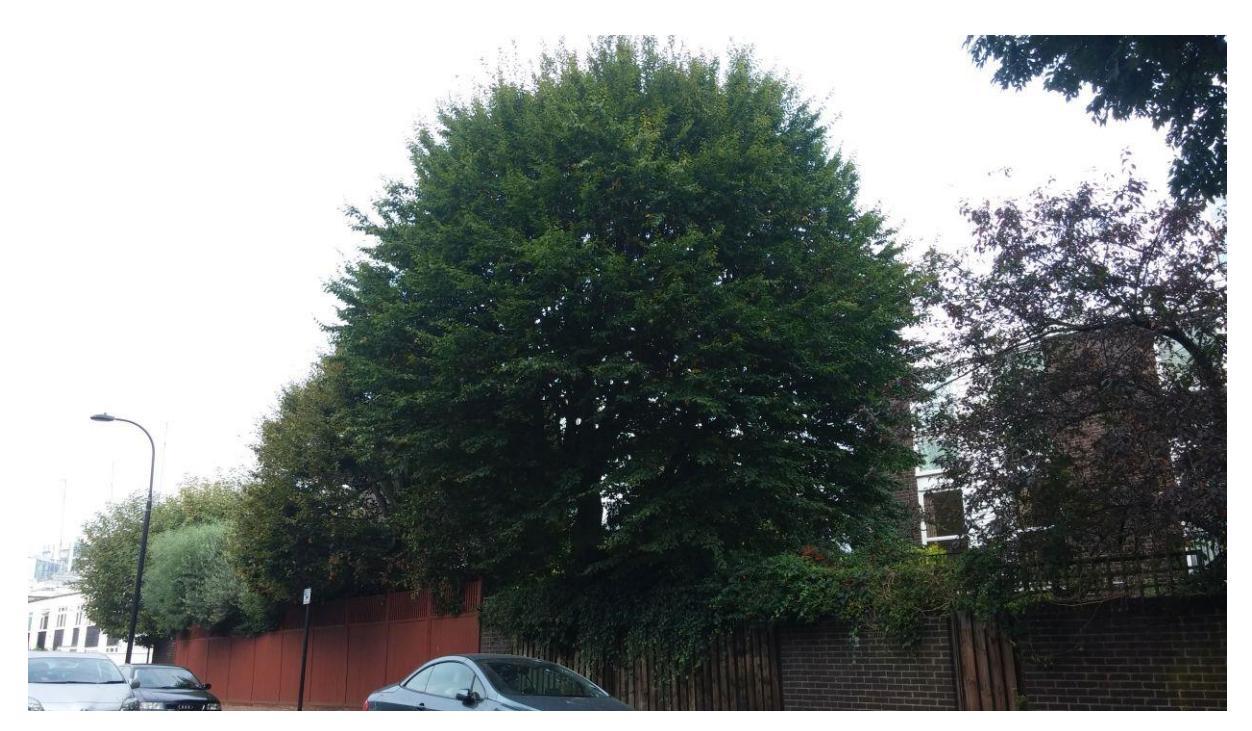
- 3.1 The tree is approximately 11m tall, with a crown spread of approximately 8m and a trunk diameter of 55cm at 1.5m from ground level. The crown appears relatively healthy from a distance, however there is some small diameter (<2cm) deadwood throughout the crown and one larger diameter (approx. 8cm) broken, decayed branch in the middle of the crown at an old reduction point.
- 3.2 The tree has had significant crown reduction works in the past, and appears to have been most recently reduced within the last five to ten years. There is some epicormic growth throughout the crown indicating that the tree has been stressed, which is likely to be associated with the previous crown reduction work.

Image 2: T1 Hornbeam viewed from the south east

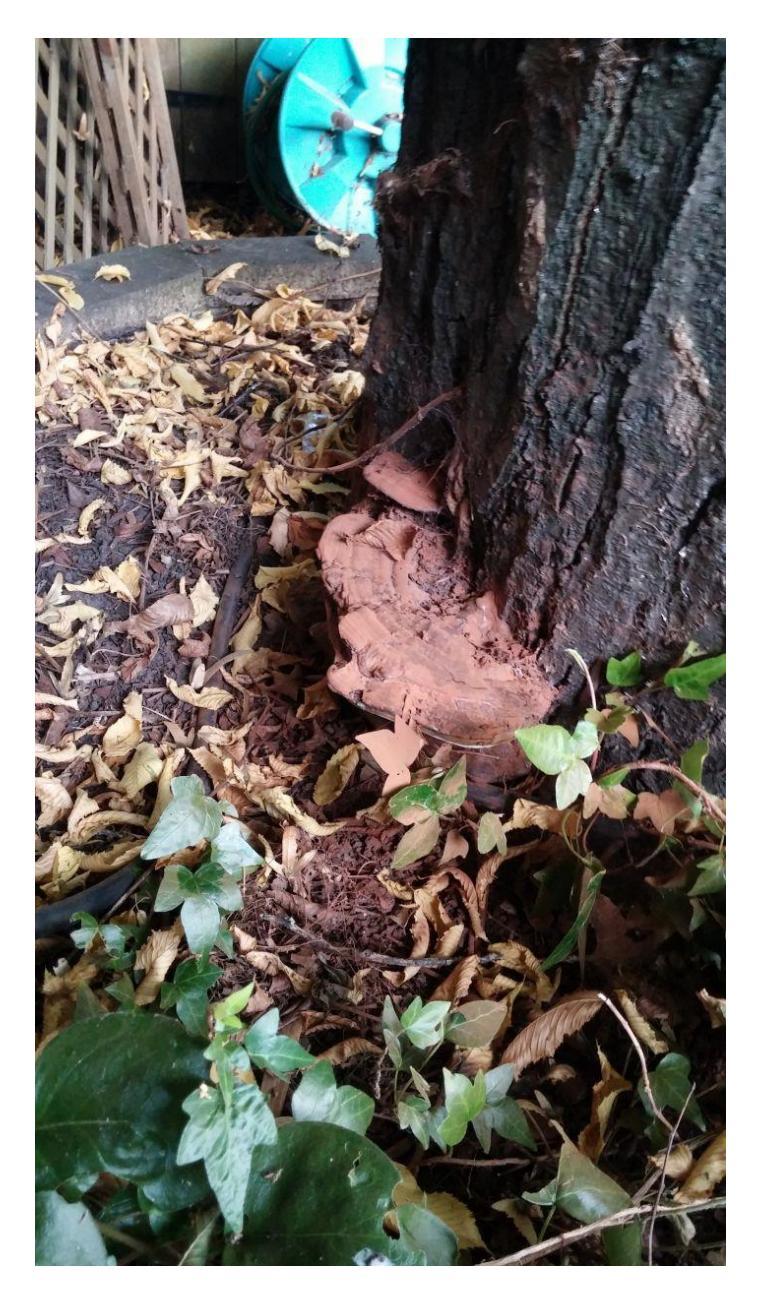
- 4.2 There is very little buttressing at the base of the stem indicating limited response from the tree to help mitigate against the effects of decay, despite the presence of *Ganoderma* fungal fruit bodies, some of which appear to have been present for several years.

- 4.3 There will be decay associated with the *Ganoderma* decay fungi; however it has not been possible to assess or quantify the level of decay in the stem and base of the tree beneath the fungal fruit bodies. The extent of decay present is likely to increase with time.

Image 3: Ganoderma fungal fruit bodies to the south

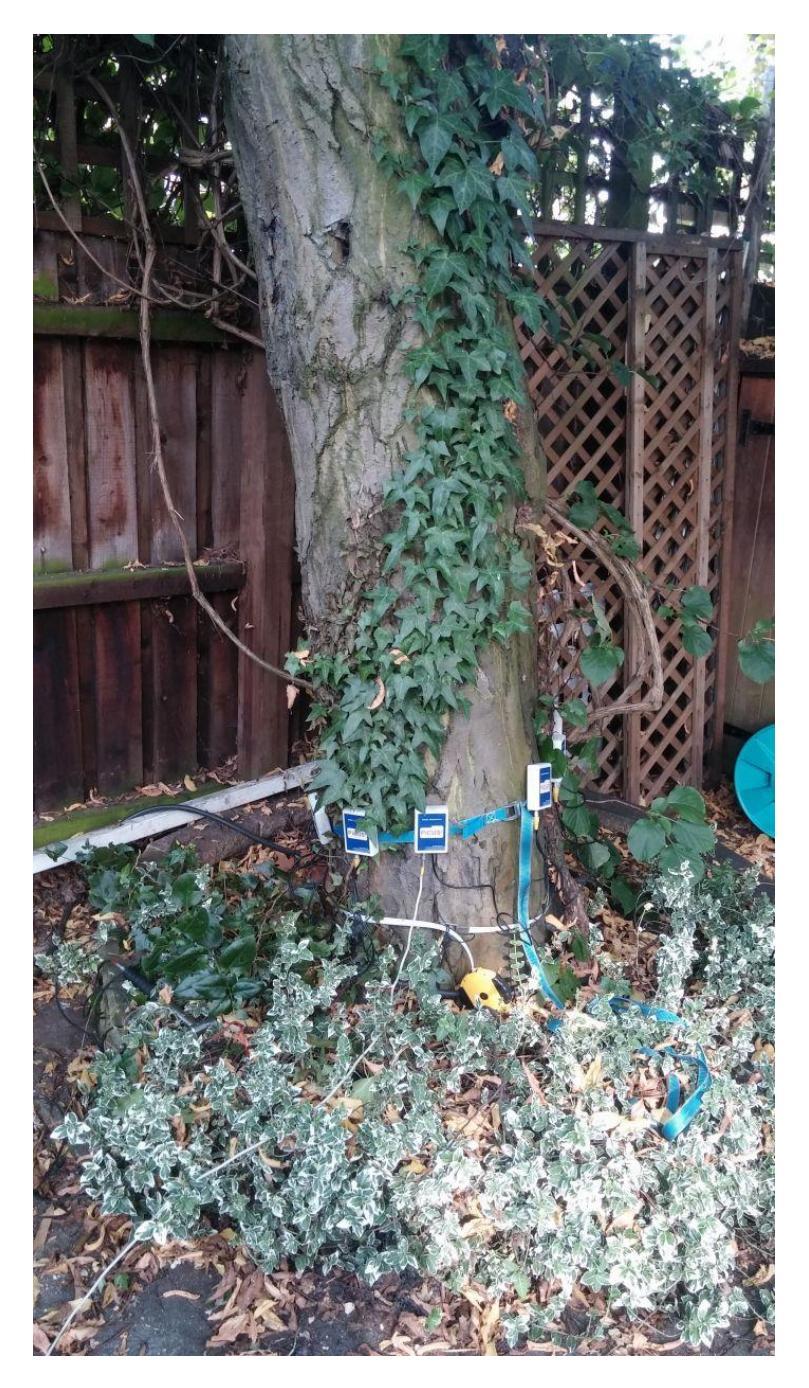
Image 4: PiCUS set up viewed from the north
