- Atelier One letter to Hanna summarising the structural concerns with the proposed development at 7 Branch Hill.
- Detailed geotechnical comments from our geotechnical consultant

Effect of proposed construction of new level of basement at 7 Branch Hill

PLANNING PROPOSAL FOR 7 BRANCH HILL

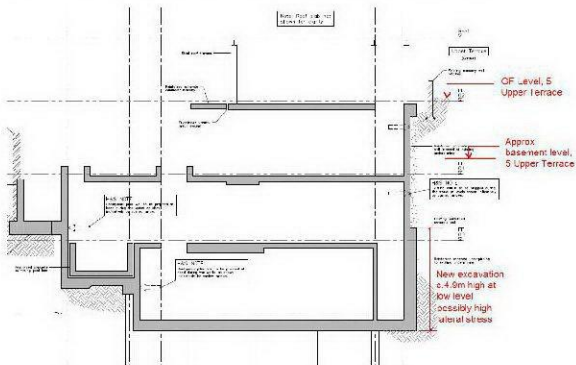
- The excavation for the new basement will be at a level significantly below the basement of 5UT (see fig below). The stress levels will be relatively high and the deposit is essentially a sand, though groundwater is probably below excavation depth. For underpinning, it will be essential to support the underpins as stiffly as possible throughout construction.

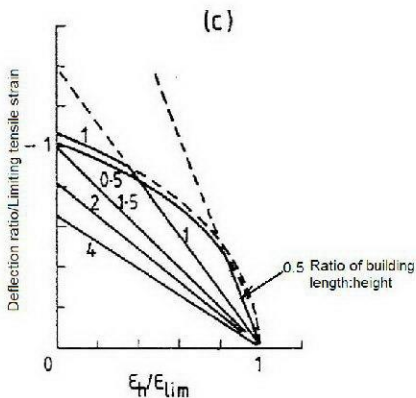
Figure 2.18 Relationship between damage category, deflection ratio and horizontal tensile strain (after Burland, 2001)

These are solely based on CIRIA C580. A more rigorous analysis should be carried out to determine the ground response. The heave resulting from unloading of vertical stress needs to be estimated. Damage criteria should be based on the attached table and graph and must take into account the distortion of the building as well as the strain. The figures given on Drg P008 suggest a horizontal strain of about 0.15% in the walls close to the corner of 5UT. This is high and should be considered in more detail.
