TREE SURVEY AND ARBORICULTURAL METHOD ASSESSMENT

A report to accompany a Planning Application for development
at 18 Redington Road, London, NW3 7RG

Report by Dr Martin Dobson

6 September 2010

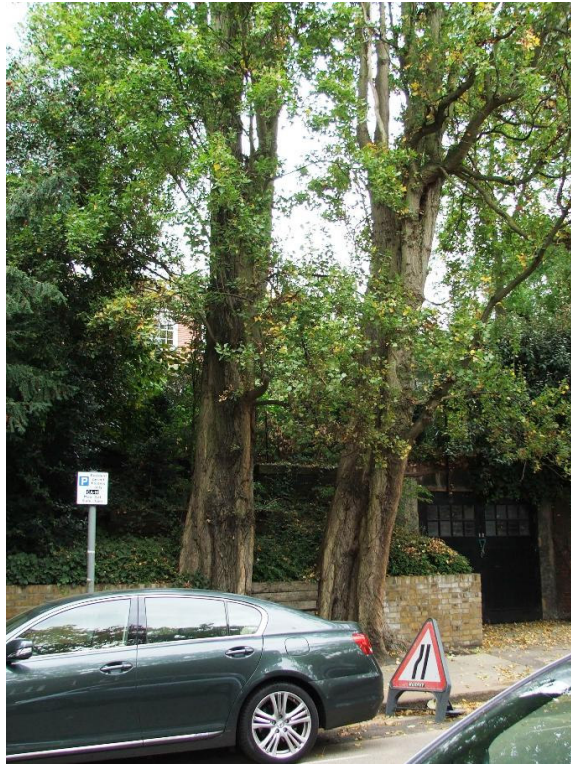
- 3.1 The site comprises a detached two storey family house set back from the road and largely screened from view by mature trees and shrubs and is located in a leafy part of Camden near to Hampstead Heath. The site slopes from back to front and the front garden is above street level; the front boundary being formed by a 1 m high retaining wall. On the line of the retaining wall, at street level, are two mature Lombardy poplars (Plate 1) which are a significant feature in the local landscape. The future growth of their trunks may well be

constricted by their position in relation to the retaining wall but at present they are considered to be trees of high value and have therefore been given an A rating.

Figure 1. Two Lombardy poplar trees (T1 and T2) at the front of the property.

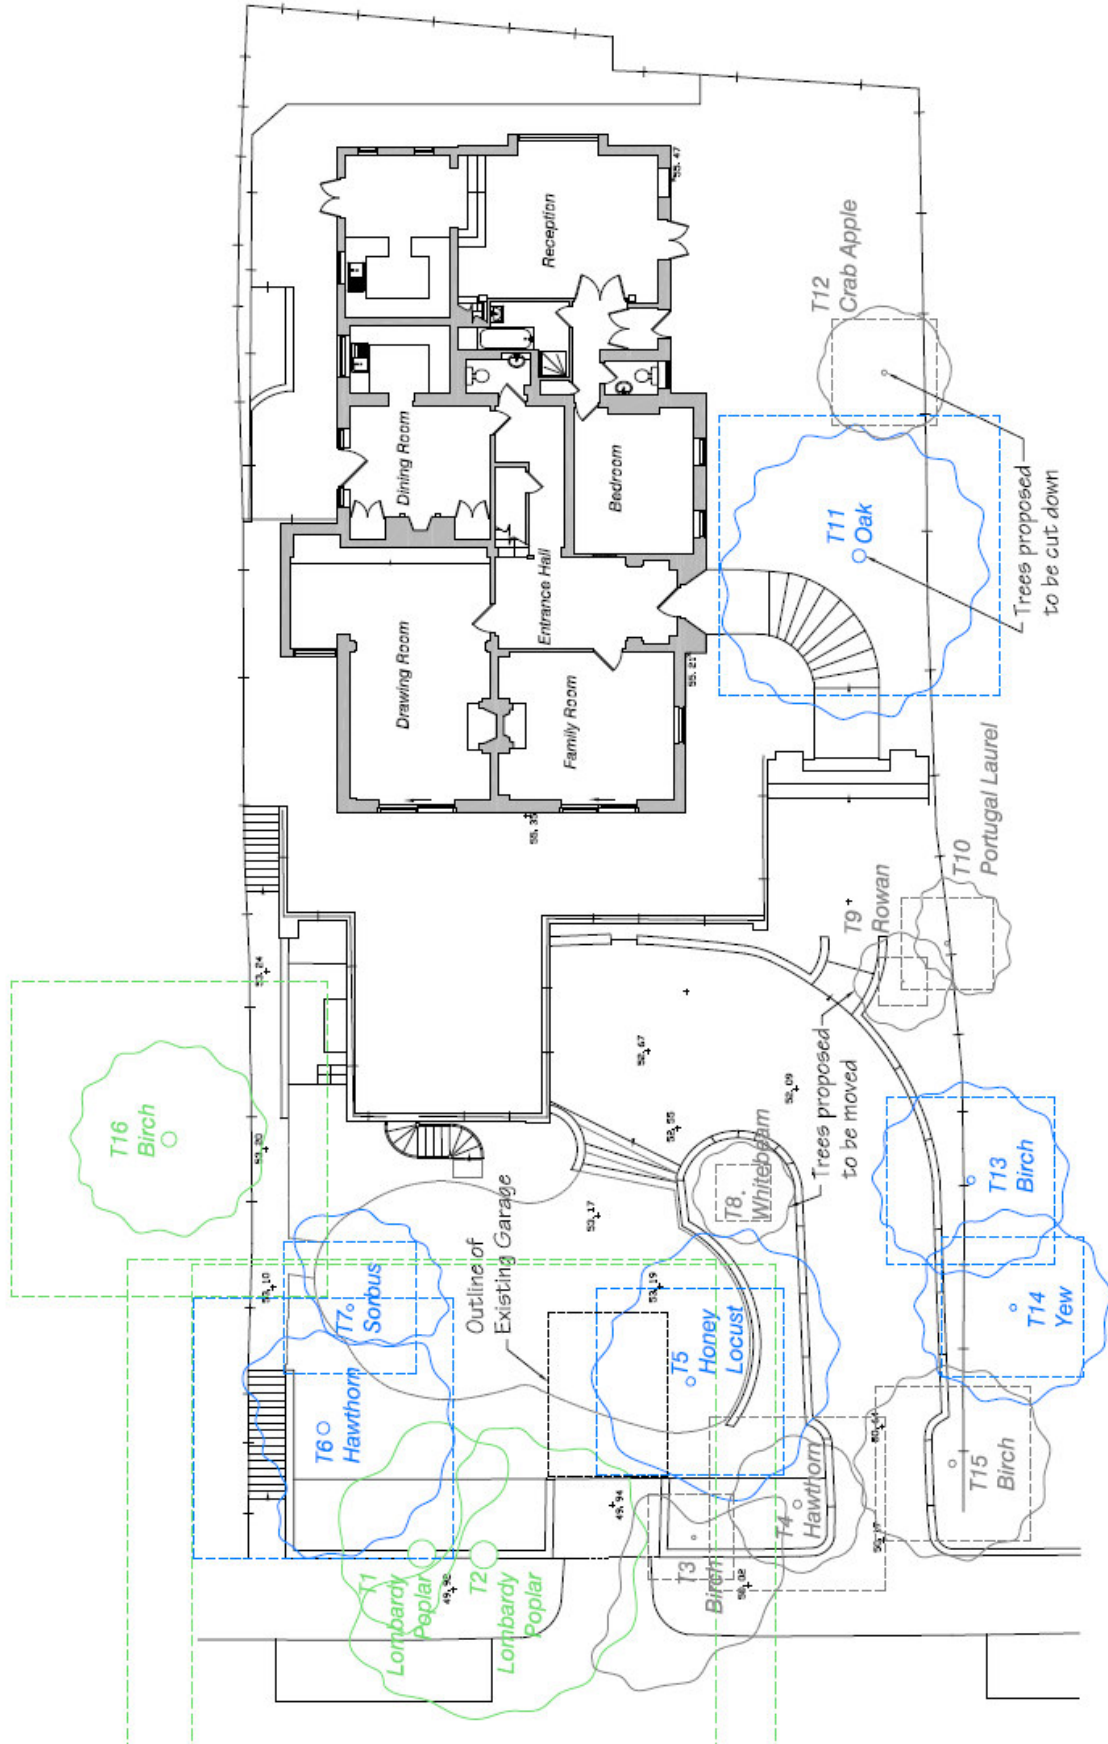
APPENDIX MD2

- 4.3 Adequate protection, both above and below ground, is therefore essential for trees that are to be retained as part of a new development. The British Standard BS5837: 2005 *Trees in Relation to Construction - Recommendations* advises that there should be a root protection area (RPA) around trees which is kept free of all construction activities by means of an exclusion zone enforced by protective fencing and/or ground protection. The RPA is calculated as the area equivalent to a circle with a radius of 12 times the trunk diameter at a height of 1.5 m above ground level. Based on the tree survey data root protection areas (and radial distances from the trunk to be protected) have been calculated and these are illustrated at **MD2** and tabulated at **MD3**.

Site survey drawing showing existing plot layout with tree numbers and BS5837 colour codes (A – Green, B – Blue, C – Grey) and root protection areas

- 5.4 Protective fencing will be installed in the positions shown at **MD2** before any materials are delivered to site or construction work takes place. The fencing will consist of a scaffold framework, well braced to resist impacts, with vertical tubes spaced at a maximum interval of 3 m (Figure 1). Onto this, weld mesh panels or 2 m high shuttering board will be securely fixed with wire or scaffold clamps. Weld mesh panels on rubber or concrete feet will not be used as these are not resistant to impact and are too easily removed by site operatives.

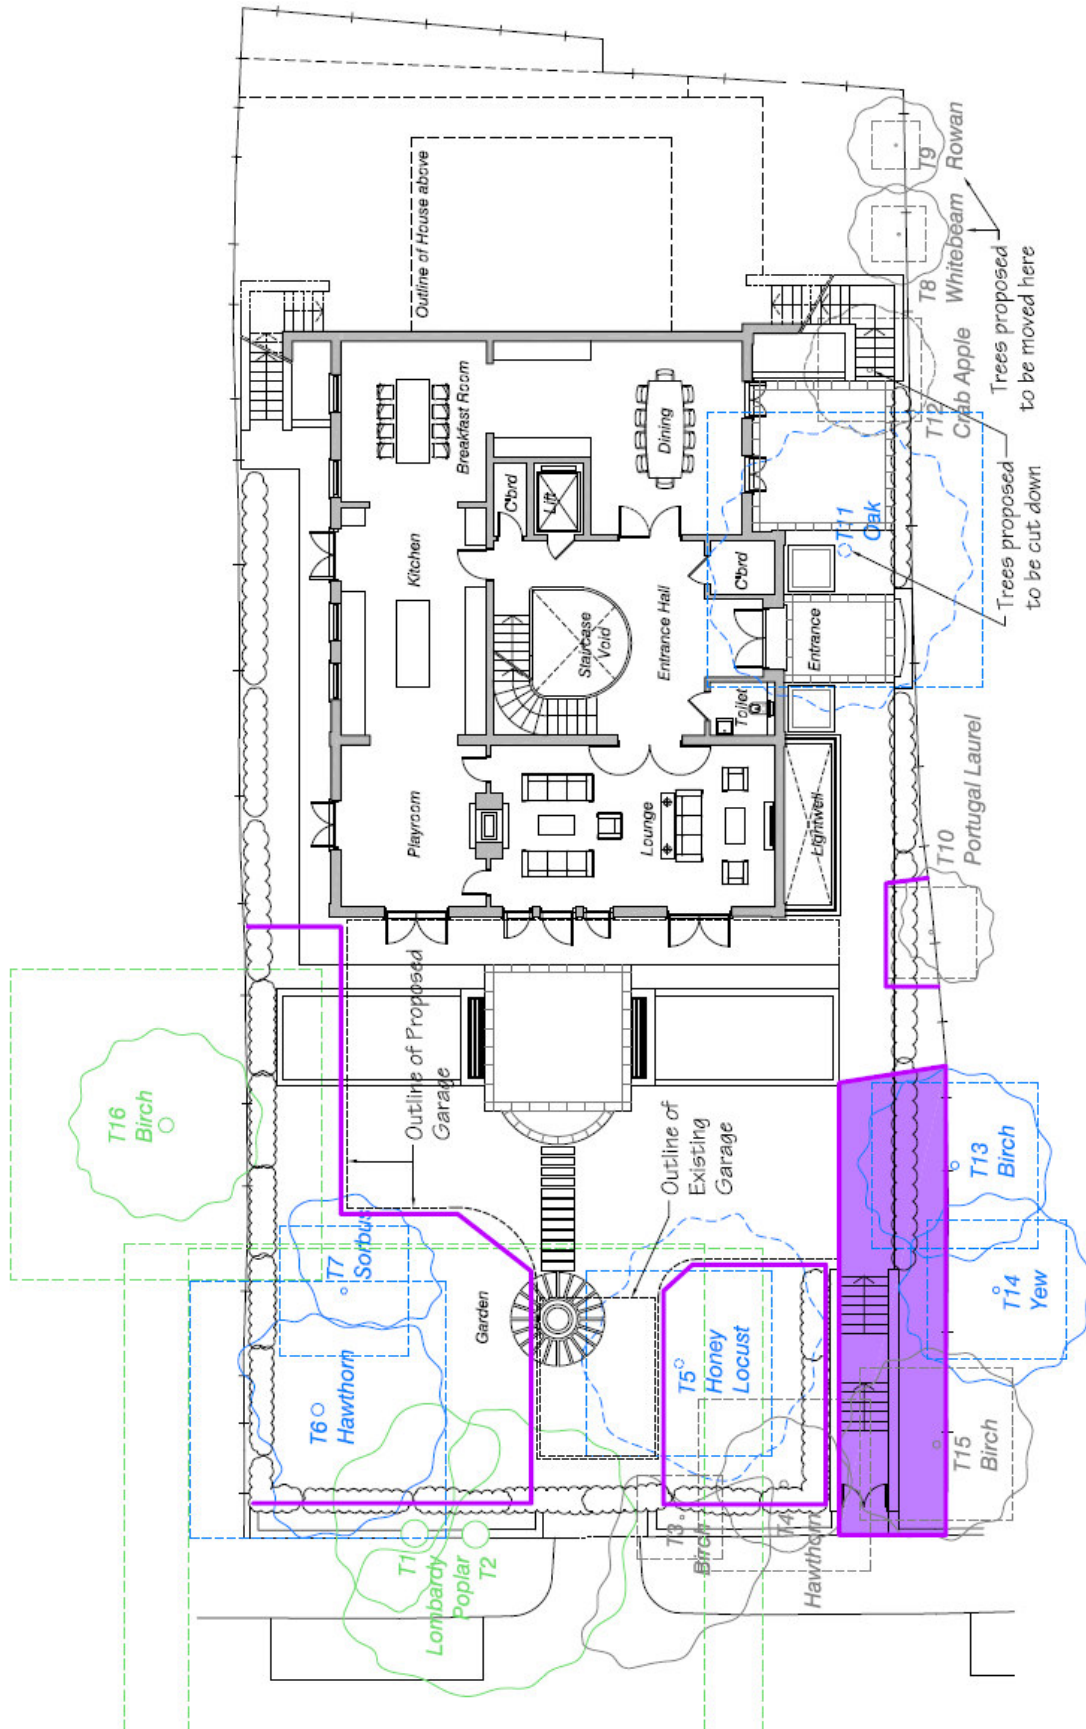
APPENDIX MD4

- 4.4 The proposed positions of protective fencing and ground protection are shown at **MD4**. The existing garage falls within the protection zone for the Honey locust T5 but it is considered that the retaining wall together with its foundations will create a barrier to root growth and therefore it is probable that there will be very few, and no significant, roots beneath the garage. Roots are likely to grow in other directions. The area of the existing drive cannot be fenced as it will be used temporarily for access to the site until a new access is formed through the existing garage. Nonetheless, roots will be protected from severance and compaction by the existing driveway surface. Once a new access has been formed the area shaded purple will be fenced until final landscaping commences. It is intended that the existing drive will be replaced by pedestrian access and steps. The steps will be formed above the existing driveway level so as not to disturb roots and the foundations will be formed on piles rather than strip footings.

Proposed plan showing location of tree protection zones, protective fencing (heavy purple lines) and ground protection (purple shading)

- 5.6 A new access will be formed through the existing garage early on in the development of the site and subsequently the area shaded purple in **MD4** will also be fenced for the duration of the construction works.

- 5.12 Incoming and outgoing services will all be installed at the front of the property underneath the proposed garage and away from tree protection areas. There will therefore be no need to dig service trenches within root protection zones (**MD4**).
