Your ref: 2013/2365/L

Dear Ms. Pound,
Fencing at main entrance to Holly Village

RESPONSE TO PLANNING APPLICATION No 2013/2365/L

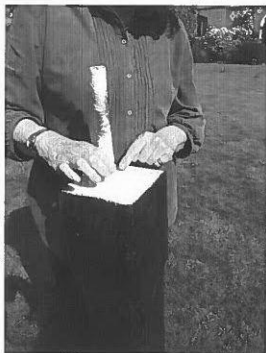
With reference to the application, the so-called 'test post', has been trimmed to remove the rotten timber at the base. It has been steam cleaned, oiled and lacquered. A metal tube has been inserted at the bottom end set in resin.

Establishing the height of a 'test post' without reference to the remaining twenty of varying condition compromises their repair. Some posts are significantly shorter and even appreciably hollow.

Location of steel pole in 'test post' by U.F.-
eccentricity renders methodology impractical.

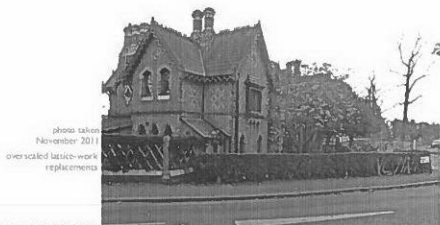
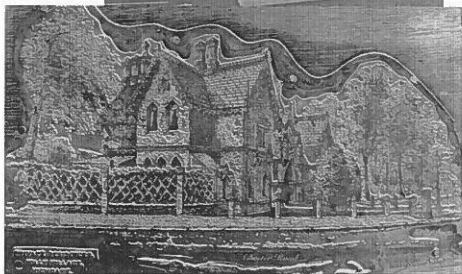
The detailed topography of the Chester Road and Swains Lane sections is different, Swains Lane having the greater fall in the direction of the road and Chester Road being affected by the Highways heightening of the back of pavement. The level difference between Chester Road and the private footpath is quite marked, unlike that of Swains Lane.

Chester Road view 2012 / etching pre-dates 1956: 'transparent' view of main entrance elevation.

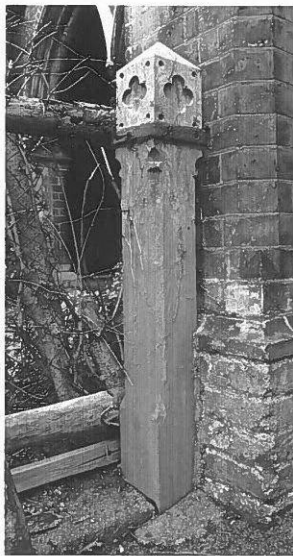
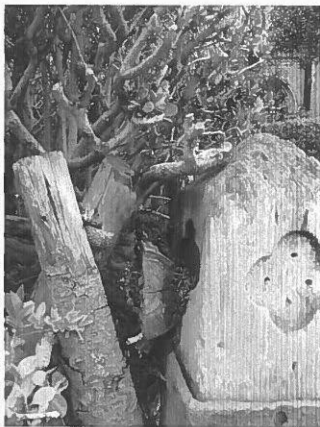
Encroachment by Highways onto private footpath / Post C1 / Post C5

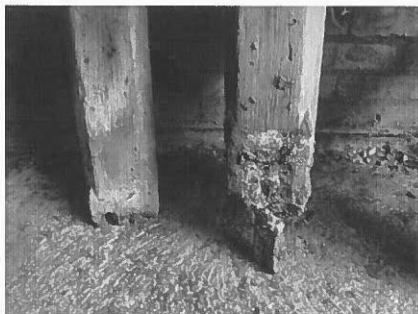
Figure 1. Rotten bases on two of the fence posts

The solution chosen to this problem was secure the posts by means of a hidden galvanised tube inserted into the base, which would then be secured by a concrete foundation hidden underground. This both provides the necessary support, and should greatly alleviate any further issues with rot. The approach is outlined in **Figure 3**. The posts would then rest on granite setts, rather than directly on the ground, which is a small visual change. Previously the posts entered a plain concrete surface, which was presumably added some decades ago, so arguably this would be an improvement.

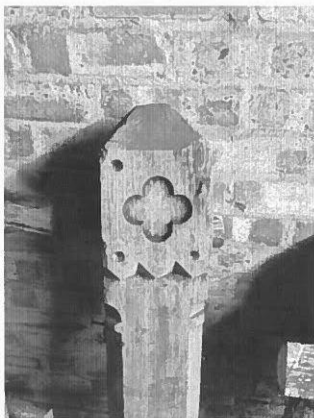
Figure 2

- The positioning of the granite setts has not allowed for the whole range of the finished heights of the posts.

Figure 2. Post header detail.

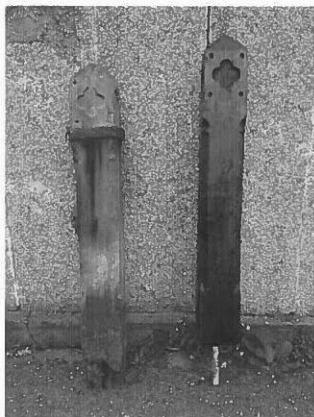
Figure 4

- The 'renovated' post illustrated is taller than the unrestored post.
- The iron collar is clearly visible on the unrestored post but omitted from the 'renovated' post.

Figure 4. Right: restored test post, left: unrestored post for comparison.
