## **Camden Lock Village**

### **Building and Tree Inspection Surveys 2014**

**Client Name:** Stanley Sidings Ltd  
**Document Reference:** EED14664-100\_R\_1\_1\_6\_SD  
**Project Number:** EED14664

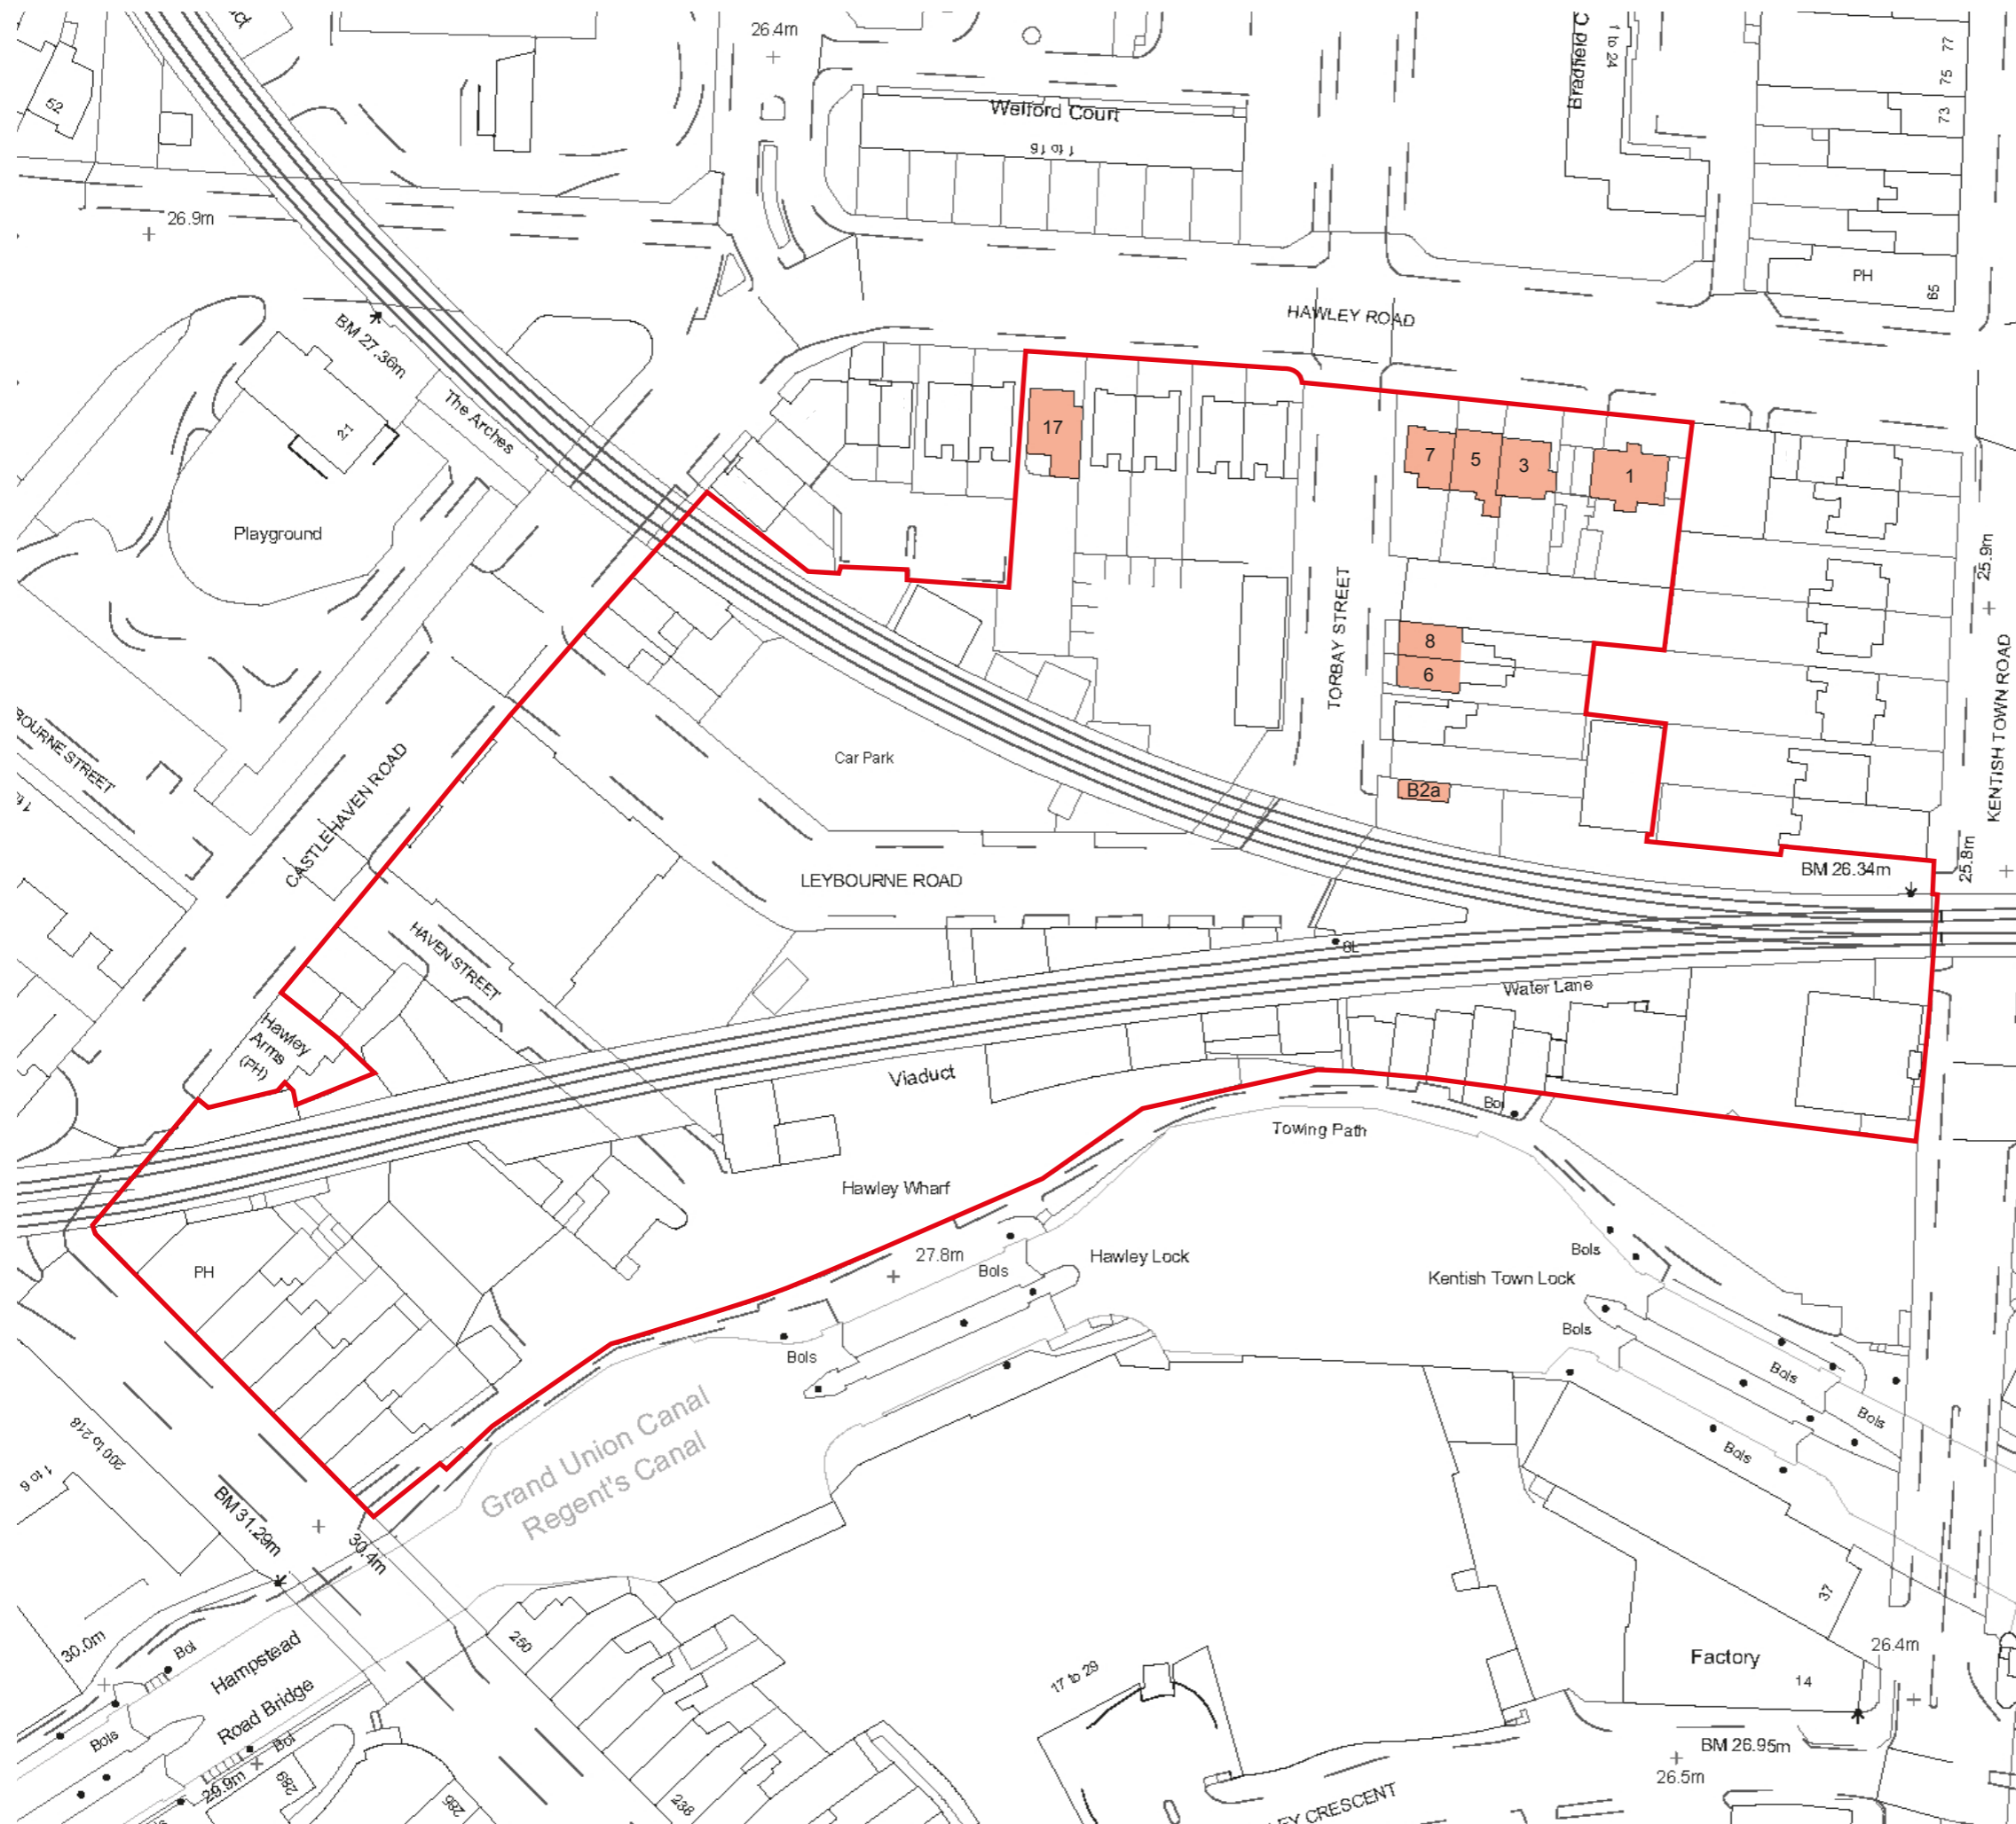
Figure 1: Buildings with Bat Potential Site Plan.

- 5.2. Eight buildings were deemed to have low potential for roosting bats (See **Appendix A**). Although the Site is located within London, habitats such as the Regents Canal, Camden Gardens and Castle Haven Open Space which are all located adjacent to the Site, provide suitable foraging habitat for bats. Given the low potential rating, a single dusk emergence or dawn re-entry survey on each building with low potential should be carried out to determine presence or likely absence of bats. Presence/absence surveys should be undertaken at an appropriate time of year when the bats are most active (May to September).
