Camden Lock Village

Building and Tree Inspection Surveys 2014

September 2014

Client Name: Stanley Sidings Ltd
Document Reference: EED14664-100_R_1_1_6_SD
Project Number: EED14664

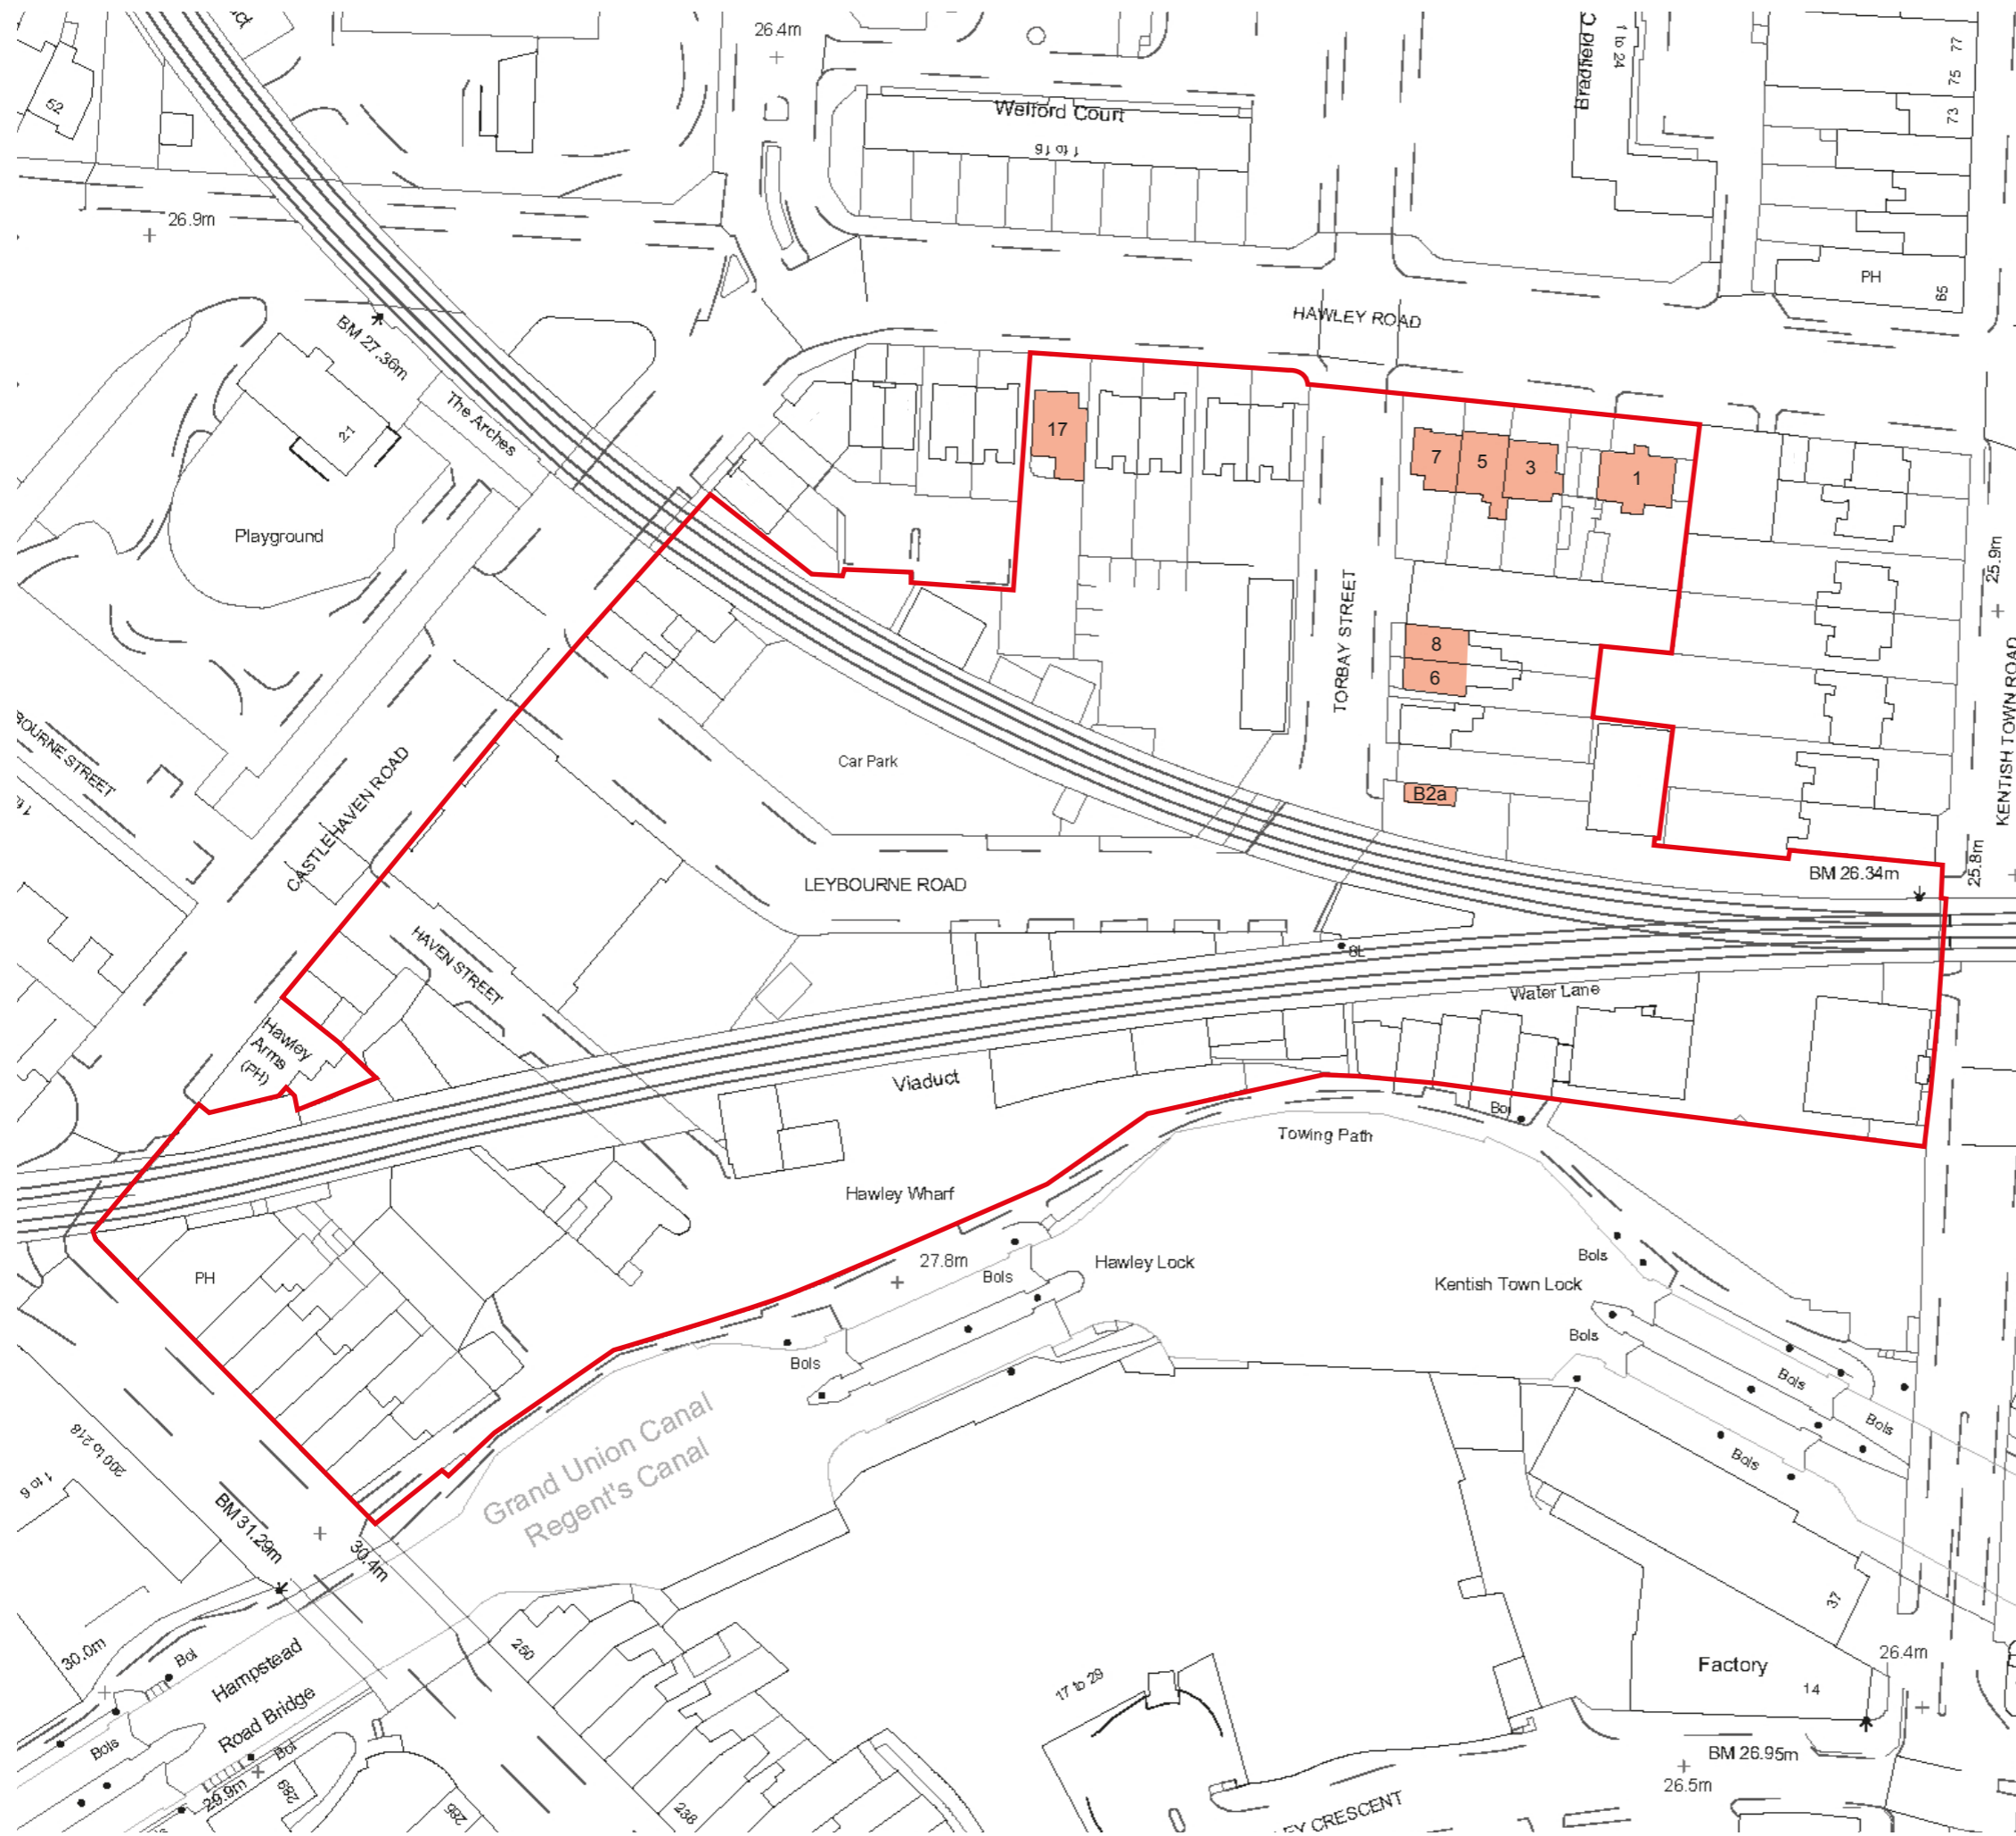
Figure 1: Buildings with Bat Potential Site Plan.

- 4.1. In total, twenty three buildings were assessed during the Site survey and eight were deemed to have potential for roosting bats. A full description of buildings and their ratings for roosting bats is given in **Appendix A**.
- 4.2. Eight buildings on Site were deemed to have low potential to support roosting bats and it is considered necessary to carry out a single dusk emergence or dawn re-entry survey on each building with low potential to determine presence or likely absence of bats. Presence/absence surveys should be undertaken at an appropriate time of year when the bats are most active (May to September).

- 5.2. Eight buildings were deemed to have low potential for roosting bats (See **Appendix A**). Although the Site is located within London, habitats such as the Regents Canal, Camden Gardens and Castle Haven Open Space which are all located adjacent to the Site, provide suitable foraging habitat for bats. Given the low potential rating, a single dusk emergence or dawn re-entry survey on each building with low potential should be carried out to determine presence or likely absence of bats. Presence/absence surveys should be undertaken at an appropriate time of year when the bats are most active (May to September).
