31 Chalcot Square London NW1 8YA

DESIGN, ACCESS & HERITAGE STATEMENT

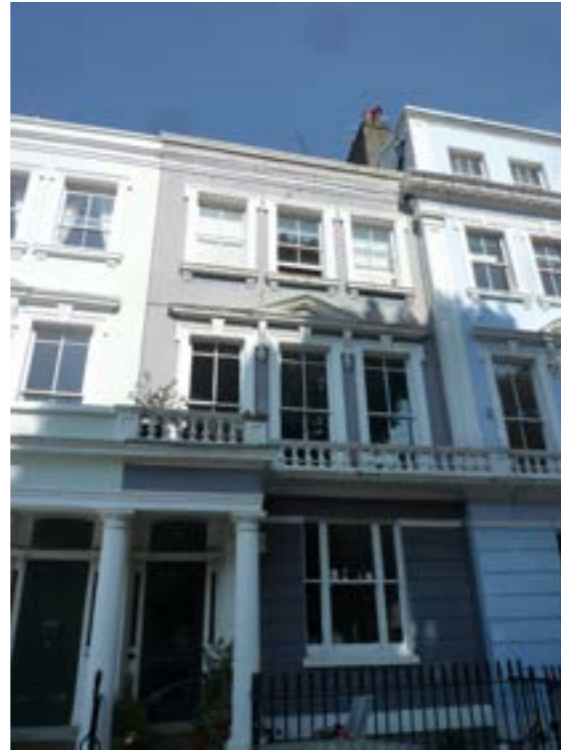
Street facade of 31 Chalcot Square

The street facade at 31 Chalcot Square is in a state of slight disrepair due to water damage and neglect.

The proposed works intend to restore the facade to a level of upkeep seen in the neighbouring properties.

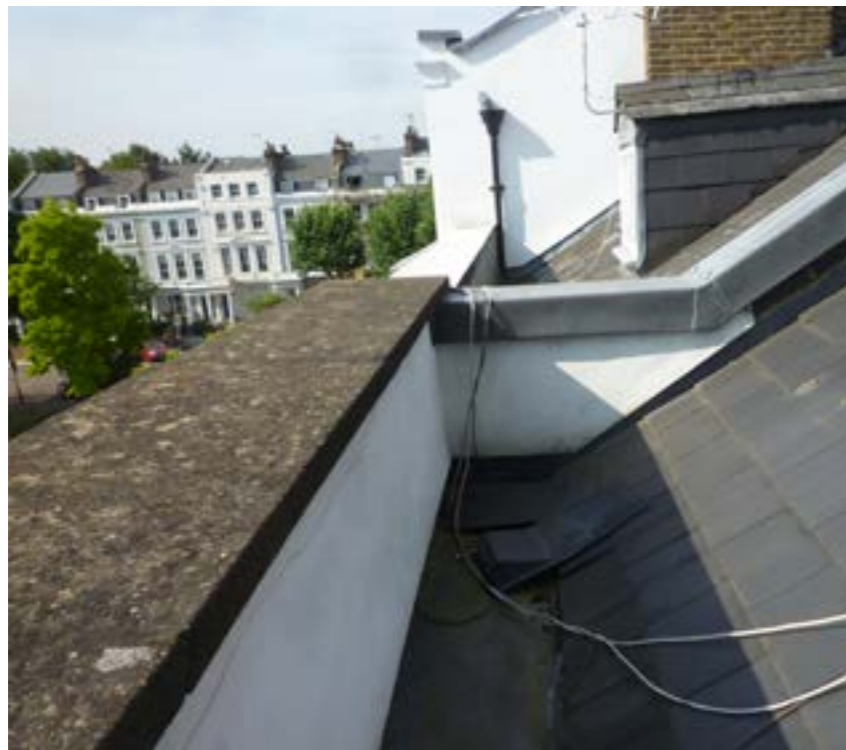
Existing concrete coping parapet to 31 Chalcot Square (32 Chalcot Square beyond)

The stonework detailing to the first floor balcony is crumbling and in some places large sections are missing. The mouldings are discoloured and the coping to the parapet wall is finished in unoriginal concrete coping stones and out of line with the neighbouring house at 32 Chalcot Square.

Removal of unoriginal concrete coping to parapet wall and replacement with lead coping. The new coping will match the height and 'inverted crenellation' drip detail at the very top of the facade.

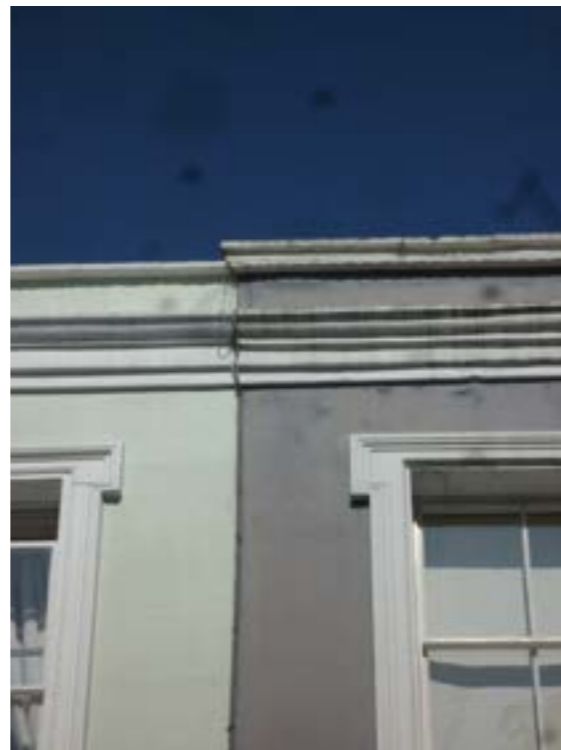
Existing mis-alignment of the parapets to 32 Chalcot Square (left) and 31 Chalcot Square (right)

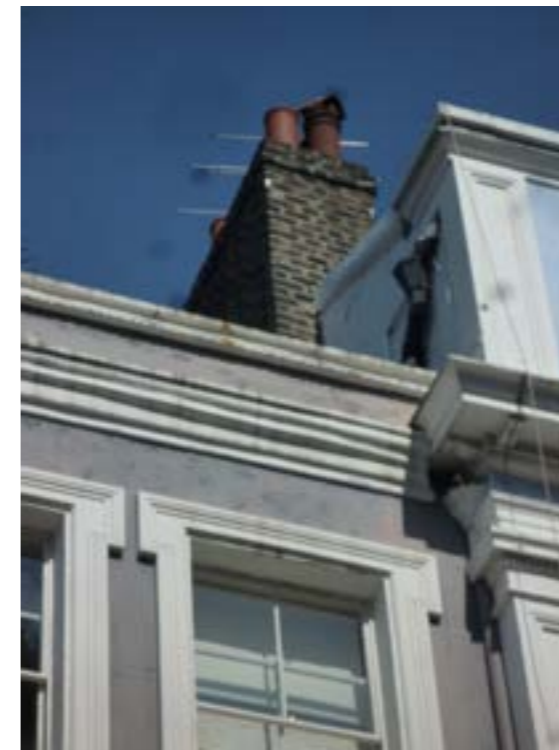
Discoloured and damaged mouldings and cornice

Repair and repainting of the window mouldings and capitals.
