PROPOSED WORKS TO FACADE

STREET ELEVATION AS PROPOSED

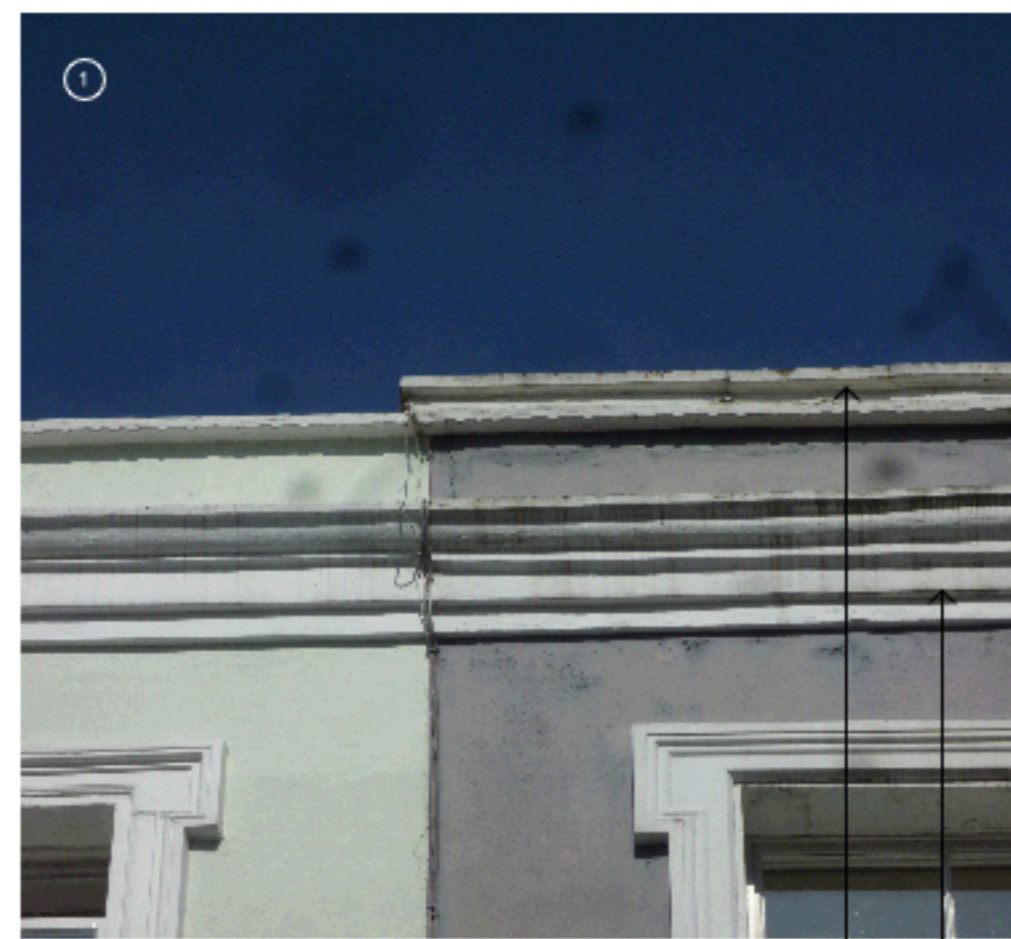
damaged cornice to be repaired

Coping to be restored to original height to match neighbouring building by the removal of the concrete coping and replacement with lead coping (see below)
