REPORT

on the impact on trees

of proposals for development

8-9, Oak Village, London, NW5 4QR

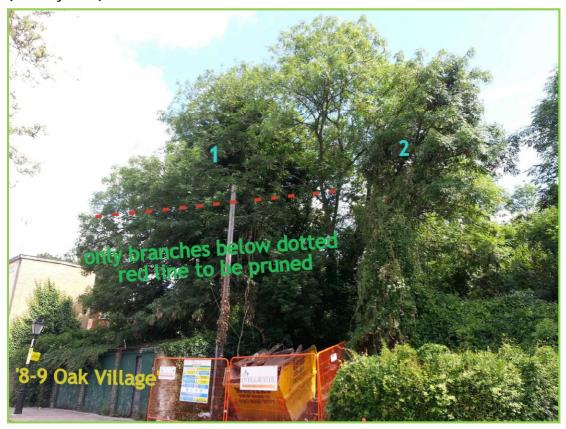
The two ash trees 1 & 2 listed below are of some general public amenity value, as they are visible from Oak Village. They stand, not on the site, but on the railway embankment behind the garages. Branches currently overhang the roof of the existing garages to a considerable degree and therefore the lower edge of the crown of T1 extends to within 3.5m of ground level (see cover photo).

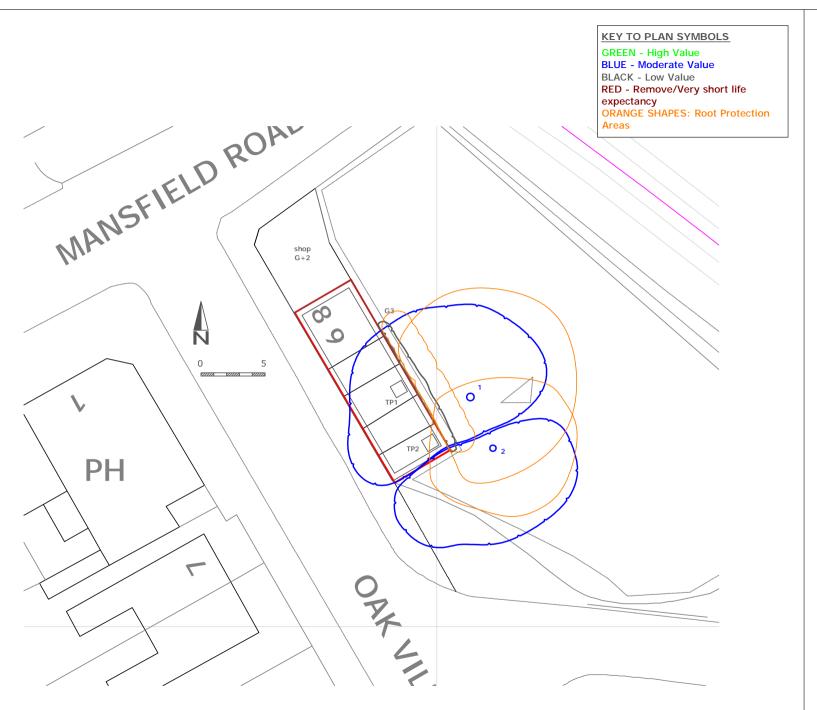
ref: 1-38-3815/P1 1:200 scale @ A3 Jul 2014

1-38-1815/P1 gives an approximate representation (in plan) of actual crown form, and is intended to indicate the relationship of neighbouring trees to each other, and should be read with the comments on crown shape and tree value in TREE DETAILS appended. The plan gives a quick reference assessment of value as per section 4, table 1, of BS 5837:2012. Assessment of value in the TREE DETAILS table appended is, in accordance with British Standard 5837:2012 'Trees in relation to design, demolition and construction - Recommendations' related mainly but not exclusively to the criterion of visual value to the general public. The Standard recommends a way of classifying trees when assessing their potential value in relation to proposed development. Some surveys may not include any trees of one or more categories. Table 1 suggests categories 'U', 'C', 'B' and 'A', in ascending merit. 'U' (RED crown outline on plan) category trees are dangerous \ low value trees that could require removal for safety or arboricultural reasons. 'C' (GREY or black/uncoloured crown outline on plan) category trees are of no particular merit, but in adequate condition for 'A' category trees (GREEN crown outline on plan) are trees of high vitality or good form, or of particular visual importance: 'B' (BLUE crown outline on plan) category are good trees but may be of slightly poorer form or

be not sited as importantly as 'A' category trees. See TREE DETAILS appended. Category Assessment appears in column 10. This standard also provides a way of determining an area (see TREE DETAILS column 7) – the RPA – root protection area - around the trunk of the tree in which protective measures should be used in order to prevent significant damage to trees. There are various ways of achieving this. A simple way is to use exclusion fencing, but other methods have been shown by established use to be very effective.
