Camden Lock Village

Bat Emergence/Re-entry Surveys 2014

October 2014

Client Name: Stanley Sidings Ltd
Document Reference: EED14664-100_R_2_1_3_SD
Project Number: EED14664

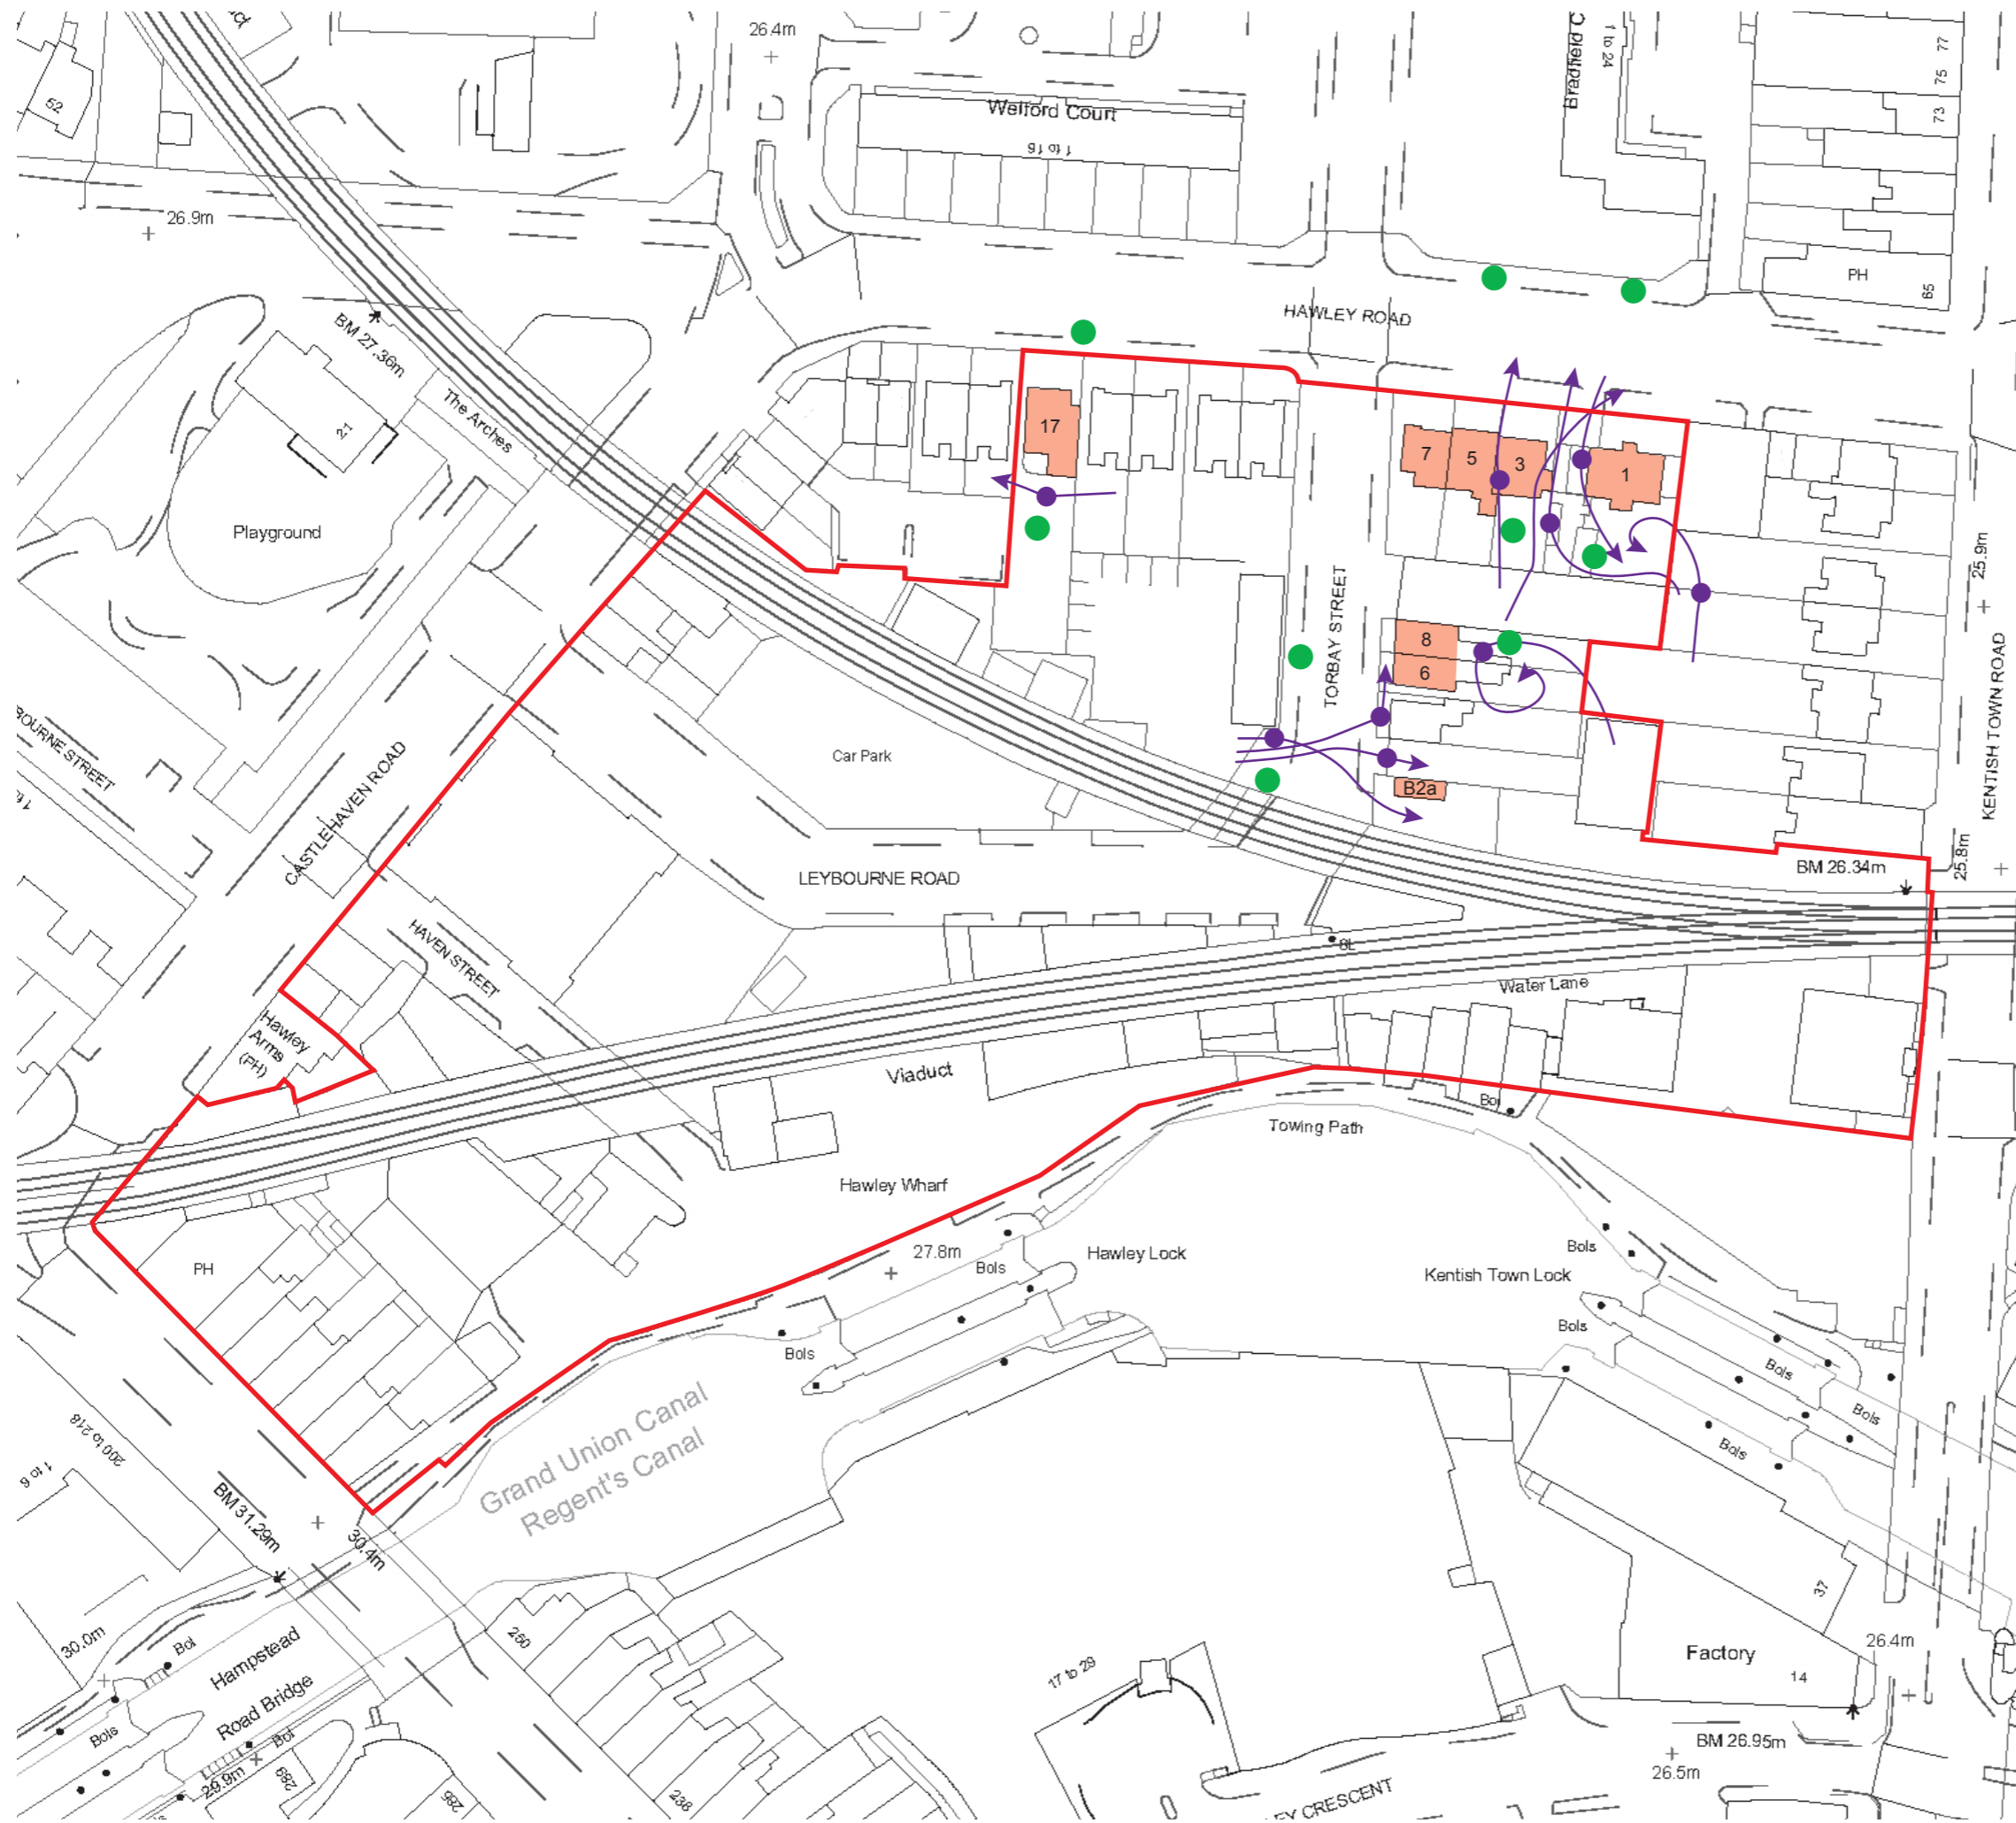
Figure 1: Buildings with Bat Flight Plan.

- 4.3. One species of bat was recorded during the emergence / re-entry surveys; the bat passes consisted of foraging and commuting common pipistrelle bats. No bats were seen emerging from or re-entering any buildings which were assessed as having low potential within the Site. The level of activity recorded at the Site was low, with most activity associated with the vegetation within gardens.

- 5.2. Precautionary mitigation measures, including the timing of works affecting bats should be timed to avoid disturbance to foraging and commuting bats (e.g. no night time working). Due to the mobile nature of bats (i.e. temporal nature of use of buildings as roosts) and the buildings potential to support bats within the Site, it is recommended that demolition works are carried out at a time of year when bats are least likely to be utilising the Site (e.g. October – March).
