## Chelmer Consultancy Services

13/15 John's Mews, London, WC1N 2PA

Title: Photographs - Sheet 1

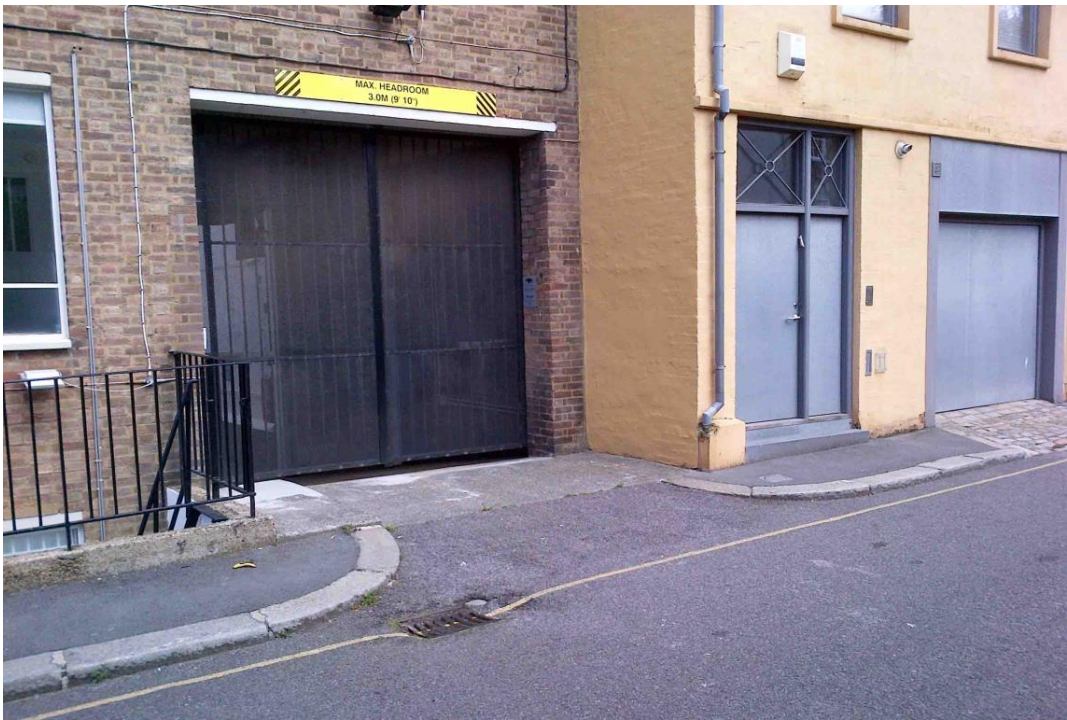
**Photo 3:** No.11 (on right) and adjoining commercial property.  
Note lightwell to lower ground floor (behind railings) and steep ramp down from vehicle access.

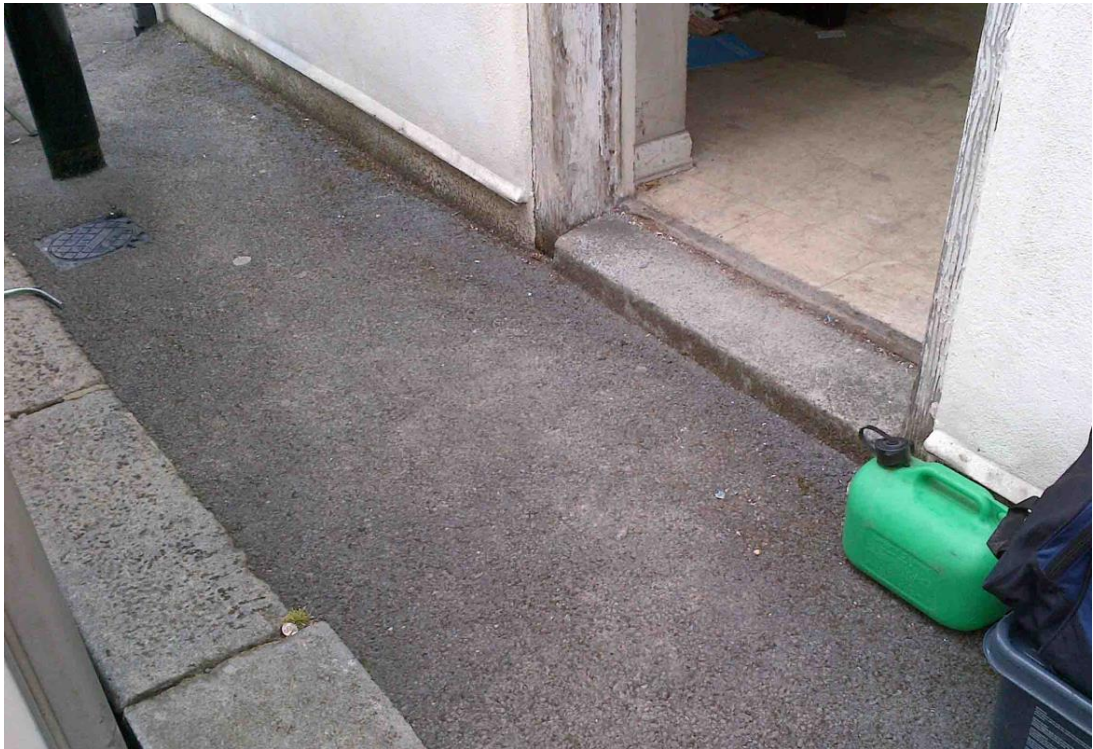
The latest surface water flood modelling shows a ribbon of 'Low' risk of flooding along the east side of the carriageway to John's Mews, which must represent a flow route when highway gullies are surcharged. No.13's garage opening and No.15's entrance door are already both raised above the gutter level by approximately 0.2m. The lower part of the new screen which will replace No.13's garage door should be designed and specified to be fully watertight. Further flood resistance could, optionally, be provided by the provision of watertight entrance doors although it is considered very unlikely that flood water would ever rise above the level of the thresholds under the modelled event.

**Photo 4:** Threshold to No.15.

- 11.16 Flood resistance measures to protect the property from the Very Low risk of surface water flooding include making the lower part of the screen which will replace No.13's garage door fully watertight, possible provision of watertight front entrance doors, and provision of suitably raised thresholds to the rear courtyard access doors (10.6.4, 10.6.5).

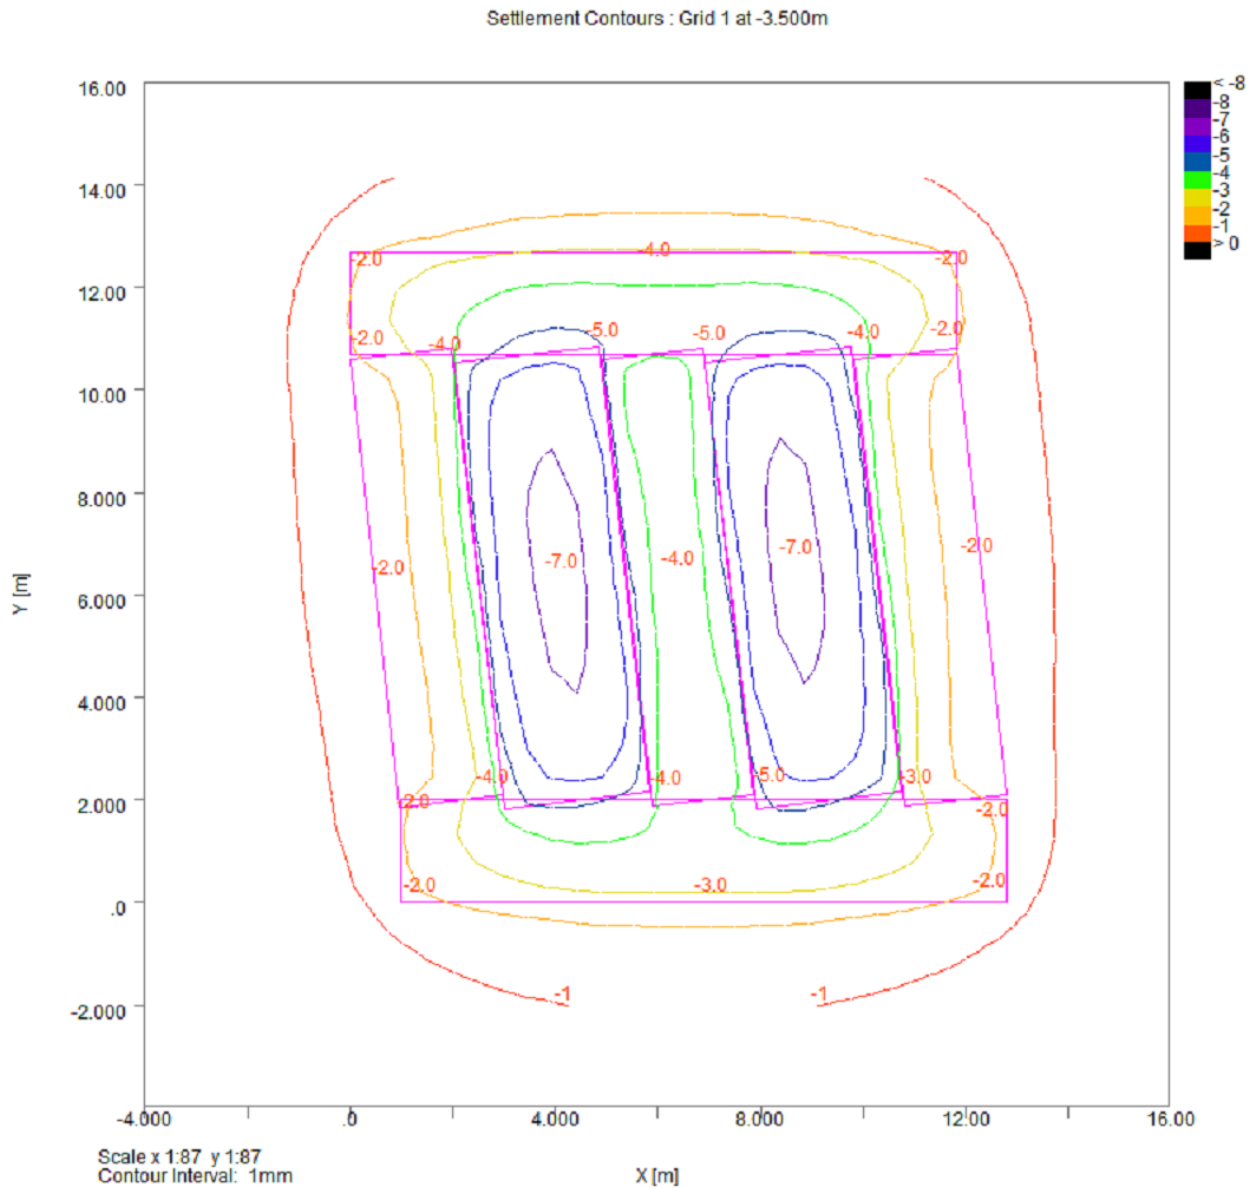
Figure C3. Short term (Stage 2) heave assessment contour

10.5.3.2 The results of the short-term and long-term analyses are presented as contour plots on Figures C3 and C4 respectively in Appendix C.

10.5.3.3 The analyses indicated that small heave movements are likely to develop beneath the underpins to the perimeter walls, while slightly larger heave movements are predicted beneath the basement slab. The ranges of predicted short-term and long-term movements for each of the main walls are presented in Table 3 below. These values are approximate, so should be used as a general guide to possible movements rather than definitive values.

<b>Location</b>	<b>Short-Term (Figure 3)</b>	<b>Long-Term (Figure 4)</b>
Front wall (Wall D)	2 - 5mm Heave	2 - 8mm Heave
15/17 Party Wall (Wall B)	2 - 5mm Heave	2 - 7mm Heave
Rear wall (Wall C)	2 - 5.5mm Heave	3 - 9mm Heave
11/13 Party wall (Wall A)	2 - 5mm Heave	3 - 7mm Heave
Central wall (Wall E)	3 - 5mm Heave	4 - 8mm Heave
Centre of basement slab	Max 7mm Heave	Max 11mm Heave

- 10.5.3.7 Given the presence of Made Ground below the basement and the resulting importance of balancing, as far as possible, predicted heave and settlement magnitudes which will result from construction of the basement, it is recommended that further ground movement analyses must be undertaken during the design stage in order to assess further the likely range of heave/settlement magnitudes.

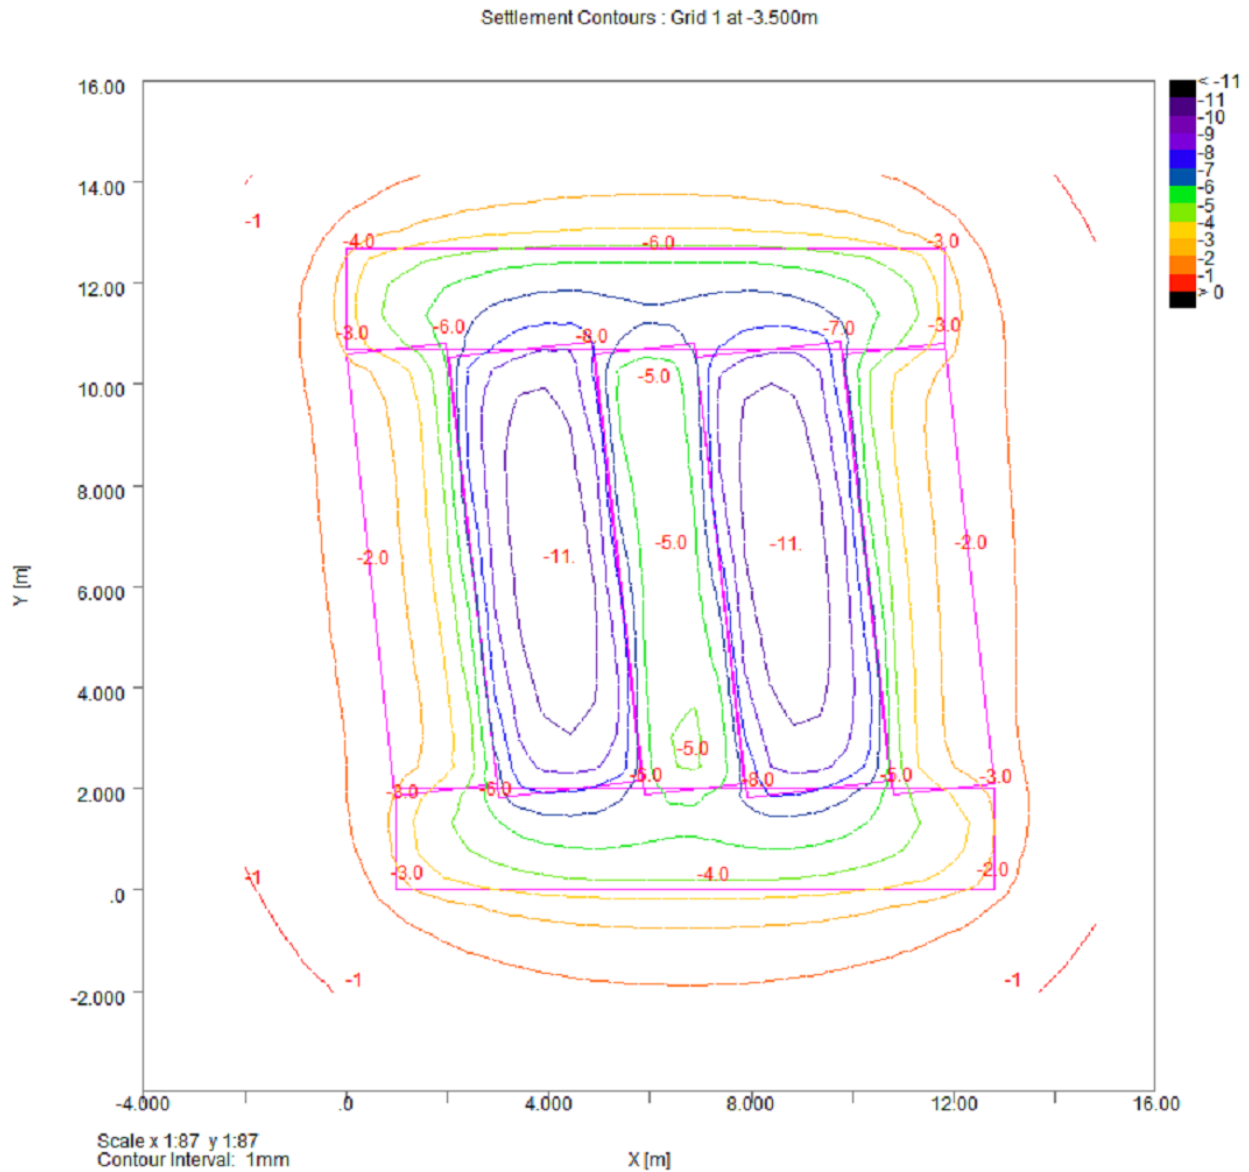
Figure C4. Long term (Stage 4) heave assessment contour

- 10.5.3.6 All the short-term ground movement would have occurred before the basement slab is cast, so only the post-construction incremental heave is relevant to the slab. The maximum predicted heave beneath the slab is in the central area of excavation, where the maximum post-construction heave beneath the basement slab is predicted to be approximately 4mm.
